Origin of Gypsum-rich Coatings on Historic Buildings

J. Sanjurjo Sánchez · C. A. S. Alves ·
J. R. Vidal Romaní · D. Fernández Mosquera

Received: 12 August 2008 / Accepted: 19 February 2009 / Published online: 14 March 2009
© Springer Science + Business Media B.V. 2009

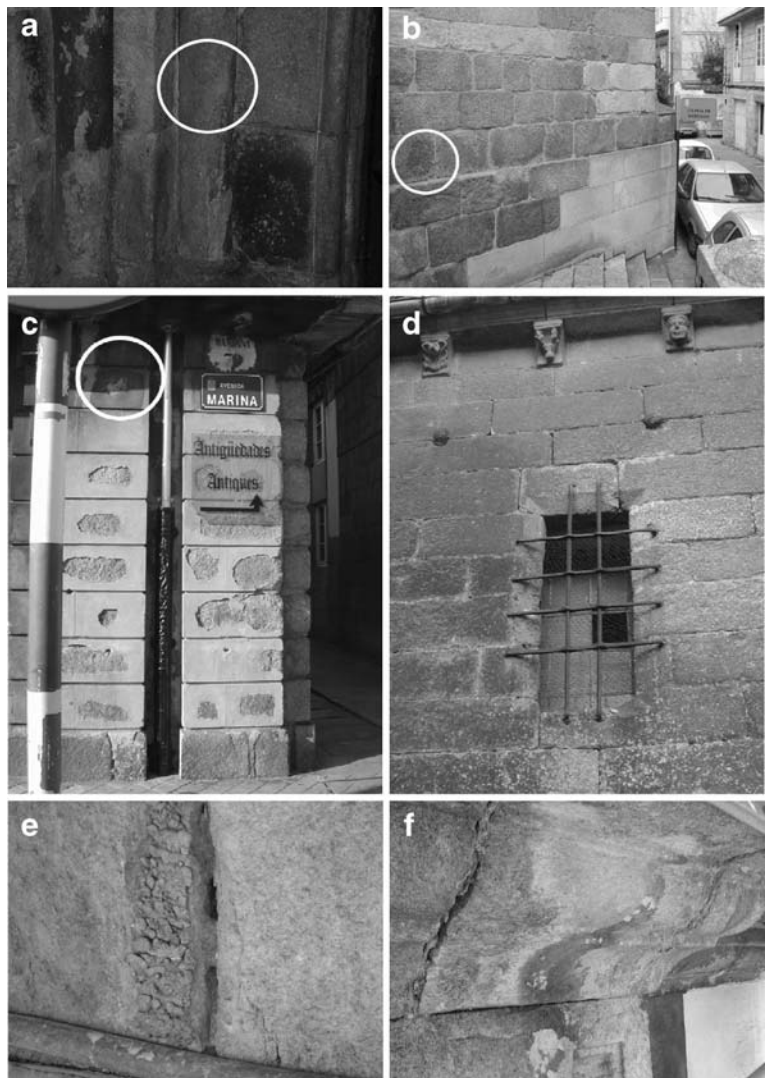
Type 1 coatings are gypsum plasters (light yellow, up to 1 cm thick) located in niches and arcades (Fig. 4a), relatively sheltered from air pollution and rainwater. They have been found on San Pedro leucogranite because the use of this fine-grained rock to build these constructive features (on Las Capuchinas Church and both the N and S façades of Colegiata de Sta. María del Campo in A Coruña). A porous surface containing sand and calcium sulfate, mainly massive (without apparent crystalline forms) but also in tabular and sheetlike gypsum crystals in some areas have been observed by SEM. A few amounts of soil airborne particles, Ba-rich aggregates and fly-ash have been observed on the plaster surface. In the Colegiata de Sta. María del Campo, two layers have been noticed. The internal one (200 µm maximum thickness) is a C- and P-rich calcium sulfate layer, with clays and isolated Ba-, Ti-, Fe-, and Cr-rich particle aggregates on the surface. The external one is a 5- to 10-µm-thick Si-rich compact and fractured amorphous layer.

They are calcium carbonate coatings with a blackened sulfated surface (Fig. 4b,c). A wide variety of colors among brown, gray, and black have been observed. They have been found on all rock types, independently of the façade orientation, at both localities.

ashlars on the N (not exposed to traffic pollution) and S (moderately exposed) façades of the Colegiata de Sta. María del Campo, on both rock types (Fig. 4d). They are heterogeneous and distributed as runoff

They are black crusts, observed only in A Coruña, with variable porosity (Fig. 4a). They have been

Fig. 4 Photos of studied coatings: **a** type 1 (see *circle*) and type 4 coatings (*black*); **b** and **c** type 2 coatings (see *circle*); **d** type 3 coating; **e** type 5 nodulated crust; **f** type 6 coating

They are compact nodulated black crusts (Fig. 4e), found below cornices and moldings in buildings exposed to road traffic pollution: Las Capuchinas

These coatings are gray or black porous patinas formed by runoff washing and precipitation (Fig. 4f). They are located below cornices or arranged as runoff patches on the façades. They have been

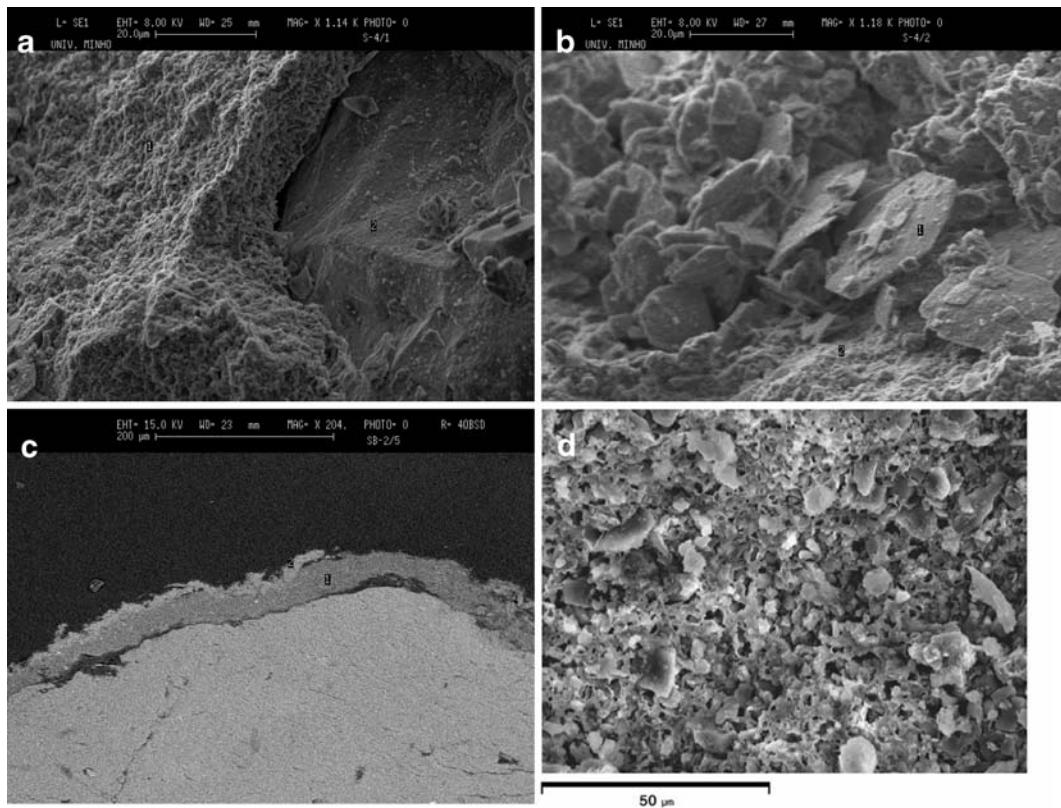
Fig. 5 SEM images of coatings: **a** surface view of a low sulfated type 2 coating; **b** detail of sheetlike gypsum crystals on type 2 coating surface; **c** cross-section of a well-developed

gypsum surface layer of a type 2 coating (1 carbonate calcium layer, 2 gypsum surface layer); **d** surface detail of a type 3 coating

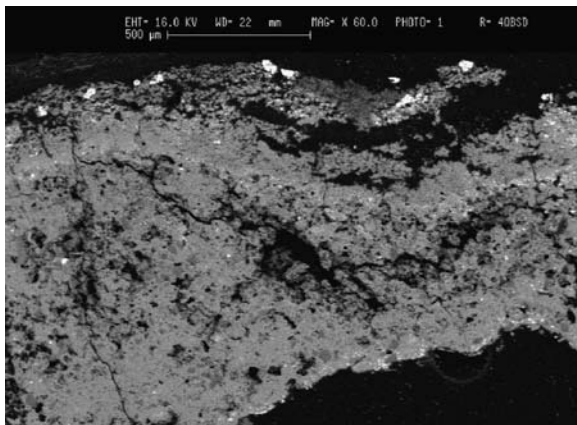
Fig. 6 SEM micrograph from a type 4 coating cross-section. The upper side is the surface layer, white particles are Pb-rich aggregates and black parts are resin-covered pores

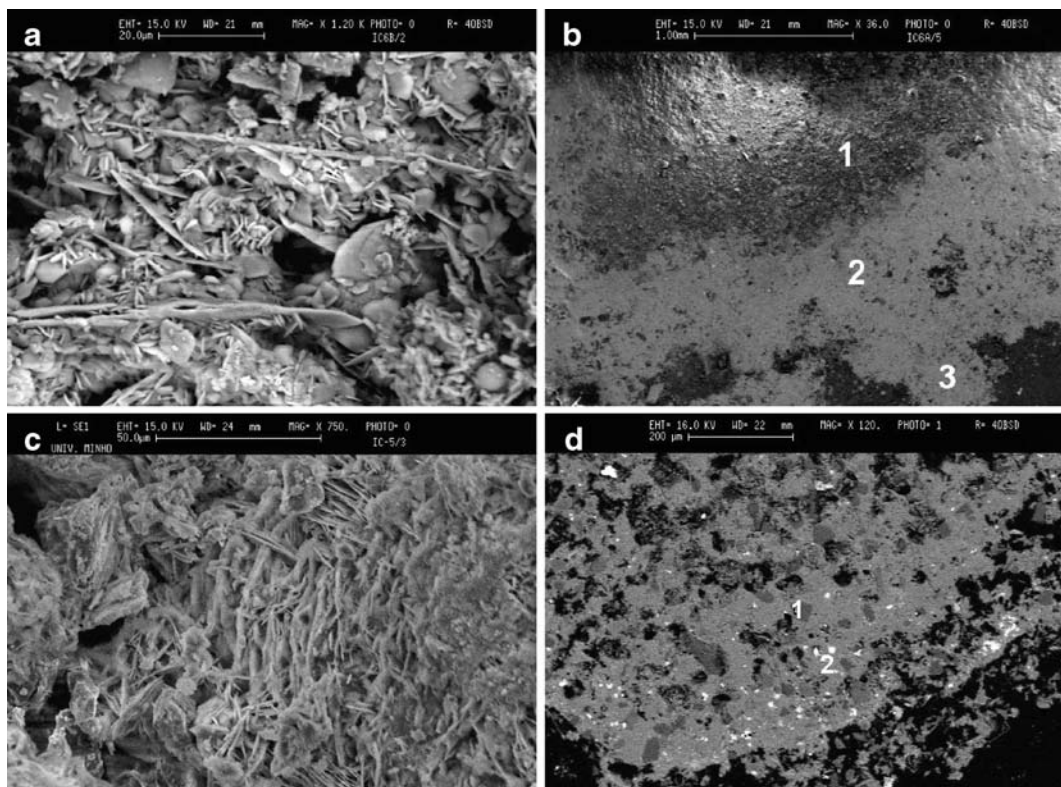
Fig. 7 SEM micrographs of coatings: **a** detail of gypsum sheetlike crystals of two different sizes on the surface of a type 5 coating sample; **b** cross-section of a type 5 coating with both internal (1) compact calcium sulfate C-rich layer, a surface

porous gypsum layer (2) and surface nodules (3); **c** surface gypsum sheetlike crystal on a type 6 coating; **d** Cross-section of a type 6 coating with halite crystals (1 light gray) and Fe-rich aggregates (2 white)
