# The Effects of Air and Underwater Blast on Composite Sandwich Panels and Tubular Laminate Structures

H. Arora · P.A. Hooper · J.P. Dear

**Abstract** The resistance of glass-fibre reinforced polymer (GFRP) sandwich panels and laminate tubes to blast in air and underwater environments has been studied. Procedures for monitoring the structural response of such materials during blast events have been devised. High-speed photography was employed during the air-blast loading of GFRP sandwich panels, in conjunction with digital image correlation (DIC), to monitor the deformation of these structures under shock loading. Failure mechanisms have been revealed by using DIC and confirmed in post-test sectioning. Strain gauges were used to monitor the structural response of similar sandwich materials and GFRP tubular laminates during underwater shocks. The effect of the backing medium (air or water) of the target facing the shock has been identified during these studies. Mechanisms of failure have been established such as core crushing, skin/core cracking, delamination and fibre breakage. Strain gauge data supported the mechanisms for such damage. These studies were part of a research progr

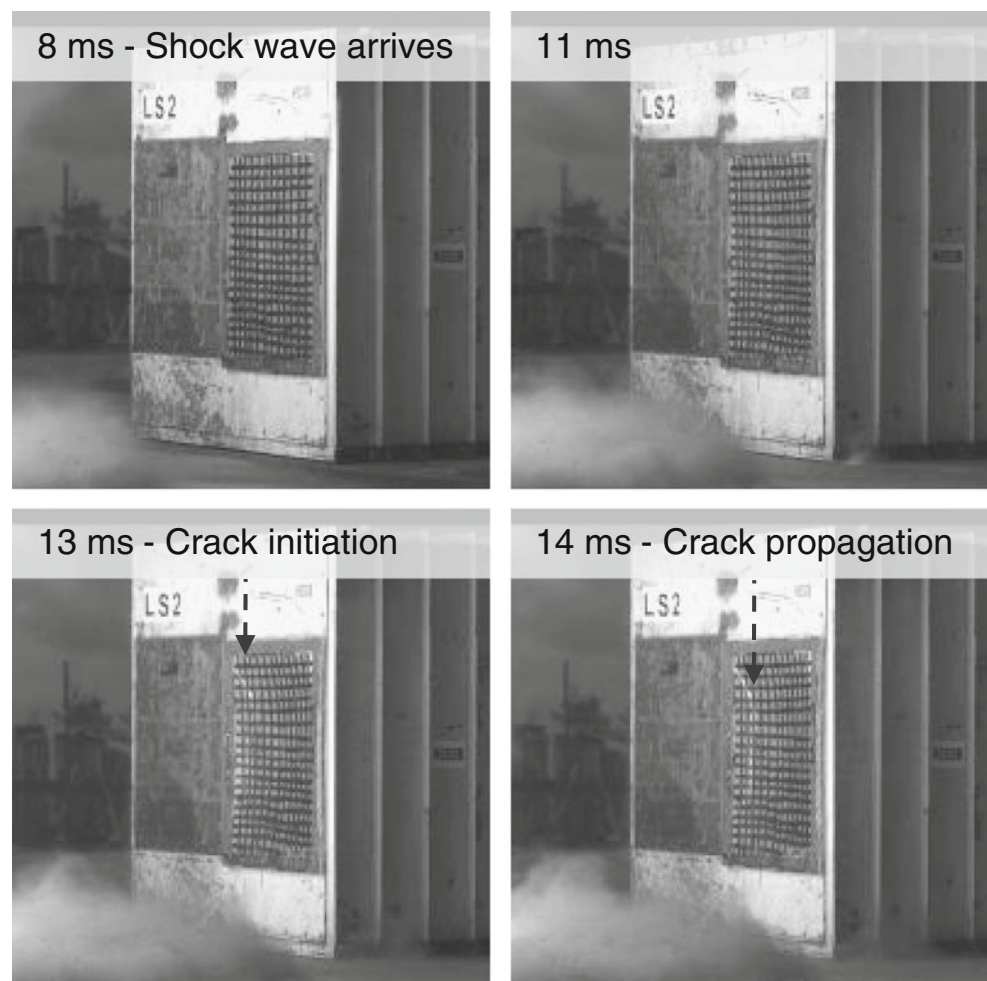
As the DIC analysis agreed with predictions for peak elastic displacements of the targets due to a 2 bar shock pressure, and both the DIC analysis and visual inspection showed no visible skin damage to panel G1, it was decided that another panel of the same construction as G1 be subject to a more substantial blast to induce significant skin and core damage. This highlighted clearly the failure diagnostic capabilities of the DIC technique in this context. Blast parameters for this final air blast involved a 30 kg charge positioned at a reduced stand-off of 8 m from G1. Figure 7 shows the progressive deformation and eventual skin damage inflicted on G1 by the 8 bar pressure shock wave. A skin crack is seen to originate from the top left hand edge of the panel and propagate down that side of the target.

**Fig. 7** Images of the shock wave impinging on the test sample (8 ms) causing deformation and front-skin damage thereafter (sandwich panel G1 with core thickness 40 mm and charge of 30 kg charge at stand-off of 8 m)

during the first oscillation. Looking closely at the time period 12.5–13.5 ms, one can observe a flattening in the displacement curve near its maximum condition. This coincides with the time (13 ms) when the crack is observed to form in Fig. 7.

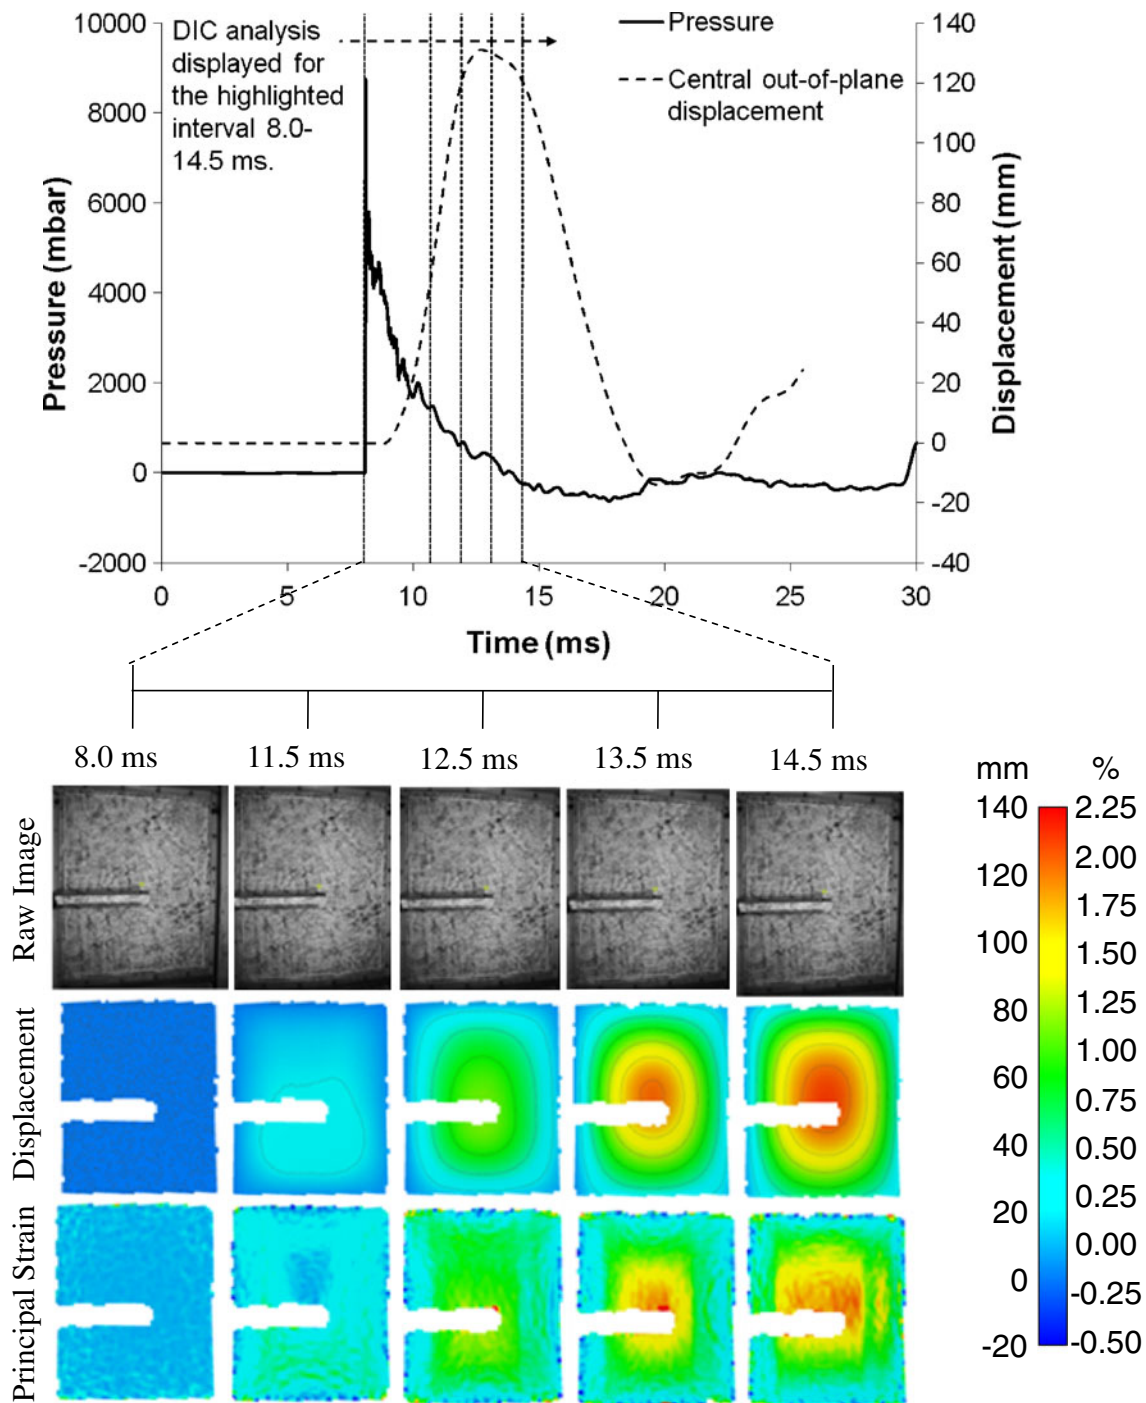
**Fig. 8** Transient reflected pressure recording and the central out-of-plane displacement of panel G1 (core thickness 40 mm) during blast loading (30 kg at 8 m stand-off) showing high-speed images of the back-face of the target with analysed results from ARAMIS. Images are displayed from the point of shockwave arrival at the target 8 ms after detonation

blast event for G1 with at 30 kg charge at stand-off of 8 m. Comparing this plot of out-of-plane displacement to that shown earlier in Fig. 5, besides from the magnitude of peak out-of-plane displacement, immediately one can notice the difference in smoothness of the path taken

face of the target. Employing DIC was a powerful tool for damage detection during the blast. The major principal strain fields generated can tell a great deal about what is happening to the structure. Referring to Fig. 8 it is clear that

there is a build up of high-strain of around 3% in the central region until a point, where there is a split in the strain field, with some strain relief appearing in a narrow region down the right-hand side of the panel. This region of stress relief indicates a region of separation between the core and skin (where the skin is unsupported by the core), resulting in the load concentrating on the edges of this (cracked-core) region on the skin. The levels of strain observed in the skin along these edges peaked at 1.8%. Further analysis in Fig. 18 displays the deformed profile of the width of the panel. Out-of-plane displacement of a horizontal central section was taken within the ARAMIS post-processing software and plotted over regular time intervals for the duration of the initial response. It shows the panel deflecting in a symmetrical manner during its inward stroke, up until the point of maximum deflection occurring at 12.5 ms. It is clear that a failure (or change in structural balance) has occurred within the panel, causing an asymmetric rebound profile of the panel at 15.5 ms.

This reinforces the notion of a complete core shear failure, resulting in complete crack propagation from face-to-face down a significant portion of the panel. The first 1.5 ms (8.0 to 9.5 ms) of response show the flat central area of the panel progressing, which is characteristic to impulsive loading situations. After 1.5 ms, there is a faint region of stress-relief on one edge of the panel due to crack initiation causing separation between the skin and core (locally). Now it can be accounted for due to the exaggerated bending stresses experienced in the early

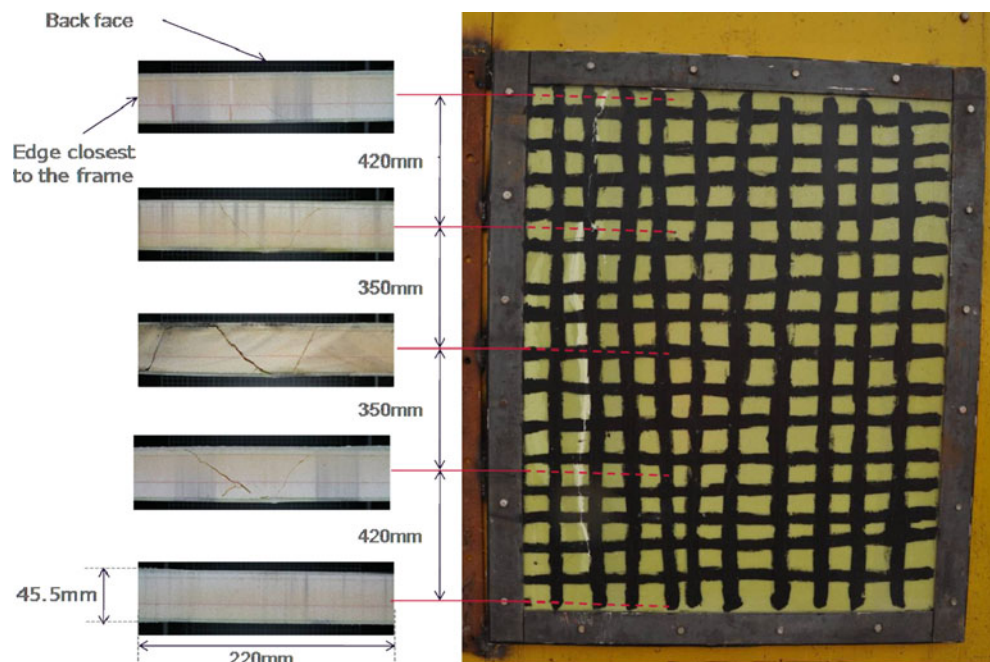
The peak out-of-plane displacement was 131 mm and strains peaked in the region of 3% prior to the crack developing. Upon post inspection, the front face sustained inter-laminar skin failure and front-ply fibre breakage whilst the core suffered a severe skin-to-skin crack (see Fig. 9). Towards the centre of the panel, the severity of the failure increased.

**Fig. 9** Front face damage: The whole panel with a clear crack down the left-hand edge of the panel (*right*), sectioned at regular intervals showing various failure mechanisms (*left*). This is for sandwich panel G1 with core thickness 40 mm and charge of 30 kg charge at stand-off of 8 m

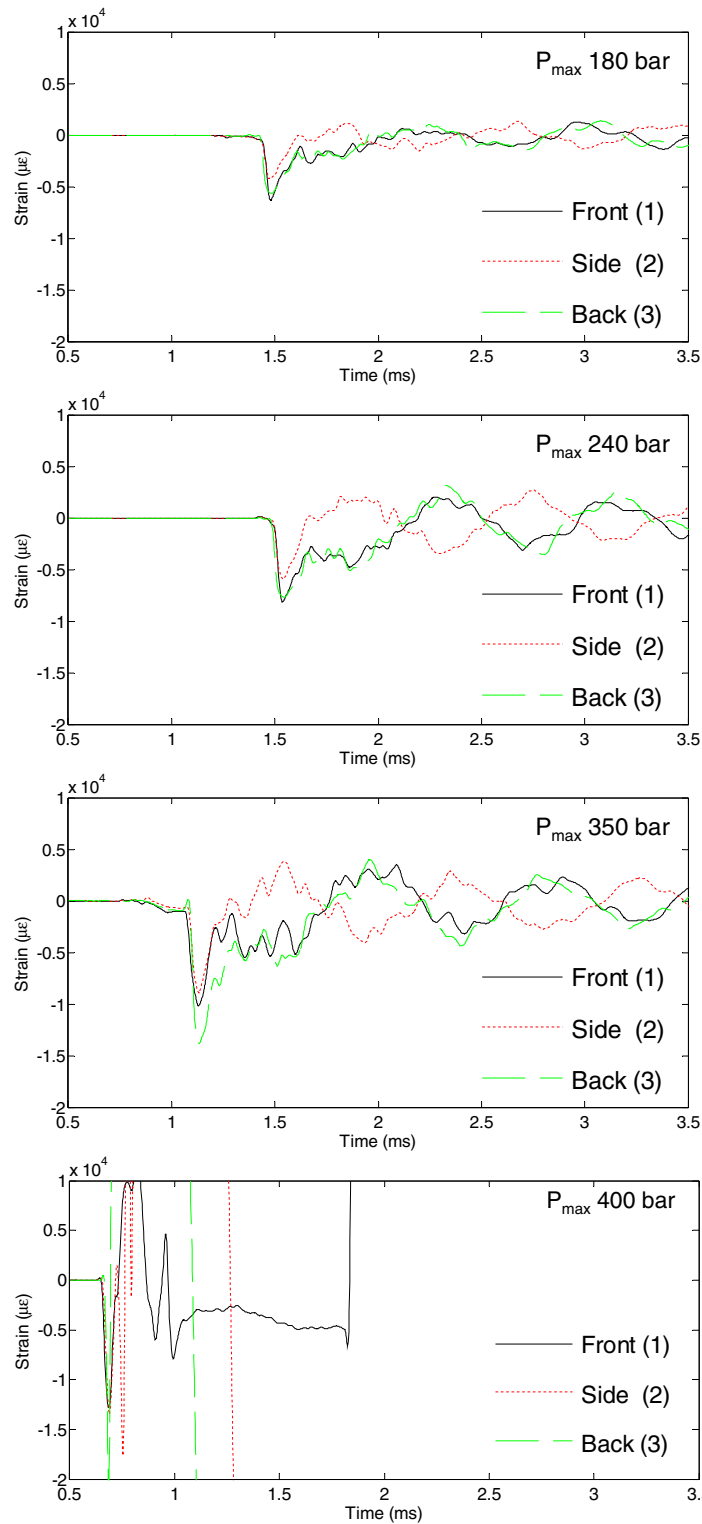
filled (AF) design. Peak pressures ranged from 180 to 400 bar for a range of blast parameters from 0.5 kg C4 explosive charge at a 2.0 m stand-off distance at a 6 m depth to a 1.0 kg charge at 1.0 m stand-off distance at the same depth. Figure 15 shows the combined results for the progressive loading of these tubular laminates. The 180 bar blast produced no visible skin damage to the targets with the surface strains sufficiently low to form an agreement with this observation. The 240 bar blast proved to be the threshold for damage evolution with surface strains reaching 1%. The tubes were then tested at a peak shock pressure of 350 bar and visible damage was inflicted on the targets with axial cracks forming along the front facing side of the sample as strains reached 1.5%. In the final test the tubes were taken beyond their limit, where complete shear failure was observed for a peak shock pressure of 400 bar. Similar signs of axial cracking were observed in this final sample (as for the blast of 350 bar) evident from the remains at the end-tabs featured in Fig. 15 prior to the entire gauge length shearing off at the supports.

**Fig. 15** Shock loading of composite tubes with max shock pressure increasing from 180 to 400 bar

This set of blasts produced progressive damage on the tube constructions from no visible damage to complete shear failure, when subjected to peak shock pressures of 180 bar

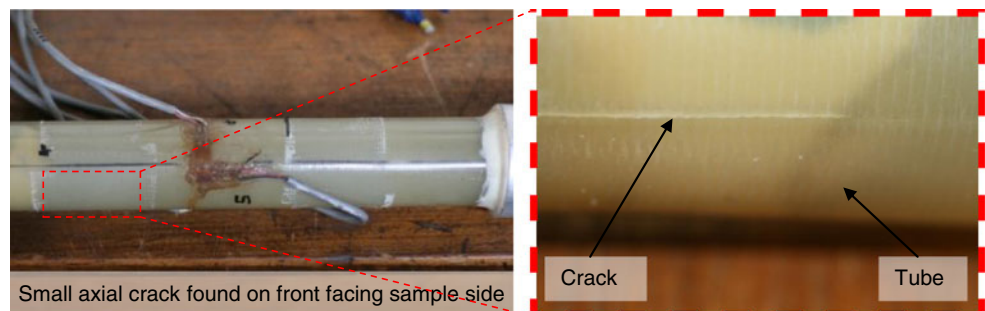
The tubes were both subject to a pressure of 350 bar (there were two independent recordings of pressure either side of the targets). The damage sustained by AF relative to WF was apparent with no visible damage observed for WF whereas AF shown in Fig. 17 shows axial cracking, most likely caused by shear failure during the circumferential crushing phase of the sample deformation causing cracks to initiate.

**Fig. 17** Post-test images of the AF tube (peak shock pressure of 350 bar) featuring delaminations near one end (*left*) and a zoomed in view of the sub-surface darkening formed from the delaminations (*right*)
