# Seismically Induced Slope Instabilities and the Corresponding Treatments: the Case of a Road in the Wenchuan Earthquake Hit Region

LI Xinpo\*, HE Siming

*Key laboratory of Mountain Hazards and Surface Process, CAS, Chengdu 610041, China*

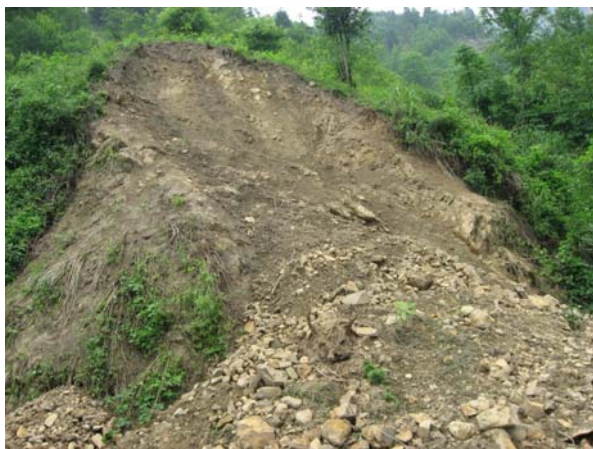
As shown in Figure 2, the slope is mainly composed of soil, and is considerably gentle. Due to the shaking caused by the earthquake the soil became loose, but the geometry of the slope results in a low probability of developing to deep seated landslide. So, retaining walls built of concrete or cemented rock blocks can be used to stabilize the slope. As the slope is stable, the scar surface will soon be recovered by vegetation because there are plenty rainfalls in the area.

Figure 2 Shallow failure of soil slope

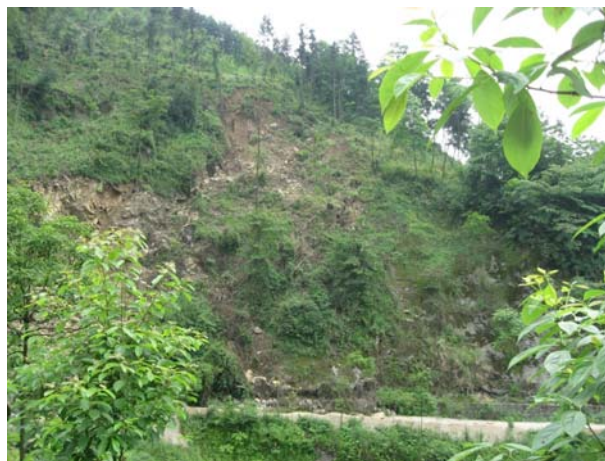
Earthquake induced ground shaking is one of the most frequent causes of landslides. Generally, soils composed mainly of fine grains are not considered to liquefy during earthquakes under any kind of cyclic loading (Zhang 2007). In this view, the shear strength of the slope shown in Figure 3 may have considerable high value, but as the soil has been disturbed by the quake and there is obvious deformation with the soil mass, the slope is in danger. Because the potential slip surface is deep, anchor bolt is not long enough to reach the stable ground beneath the failed surface, and thus can not prevent the slope from slipping downward. As a result, anchor ropes with or without prestresses will be used to provide sufficient resistant force to the instable soil mass. The reinforcing mechanism of anchors in slopes can be explained by the additional shear resistance, induced by the axial tension, on the slip surface

Figure 3 Potential landslide

(Cai & Ugai 2003). So this landslide can be treated by pretensioned anchor ropes and retaining walls.

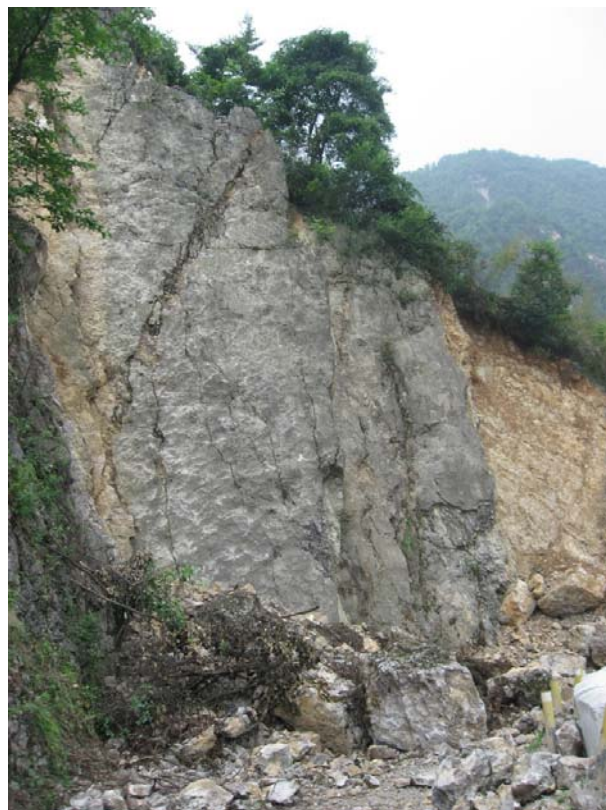
Figure 4 A steep rock slope with fully developed cracks

rapid movement of this debris downslope and into a valley. The picture (Figure 4) shows a high and steep rock slope with fully developed joints and cracks, and thus is vulnerable to failures, such as rock avalanches and rock topples. As the cracks are deep in the rock mass, long anchor ropes are needed to fix the instable rock mass to the stable bed rock. So pretensioned anchor ropes with bolts are suggested to stabilize the slope. Besides, shotcrete may be applied to protect the slope surface.

(3) Slope cuts: Construction of the road made abundant human cut slopes along the road (Figure 4). Slope cutting causes the instability of a slope in several manners. Firstly, high horizontal in-situ stresses acting roughly perpendicular to a cut slope

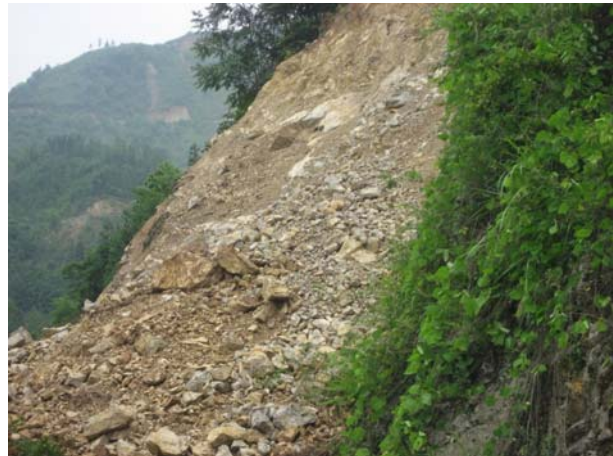
Figure 5 shows a fractured rock slope face which is prone to surficial failure. Due to the intensive earthquake shaking and the undesirable geological conditions, this type of slope failure is very common in the studied area. As the slope as a whole is stable, slope surface protection method such as short rock bolts with shotcrete can solve the problem.

**Figure 5** Surficial failure of rock slope

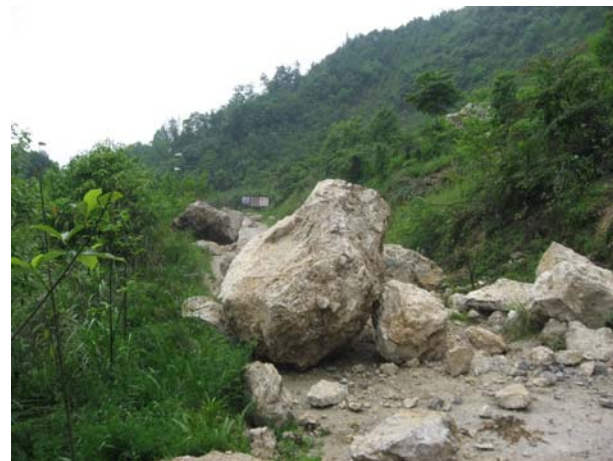
The downward movement of rocks that fall off after separating from the bedrock is called rock fall<sup>(1)</sup>. Limestone, siltstone and sandstone rocks fallen from the upslope can be seen along the road (Figure 6). The fallen rocks range greatly in size from over 1 m to several cm. To stop the boulders, very robust barrier fences with huge energy absorbing capacity are introduced in this place (Whittaker 2003). The design of these fences requires factors, such as slope geometry, the coefficients of restitution, the size and shape of rock boulders, and the coefficients of friction of the rock surfaces to be known. Rock traps work well in catching rockfalls, provided that there is sufficient room at the toe of the slope to accommodate these rock traps.

**Figure 6** Large rock blocks and boulders fallen from the slope

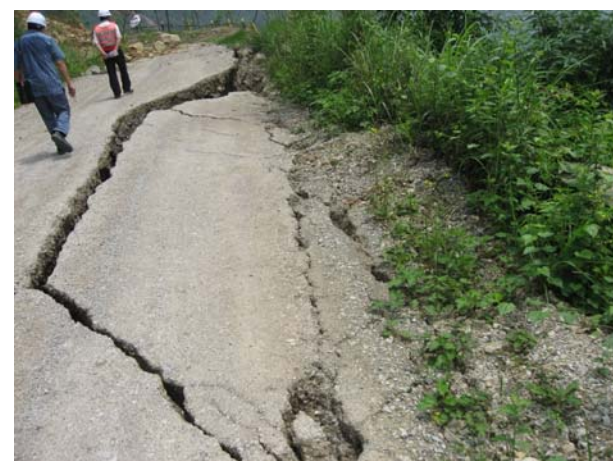
Site investigation shows that ground cracks, most of them were resulted from the earthquake, are intensively developed in the roadbed. As shown in Figure 7, cracks are seen extending

**Figure 7** Development of cracks along the road indicates the instability of down slope of the road

along the road for about 50 meters, and settlement of the roadbed also is obvious. These factors indicate that the down slope of the roadbed may be not stable. Treatment of the down slope problems needs more detailed exploration to the site, and then retaining wall or piles can be chosen to stabilize the roadbed according to the depth of potential slip surface. Moreover, if the down slope has grown into a potential landslide, the investment costs may be very high, and thus it may be a better choice to change the road way provided that there is sufficient room near the old road.
