Assessment of prospective hazards resulting from the 2017 earthquake at the world heritage site Jiuzhaigou Valley, Sichuan, China

Abstract: On August 8, 2017, a Ms = 7.0 magnitude earthquake occurred in the Jiuzhaigou Valley, in Sichuan Province, China (N: 33.20°, E: 103.82°). Jiuzhaigou Valley is an area recognized and listed as a world heritage site by UNESCO in 1992. Data analysis and field survey were conducted on the landslide, collapse, and debris flow gully, to assess the co-seismic geological hazards generated by the earthquake using an unmanned aerial vehicle (UAV), remote-sensing imaging, laser range finders, geological radars, and cameras. The results highlighted the occurrence of 13 landslides, 70

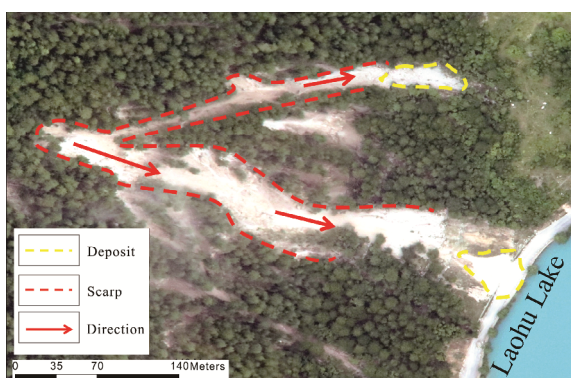
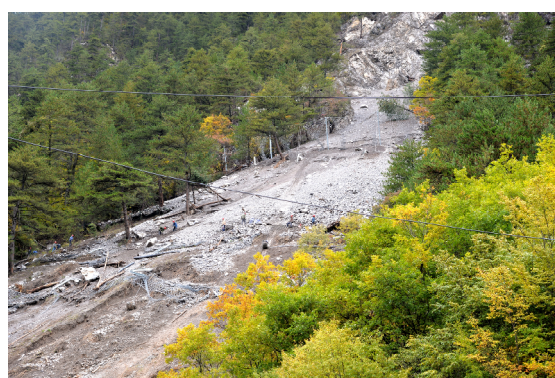
(a) Collapse on slope beside Laohu Lake

The Laohu Lake collapse, as shown in Figure 3(a), was located at N: 103°53' and E: 33°11', at an altitude of 2288 m. The total volume of the collapse body was 11,000 m³ and the threatened area extended to nearly 3.95 × 10⁶ m². The maximum vertical fall height was 50 m and maximum horizontal fall distance was 50 m at the collapse point. The collapse possessed a loose structure and was comprised of gravel with diameters ranging from 0.02 m to 0.30 m. The Zharu Gully collapse

was located at N: 103°55' and E: 33°15'. The total volume of the collapse body was 12,100 m³ and the risk area extended over 3.34×10^6 m². The maximum fall height difference was 100 m and maximum fall distance was 80 m. The accumulation body of this collapse was characterized by loose structure and poor classification. The diameters of the fallen stones ranged from 0.02 m to 0.40 m.

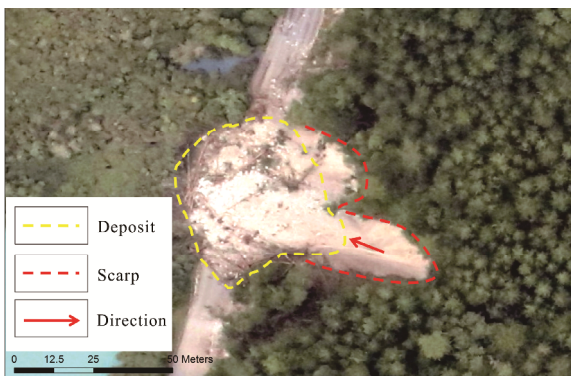
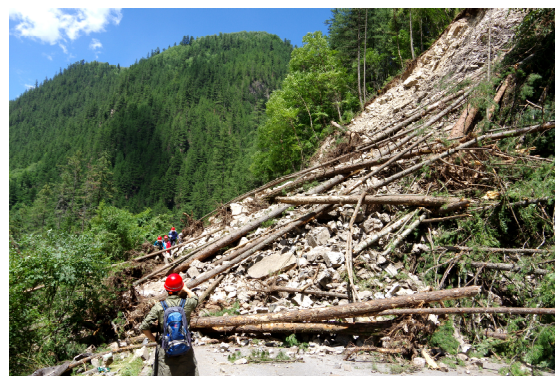
(b) Landslide near Pearl Beach and buried the tourist road

Small and medium-sized shallow landslides were dominant. The main types of landslides were soil landslides and rocky landslides and calcareous and metamorphic rocks dominated their lithologies. The earthquake-induced landslides were mostly concentrated along roads, and threatened the security of, and occasionally blocked roads. For example, nine medium or small landslides were detected along the road near the Mirror Lake; these landslides blocked the road upstream of the Mirror Lake and completely blocked road traffic upstream of the Five Flowers Lake, as shown in [Figure 3\(b\)](#). This landslide, located at N: 103°53' and E: 33°09', covered a total area of 2350 m², was 100 m in length, 50 m in width, up to 20 m in thickness, with an estimated volume of 25,000 m³. The elevation of the crown and toe were 2600 m and 2530 m, respectively, indicating that the height difference of the landslide was 70 m; the slope angle of the landslide body was 32°. The aspect of the landslide was NWW 290°. The exposed main scarp indicated that the landslide was a rocky landslide and the lithology of the exposed bed rock was carboniferous dolomite.

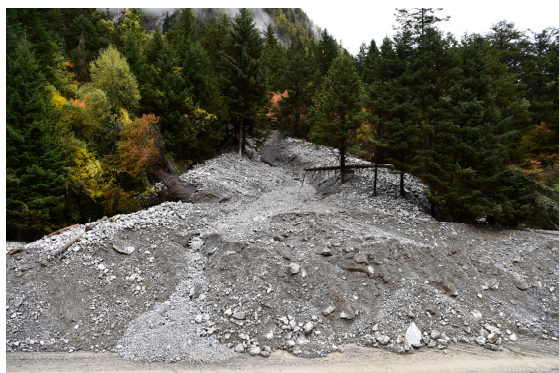
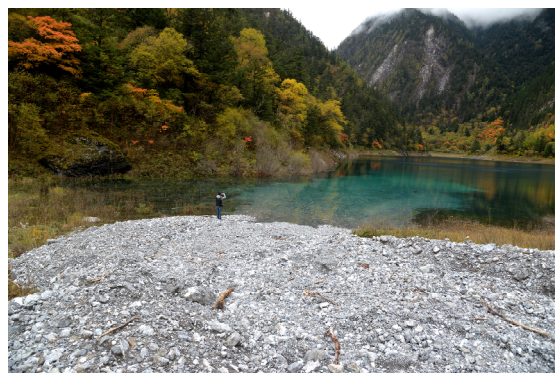
(c) Debris flow at Xiajijie lake in September 2017

Pre-earthquake measurement of the watershed area of the Xiajijie Lake was 2.1 km²; main gully length was 2.5 km; and the mean channel slope was 612‰. An old debris fan was located at the gully outlet. The debris flows triggered by the 2017 earthquake exerted a scour effect on the fan, producing a scour channel with mean depth of 4.5 m, mean width of 11.5 m, and channel slope ranging from 268‰ to 380‰. Some collapses and landslides were noted along the gully; these solid materials acted as the source material for the debris flow. In this gully, three debris flows were triggered in 1976, 1983, and 1984; the debris flow in 1983 was the largest; the density ranged from 2100 kg/m³ to 2200 kg/m³, with maximum stone diameter of 3 m, and maximum debris flow discharge of 142 m³/s ([Cui et al. 2003; Cui et al. 2007](#)). After the 2017 Jiuzhaigou earthquake, four debris flows were triggered from September 14 to September 25, 2017, and about 15,000 m³ of solid materials were transported. These debris flows resulted in the burial of nearly 150 m of a long road and some of the debris flow materials poured into the Xiajijie Lake, shown in [Figure 3\(c\)](#), on September 25, 2017.

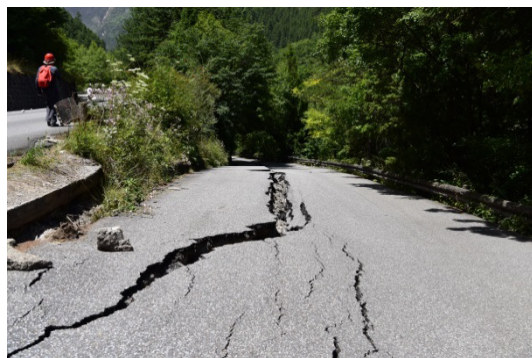
earthquake, as illustrated in Figure 5. These have been manifested in three modes: (a) original tourist roads were deformed or partially collapsed. For example, the tourist roads on the right bank of the Mirror Lake were affected by unstable slope deformation. Cracks nearly 200 m to 300 m in length, 0.01 m to 0.30 m in width, and 0.01 m to 0.80 m in height, were observed on this road. (b) Geological disasters caused partial landslide deformation in some sections of the roads. For example, two landslide deformation events caused by unstable slopes occurred on roads on the right bank of the Mirror Lake. (c) Due to collapses, landslides, and deformation of unstable slopes, tourist roads were buried or blocked. Collapses in the inner sections of roads resulted in fragmentary sliding or collapse, which affected road safety.

(a) Road-surface damage

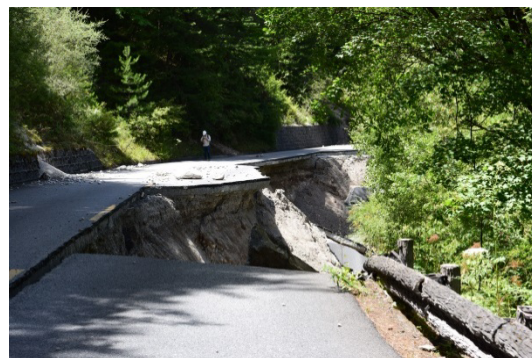
(b) The subgrade damage

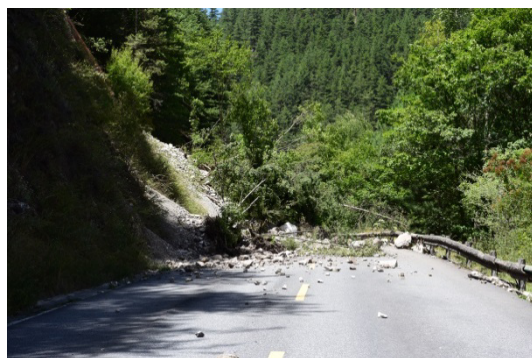
(c) Landslide blocked the road

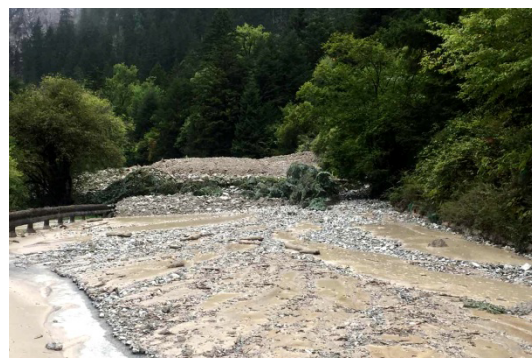
(d) Debris flow blocked the road

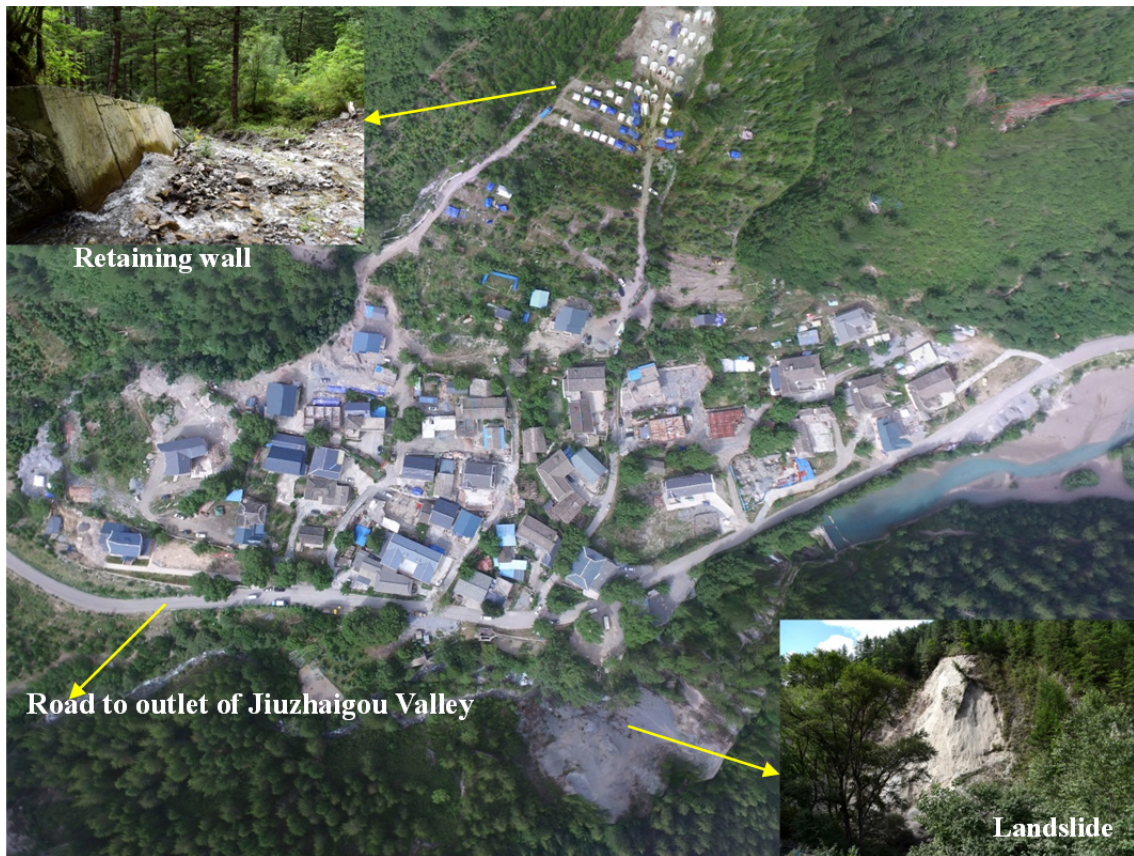
(a) Zharu village

These communities were located in the danger zone of geological hazards and were vulnerable to landslides, collapses, and debris flows, such as the landslide in Zharu Gully. Additionally, unstable deformation blocked channels resulting in varying degrees of damage, such as the collapse that occurred behind the Zharu Temple. As shown in Figure 6(a), Zharu village is located on a debris-flow fan. Some hazard mitigation structures were constructed in the gully before the earthquake, but after the earthquake, the amount of loose earth increased, much of it due to the occurrence of many collapses and landslides in the gully. We deduce that the risk of debris flow disaster increases with the strong rainfall. The potential risk area of the debris flow hazard is evaluated to be $55 \times 10^4 \text{ m}^2$ and 134 local people living in this area are threatened. Moreover, a landslide with risk area of $5 \times 10^4 \text{ m}^2$ is located opposite Zharu village on the left bank of the river; it has the potential risk of blocking the river.

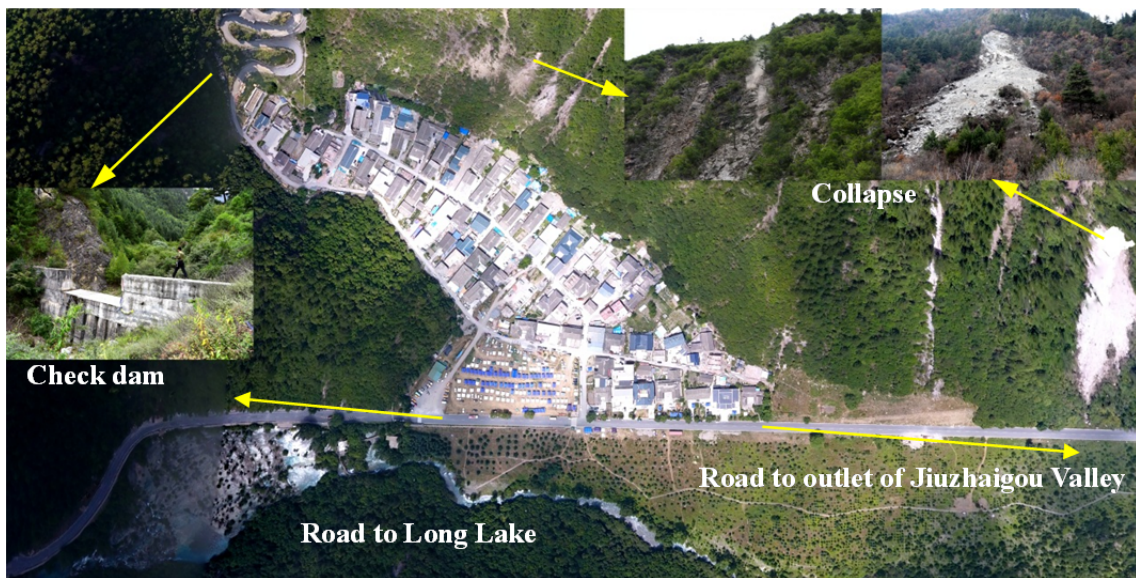
(b) Heye village

Figure 6(b) shows the Heye community, which is exposed to risks of collapses, landslides, and debris flows. Before the 2017 Jiuzhaigou earthquake, seven debris-flow check dams were

constructed in 1991 and a debris-flow blocking system was implemented. After the earthquake, active and passive protective measures against collapses were implemented to protect the

residents. However, under the double effect of the earthquake and engineering design limitations, large-scale debris flows can be triggered by strong rain storms, indicating that the potential risk to the

Heye community is high. After the earthquake, two large collapses occurred around the community and the potential debris flow volume was increased. The total volume of the collapse around the community is estimated to be $13.1 \times 10^4 \text{ m}^3$ and the risk area is $5.6 \times 10^4 \text{ m}^2$. The potential risk area of the debris flow hazard is $25 \times 10^4 \text{ m}^2$ and about 452 local people living in this area are threatened. Moreover, the traffic road and the scenic spot near the community are also in the risk area.

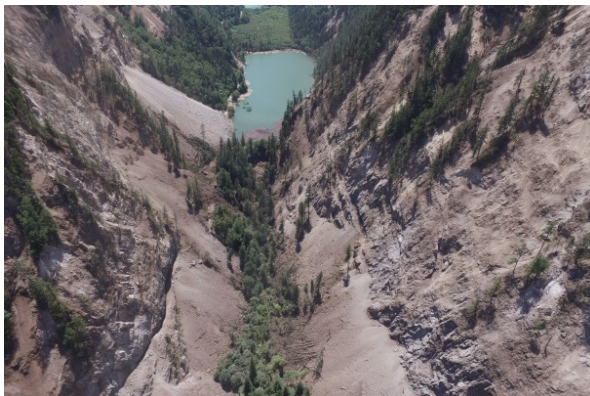
The Panda Lake is located at an elevation of 2587 m, with depth of 14 m and an area of $9 \times 10^4 \text{ m}^2$. Figure 7(a) illustrates the situation at the Panda Lake after the earthquake. The surface area of Panda Lake was affected by the collapse and landslide, which slipped into the lake. The clarity of the water became cloudy. Around the Panda Lake, the collapse volume is totally $8.43 \times 10^5 \text{ m}^3$ and the risk area is $1.94 \times 10^6 \text{ m}^2$. Sparking Lake is downstream from Panda Lake, located 2211 m above sea level, 232 m long, 134-294 m wide, and 16 m deep, with a total capacity of $45 \times 10^4 \text{ m}^3$. Following the earthquake, the dam of Sparking Lake was broken and a dam failure breach was formed, which was 40 m long, 12 m wide, and 15 m deep. All the water flowed into the downstream lakes of the Sparking Lake and the completely destroyed Sparking Lake was shown in Figure 7(b).

(a) Panda lake affected by landslide and collapse

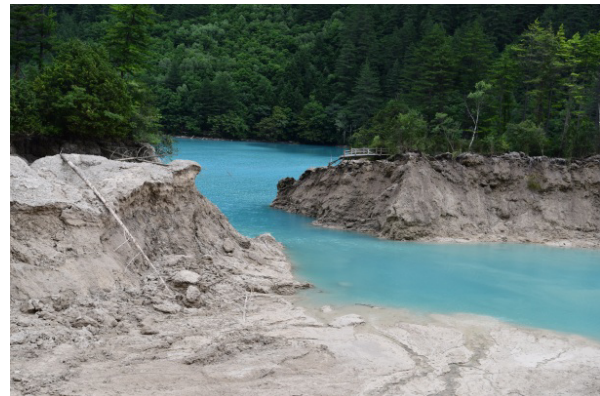
(b) Outbreak of the Sparking lake

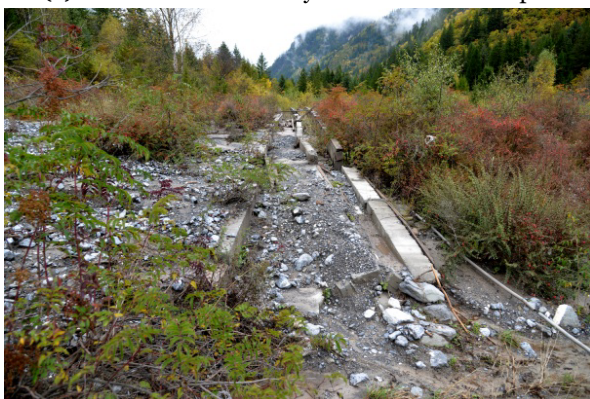
Seven disaster points threatened the tourist facilities in the Jiuzhaigou Valley. Most of the damage to tourism facilities was caused by collapse in this area and a small number of facilities were seriously damaged by the debris flow and outbreak

(c) Damaged tourist facilities by debris flow

flood, such as the plank walk, as shown in [Figure 7\(c\) and \(d\)](#). The risk area of the debris flow in the Zechawa gully is 5×10^4 m² and the plank walk located in the debris-flow accumulation area will be damaged after a large-scale debris flow. After the dam failure of the Sparking Lake, a nearly 900 m long plank walk was washed away by the outbreak flood. Additionally, 53 geological hazards threatened water bodies. Vegetation was severely impaired by landslides, collapses, and deformation of unstable slopes. These hazards can destroy the landscape and affect its outstanding universal value. Further, these hazards may aggravate soil erosion and affect the downstream landscape area and water bodies and cause serious damage to the original forestland.

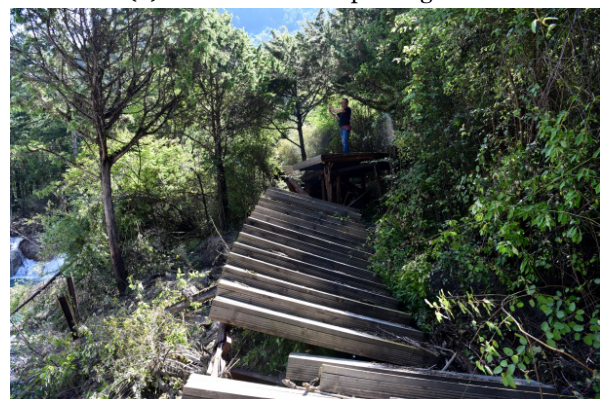
(d) Damaged tourist facilities by outburst flood
