# Bifilm Defects in Ni-Based Alloy Castings

JOHN CAMPBELL and MURAT TIRYAKIOĞLU

DOI: 10.1007/s11663-012-9655-1

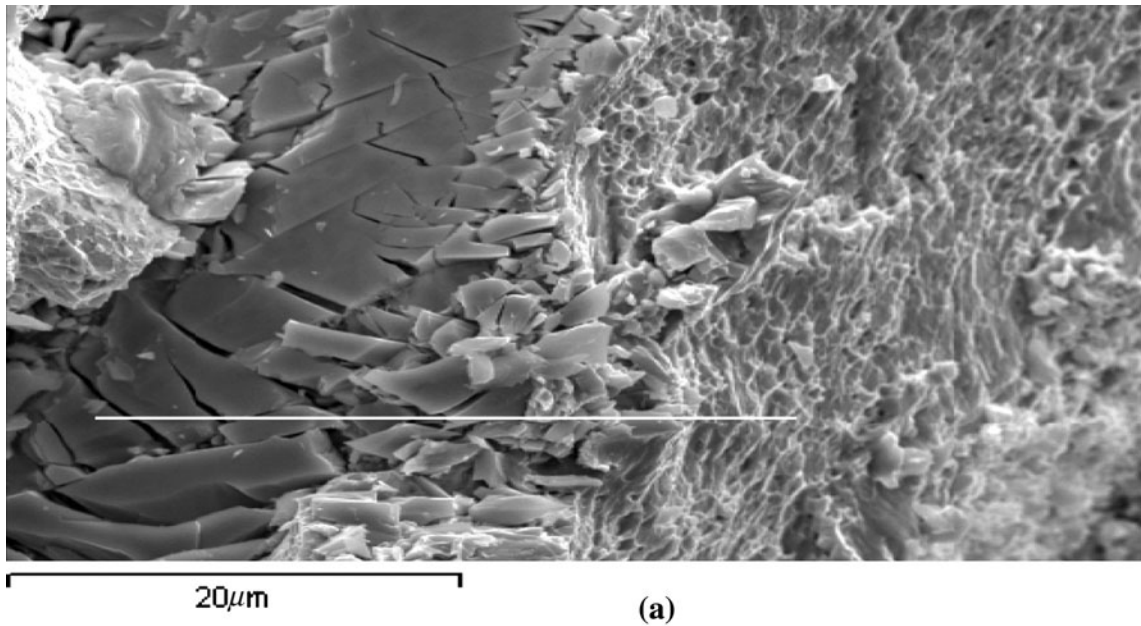
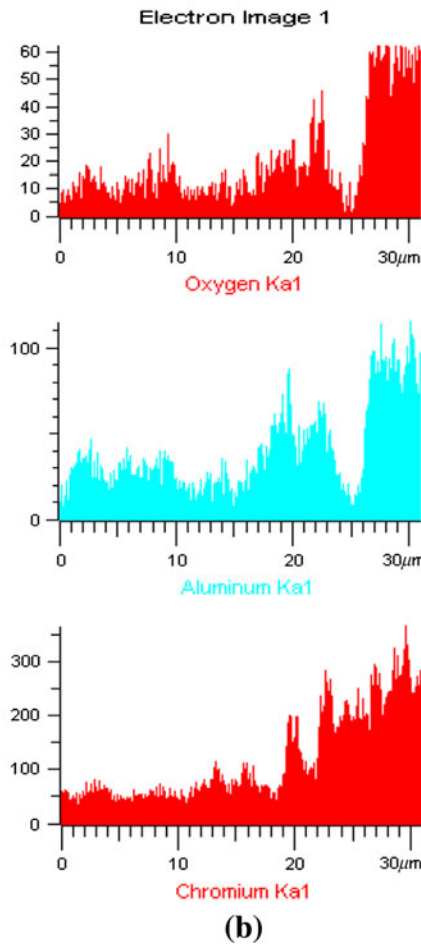
Fig. 5—(a) Close up of fracture surface observed in Fig. 2, showing brittle carbide and (b) line scans for O, Al, and Cr through carbide and oxide layers.<sup>[16]</sup>

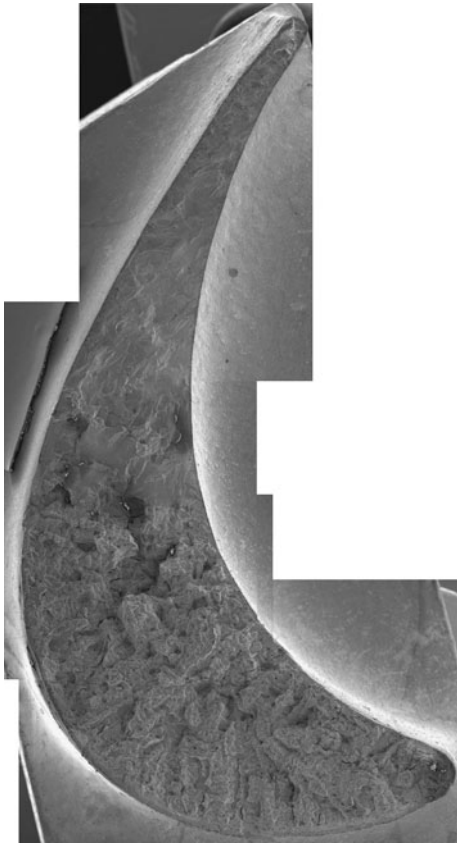
In a single-engine plane, a high-pressure turbine blade failed, causing the engine to fail with the resulting loss of the plane and lives.<sup>[4]</sup> The turbine blade failed only after 1800 hours of operation and before the scheduled inspection time of 3000 hours. The fracture surface of the blade is observed in Figure 8. Approximately half of the area of the blade, starting from the trailing edge, is the fatigue failure. The remainder is the rapid final overload fracture. Both of these fracture regions deserve a close examination.

Fig. 8—The SEM fractograph of the turbine blade where fatigue failure occurred.<sup>[4]</sup> (Courtesy of the Transportation Safety Board of Canada with the permission of the Minister of Public Works and Government Services).

The final overload failure region observed in Figure 8 has no evidence of ductile dimples indicating practically no ductile component of the failure, which is perhaps surprising in a high Ni-base alloy at service temperature. In fact the overall appearance of the final fracture region in Figure 8 is somewhat chaotic. However, a closer examination in Figure 13 shows regions that can be approximately identified as grains, within which are traces of regular periodicity suggesting dendritic structure. A trace along the fracture surface following the length of one of the dendrites would be expected to exhibit a roughly sinusoidal form. It is proposed that this form is taken up by the bifilms that are pushed

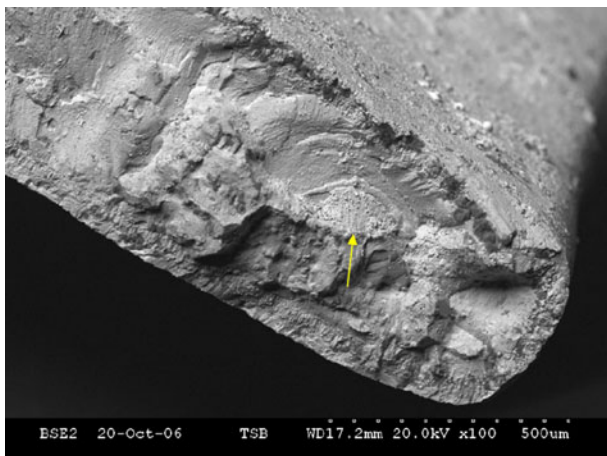
Fracture seems to have initiated close to the trailing edge shown in Figure 9. However, in this region, and over the whole fatigued area up to the transition to the overload fracture area (Figure 10), the grain structure of the casting is clear. This region has been interpreted by some as a thermal fatigue failure mode. This is probably true, but in the experience of the authors, thermal fatigue only occurs in the presence of bifilms; the thermal stresses open up the bifilms to create an easy crack propagation route. Some areas outlined as grains show beach marks clearly (Figure 11), indicating that these are sound regions integral with the matrix of the casting and exhibit classic features of fatigue crack advance. However, many areas of the fracture that seem to be outlined as grains show no beachmarks but instead show folds and wrinkles that are typical evidence of oxide films entrained during the turbulent pouring of the liquid (Figure 9). These areas have been precracked effectively, allowing instantaneous crack extension across these regions and allowing rapid average propagation of the fatigue failure over this half of the blade.

Fig. 9—Fractograph showing apparent fatigue initiation site.<sup>[4]</sup> (Courtesy of the Transportation Safety Board of Canada with the permission of the Minister of Public Works and Government Services).

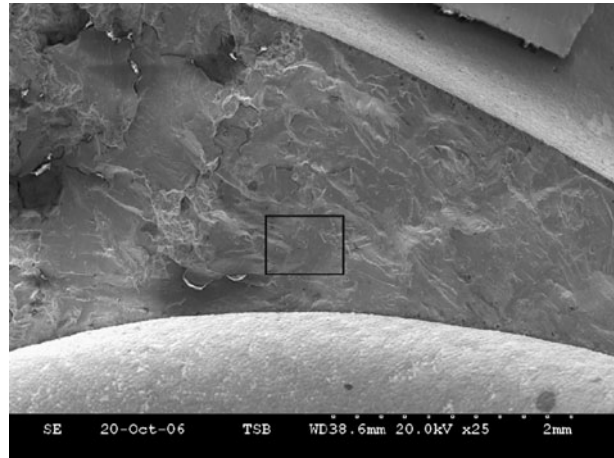
Fig. 10—Fractograph of the transition region between the fatigue fracture and the stress rupture fracture.<sup>[4]</sup> (Courtesy of the Transportation Safety Board of Canada with the permission of the Minister of Public Works and Government Services).

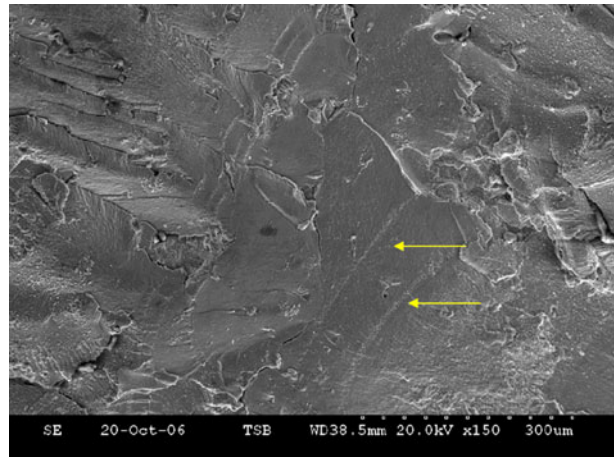
In the transition region in the left-hand top corner of Figure 11, some cracks can be observed to be aligned with the assumed crack growth direction but seem to be

at right angles to the surface, disappearing into the depth of the matrix. It seems likely that these cracks are bifilms straightened by the growth of dendrites as illustrated schematically in Figure 12. This figure illustrates how flat regions of cracks can be formed that are aligned parallel to the generally closer packed 100 or 110

Fig. 11—Fractograph showing beach marks (arrowed) in the transition region marked in Fig. 9.<sup>[4]</sup> (Courtesy of the Transportation Safety Board of Canada with the permission of the Minister of Public Works and Government Services).

planes of the matrix in the 100 direction of growth of the dendrites. In this case, their mutual alignment in Figure 11 would have been encouraged by the heat flow direction from the thicker leading edge to the thinner trailing edge.

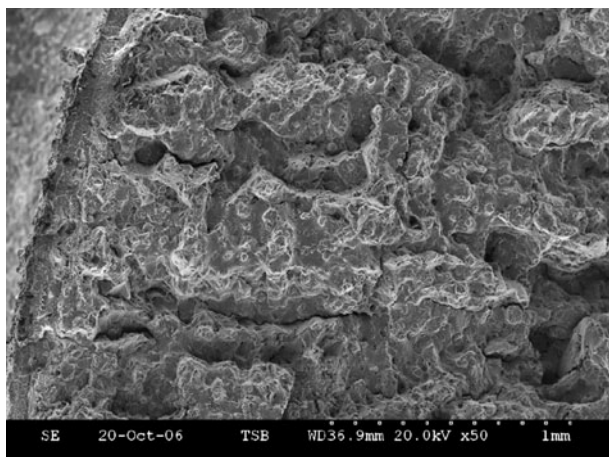
Fig. 13—Fractograph showing stress rupture region.<sup>[4]</sup> (Courtesy of the Transportation Safety Board of Canada with the permission of the Minister of Public Works and Government Services).

ahead of the advancing grains as shown at the tips of dendrites in Figure 12. Such sinusoidal fracture surfaces are relatively common in many cast alloys and can usually be definitely associated with the dendrite tip outlines delineated by bifilms. In Figure 13, the traces of cracks disappearing into the matrix of the casting are, once again, typical of this structure.

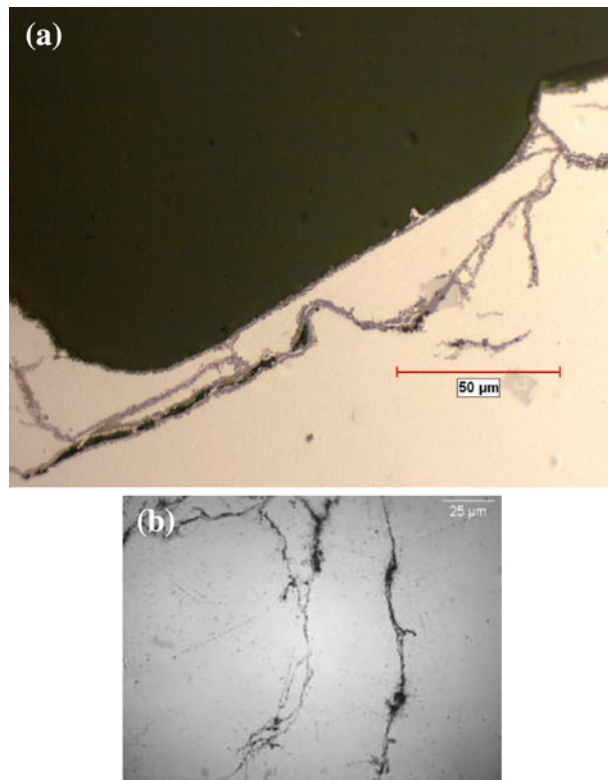
Turning to other metallographic evidence from this study, Figure 14(a) shows a polished cross section at right angles to the fracture surface. The presence of an

Fig. 14—Old bifilms in hot isostatically pressed castings: (a) on and near the fracture surface of the failed turbine blade<sup>[4]</sup> and (b) in A206 castings.<sup>[30]</sup> (Part (a) Courtesy of the Transportation Safety Board of Canada with the permission of the Minister of Public Works and Government Services).

oxide on the surface cannot necessarily be identified as half of the original bifilm crack because of oxidation of the fracture surface in air, while still at a high temperature immediately after the fracture. However, its similarity to the thickness and structure of submerged bifilms indicates that any post-fracture oxidation was probably not severe, so that the observed oxide is probably mainly the original oxide from the liquid casting condition. Interestingly, the three parallel cracks cannot be engineering cracks, for instance as the result of stress, because the propagation of the first crack would relieve the local stress so that the nearby parallel cracks could not propagate. Thus, the three parallel cracks are most probably identified as bifilms that have been straightened and crystallographically aligned by dendrite growth. The unbonded nature of the central interface between the two films is also clear in this image in the form of traces of porosity, and it shows how bifilms naturally initiate porosity in castings. The old oxide bifilms found<sup>[33]</sup> in the Al alloy A206 castings subjected to HIP are presented in Figure 14(b). These bifilms are strikingly similar to those in Figure 14(a) and are the cause of the lower distribution of tensile strength in Figure 7, mainly because they are resistant to HIP treatment.

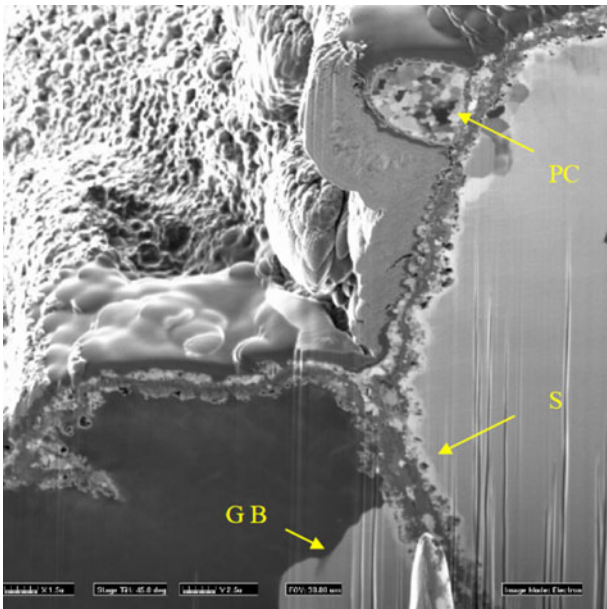
Figure 15 shows a focused ion beam (FIB) section at right angles to the fracture surface viewed in the SEM. (The fracture surface has been protected by a thick layer of sputtered Pt.) Grains are revealed clearly, separated by thickly oxidized regions that are assumed to be

Fig. 15—Grain boundary (GB) and seam (S) comprising oxide bifilms and central crack, and the fine, polycrystalline area (PC) observed on an FIB section of the failed turbine blade.<sup>[4]</sup> (Courtesy of the Transportation Safety Board of Canada with the permission of the Minister of Public Works and Government Services).

bifilms. However, a small, fine-grained feature can be observed sitting on the fracture surface. This is clearly a droplet formed during the casting process, confirming the turbulent nature of the mold-filling technique. Because the droplet is apparently isolated from the surrounding metal by its oxide film, it has solidified totally independently. Clearly, it has not had the benefit of nuclei for the easy initiation of solidification, with the result that it has undercooled probably by hundreds of degrees Celsius. Its final rapid freezing, long after the general freezing of the casting, explains its fine grain structure, more than one order of magnitude finer than the grain structure of the casting. The isolation of small regions of castings, as oxide-coated droplets, is commonly observed. An example in an Al alloy is given by Dispinar and Campbell.<sup>[34]</sup>

In the case of the turbine blade, the fact that such a safety-critical casting got into service is, unfortunately, perfectly understandable; an examination by X-ray radiography cannot detect such narrow cracks, and the dye penetrant test can, of course, only detect the defects that intersect the surface. Many bifilms will be expected to touch the surface but make perhaps only point contact on a random basis. Thus, as an aside, and as many know, it is superfluous to emphasize that quality cannot be inspected into a part; quality has to be ensured by the production process. Clearly, for turbine blades, the use of gravity to fill molds inevitably accelerates the metal to speeds at which damage is inescapable, with the result that gravity casting is a fundamentally unsuitable and clearly incapable process. This deep concern is regrettably enhanced by the use of nondestructive testing techniques that are also demonstrably incapable.
