Effects of Aging and Environmental Factors on Performance of CdTe and CIS Thin-Film Photovoltaic Modules

Key words: Thin film solar module, PV module failure, delamination, corrosion, module efficiency, module degradation factor

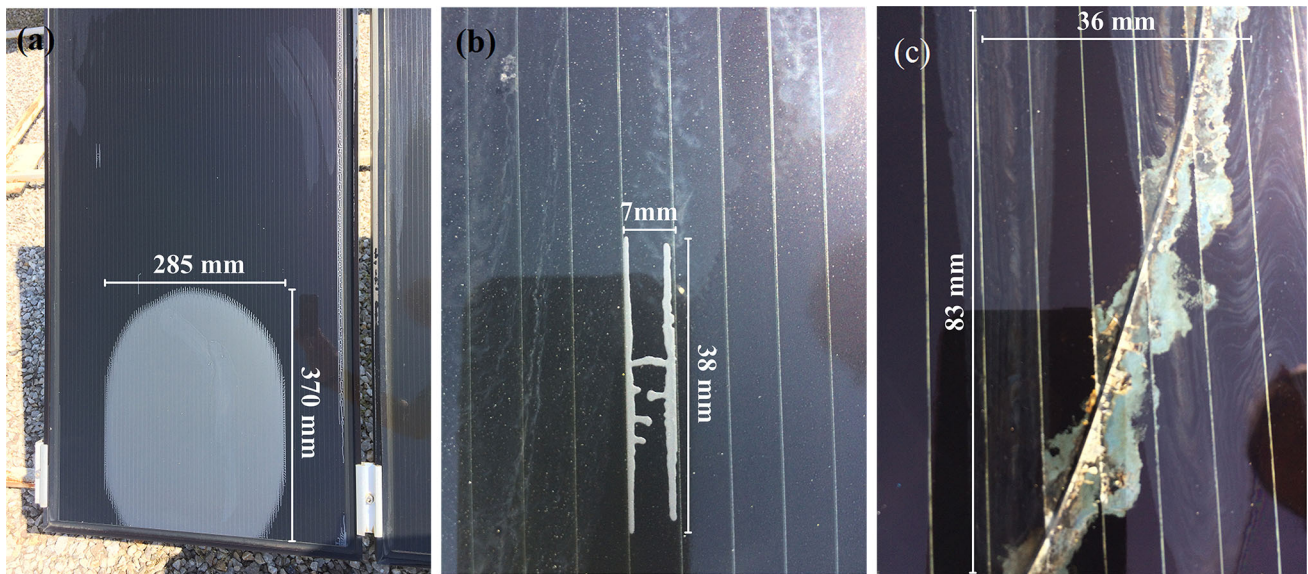
As shown in Fig. 3, we observed delamination, hot-spot, and micro-crack failures in the PV modules during the examination period. The delamination and hot-spot failures shown in Fig. 3a and b were observed in the CIS modules, and the micro-crack failure shown in Fig. 3c was observed in the CdTe modules. These failures started appearing in July 2017 and became more prominent depending on the meteorological and environmental conditions.

Fig. 3. Failures occurring in PV modules: (a) delamination, (b) hot spot, and (c) micro-crack.

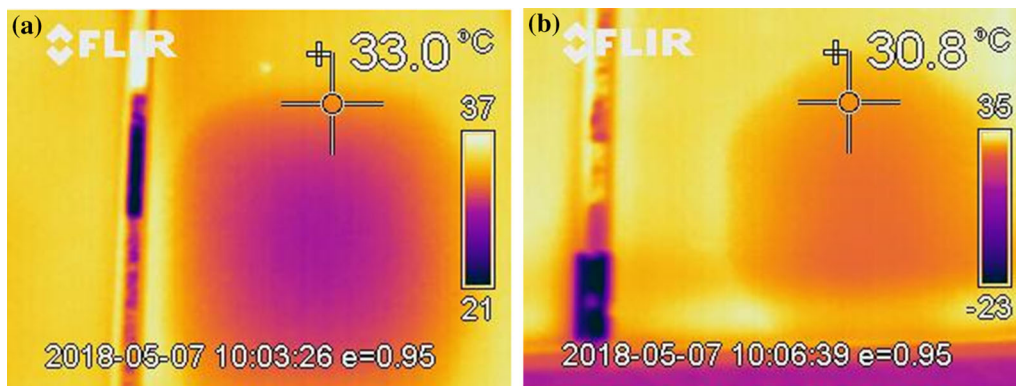
We used a FLIR IR camera to monitor and evaluate the failures occurring in the modules. Images of the delamination defects in the CIS modules are presented in Fig. 6. The regions of the delamination failures were colder than the other regions in the modules. The physical structures in these modules differed from the structures in monocrystalline modules, and these modules behaved more like a single cell structure than like modules consisting of multiple cell structures. Therefore, the heat loss at any point in the module or irradiation loss due to surface coverage affected the entire module.

Fig. 6. Images of delamination defects on CIS modules taken using with an IR camera.

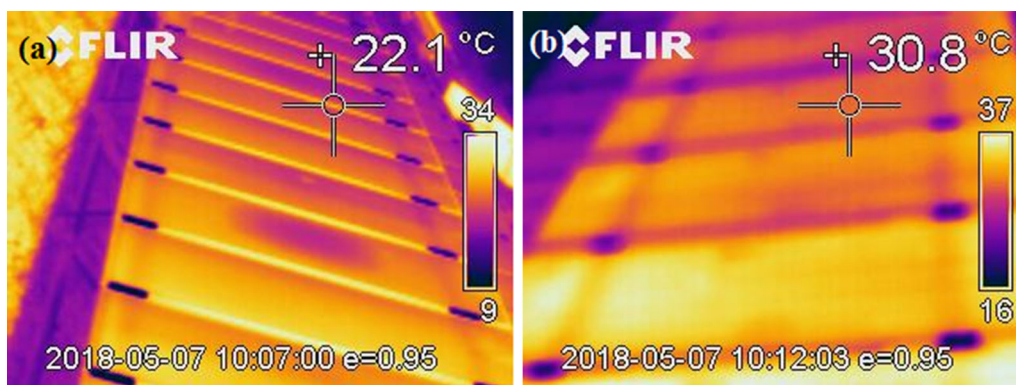
Figure 7 presents IR images of the compared modules. The delamination failures in the CIS

module string were easily detected because they created cold regions. However, the micro-cracks occurring on the CdTe module string were not visible. Thus, the IR imaging method could not be used to analyze the micro-crack failures, and failure detection of the CdTe modules was instead performed using XRD structural analysis. The results of these analyses are presented in the next section (“XRD Structural Analysis of CdTe Thin-Film PV Arrays” Section).

Fig. 7. IR camera images of thin-film PV module strings: (a) CIS and (b) CdTe.

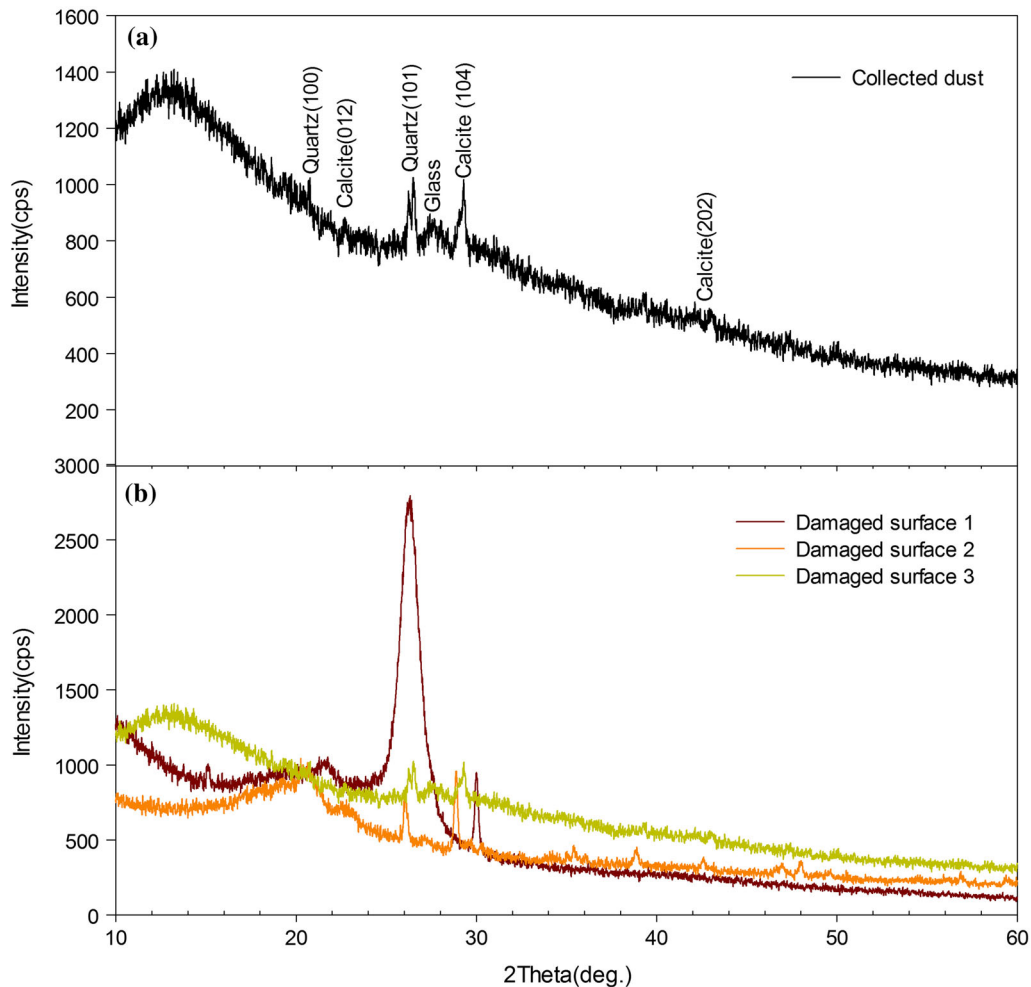
Structural analyses of three regions, especially around the crack of the CdTe PV, were also performed to analyze the structures of the defected regions. In addition, powder samples were collected from locations where the PV was broken to determine the environmental contaminants in the surface crack zone. XRD patterns of all the samples are presented in Fig. 10, and the XRD pattern of the powder is presented for the comparison in Fig. 10a.

The dust mainly consisted of quartz and calcite minerals according to the measurements. The XRD peak of the glass is visible at 26.530° . The calcite corresponds to PDF 01-074-0764 with a hexagonal

structure and lattice parameters of $a = b = 4.9977 \text{ \AA}$ and $c = 5.4601 \text{ \AA}$; the main peak in Fig. 10a at 26.2540° is indexed to the (101) plane. In addition, a (100) peak is observed at 20.5040° . The quartz was

identified as PDF 01-086-0174 with $a = b = 4.9880$ Å and $c = 17.0680$ Å and a rhombohedral structure, and the main peak in Fig. 10a at 29.3990° is indexed to the (104) plane. The other (202) peak appeared at 43.3990° . The XRD patterns of the three different regions differed from each other, as observed in Fig. 10b. In the XRD pattern of the first damaged part, crystallized quartz was detected and appeared to be a grown layer. Comparison of the XRD patterns of the dust and damaged areas reveal that the peak intensities of the quartz and calcite XRD

planes fluctuated on the imperfect surfaces, indicating the collected amount of dust on the surface. As a result of long-term damage, CdTe was not detected in the XRD pattern. Indeed, the CdTe was removed from the surface because of the moisture content on the damaged surfaces.

Fig. 10. XRD patterns of (a) dust collected on CdTe PV surface, and (b) damaged CdTe PV surfaces.
