# Debonding of Porous Coating: A Late Failure Mode of Uncemented, Partially Threaded Acetabular Components—Retrieval Analysis

Submitted: 23 November 2023 / in revised form: 24 May 2024 / Accepted: 30 May 2024  
© The Author(s) 2024

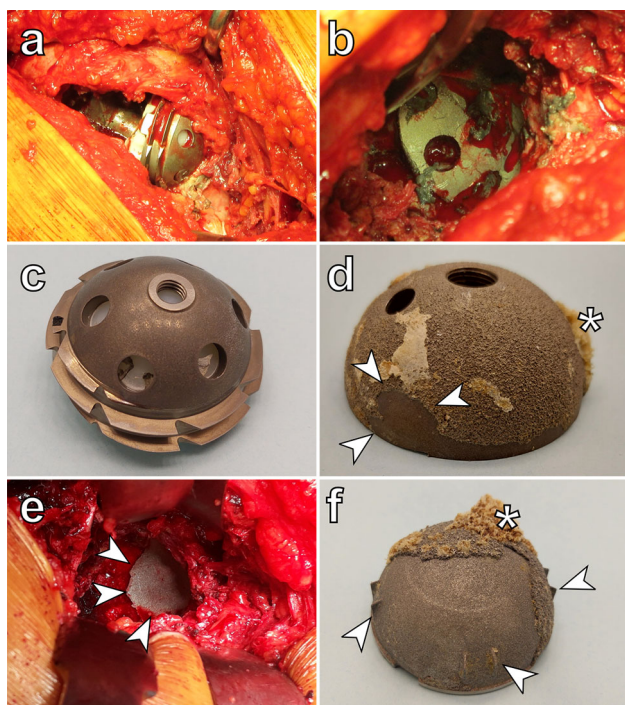
**Fig. 1** Implants included in the study: (a-c) Case 2: (a) Intraoperative view of a loose L-Cup component with a debonded TPS coating; (b) Fragments of the coating still attached to the acetabular bone; (c) A retrieved L-Cup component with a peripheral threaded part and six screw holes; (d) A retrieved EcoFit cup (case 20) with a partially debonded porous coating indicated by arrows; asterisk indicates area with bone still attached chosen for measurement of coating thickness (e, f) Failure of a ReCap component (case 17) (e) Intraoperative view of the debonded coating of the ReCap acetabular component; (f) A retrieved ReCap acetabular component with large fragments of coating missing; arrows indicate the antirotational fins present on this implant; asterisk indicates area with bone still attached chosen for measurement of coating thickness

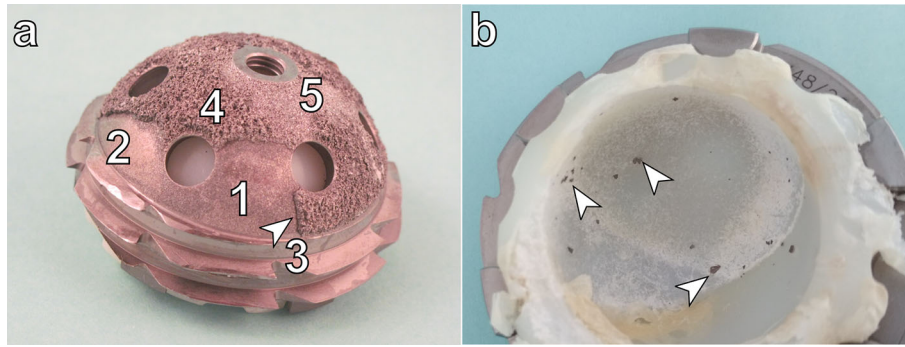
The outer surface of the TPS coating in implants with no migration displayed no signs of wear, and fragments of acetabular bone were still attached to it. In implants with partial failure and migration, certain areas of the coating remained undamaged and had bone fragments attached, while other areas showed signs of polishing. In two implants, areas with cohesive coating failure characterized by mostly rough surface with localized polishing were identified. (Fig. 2a)

**Fig. 2** A L-Cup retrieval with various modes of coating failure present: (a) TPS layer debonding with rough (1) outer surface and areas of localized polishing (2). A crevice (3) visible at border (arrow)

of the intact coating (4); small areas of cohesive failure (5) near the polar region (b) the PE liner of this implant underwent severe wear, accelerated by the presence of metallic third bodies (arrows)

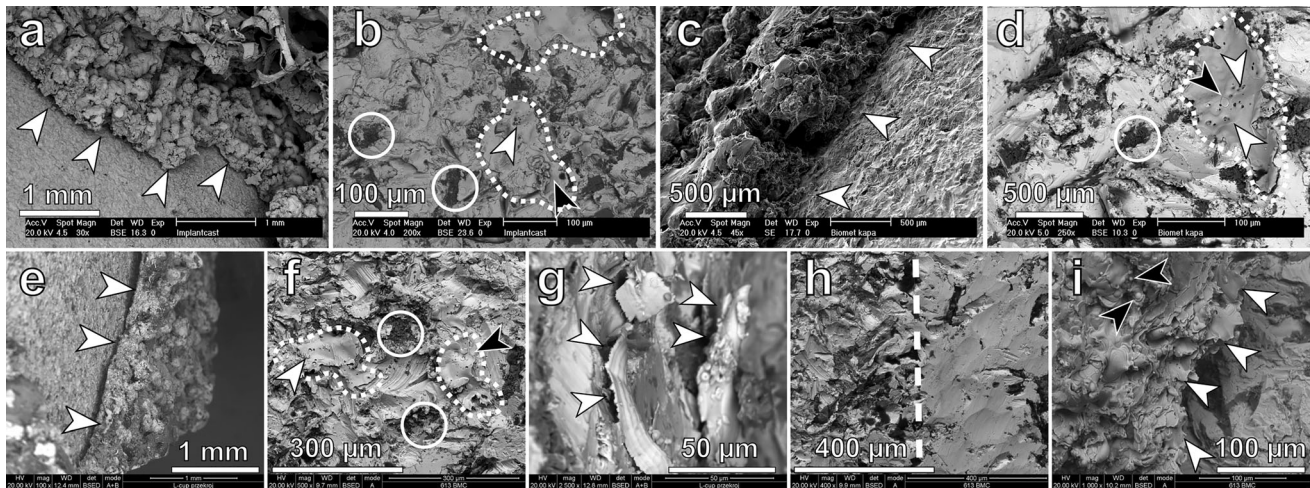
**Fig. 3** SEM examination of the retrieved components: (a) The cliff-like edge of coating failure in an EcoFit cup; arrows indicate a crevice beneath the still attached coating (corresponding to Fig. 1d—border indicated by arrows); (b) Denuded areas of the EcoFit cup (corresponding to fit 1d) : marks caused by grit blasting with embedded alumina particles (in circles); splashed splats (outlined with dotted lines) with voids (white arrows) and droplets (black arrows); (c) The cliff-like edge of coating failure in a ReCap component (corresponding to Fig. 1c); a small crevice marked by arrows; (d) Denuded part of the ReCap component (corresponding to Fig. 1c)—grit blasted surface with embedded alumina grains (in circles); a splashed splat (outlined by a dotted line) with voids (white arrows) and droplets (black arrow) is visible; (e) The edge of coating failure in an L-Cup component (corresponding to Fig. 2a; region marked as 3); arrows indicate a crevice beneath the debonded coating;

(f) Denuded area of an L-Cup implant (corresponding to Fig. 2a; region marked as 1)—grit blasted surface with alumina grains (in circles) embedded into the base material; splashed splats (outlined by dotted lines) with voids (white arrows) and droplets (black arrows); (g) Individual splats from an L-Cup component (corresponding to Fig. 2a; region marked as 1); arrows indicate peripheral detachment of these splats from the base material; (h) Fragment of an L-Cup retrieval (corresponding to Fig. 2a; region marked as 2) where wear-induced smoothing of the outer grit blasted surface due to implant migration is visible to the right of the dashed line; undamaged surface to the left; (i) Areas of cohesive failure in the L-Cup implant (corresponding to Fig. 2a; region marked as 5); splats (white arrows) do not contain voids; however, multiple droplets (black arrows) were present

(Fig. 3b, d, f). In all types of implants, these rough areas contained individual titanium alloy splats with an irregular shape. The splats contained small voids, and multiple small droplets and splashes were visible in their proximity (Fig. 3b, d, f), while their borders were often not attached to the base material (Fig. 3g). Parts of cups polished due to implant migration exhibited flattening of the grit blasting marks and removal of most alumina grains (Fig. 3h). Areas of cohesive failure also had well-defined cliff-like borders

and were characterized by the presence of multiple irregular splats with very few voids, however, a large number of droplets were present between them (Fig. 3i).

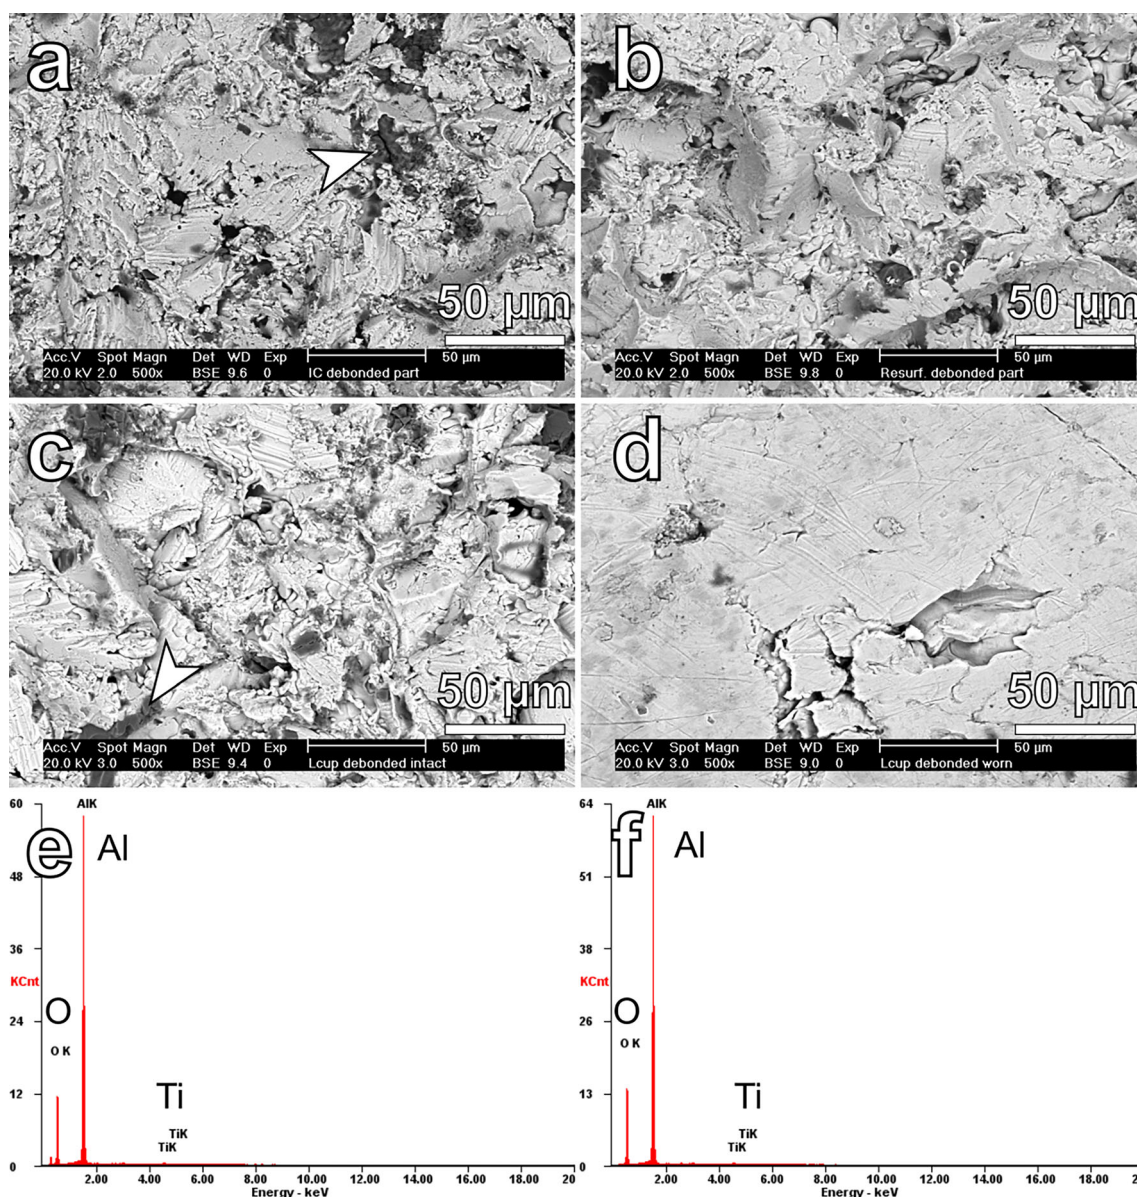
The adherent surface of the delaminated coating fragments was composed of titanium alloy splats with a comparable morphology and a small number of alumina grains pulled out from the cup's bulk material (Fig. 4a-c). Detached fragments of coatings corresponding to polished fragments of the L-Cup shells had a smooth surface with

**Fig. 4** SEM analysis of debonded coating fragments—the side previously attached to the cups visible on all micrographs: (a) Coating from the EcoFit cup—splats with a small number of alumina grains visible arrow indicates a grain evaluated using EDS (Fig. 4e); (b) Coating detached from the ReCap component; multiple splats, droplets and small alumina grains; (c) Coating fragment detached from an L-Cup component consisting of splats, droplets and alumina grains; arrow indicates a grain analyzed using EDS (Fig. 4f) (d) A

thin boundaries between the splats forming the TPS coating visible (Fig. 4d).

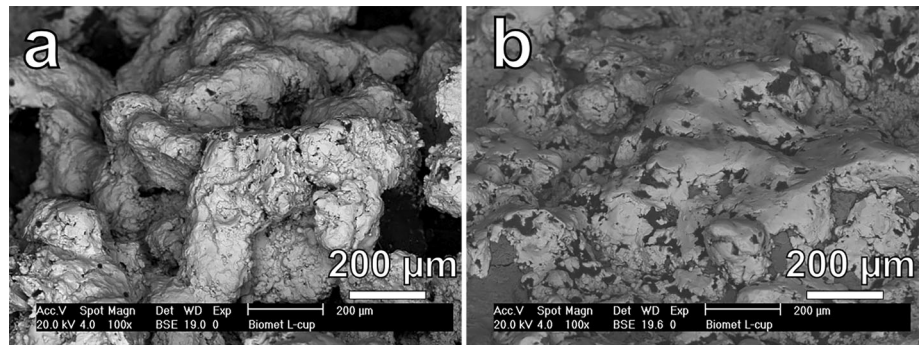
In controls and retrievals that did not migrate the outer surface of the TPS coating consisted of splats and droplets forming a porous macrostructure overgrown by bone (Fig. 5a). Implant migration also affected the appearance of the outer coating surface resulting in localized polishing

**Fig. 5** SEM analysis of the outer surface of coating from L-Cup retrievals (a) Typical appearance of undamaged coating—multiple splats and droplets forming a porous structure (corresponding to Fig. 2a; region marked as 4); (b) flattening of the porous structure due to wear and polishing related to implant migration (sample 21—control)

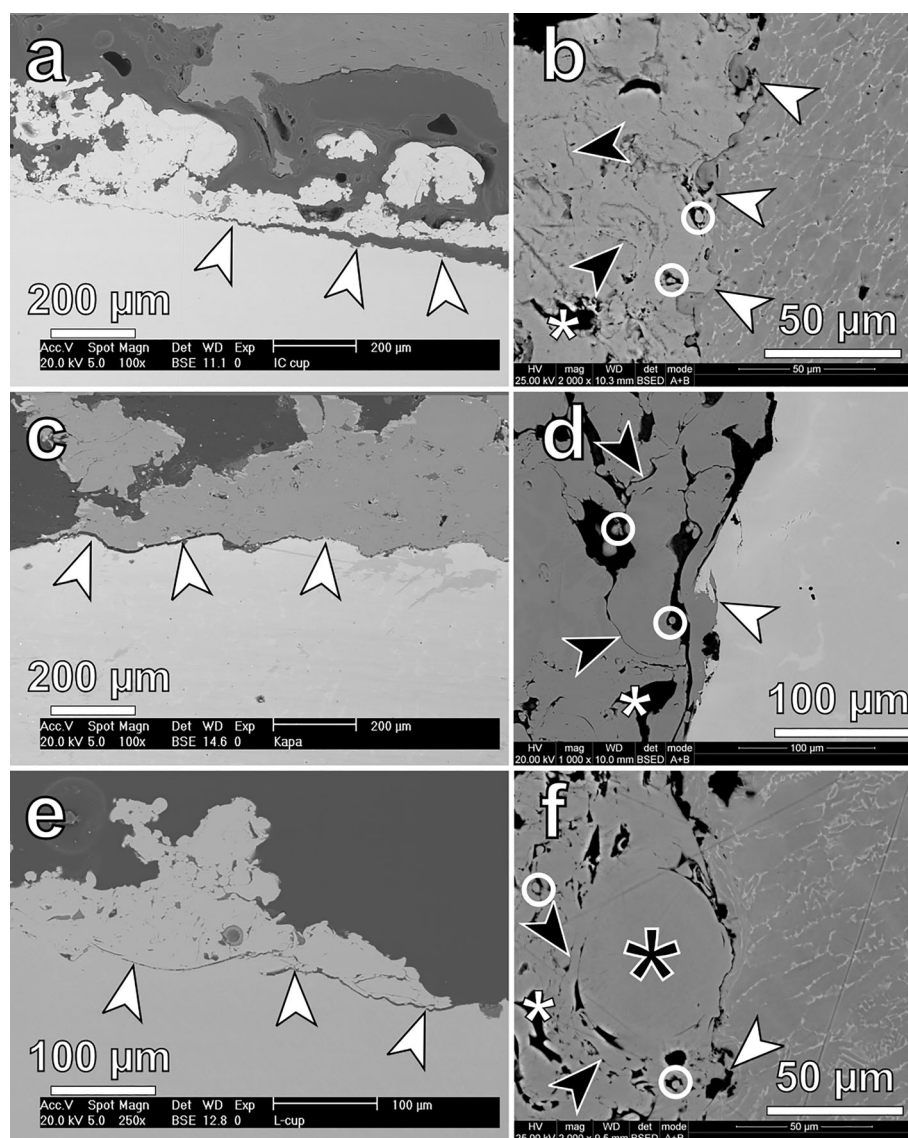
observed in samples with partial debonding and some controls (Fig 5b). Metallographic cross sections revealed a clear demarcation between the bulk cup material and the TPS coating in all components, including the controls. The splats in the TPS exhibited interlocking with the rough outer surface of the implant and alumina grains, with no metallurgical bonding occurring at the interface (Fig. 6a-c). Borders

between splats forming consecutive layers of the coating were typically less distinct, and metallurgical bonding was commonly observed. Near areas where coating failure occurred, the demarcation between the TPS layer and cup material extended into a gradually widening gap, which was observed in both the cliff-like borders and the areas where a crevice was formed (Fig. 6a-c).

**Fig. 6** SEM analysis of metallographic cross sections of all types of components (a) delamination in the EcoFit cup (corresponding to Fig. 1d): arrows indicate a gap between the coating (upper part of the micrograph) and the base material that gradually extends to the right. (b) cross section of the coating—base material interface in a EcoFit control sample (case 29) demonstrating mechanical interlocking of the coating (white arrows), thin borders between splats (black arrows) and presence of voids (white asterisks) and droplets (white circles) in the TPS layer. (c) coating failure in a ReCap implant (corresponding to Fig. 1f): arrows indicate a gap between the coating (upper part of the micrograph) and the CoCrMo base material. (d) cross section of the interface of coating—base material of a ReCap control sample (case 28) demonstrating mechanical interlocking of the coating and

base material (white arrow), borders between splats (black arrows) and presence of voids (white asterisks) and droplets (white circles) in the TPS layer. (e) Coating failure in an L-Cup implant (corresponding to figure 2a; border of the coating in region marked as 1): arrows indicate a gradually widening gap between the TPS layer (upper part of the micrograph) and the base material. (f) cross section of the interface of coating—base material of a L-Cup control sample (case 21) demonstrating mechanical interlocking of the coating and the substrate material (white arrow), borders between splats (black arrows) and presence of voids (white asterisks) and droplets (white circles) in the TPS layer; an unmelted titanium particle visible in the center (black asterisk)

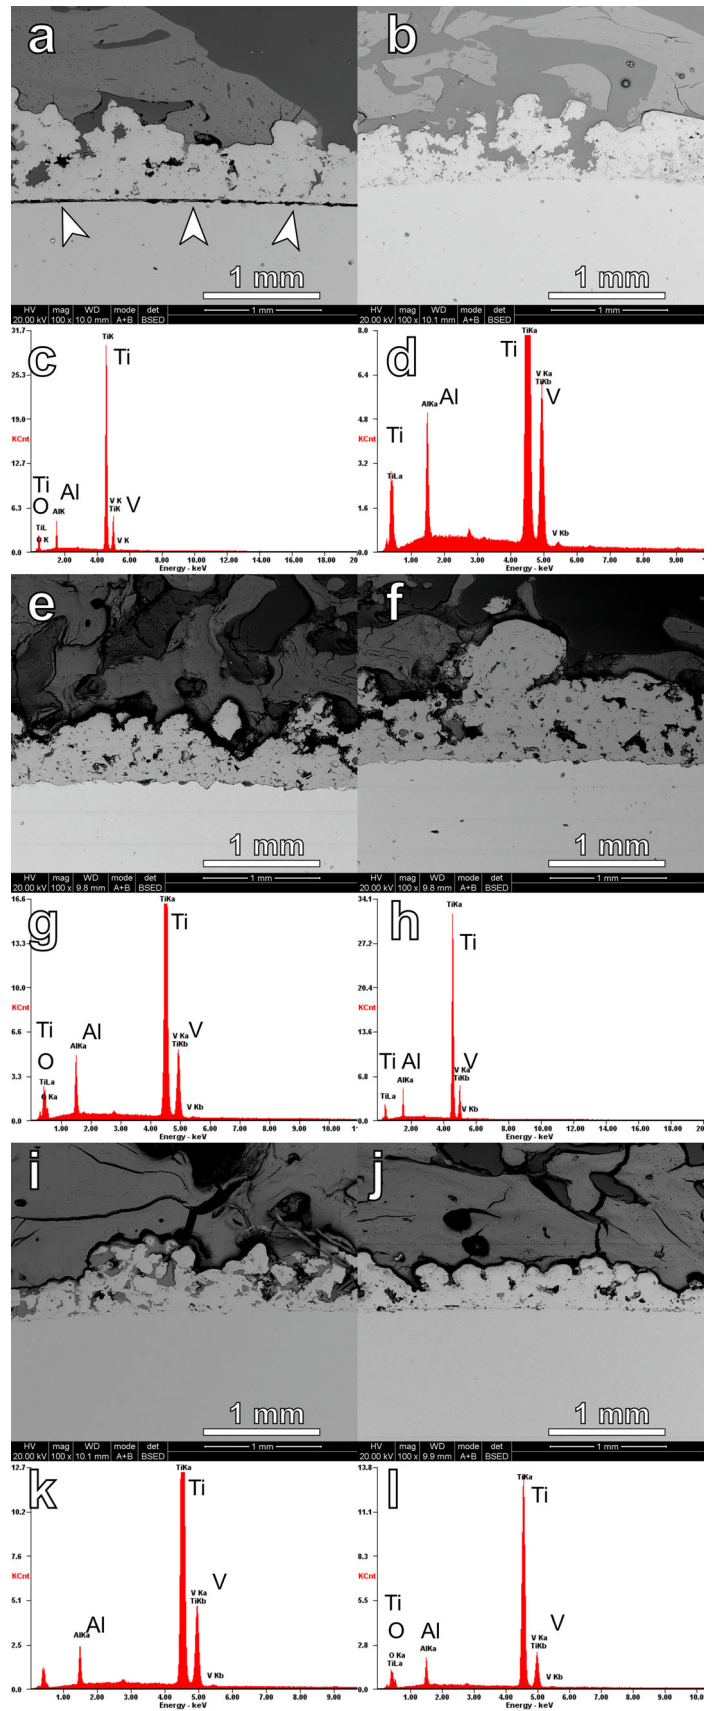
In order to determine if coating thickness, structure, and chemical composition differed between implants with and without debonding, metallographic sections in areas with bone attached to retrieved components were evaluated. In the case of L-Cup implants (Fig. 7a-d), there was no statistically significant difference between the thickness of the TPS layer in implants with (mean 480.72 µm; range 181-973 µm) and without (mean 516.28 µm; range 147-1102 µm) coating failure. On the ReCap samples (Fig. 7e-h) comparable TPS layer thickness was found in implants without debonding where (mean 527.73 µm; range 180-1066 µm), and in samples with debonding (mean 542.53 µm; range 139-1386 µm). There was also no statistically significant difference between the EcoFit samples (Fig. 7 i-l); mean coating thickness in the implant with debonded coating was 416.32 µm (range 91-891 µm), while in controls, it was 394.87 µm (range 110-1281 µm). In all types of implants, there were no noticeable differences in coating structure between implants with and without debonding. EDS analyses did not demonstrate the presence of any contamination in any of the samples.

**Fig. 7** Thickness evaluation of coating in implants with and without coating failure: (a) Cross section of an L-Cup implant with partial coating failure (Case 12); arrows indicate the area where debonding occurred (b) L-Cup control sample (Case 22) cross section (c) EDS analysis of a  $200 \times 200 \mu\text{m}$  coating fragment from Fig. 7a (d) EDS analysis of a  $200 \times 200 \mu\text{m}$  coating fragment from Figure 7b (e) Cross section of a ReCap implant (Case 17) with partial coating failure (f) ReCap control sample (Case 28) cross section (g) EDS analysis of a  $200 \times 200 \mu\text{m}$  coating fragment from Fig. 7e (h) EDS analysis of a  $200 \times 200 \mu\text{m}$  coating fragment from Fig. 7f (i) Cross section of an EcoFit implant (Case 20) with partial coating failure (j) EcoFit control sample (Case 31) cross section (k) EDS analysis of a  $200 \times 200 \mu\text{m}$  coating fragment from Figure 7i (l) EDS analysis of a  $200 \times 200 \mu\text{m}$  coating fragment from Fig. 7j

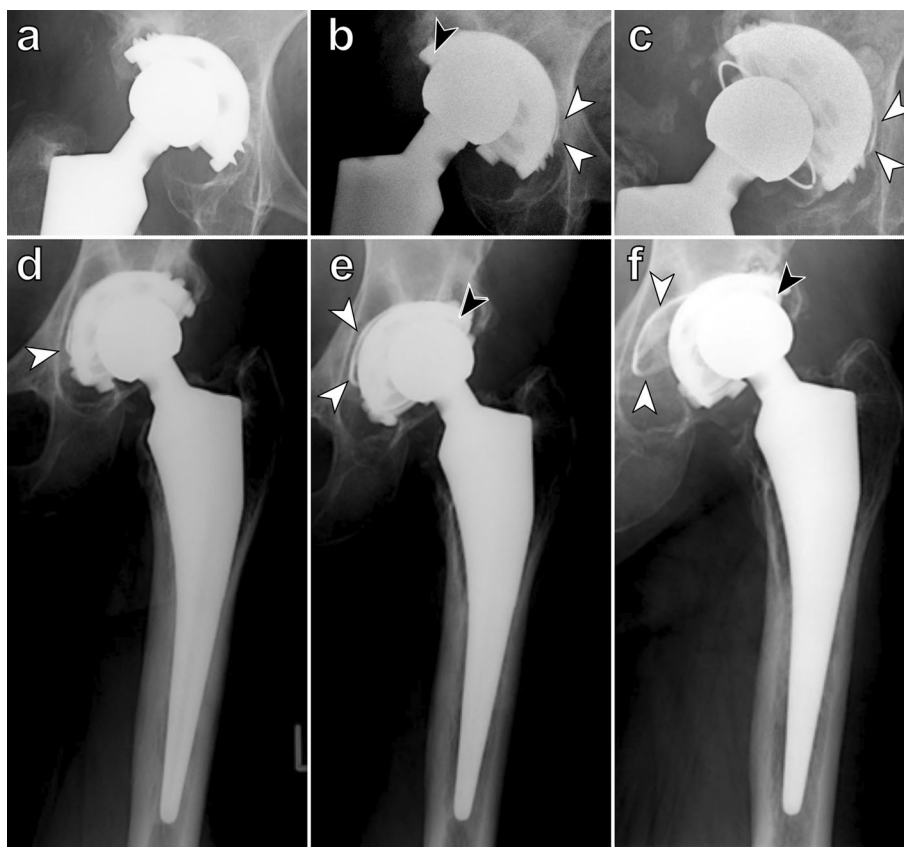
Data from serial radiographs available for some patients suggest that the debonding process may be initiated in the lower part of the acetabulum corresponding to zone 3, according to DeLee and Charnley (Fig. 8). Remarkably, one patient with coating debonding and liner wear gave consent to undergo a liner exchange only, and after this procedure, the acetabulum has (as of writing) been asymptomatic for the last 5 years (Fig. 8a-c). In a different patient, asymptomatic debonding was confirmed as early as 3 years before any symptoms were present and 5 years before the implant was revised due to migration and polyethylene wear (Fig. 8d-f)

**Fig. 8** Serial radiographs demonstrating progression of coating debonding in two hips (a–c—case 27; d–f—case 2) with L-Cup components; (a) routine check-up radiograph from 2009—no signs of coating damage; (b) radiograph from 2018 prior to revision due to PE liner wear (black arrow), coating debonding in Gruen zone III visible (white arrows); the patient gave consent only for liner exchange. (c) radiograph from 2023—no major implant migration; coating debonding indicated by white arrows. (d) routine check-up radiograph

from 2010—initial coating debonding (white arrow) in an asymptomatic patient; (e) subsequent radiograph from 2013—the patient developed mild pain and was initially qualified for revision due to liner wear (black arrow); white arrows indicate debonded coating. (f) radiograph from 2015, shortly before the revision; cup migration exposed the debonded coating (white arrow); severe liner wear (black arrow)

The authors believe that TPS debonding detected on radiographs should be considered as a relative indication for implant revision, since it tends to progress over time, as evidenced by serial radiographs. However, in instances where the patient or surgeon decides against undergoing a revision surgery, regular radiographic check-ups should be performed to monitor the situation closely.

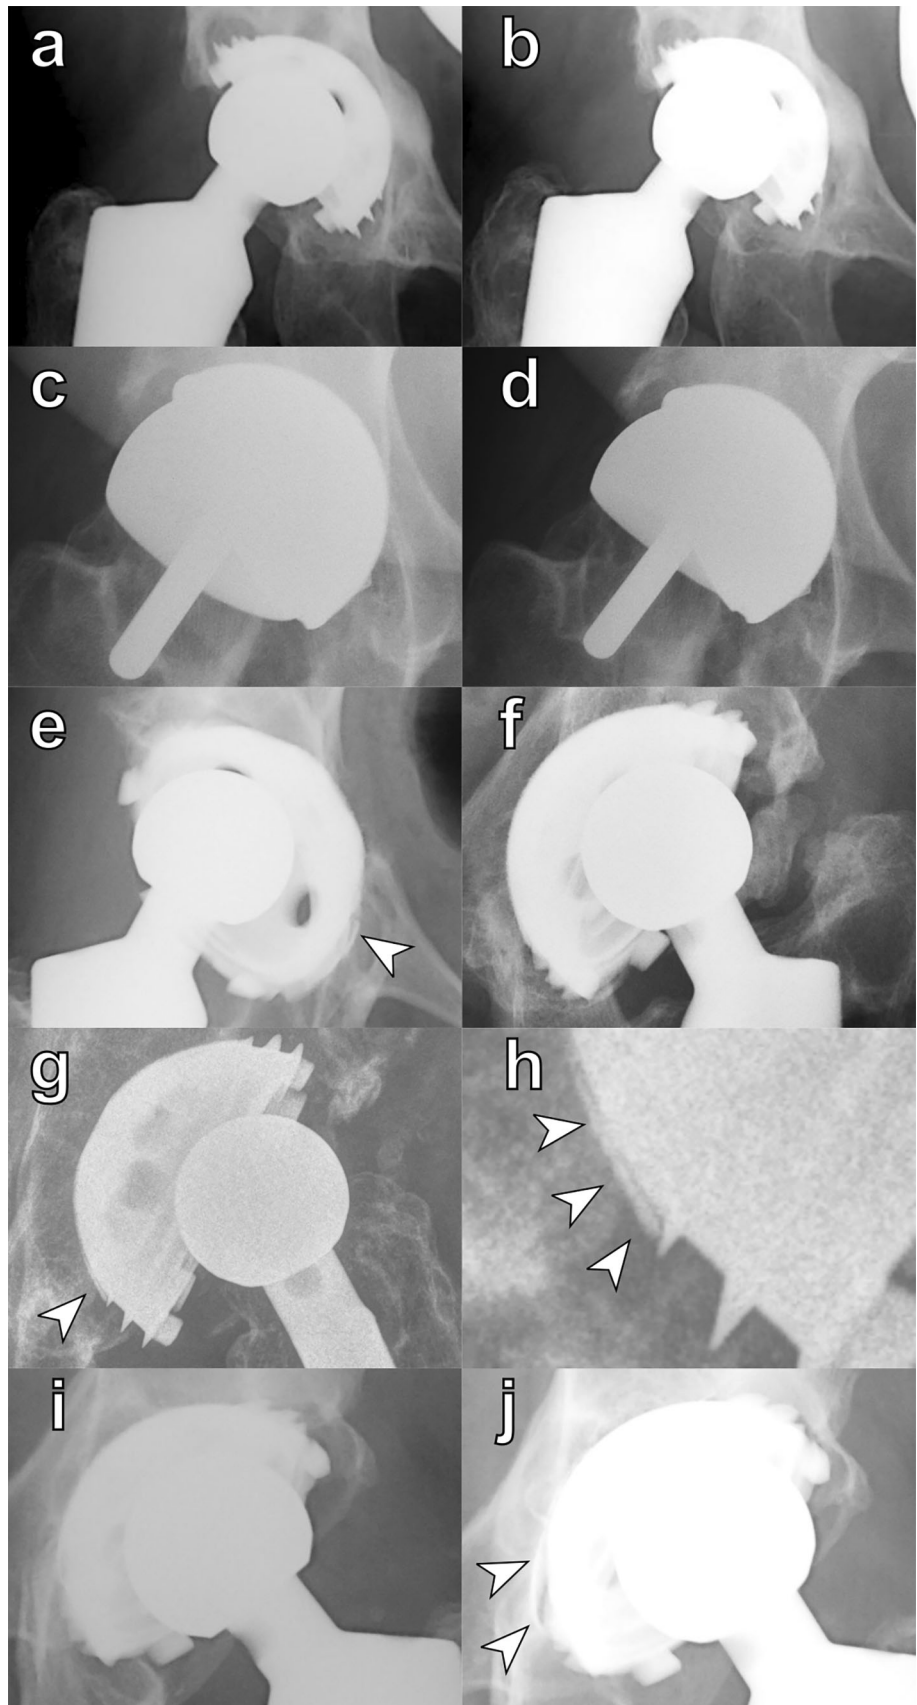
In other patients where serial images were not available, the evaluation of radiographs was challenging (Fig. 9). In some cases where no apparent coating delamination was observed on preoperative x-rays (Fig. 9a-d), the retrievals had partial debonding with the rough grit-blasted surface of the substrate material exposed, suggesting that the failure occurred during implant removal. In one case of partial failure (Fig. 9e), a small debonded fragment was visible on x-rays, and a larger debonding area with mixed (rough and smoothed) surface morphology was observed on the retrieval. Interestingly, in two cases of partial failure, debonded coating fragments could not be detected on standard AP prone radiographs but were visible on either an axial view (Fig. 9f, g) and in one case on a standing AP view (Fig. 9i, j). This was most likely a result of a slight change in the cup's position while these radiographs were taken; also in both cases debonding with abrasion induced surface polishing was observed. Still, in all patients where at least some signs of partial coating debonding were observed, they occurred in DeLee and Charnley zone 3.

**Fig. 9** Radiographs from patients where serial images were not available: (a, b) Case 10—L-Cup implant; partial debonding: (a) Radiograph from 2014—no apparent debonding (b) Radiograph from 2017—no apparent debonding (c-d) Case 17—ReCap implant; partial debonding: (c) Radiograph from 2019—no TPS failure (d) Radiograph from 2021—no coating damage (e) Case 14—L-Cup implant, partial coating failure; arrow indicates a small debonded coating fragment. (f-h) Case 12—L-Cup implant; partial failure: (f) Preoperative prone AP radiograph taken in 2020—no signs of coating damage (g) Axial radiograph taken the same day—arrow indicates the area where coating debonding became apparent (h) Enlarged part of Figure 9 g—arrows indicate the debonded fragment (I, j) Case 16—L-Cup implant: (i) Radiograph from 2018—no apparent coating damage on prone AP view (j) Standing AP radiograph taken two weeks later with debonding visible—arrows indicate the debonded fragment. The patient did not report any falls or changes in symptoms suggesting debonding between the radiographs

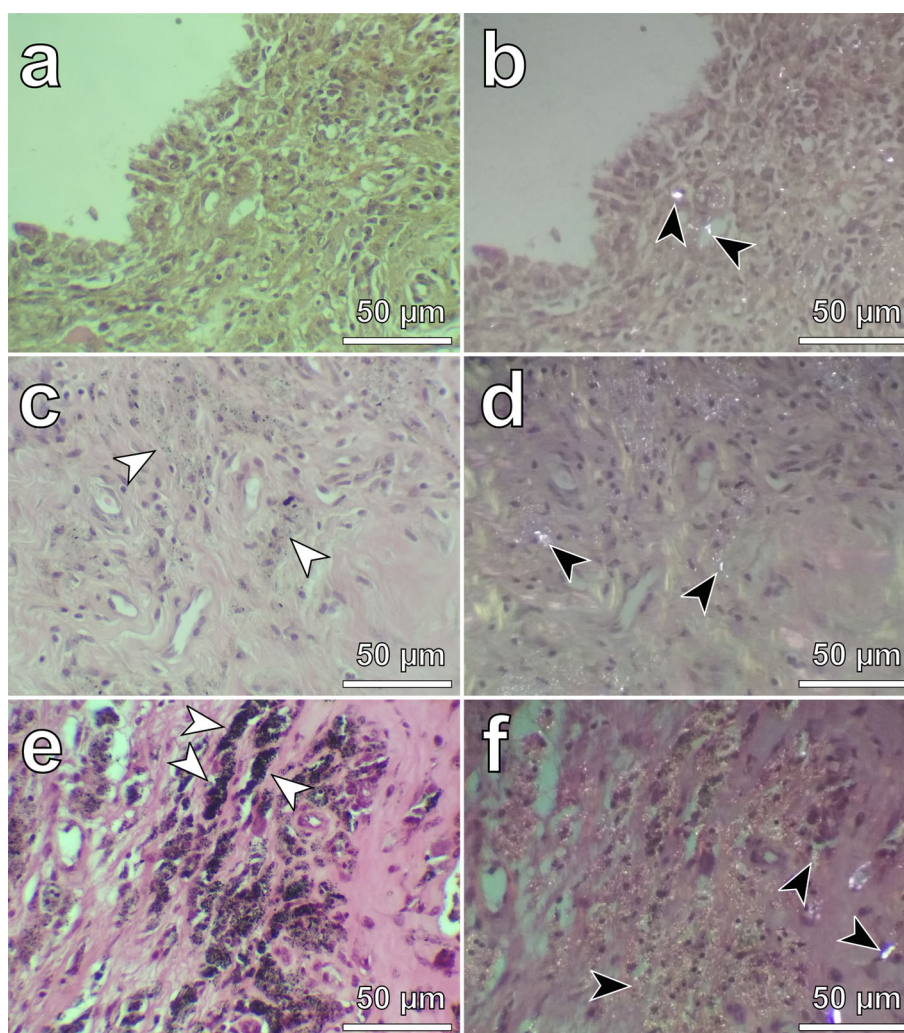
Pathological examination of periprosthetic tissues revealed distinct morphological differences depending on the failure mechanism; however, samples were only available for some of the patients with MoP bearings. The interfacial membrane obtained from controls and cases where implant migration did not occur exhibited a white-yellowish color and contained polyethylene debris in cases of liner wear and small amounts of metallic debris when component loosening occurred (Fig. 10a-d). In contrast, samples from cases with total or partial debonding and implant migration displayed a dark color and contained a significant number of macrophages loaded with metallic and polyethylene debris (Fig. 10e-f).

**Fig. 10** Paired microscopic slides of periprosthetic tissues from patients with L-Cup failures; images on the left were taken using standard conditions, while those on the right were taken using polarized light to visualize polyethylene debris. (a) Conventional image of a control case—L-Cup implant loosening due to PE wear; typical morphology of an interfacial membrane associated with aseptic loosening. (b) The same part of the slide under polarized light; black arrows indicate polyethylene debris. (c) Periprosthetic tissue from a patient with partial debonding and no migration; macrophages with small amounts of metallic debris marked by white arrows. (d) The same tissue fragment under polarized light; black arrows indicate polyethylene debris. (e) Fragment of periprosthetic tissue from a patient with coating debonding and implant migration; white arrows indicate macrophages loaded with metallic debris. (f) The same fragment under polarized light; polyethylene debris indicated by black arrows
