Dealloying of a Nickel–Aluminum Bronze Impeller

Albert M. Olszewski

Abstract A brackish water pump impeller was replaced after 4 years of service, while its predecessor lasted over 40 years. The subsequent failure investigation determined that the nickel–aluminum bronze (NAB) impeller was not properly heat treated, which made the impeller susceptible to aluminum dealloying. The dealloying corrosion was exacerbated by erosion, because the pump was slightly oversized. This investigation recommended proper heat treatment of NAB alloys that are to be used in salt water or brackish service. Additionally, the investigation recommended closer evaluation of new pumps to ensure that they are properly sized.

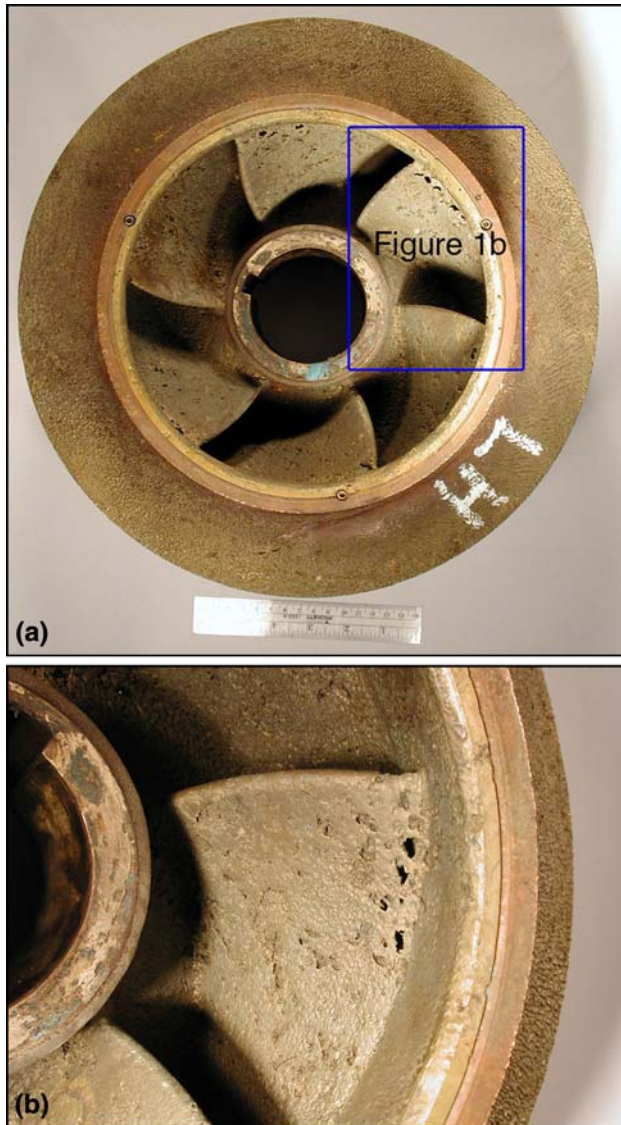
The impeller exhibited severe pitting damage that perforated the vanes (Figs. 1 and 2). The most severe damage was predominately on one suction eye; however, pitting was observed throughout the body. Erosion damage that was characterized by a continuum of overlapping pits was also present throughout the body. Additionally, the ceramic coating was completely removed from the impeller. Chemical analysis at two different locations was performed by inductively coupled plasma (ICP) spectroscopy. The results were consistent with a cast NAB alloy, C95800 (Table 1). The aluminum content varied from 8.4 to 9.6 wt.% and the nickel content varied from 3.9 to 4.2 wt.%. Converted microhardness measurements averaged 87 Rockwell B, which is consistent with an as-cast C95800. Three metallurgical mounts were taken for examination. The microstructure was consistent for an as-cast NAB, which consists of mostly alpha phase (Fig. 3). In the mounts, areas of selective grain attack were observed at the surface and propagating inward (Figs. 4 and 5). Energy dispersive X-ray spectroscopy (EDS) was used to compare chemical composition within the microstructure. The aluminum concentrations were significantly lower (~4%) in the areas of selective grain attack than in the bulk material (~8%) (Fig. 6).

Fig. 1 (a) Severe damage on suction side caused (b) multiple perforations of the vanes

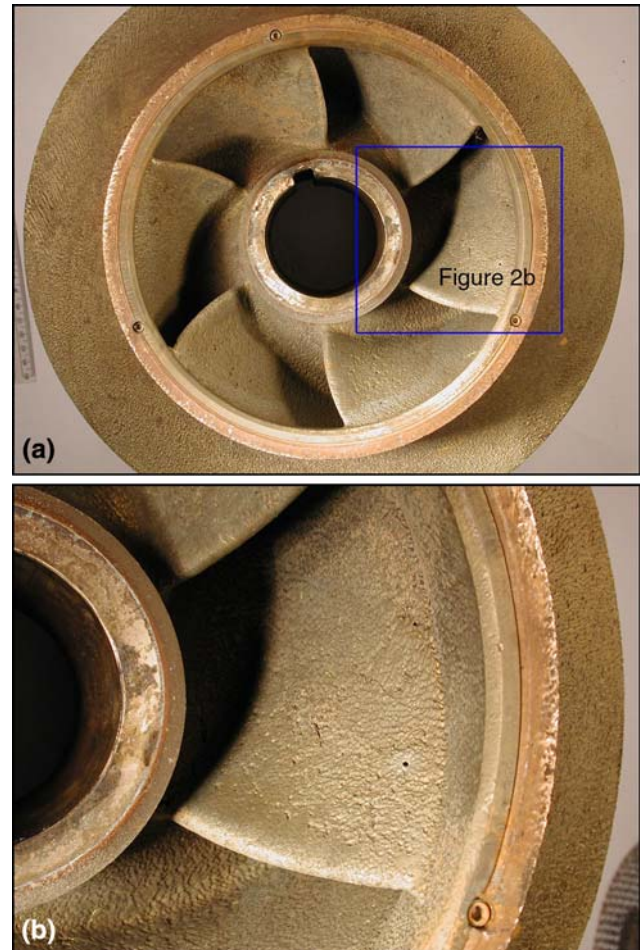
Fig. 2 (a) Opposite suction side of impeller showed less damage but it still contained a (b) perforated vane

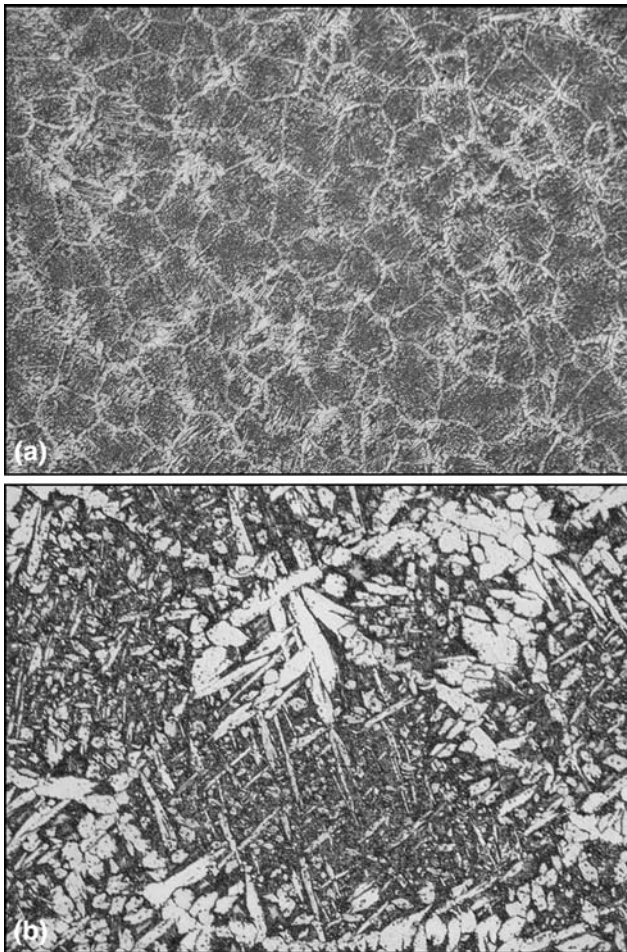
Fig. 3 Typical microstructure in bulk material containing mostly alpha phase (a) 100 \times and (b) 500 \times , etchant: 45 mL nitric acid and 45 mL acetic acid

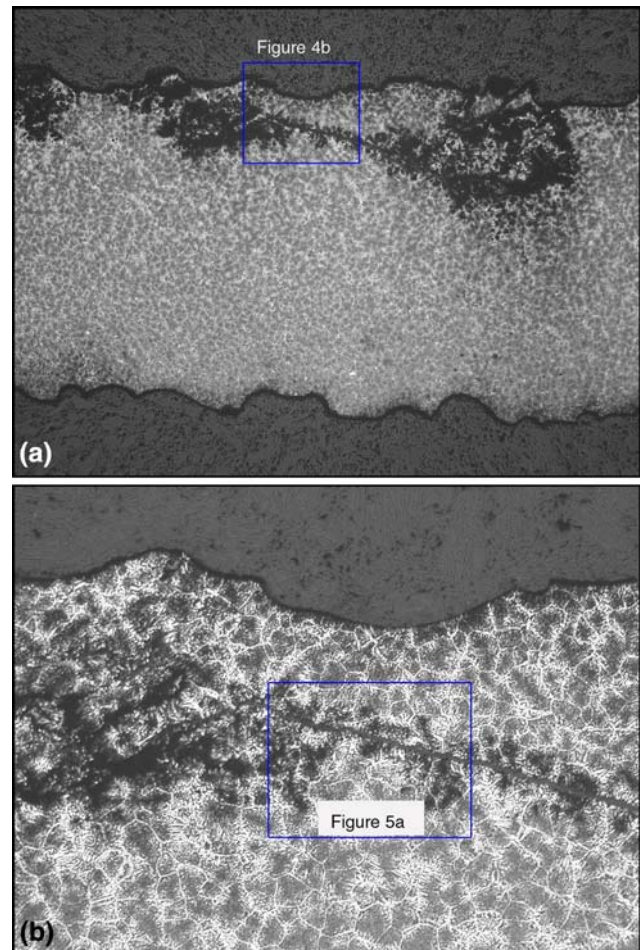
Fig. 4 Selectively attacked region near the surface contained dealloying (a) 12.5 \times and (b) 50 \times , etchant: 45 mL nitric acid and 45 mL acetic acid. Figure 5 is a higher magnification image of the boxed area in image b

The salt water impeller experienced severe aluminum dealloying corrosion assisted by erosion caused by recirculated service discharge water. The lack of heat treatment, confirmed by the observed microstructure and the lower hardness, created an undesirable microstructure. The combination of these two conditions, no heat treatment and erosion, created an environment that compromised the impeller.

- Properly heat treat all NAB components that are to be used in brackish or seawater applications.
- Verification of heat treatment by portable hardness.
- Correctly size new pumps.

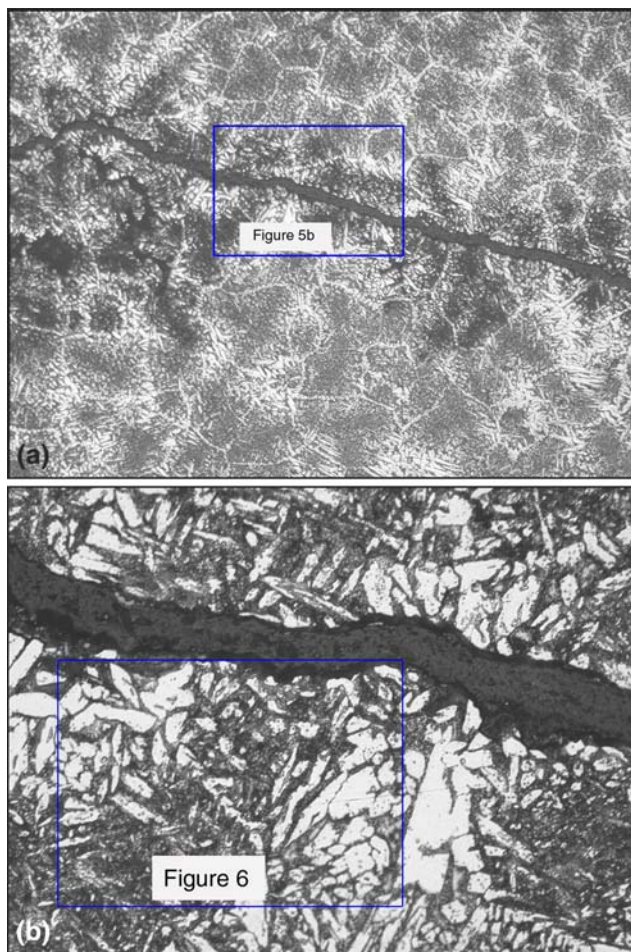
Fig. 5 Selectively attacked region near the surface contained dealloying (a) 100 \times and (b) 500 \times , etchant: 45 mL nitric acid and 45 mL acetic acid. Figure 6 is a electron micrograph of the boxed area in image b

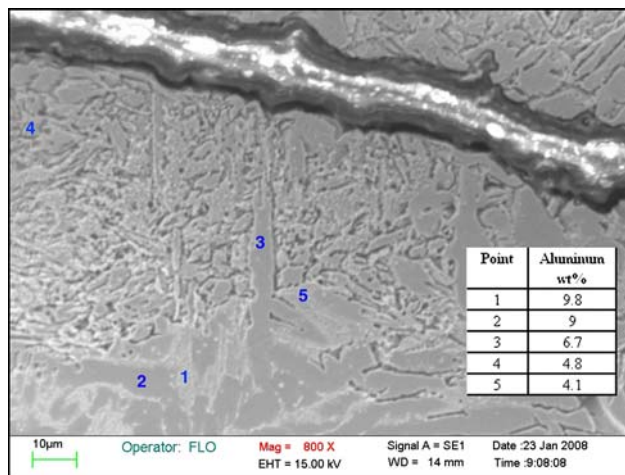
Fig. 6 SEM image revealed selective grain attack and dealloying, etchant: 45 mL nitric acid and 45 mL acetic acid. The aluminum concentration was significantly lower than in the bulk material in the area of grain attack
