Failure Analysis of Water Pump Shaft

Wali Muhammad · Kashif Mairaj Deen

Submitted: 4 August 2009 / Accepted: 28 January 2010 / Published online: 26 February 2010
© ASM International 2010

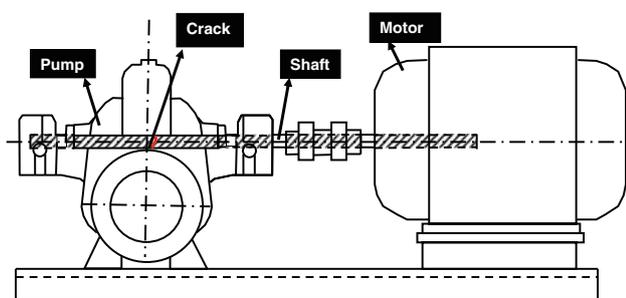
Fig. 1 The sketch of the pump assembly and the location of the crack

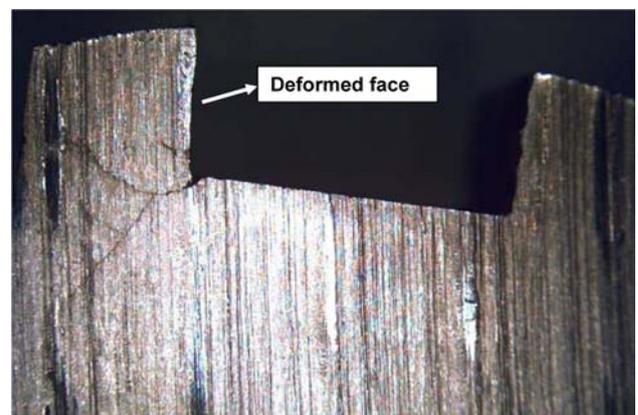
Observations under stereomicroscope revealed that the key slot portion adjacent to the RHS was cracked and notably deformed to one side. The cross section of the key slot showed that the material was probably pressed in the direction of rotation. Figure 5 shows the stereomicrograph of the deformed side and the cracks propagating from the root of the slot.

Fig. 5 Stereograph of the cross section of the key slot showing deformed side

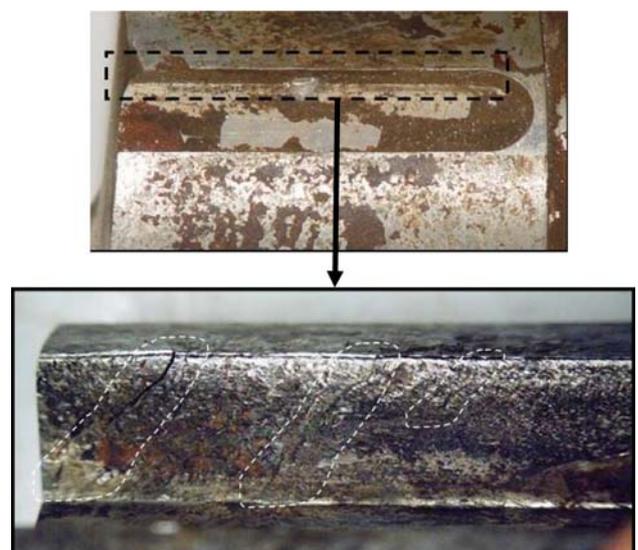
A number of inclined cracks were found on the side of the key slot which was pressed. All these cracks were oriented in the same way. These cracks were also present away from the fractured surface and started at the upper edge of the key slot and travelled to lower corner (Fig 6).

Fig. 6 Inclined cracks on one side of the key slot, boxed area shows the inclined cracks travelling from upper face to lower corner

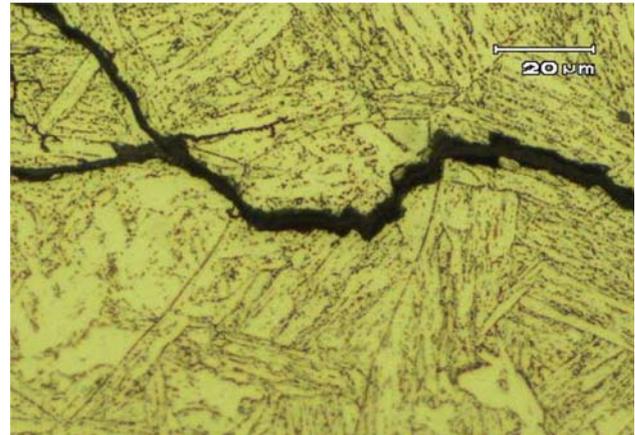
As polished samples showed appreciable concentration of MnS inclusions (Fig. 7a). After etching in Vilella's reagent, a microstructure of lath martensite was observed (Fig. 7b). A section through a crack was mounted to examine the mode of crack propagation. After etching, it was found that crack propagated in the mixed modes, i.e., inter- as well as trans-granular (Fig. 8). The inter-granular

Fig. 8 Optical micrographs of the crack showing mixed mode fracture

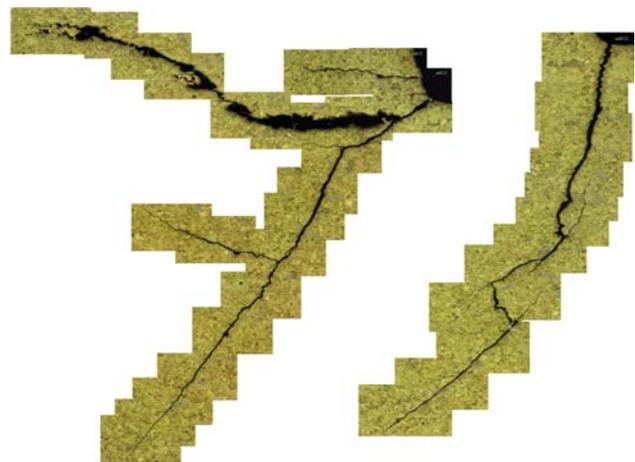
cracking proceeded along prior-austenite grain boundaries. A montage of micrographs show the origin of the crack and direction of the crack growth (Fig. 9).

Fig. 9 Stitched micrograph showing the direction of crack propagation from the fillet of key slot

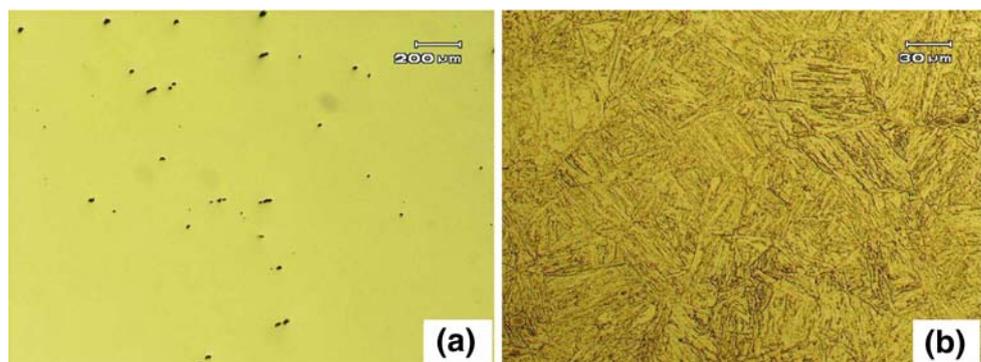
Fig. 7 Optical micrographs of the bulk material, (a) as polished samples showing concentration of inclusions, (b) martensitic structure

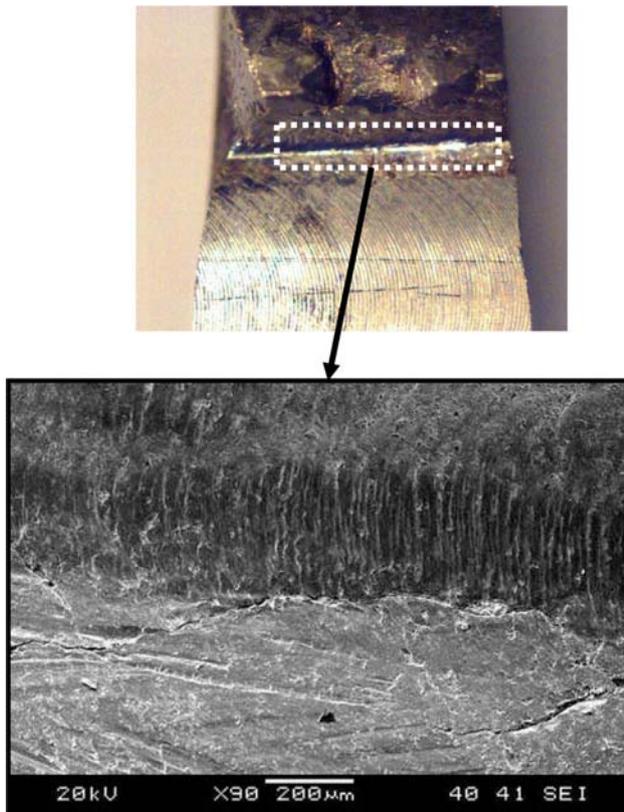
Fig. 10 SEM image of the root of key slot on RHS showing severe deformation and cracks at the corner

The fractures and adjacent regions of the key slot were observed under SEM. The root of key slot revealed that the material was severely pressed. Marks of shearing along with cracks were found in this region (Fig. 10).

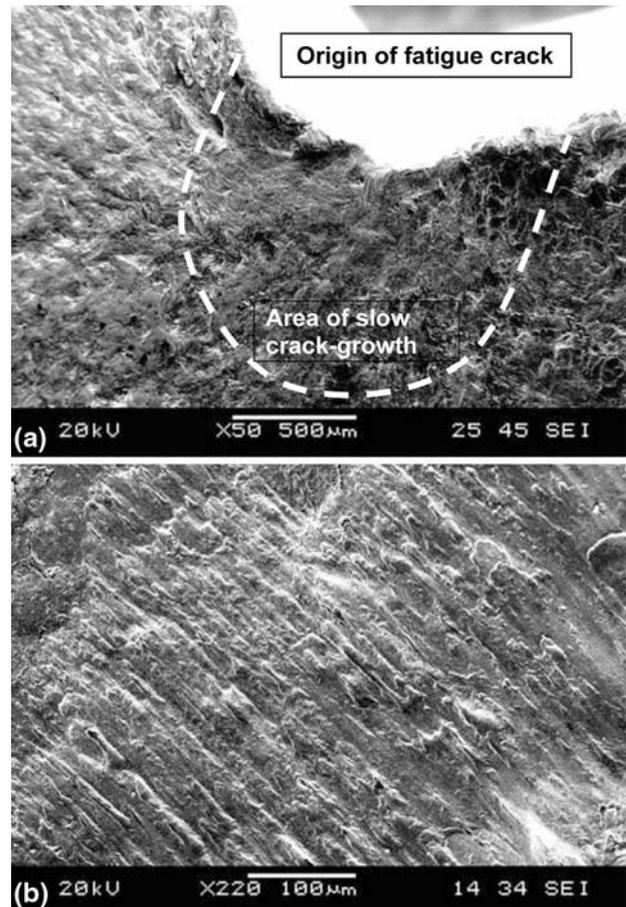
Detailed study of the fracture surfaces was also performed. The fractured surface showed a smooth region at the lower corner of the key slot, indicating the slow crack-growth area. Typical fatigue striations were found on the fracture surface (Fig. 11).

Fig. 11 SEM image of the RHS showing (a) origin of fatigue crack and slow crack-growth region, (b) fatigue striations

The experimental heat treatments carried out in the laboratory showed that the properties of the material can be improved by a suitable hardening and tempering treatment. The shear strength of the shaft can be improved by proper thermal treatment and a properly heat treated shaft should withstand the torsional loads of the impeller.
