# Failure Analysis of a Cracked Gasoline Engine Cylinder Head

**Abstract** This article presents a failure analysis on a gasoline engine cylinder head made of aluminum alloy, which has been used in passenger cars. During an endurance test, a crack initiated from the interior wall of a hole in the center of the cylinder head and then propagated through the thickness of the cylinder head. The metallurgical examinations are conducted in the crack origin zone. The results show that there are many casting pores due to poor quality of casting in the failed cylinder head which has certainly played a crucial role in initiating the crack. Finite element analysis of the cylinder head is performed to identify the stress components. Modeling of a bolt for the hole shows that the plastic stresses are occurred. Moreover, the lower strength of the material due to high assembly stress caused the failure in the cylinder head.

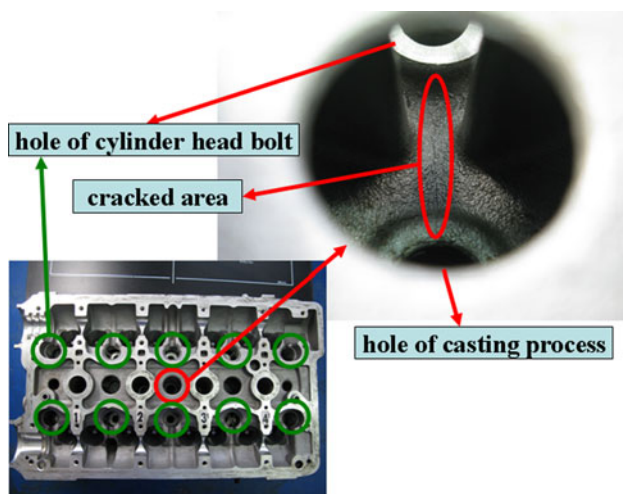
The cracked zone is shown in Fig. 1. Checking the cooling and lubricating systems of the engine shows no problem. The differences between coolant inlet and outlet temperatures were constant during the endurance test, and there was no leakage and coolant contamination in oil analysis. 20 h before engine stopping, the ECU sensed a knock, and the engine torque and power decreased because of retarding of the ignition time. After checking the engine performance condition by the defect analyzer device, it was found that there were no knocks. This was due to the crack initiation and decreasing of the cylinder head stiffness. It should be mentioned that until 300 h of the endurance test, fuel type was gasoline and then changed to compressed natural gas (CNG) type. As a result, the mean power of the

Fig. 1 Cracked zone on the cylinder head

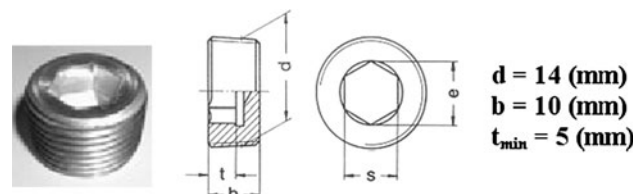
Fig. 2 Dimensions of the bolt according to DIN906 standard

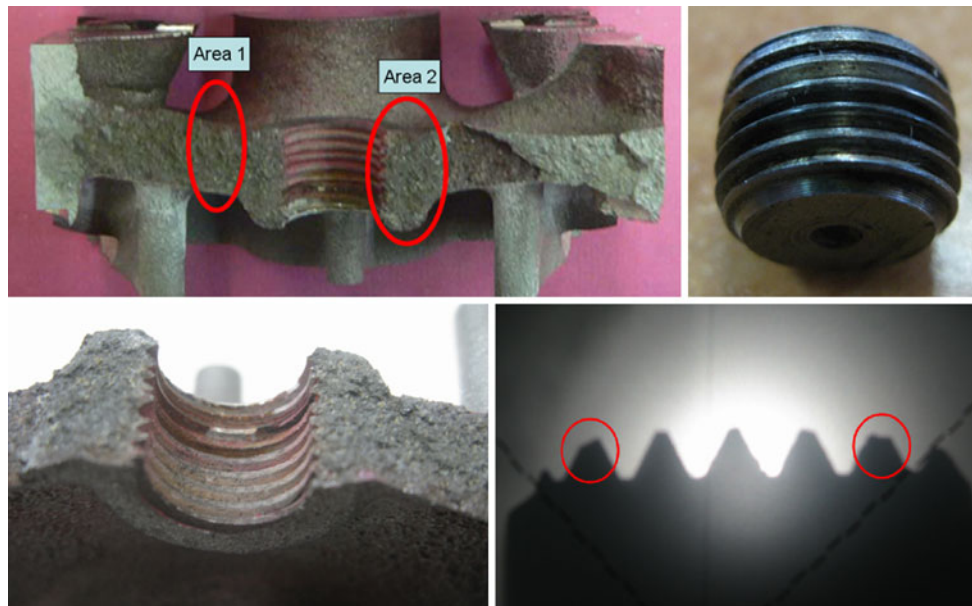
The bolt type that was tightened in the hole was DIN-906 which has a conical shape. In Fig. 2, the dimensions are shown. The results of measuring the bolt diameter and length as well as the thickness of the cylinder head (area 1 and area 2 in Fig. 3) showed a good conformance to the drawings. There was no plastic deformation noted during the visual inspection of the bolt threads. However, in the hole, threads were deformed. It should be mentioned that the material of the bolt is steel alloy in comparison with the hole made of aluminum alloy. The bolt pitch according to a straight line is 1.5 mm but for the hole thread, pitches are 1.46, 1.49, 1.52, 1.49, 1.50, and 1.51 mm, which indicate plastic deformation.

**Fig. 3** The shape of the bolt and the hole

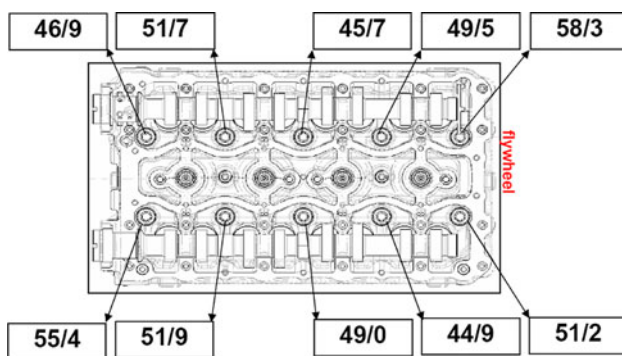
As is well known, deformation of a cylinder head has two modes including bending and torsion. Tightening torque of cylinder head bolts was 20 Nm continued with twisting of 120°. The removal torque of bolts and also the surface flatness of the cylinder head can approximately show the overall deformation (shown in Figs. 4 and 5). The cylinder head flatness was measured as 56 μm which is below the specification (100 μm max). The reported flatness is the difference between the deepest valleys and the highest peaks of the surface roughness.

**Fig. 4** Removal torque (Nm) of the cylinder head bolts during the engine disassembly

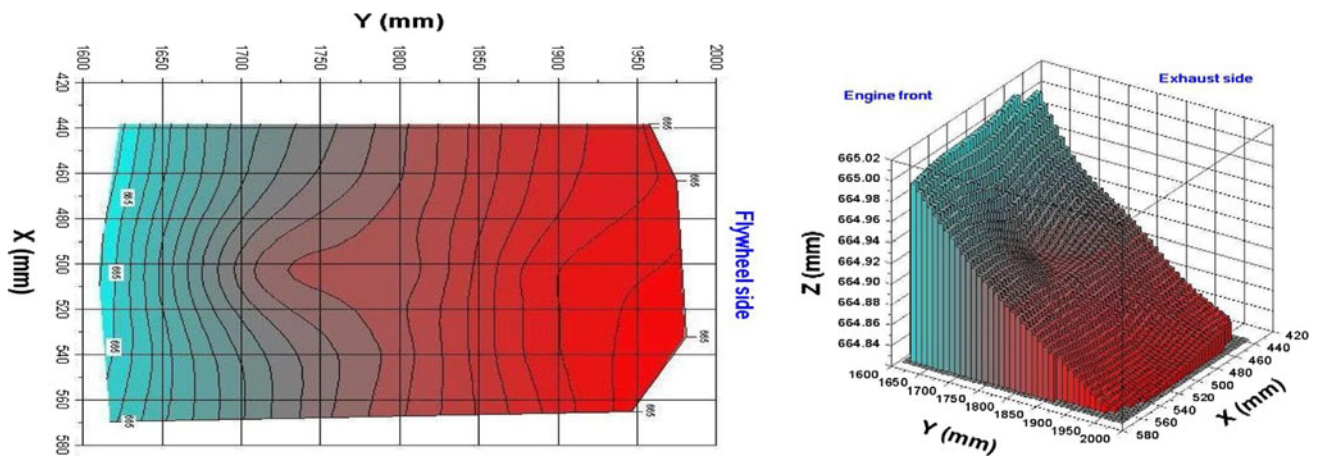
**Fig. 5** The flatness of the cylinder head surface (where connected to engine block)

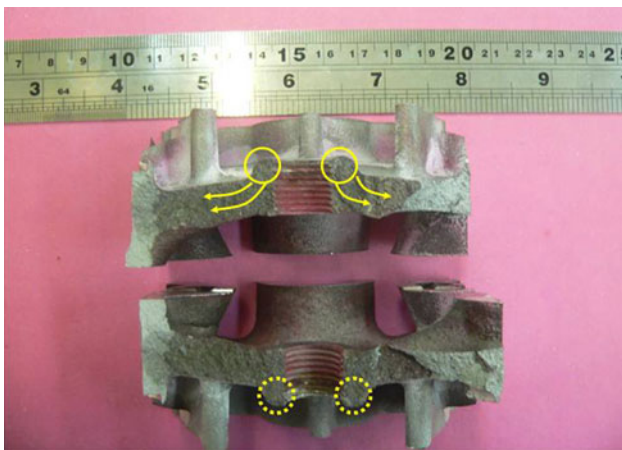
The cracked zone was fully opened to investigate the fracture surface. Figure 6 shows the crack origins and the direction of propagation. Visual inspection revealed pores around the hole because of poor quality of the casting process which needs an optimization in melting, degassing, casting, and molding methods. The existence of these pores

**Fig. 6** The surfaces after opening cracked zone

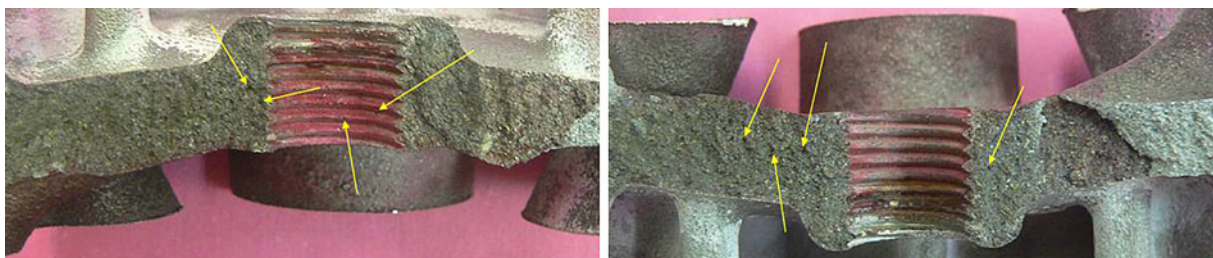
can produce a stress concentration for crack initiation and growth. Figure 7 shows casting pores.

**Fig. 7** Pores around the hole due to the casting process

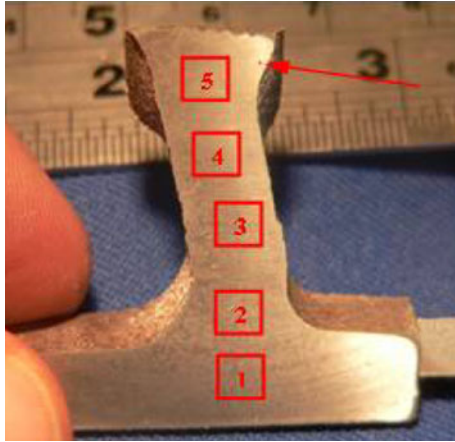
interval on the specimen surface. The locations are shown in Figs. 8 and 9, and the results are listed in Table 3. It should be mentioned that the average hardness of the material was determined to be 121 HB 5/250 which is higher than the lower limit of the specification (90 HB) due to the higher amount of silicon.

**Fig. 8** The locations of hardness measurements below cracked surface

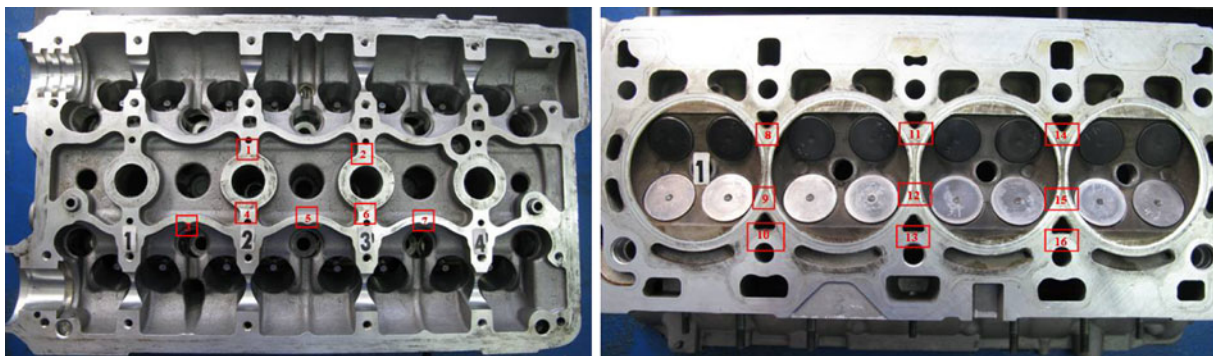
**Fig. 9** The locations of hardness measurements on the cylinder head

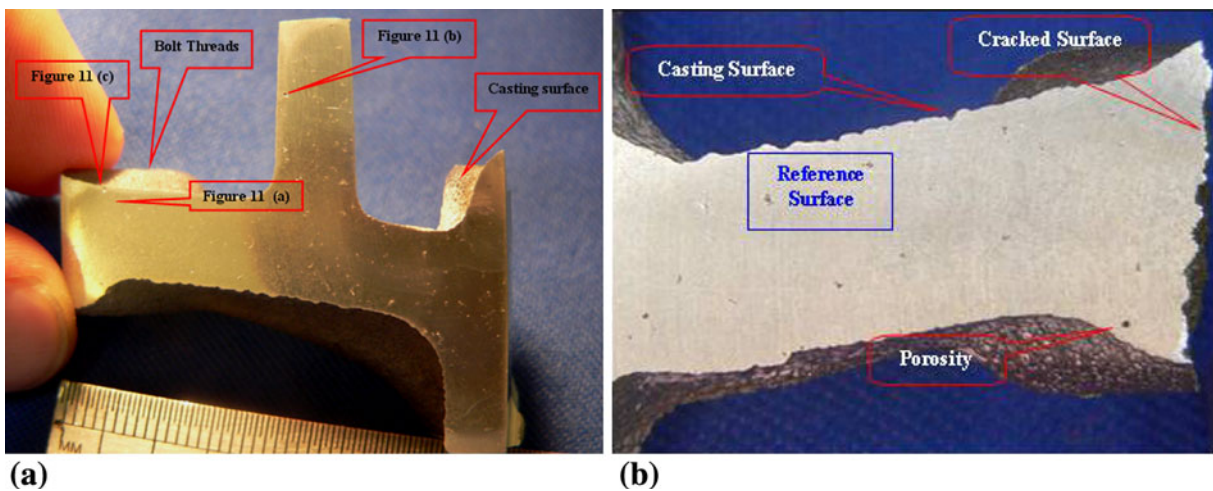
In order to investigate the microstructure and the heat treatment of the cylinder head material, a part of the cylinder head near the cracked zone was separated (as shown in Fig. 10). Pictures were taken after grinding, polishing, and etching the specimen surface in Keller's reagent for 10 s. In Fig. 11, it is seen that the microstructure of the cylinder head material consisted of a solid solution of aluminum-silicon (rich phase is made of aluminum) and a uniform distribution of a eutectic silicon phase and also intermetallic phases. In general, the microstructure conforms to the standard [6, 7], but the pores, which are near the surface, can be a place of the stress concentration and can be a site of crack initiation during the cyclic thermo-mechanical loadings.

According to the standard [6], the allowable limit for porosity is 5% in a reference surface (which is 3 mm by 4 mm). Also 500  $\mu\text{m}$  is the cutoff between micro- and macroporosity. A macro pore is a pore which can be seen visually without any microscope. Porosity was measured as 3% for the surface in Fig. 10 which is below the standard limit [6], but the diameter of the pores was more than 500  $\mu\text{m}$ . As seen in the figure, the porosity distribution is high near the surface, and this can cause lower fatigue life.

**Fig. 10** The zone below cracked surface: (a) for microstructure investigation; and (b) for measuring the porosity

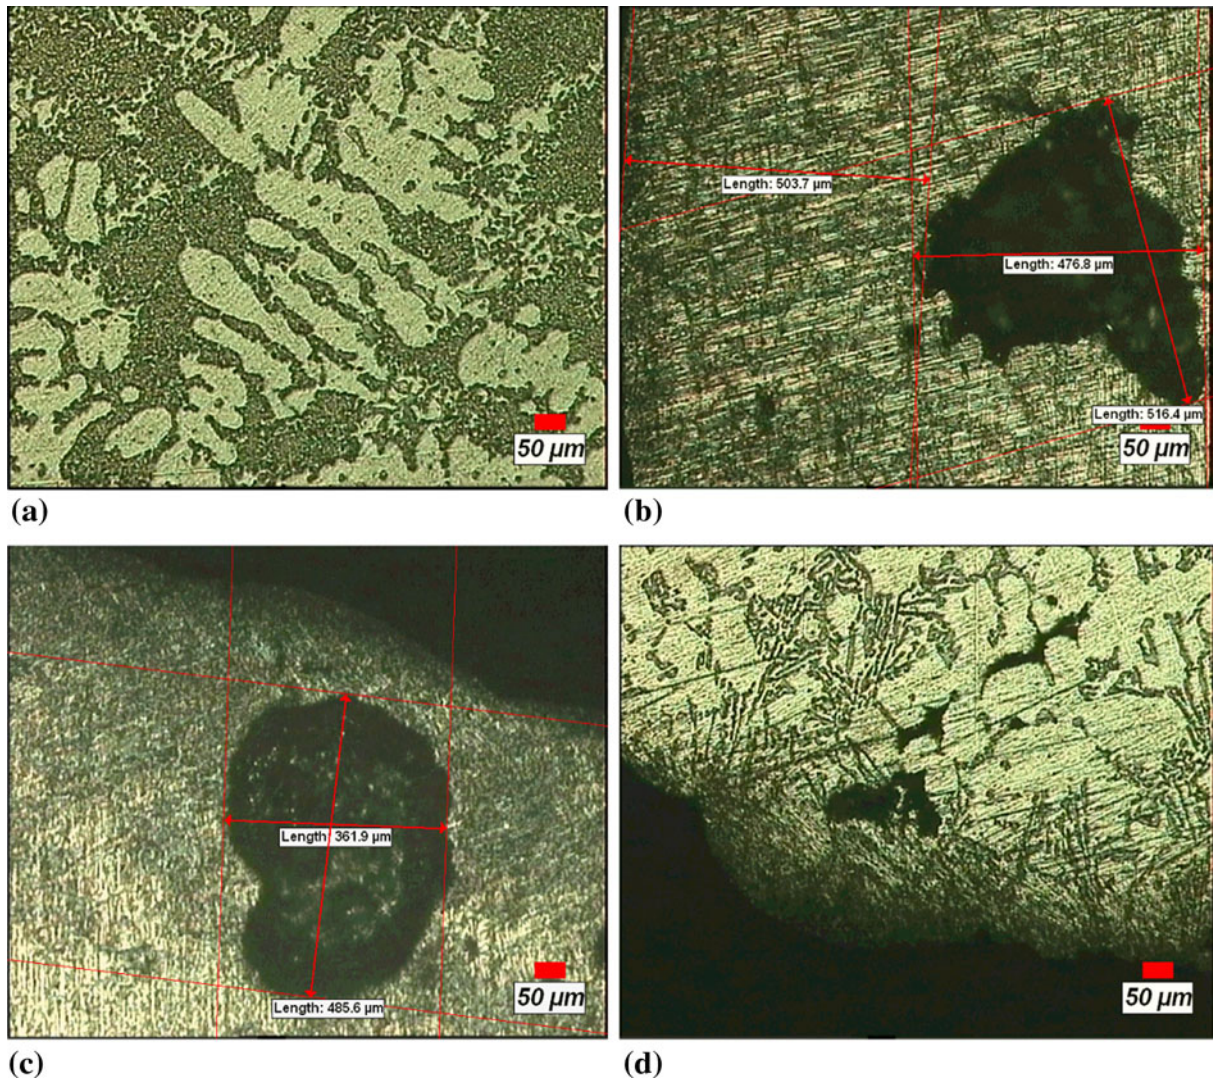
**Fig. 11** Microstructure of cracked zone: (a) aluminum dendrite and eutectic silicon particle distribution; (b) pore with  $a > 500\text{-}\mu\text{m}$  diameter; (c) pore  $100\ \mu\text{m}$  from the surface; and (d) porosity near the threads

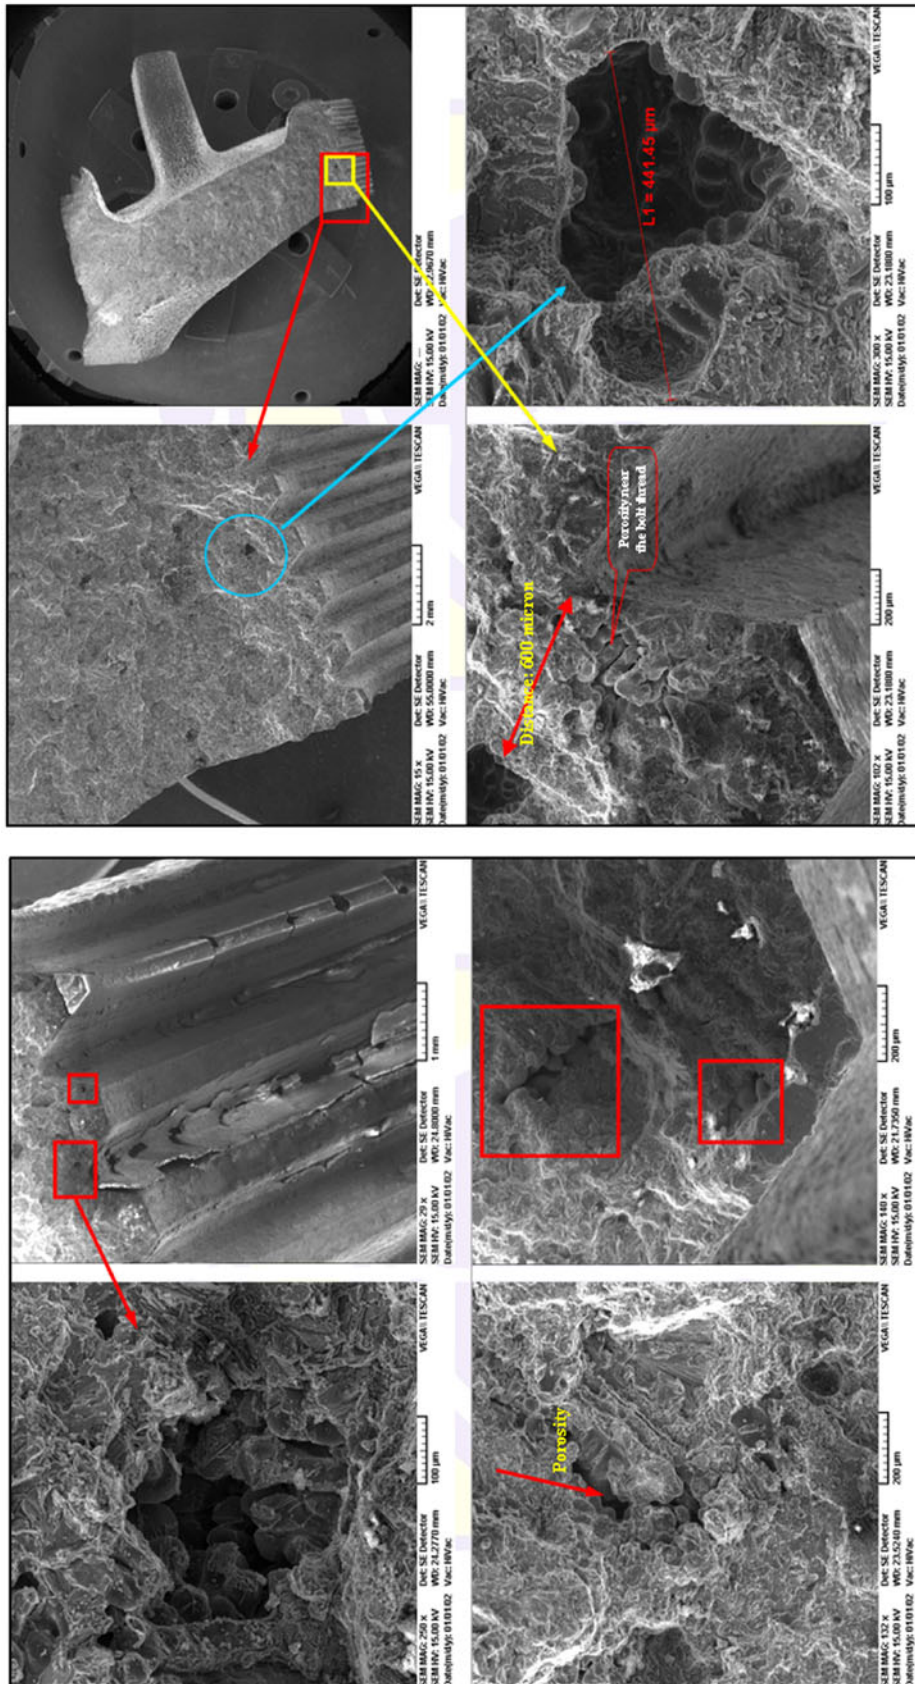
To investigate the cracked surface more accurately, a scanning electron microscope (SEM) investigation was conducted, and the results are shown in Fig. 12 with different magnifications. According to Fig. 12, casting defects and pores were observed near the threads. It should be mentioned that the diameter of the pores was about 450 μm.

Fig. 12 Results of SEM investigations near the cracked surface

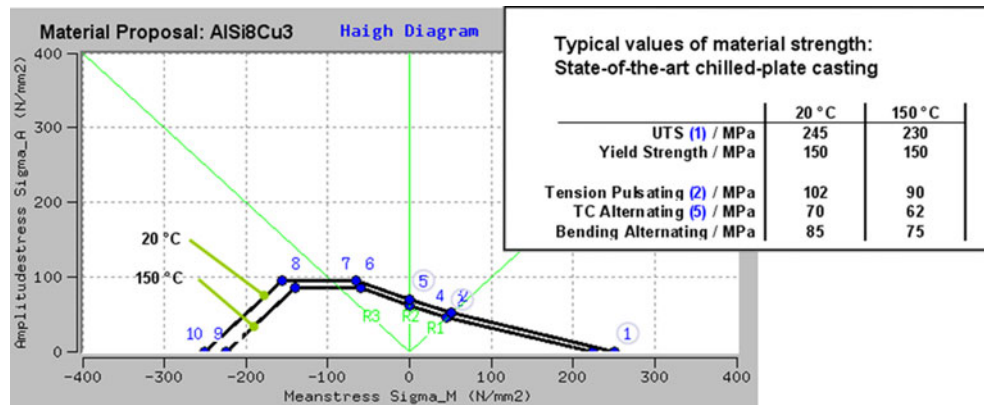
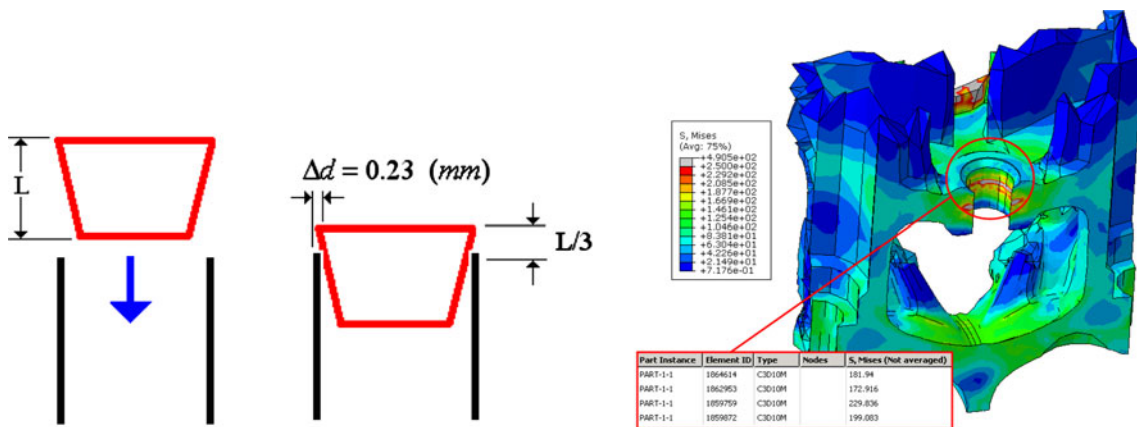
**Fig. 15** Dimensions of the bolt and the hole and Von-misses stress around the hole under the bolt forces

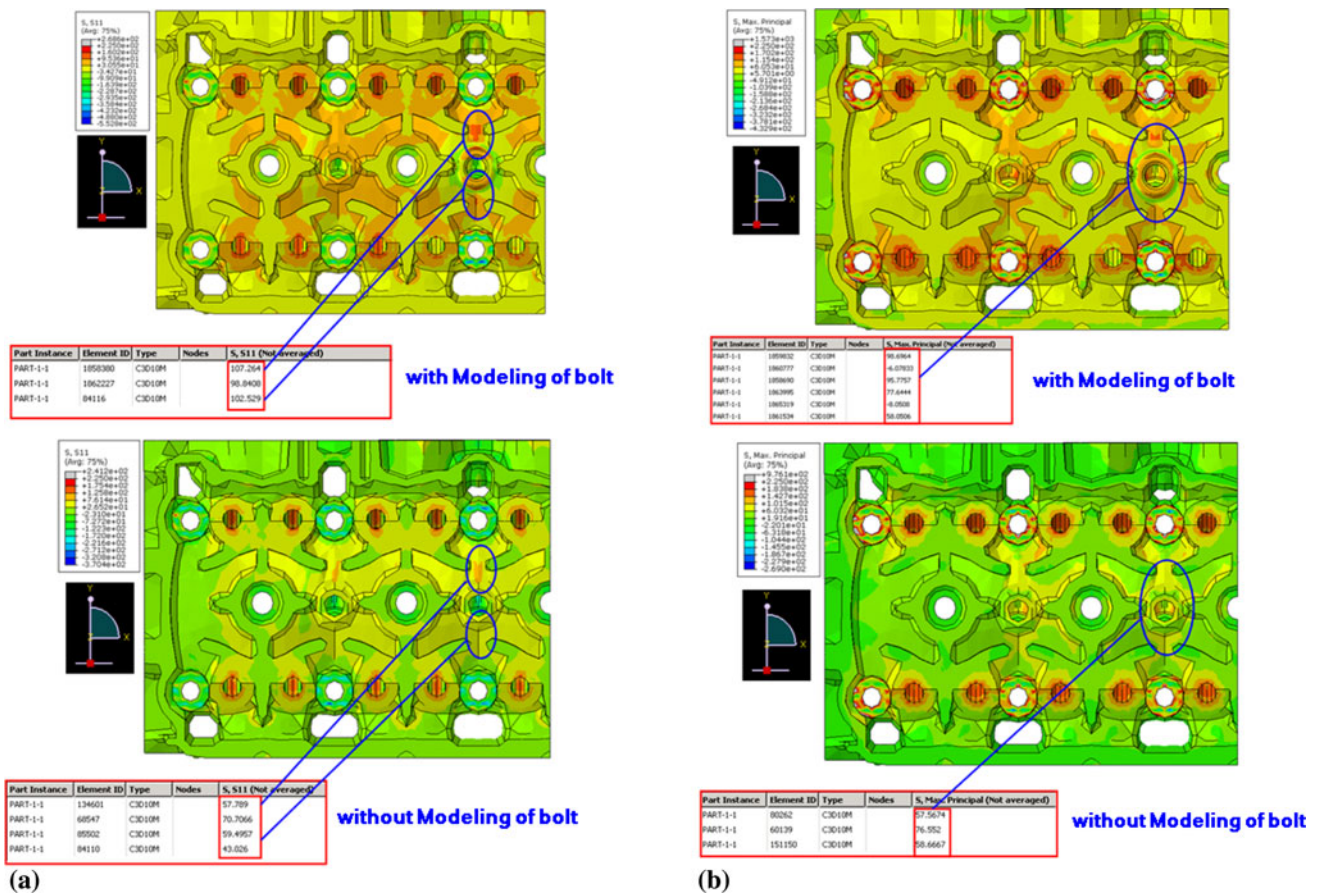
To model the cylinder head and the engine block, non-linear gasket elements and sliding contact definitions were used (Fig. 13). The full model size was reduced to 1/2 that of the model, and linear material models (Fig. 14) were utilized to simplify the calculation procedure. To model the bolt force, an external displacement of 0.235 mm on the 1/3 top of the bolt length was applied to the hole as shown in Fig. 15. The resulting Von-mises stress around the hole is shown in Fig. 15, which includes plastic deformations. The stress component in the  $x$ -direction (crack growth direction) and the maximum principal stress are shown in Fig. 16. As seen in the figure, by considering the bolt model, both stresses ( $x$ -component and maximum principal ones) increase.

**Fig. 16** Stress distribution: (a) stress component in  $x$ -direction; and (b) maximum principal stress around the hole

However, these defects could not lead to a premature fracture of the cylinder head; the main reason for cracking was the high stress and the plastic strain due to the bolt assembly in the hole, which can be a cause of crack initiation. Subsequently, the pores near the surface of the threads as well as the cyclic thermo-mechanical loadings on the cylinder head could be a cause of the crack growth. To prevent this failure mode in the cylinder head, the hole could be eliminated, the type of the bolt could be changed, or the fastening torque could be adjusted.
