# Failure Investigation of Differential Pinion Tapered Roller Bearing

K. Gurumoorthy · Jai Prakash Dayma · Vivek Rawat ·  
Maruti Vitthal Khaire

Submitted: 6 July 2015 / in revised form: 28 July 2015 / Published online: 25 August 2015  
© ASM International 2015

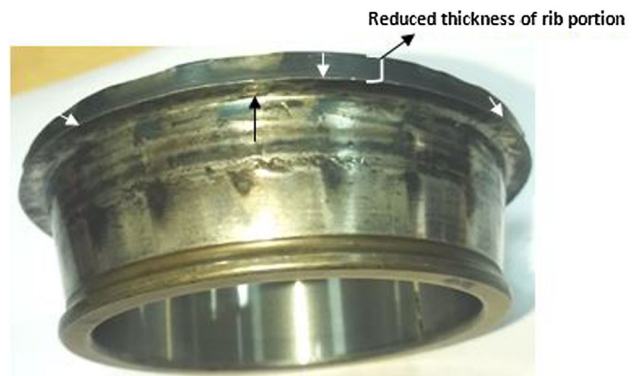
Discoloration was observed on cone, cup, and roller components. Wedge-shaped protrusion on rib and considerable reduction in thickness of rib were observed on large diameter side of the cone as shown in Fig. 3. Severe plastic

flow of material which covered the groove portion was found on the raceway.

**Fig. 3** Cone component in as-received condition; wedge-shaped protrusion on rib portion is shown by white arrows; black arrow points to the plastic flow in the groove portion

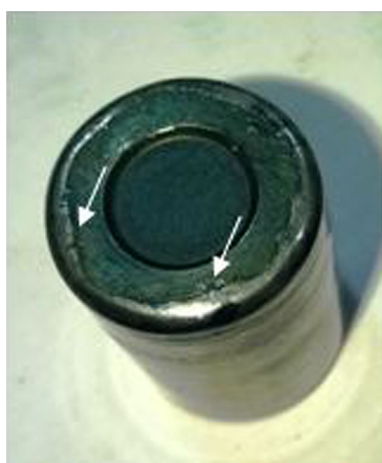
Severe rubbing marks were observed on roller surface; plastic deformation was observed on roller head where roller establishes contact with rib surface as shown in Fig. 4. In the cup, plastic flow was observed on the load zone.

Fig. 4 Material flow observed on roller head (shown by arrow)

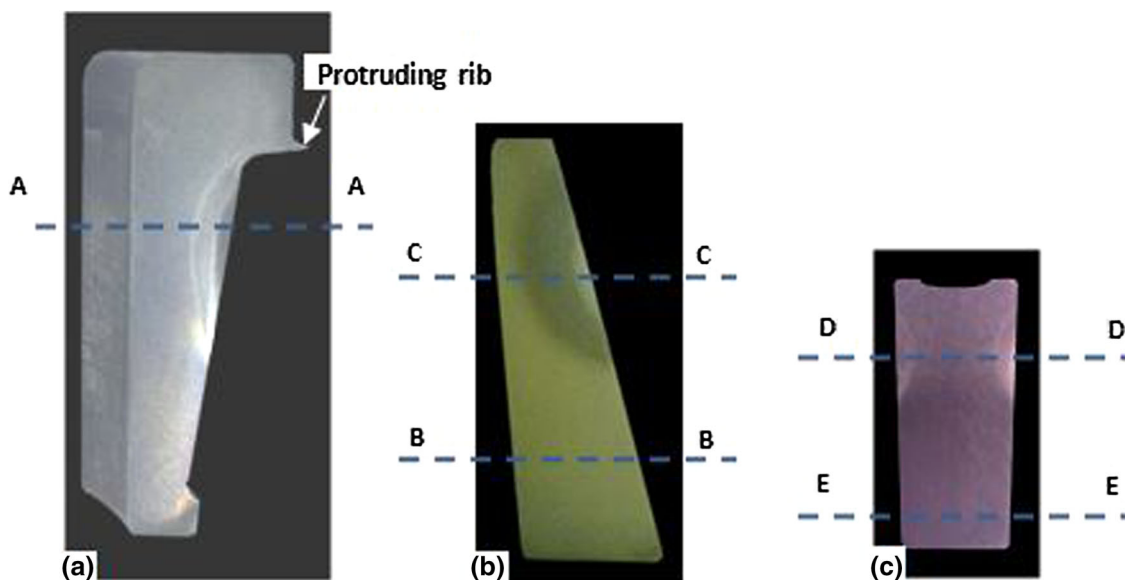
Hardness profiles were made on cone, cup, and roller cut sections as shown in Fig. 5a, b, and c, respectively.

Fig. 5 (a) Cut section of the cone showing protruding rib; (b) cut section of the cup; (c) longitudinal cut section of roller

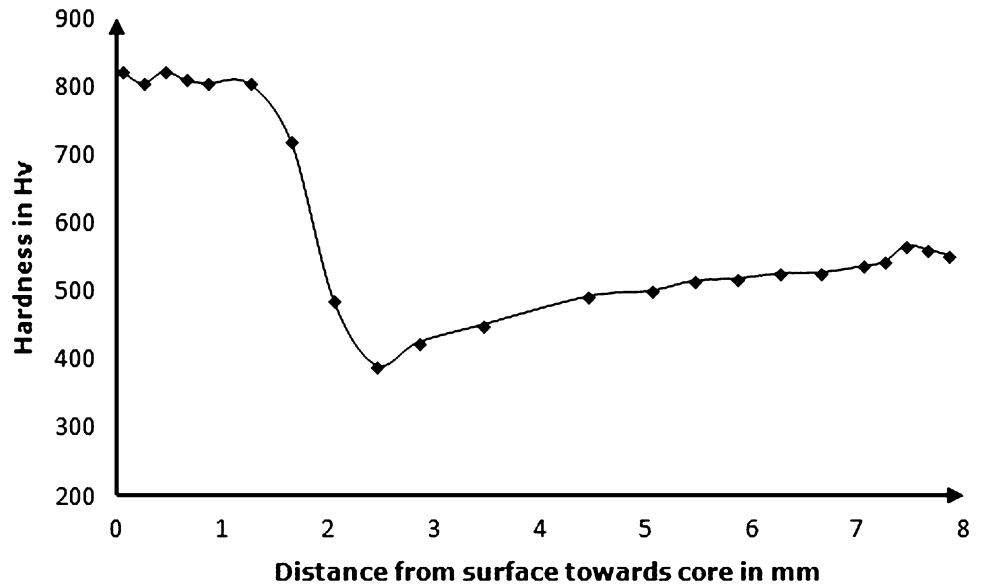
In the cone, hardness profile was taken at section A–A; the hardness of 820 HV near the raceway surface dropped abruptly toward the bore to about 390 HV. The hardness beyond this minimum hardness zone gradually increased to 500–560 HV. The hardness traverse is shown in Fig. 6.

**Fig. 6** Hardness profile of cone taken on the section A–A as shown in Fig. 5a

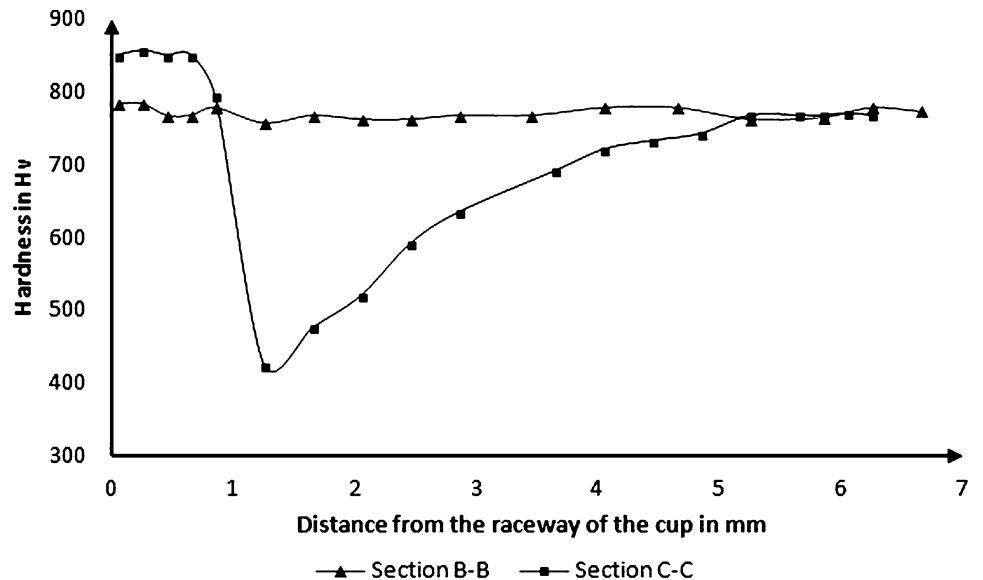
In the cup, two hardness profiles were taken on the cut section as shown in Fig. 5b. Hardness profile taken at section C–C revealed that the hardness was about 850 HV near the surface, followed by a steep drop in hardness beneath in the range of 400–450 HV as observed in cone

section. Further, moving toward the outside diameter of the cup, a gradual increase in hardness was observed in the range of 750–780 HV. On the other hand, profile taken at section B–B on the same cup, showed that throughout the section hardness was in the range of 750–785 HV. Figure 7 shows the hardness traverse graphically.

**Fig. 7** Hardness profiles of cup taken on the section B–B and section C–C, respectively, as shown in Fig. 5b

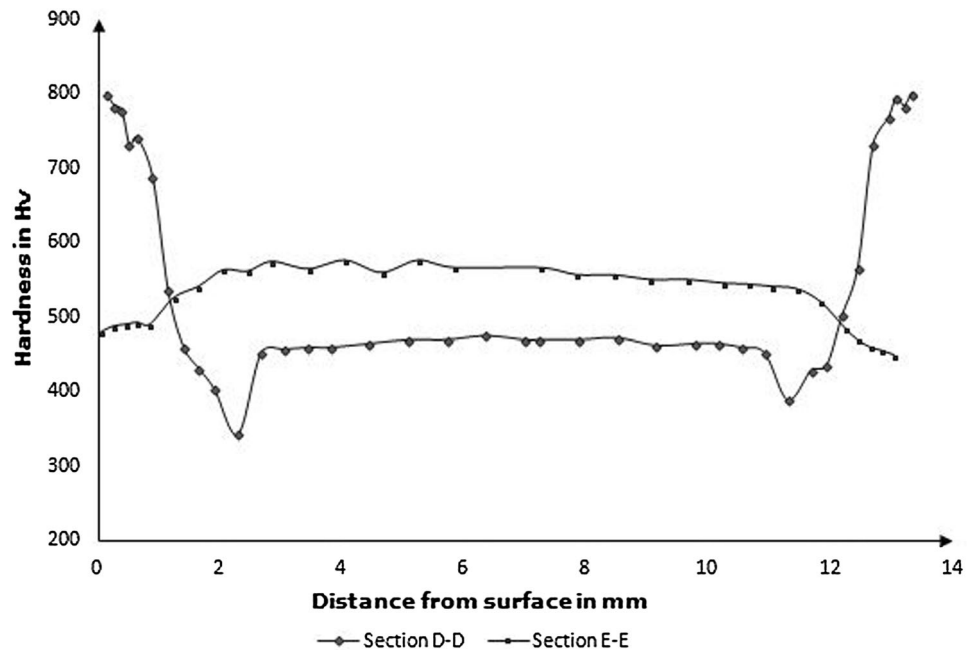
In roller, at section D–D as shown in Fig. 5c, a similar trend in hardness variation as that of cup section C–C was observed as shown in Fig. 8. Contrarily at section E–E of roller, hardness was in the range of 450–575 HV throughout the section. This shows that the entire section of the roller was subjected to tempering effect.

**Fig. 8** Hardness profiles of roller taken on the section D–D and section E–E, respectively, as shown in Fig. 5b

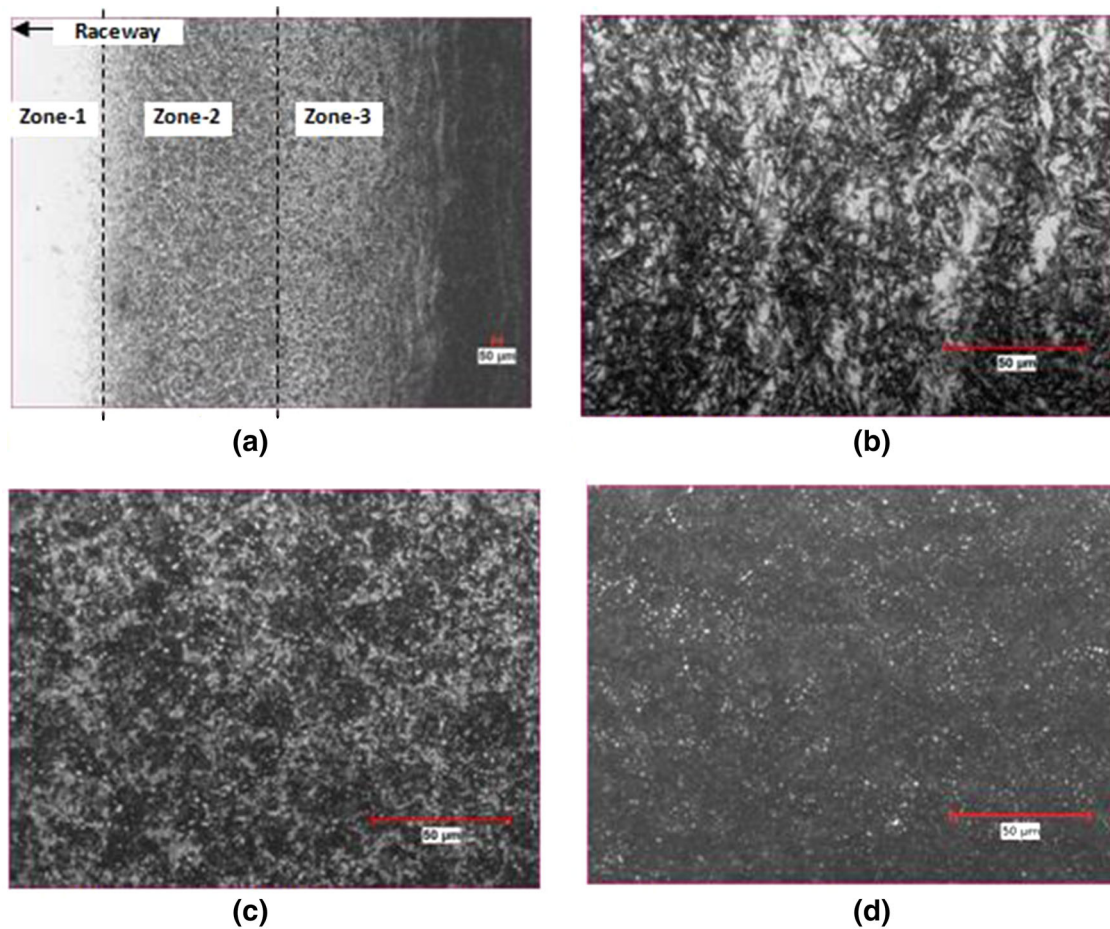
The cut sections of roller, cup, and cone were polished and etched with nital solution. The section A–A of Fig. 5 showed three distinct microstructures from surface.

The layer just beneath the raceway has white-etching (zone-I) untempered martensite as shown in Fig. 9b. This martensitic layer was confined to near raceway. In the layer below zone-I, a highly tempered microstructure was observed (zone-II), Fig. 9c. In zone-III, the tempering effect was less, indicating that the peak temperature reached at this zone is relatively less. This zone extended up to rib portion where wedge-shaped protrusion was observed. Beyond zone-III, tempering effect was diminishing toward the bore as shown in Fig. 9d.

**Fig. 9** (a) Nital-etched cone section showing different microstructure zones. (b) Zone-1 at higher magnification showing the presence of untempered martensite. (c) Zone-2 at higher magnification showing highly tempered microstructure. (d) Zone-3 at higher magnification showing relatively lower tempering effect

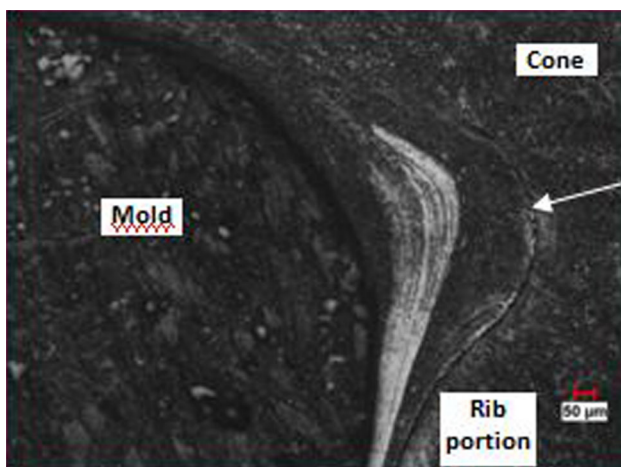
the rib portion. Localized yielding at the rib-roller head results in increased interference, and further rise in temperature and perceptible material flow as shown in Fig. 10. Continued running under such adverse conditions had caused even the rib thickness to get reduced showing wedge-shaped protrusion. As these tail pinion bearings are splash lubricated, at the initial stage of running if lubrication is not sufficient enough for the loading conditions, excessive preloading would have more pronounced effect in causing the seizure. The excess preload increases the chances of severe rubbing and thus leading to premature failure of the bearing by thermal softening.

**Fig. 10** Etched cut section of the cone showing material flow on the groove near the rib portion

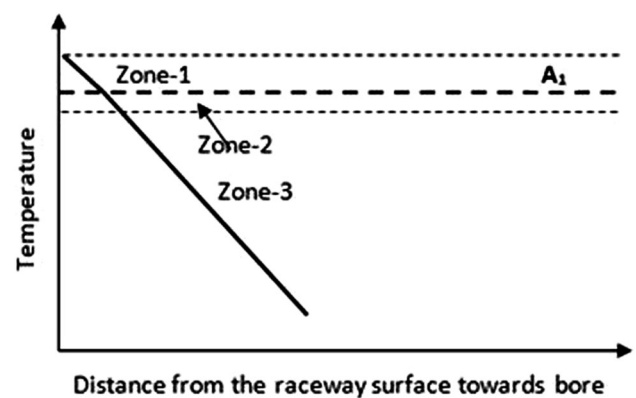
**Fig. 11** Schematic representation of temperature prevailed in the zones as shown in Fig. 9
