Failure Analysis of Butt Weld of Bimetal Composite Pipes

Hao Chen · Huizhen Ma · Xiaomin Chen · Shengfei Jiang ·
Huaijie Wang

Abstract The study aims to summarize the main failure morphology of butt weld of bimetal composite pipes which are used in a gathering pipeline of one condensate gas field with high temperature and high pressure, and then analyze the failed pipes with the methods such as SEM, energy spectroscopy, and metallographic examination. The experiments show that there is no Mo which is the key element of metal material to resist the pitting corrosion and stress corrosion in the organization of the welds. Through the microscopic morphology analysis it shows that the process of the gradual shedding of corrosion product film gives rise to the failure of pipelines. The gradual shedding of corrosion product will expose the new matrix to the corrosive environment which will accelerate further erosion. The cycle of the erosion continues and eventually leads to pipelines' leakage. The weld residual stress plays an essential role in the weld failure, besides, the existence of the residual stress will accelerate the collapse of the passivation film. The factors which lead to

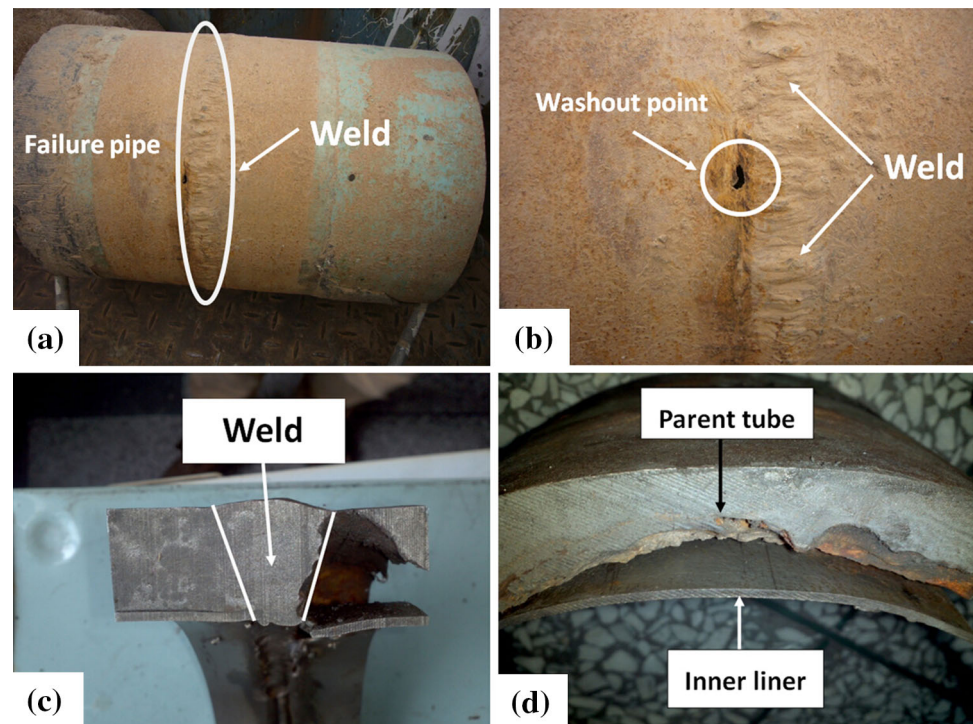
Fig. 1 Failure pipe morphology

Figure 1a, b shows the overall morphology of pipe washout point: there is an about 6 mm long and 2 mm wide washout point on the outer surface of this pipe. Cut along the washout point and the morphology of this pipe internal as shown in Fig. 1c, d. The weld of inner liner has no obvious signs of corrosion, but the corrosion of parent tube is severe. There are a lot of relative loose corrosion products in corrosion pits as shown in Fig. 1c. The inner liner around the washout point has no obvious corrosion signs, but the corrosion of parent tube corrosion is very serious. There are helicoids corrosion deep holes on the inner wall of parent tube. The inner wall of parent tube has been eroded away most as shown in Fig. 1.

The welding method of connecting composite pipes adopts uphill welding [4]. Therefore, we can judge the working range of the pipeline by observing the weld trend. In observational analyses, washout points are all in arc starting points of butt weld, which are located at the bottom of the pipe.

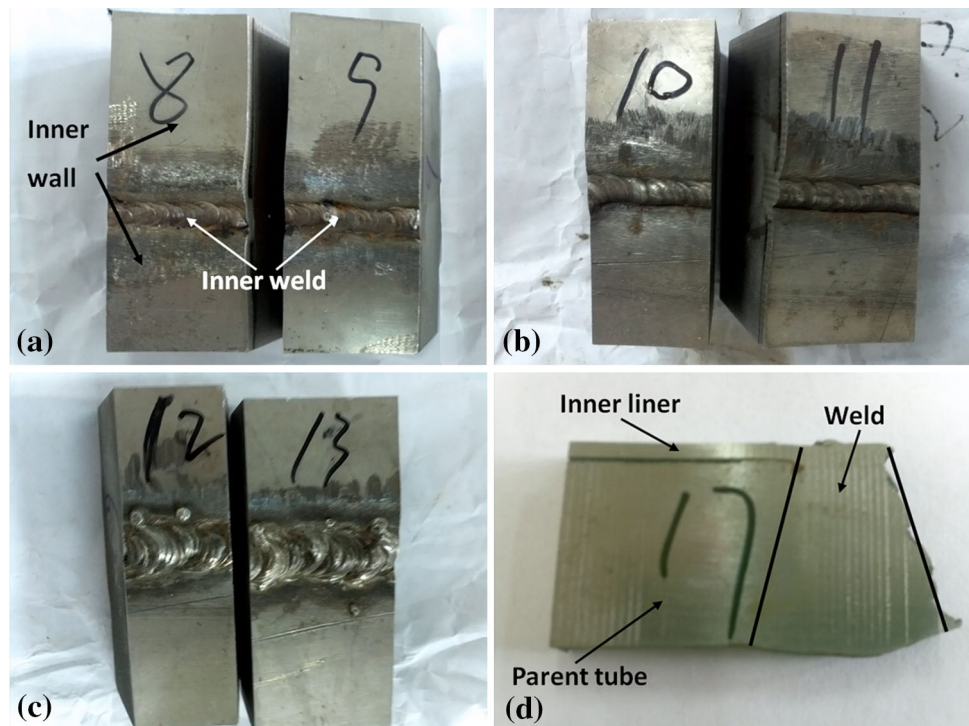
Fig. 2 Samples

In order to microanalyses the failure pipe morphology, we have cut the failure pipe with the method of wire-cutting. The weld without failure was cut into six parts by wire-cutting

and was numbered 8–13. In order to observe the micro failure morphology near the corrosion pits, we have sampled on corrosion pits of washout, numbered 17 as shown in Fig. 2.

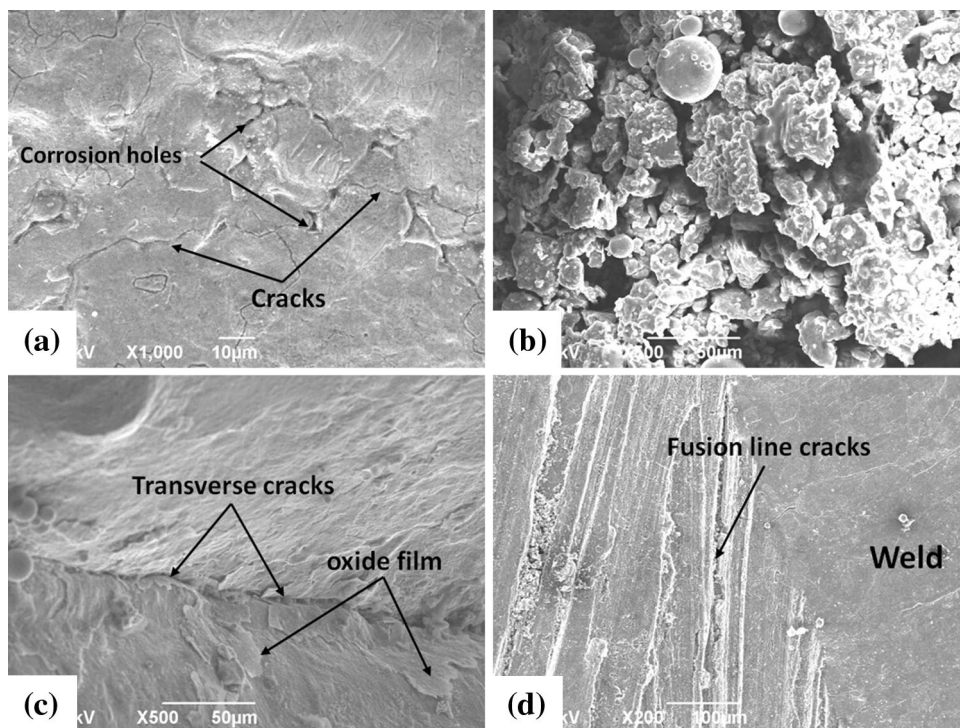
Fig. 3 SEM results of No. 8–13 weld inner surface

Figure 3 shows SEM results of weld inner surface. There are corrosion holes and microcracks on the inner surface of weld as shown in Fig. 3a. The cracks connect to corrosion holes and expand along corrosion holes. The corrosion hole was generated by pitting corrosion. The corrosion hole always promotes the generation of cracks. The existence of corrosion hole will cause stress concentration. The stress concentration would accelerate plastic deformation of corrosion holes surface and the break of passivation film. The matrix of weld is exposed to corrosion because of passivation film being broken, and lead to generate stress corrosion cracks. These cracks continue to expand forward, eventually leading to weld cracking. The media of pipeline transport into the gap of fusion line and form a large cathode-small anode corrosion cell. The corrosion cell accelerates the metal dissolution [5]. Cl^- in the medium and metal ions combined and formed chloride. The chloride is turned to hydrochloride by hydrolysis. The $\text{Ca}(\text{HCO}_3)_2$ in medium converted into CaCO_3 . Dissolved metals, hydrochloride, and CaCO_3 deposited outside the gap of fusion line as shown in Fig. 3b. There are transverse cracks on the weld bead as shown in Fig. 3c, and some parts of the oxide film have been shedding on the inner

surface of weld. Transverse cracks are produced during the process of weld solidification and belong to solidification cracks. These cracks produced shrinkage, deformation, and tensile stress during the weld crystallization process. There are fusion line cracks in Fig. 3d, and these cracks belong to hot cracks. There are eutectic films in the base material. The melting point of eutectic film is lower than matrix, so the film would be melted during welding. The film will be cracked by contraction stress when the weld is cooling.

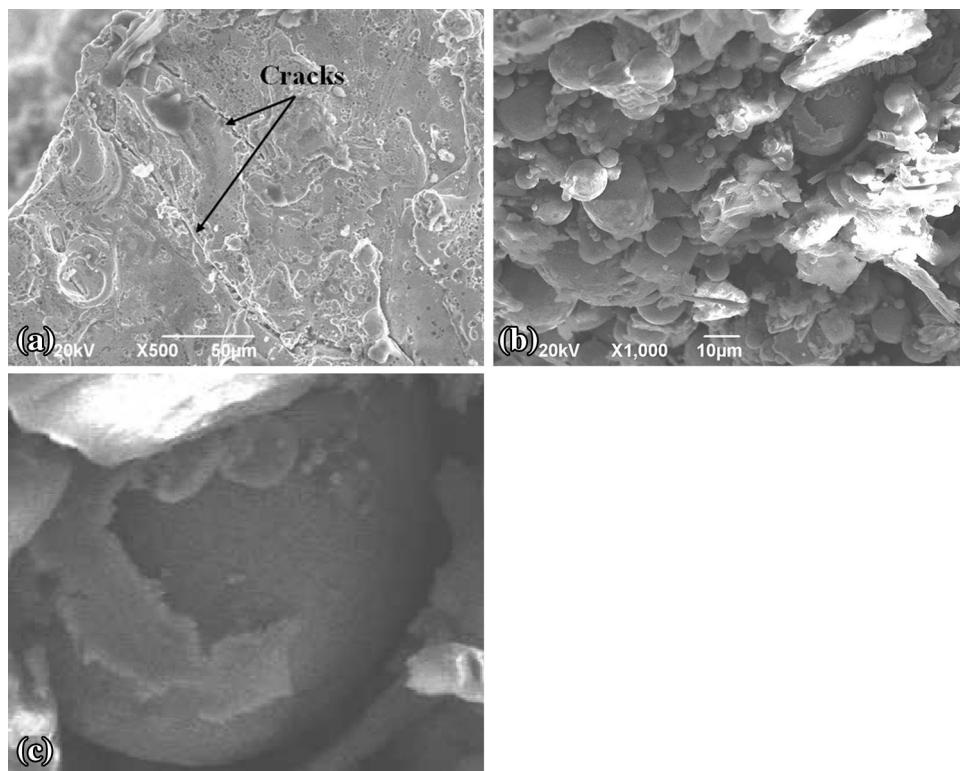
Fig. 4 The SEM morphology characteristics of corrosion pits in No. 17 sample

There are cracks near corrosion pits areas and extended to the inside weld as shown in Fig. 4a. As shown in Fig. 4b, there are plenty of small ball-like oxides in the morphology of corrosion pits. Figure 4c shows the corrosion product films that fell off. Cl^- has a strong penetrating power because of its small radius, so the Cl^- is able to penetrate the tiny cracks on corrosion product films [6]. Cl^- and metal ions of product films would produce chlorides. The chloride hydrolysis will cause decreased density of product films, and lead to falling off of the parts of films. Cl^- promotes the dissolution of newly exposed metal matrix, leading to the generation of corrosion [7]. Cl^- is the necessary condition of pitting corrosion, stress corrosion, and forming corrosion cell and occluded cell in crevice corrosion [8].

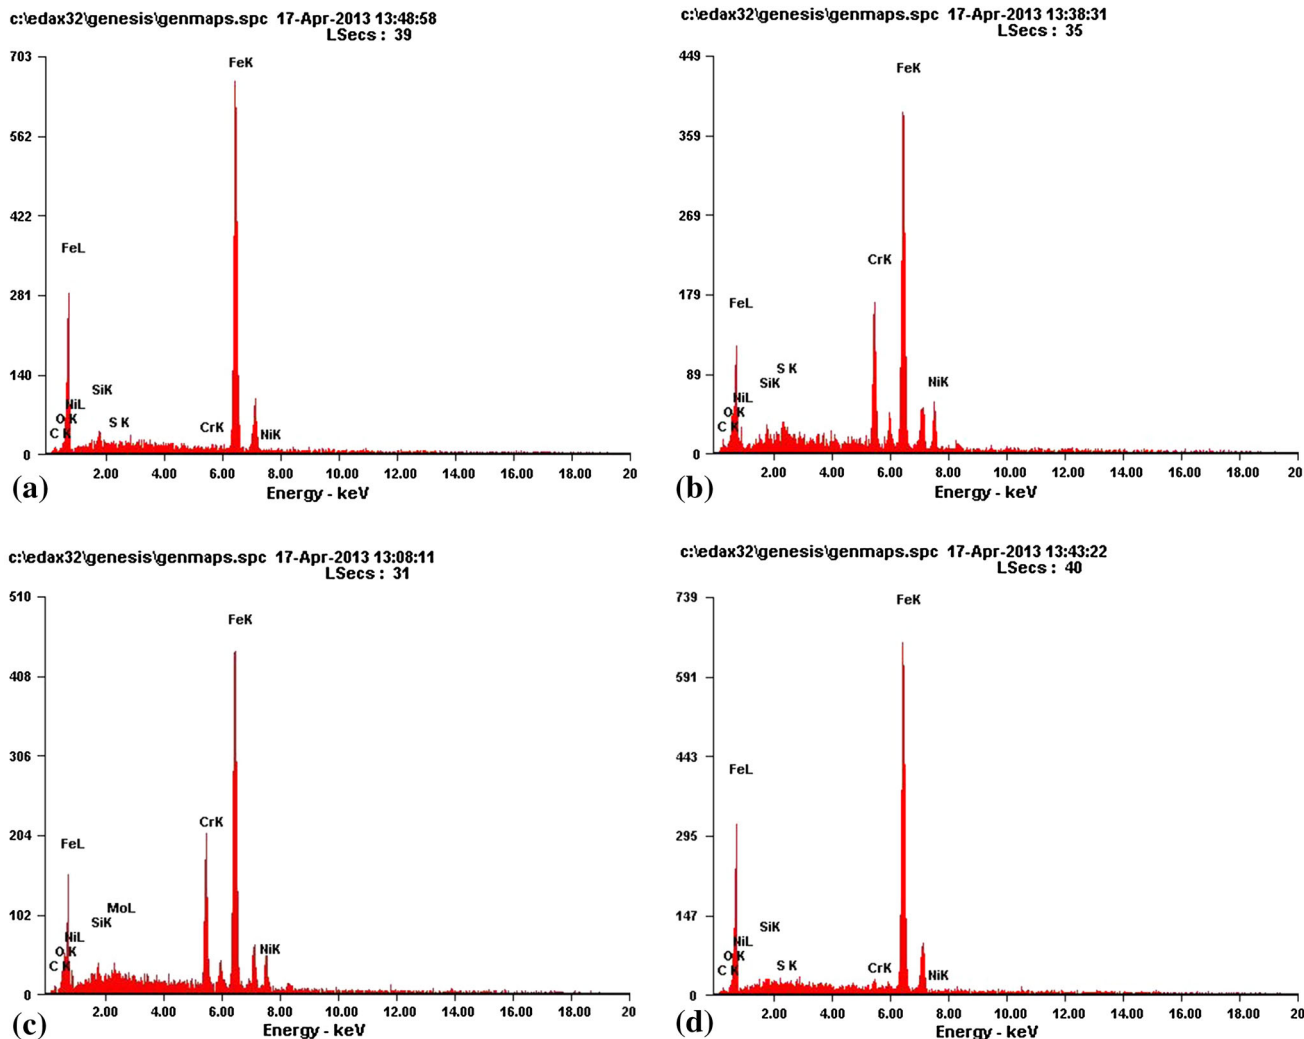
Fig. 5 The EDX of No. 11 sample (a) outside weld (b) inside weld (c) parent tube (d) inner liner

Figure 5 and Table 1 show the weld and base metal EDX results of No. 11 sample. The results show that weld does not contain the Mo element, so the weld is Cr–Ni austenite stainless steel. The inner liner is Cr–Ni–Mo austenite stainless steel. The primary function of Mo element is to improve the strength of surface passivation film and enhance the corrosion preventive of stainless steel. Mo is the main element to improve the resistance to stress corrosion cracking of stainless steel in chloride solution [7].

- (1) Control the content of alloying elements. Select welding materials that contain Ni, Mo, Cr, V, and other elements to achieve the purpose of improving the microstructure, and try to avoid losing beneficial elements (such as Mo) in the process of welding.
- (2) Control the condition of transmission medium. Reduce the concentration of the corrosive medium, raise the pH value of the medium, and reduce the operating temperature of medium. As the temperature rises, the crack propagation rate increases [12]. The increase of temperature could increase the chloride ion concentration [13], thus increasing the corrosion rate.

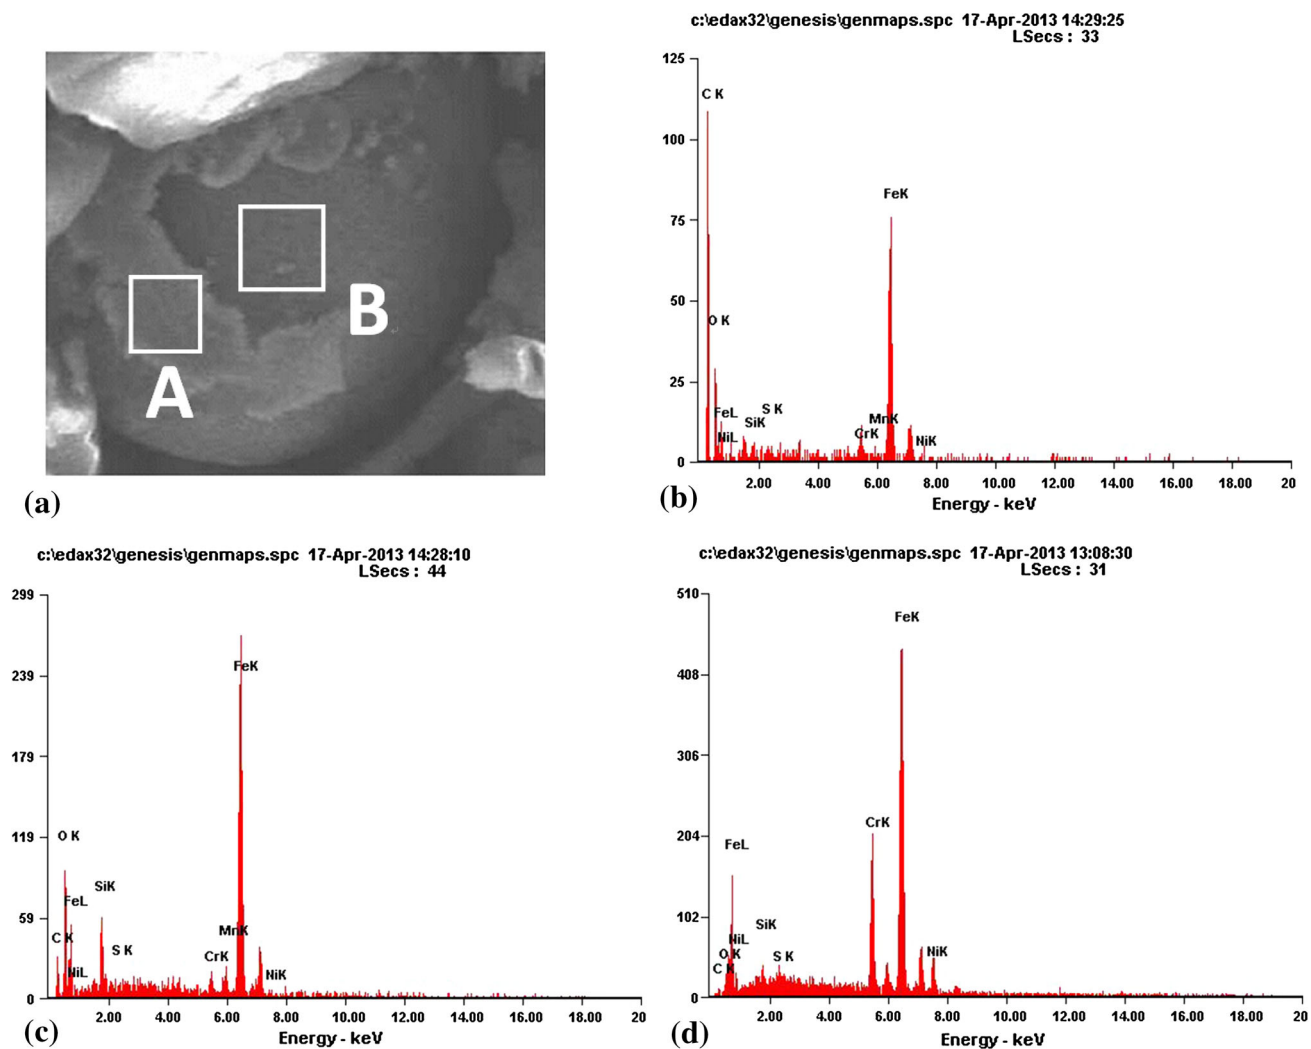
Fig. 6 The EDX of No. 17 sample (a) location of analysis (b) EDX of A area (c) EDX of B area (d) EDX of inside weld

There are product films in corrosion pits in the A area and shedding part of product films in the B area as shown in Fig. 6a. From Table 2, Fe element content in the product film is less than weld inner, and the Fe content of product film fell off area is little different with weld. This shows that the A region is the area of corrosion product films and the B region is the position of product films which have fell off. The above analysis results show that the speculation of corrosion product films abscission is correct. The main components of the corrosion product films are Fe oxides and small amount of Cr and Ni oxides. The main reason for the reduction of the content of Fe is because of the other elements addition such as Cl and corrosion product films abscission.

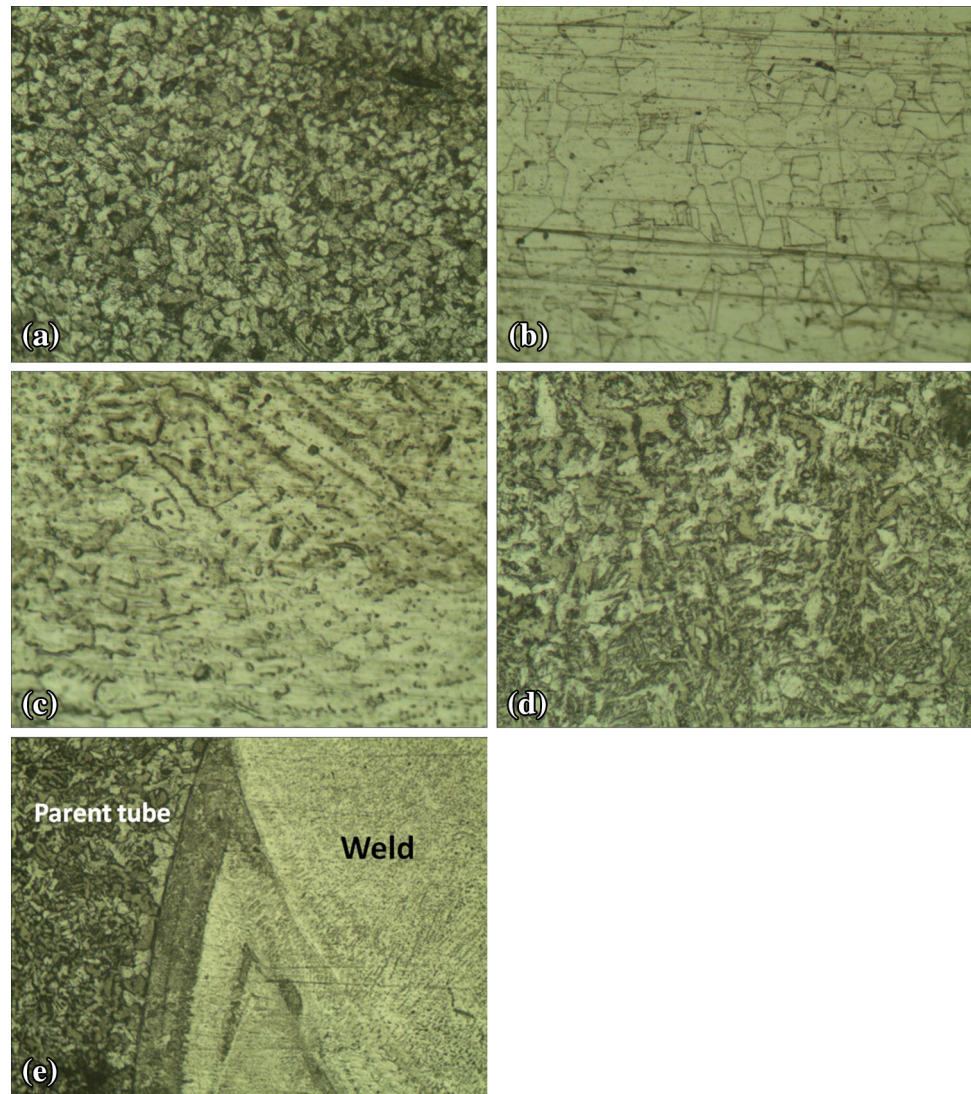
Fig. 7 The metallographic analysis results of No. 11 sample (a) parent tube, (b) inner liner, (c) inside weld, (d) outside weld, and (e) fusion line

The microstructure of parent tube is rather dense ferrite and a small amount of pearlite as shown in Fig. 7a. The microstructure of liner tube is nubbly austenite [9] as

shown in Fig. 7b. The microstructure of innermost weld is austenitic with a small amount of ferrite and the ferrite vermicular distribution in austenite. Ferrite is helpful to

reduce the possibility of weld intergranular corrosion. The microstructure of outmost weld is hot-rolled state of ferrite with a small amount of pearlite. The grain in heat-affected zone is more crassitude than the base material, which is mainly due to the welding process of heating and cooling inhomogeneity and the heat-affected zone overheated. Metal impurities tend to segregate easily at coarse grain boundaries; therefore, the possibility of producing cracks is increasing [7].

Through the analysis of microstructure, the grain of weld and parent metal combination area is relatively bulky, and the sensitivity of stress corrosion is increased. The inevitable defects in welding process have induced effect to pitting corrosion, stress corrosion, and crevice corrosion [11]. The defects of weld zone and arcing point such as microcrack, incomplete fusion and burn through, which will cause stress concentration in these areas. The medium contains Cl^- gathered at the bottom of the pipe near the arcing point and exacerbating the spitting corrosion, stress corrosion, and crevice corrosion of weld. After the inner weld was penetrated due to corrosion, the base pipe and weld contacts to the fluid and form galvanic corrosion. Because the electrode potential of weld and carbon steel are different, the base pipe and weld forms galvanic corrosion. These reasons accelerated the pipeline failure until washout.

- (3) Improve the quality of welding. Improve the quality of arc starting points and the end of welding point.
- (4) Reduce the welding residual stress by improving welding procedures (i.e., Preheat, PWHT, etc.).
