Metallurgical Analysis of Cracked AA7075 Aluminum Alloy Component Used in Control System of a Satellite Launch Vehicle

Sushant K. Manwatkar · J. Srinath · S. V. S. Narayana Murty ·
P. Ramesh Narayanan · S. C. Sharma · P. V. Venkitakrishnan

Submitted: 23 July 2016/in revised form: 4 October 2016/Published online: 9 November 2016
© ASM International 2016

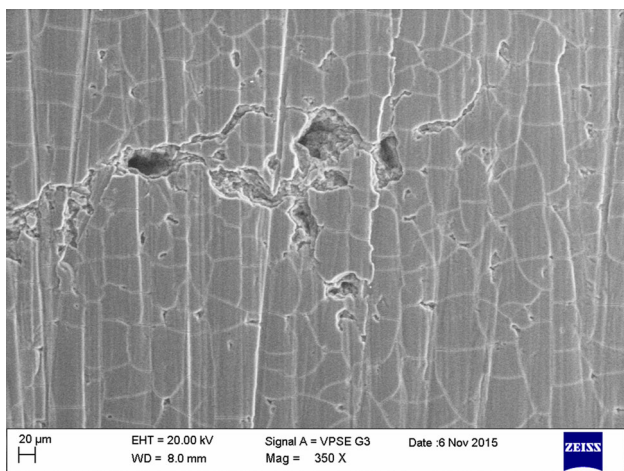
Fig. 3 Scanning electron micrograph showing the damage on the anodized layer. The general structure seen corresponds to the anodized layer which is damaged at certain locations

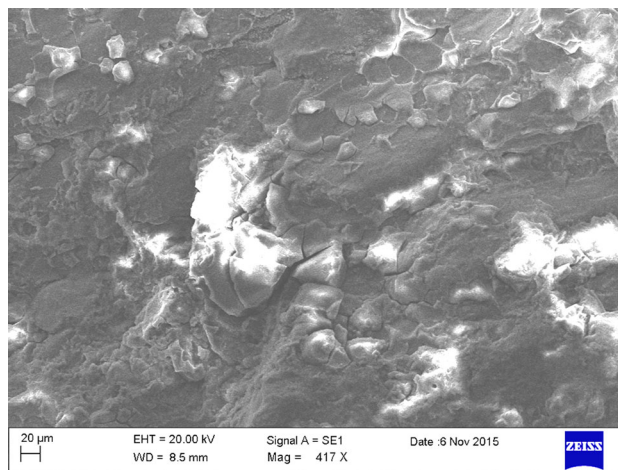
Fig. 5 Scanning electron micrograph showing the presence of corrosion products on the fracture surface. Since the corrosion products are electrically non-conducting in nature, charging takes place at the location where these products are present

The presence of corrosion products on the fracture surface indicated the role of corrosion in crack initiation and propagation. Detailed optical and SEM observations indicated that cracks were initiated from the corrosion pits and propagated inward in an intergranular mode with severe crack branching along the crack paths. The network of precipitates along the grain boundary was responsible for the preferential grain boundary dissolution (Fig. 9). Precipitation at the grain boundary was confirmed by optical and transmission electron microscopy. Grain separations were noticed along the crack path due to the complete dissolution of grain boundaries. The $MgZn_2$ precipitates present at the grain boundaries are more anodic to the matrix which results in a local cell action at the grain boundaries leading to selective dissolution of grain boundaries by electrochemical mechanism [3, 4]. The large network of sub-grains along the grain boundaries as shown in Fig. 8 has also provided additional sites for preferential precipitation at sub-grain boundaries. The $MgZn_2$ precipitation along the grain boundaries was responsible for the anodic dissolution of grain boundaries in the presence of residual stresses in the material.

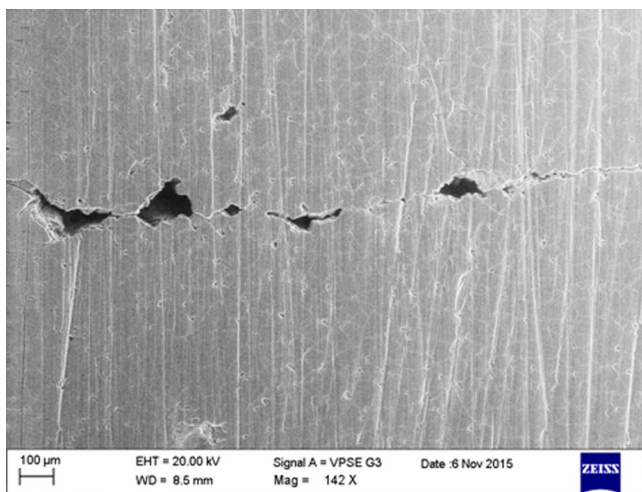
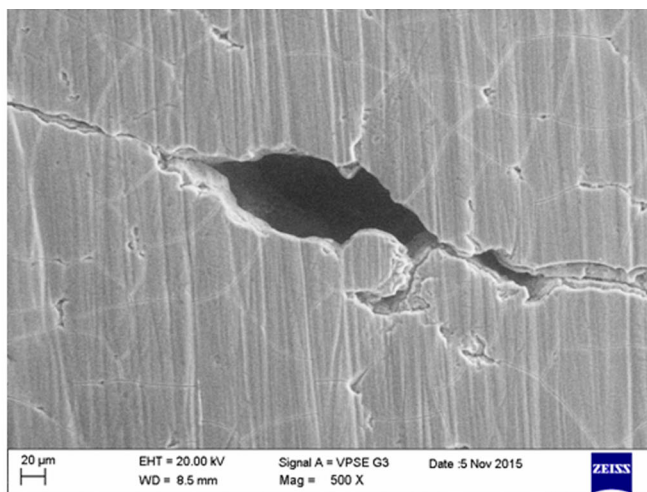
Fig. 4 Scanning electron micrographs showing dissolution of grains along the crack path, leading to the formation of cavities. The photographs are taken at two different magnifications (**a**, **b**)

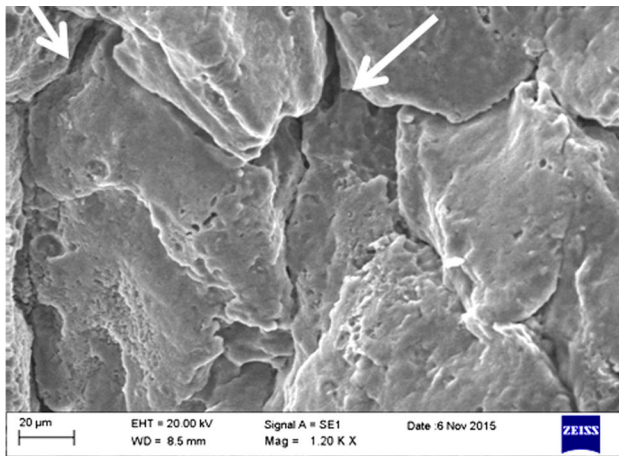
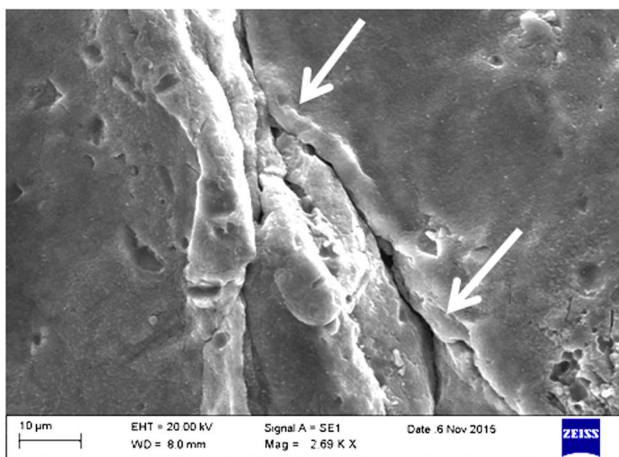
fracture surface revealed intergranular features with the cracks along the grain boundaries (Fig. 6).

Fig. 6 Scanning electron micrographs of the fracture surface showing the intergranular features (a) with the cracking along the grain boundaries (b)

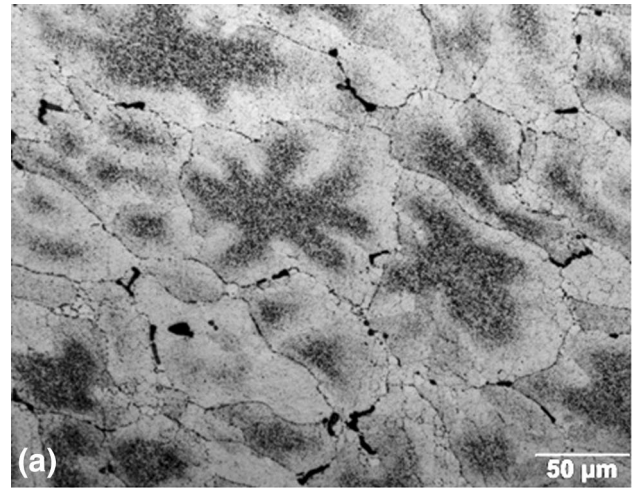
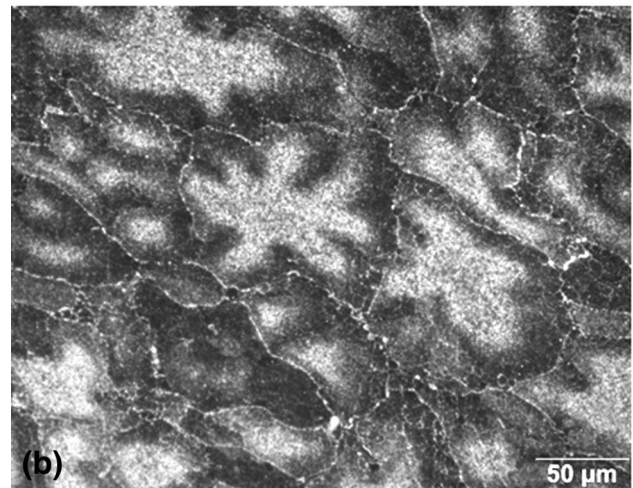
The optical microscopy of the polished and etched specimens revealed the presence of coring (elemental micro segregation) in the material indicated as dark flowery patterns. The flowery patterns were more evident in the optical photomicrographs taken in the dark field mode (Fig. 7b). The grain boundaries were decorated with precipitates (Fig. 7a). The grain boundaries also had an extensive network of sub-grains as shown in optical photomicrographs taken in the dark field mode (Fig. 8). The optical microscopic observations of the cracks indicated intergranular nature of cracking with extensive crack

Fig. 7 Optical photomicrographs showing the (a) precipitates along the grain boundaries (b) flowery pattern and grain boundaries are more evident in dark field mode

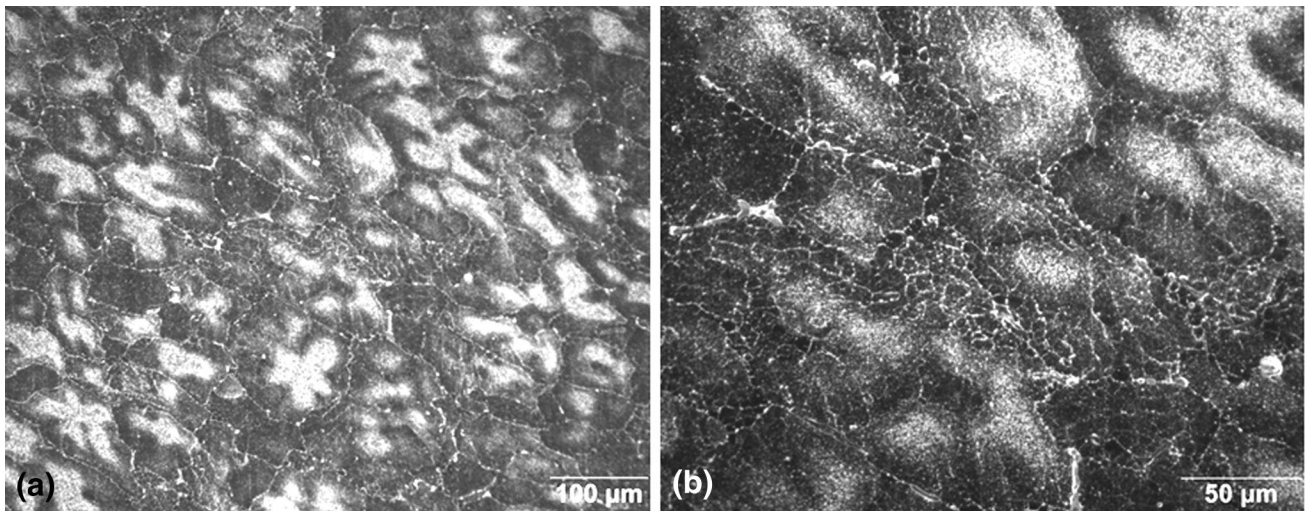
Fig. 8 Optical photomicrographs taken in dark field mode showing extensive network of subgrains along the grain boundaries. The photographs are taken at two different magnifications

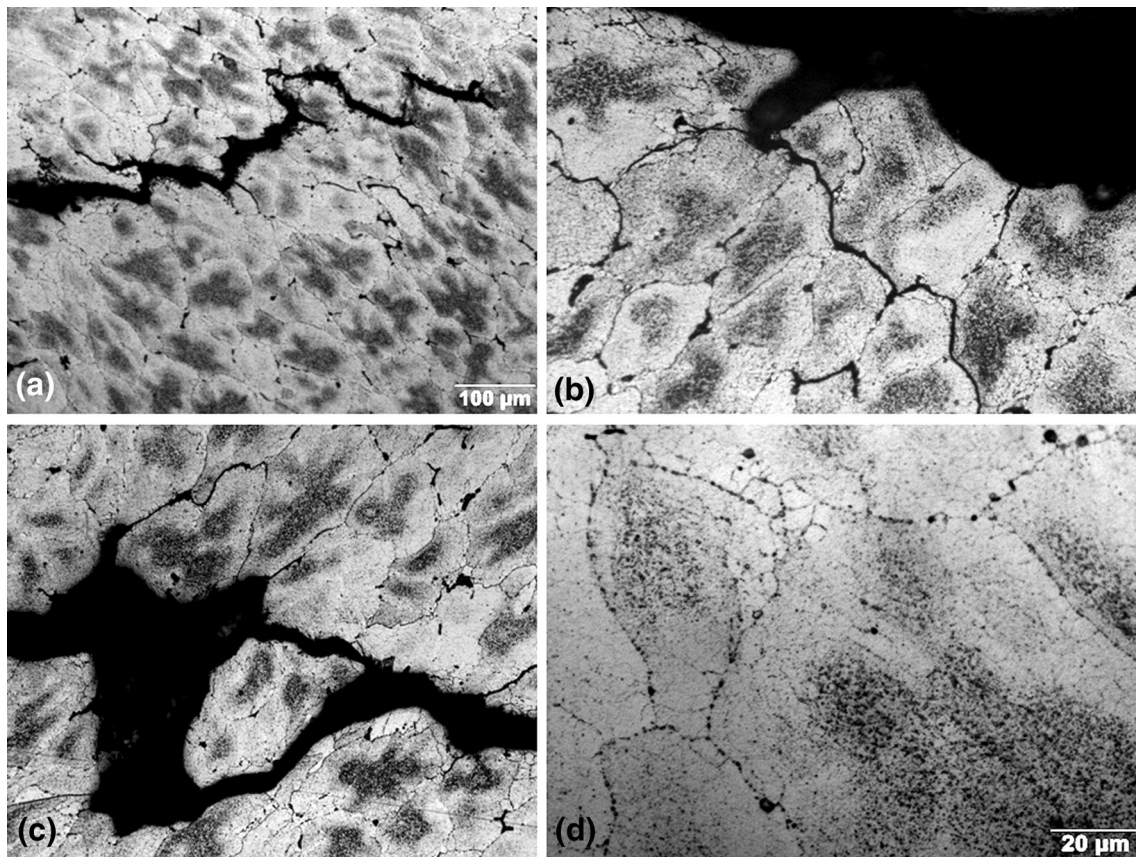
branching (Fig. 9a). The anodic dissolution at grain boundaries was also noticed (Fig. 9b). Grain separations along the crack path were also noticed as shown in Fig. 9c. Higher magnification observation revealed precipitation along the grain boundaries (Fig. 9d).

Fig. 9 Optical photomicrographs taken at the crack location showing (a) intergranular nature of cracking, (b) anodic dissolution at grain boundaries, (c) grain separations along the crack path and (d) precipitation along the grain boundaries

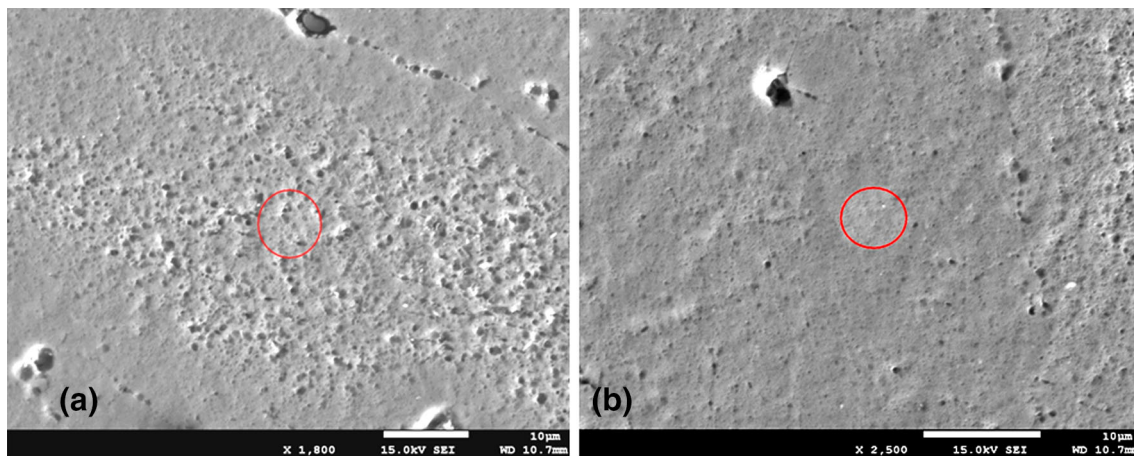
Fig. 10 Photomicrographs taken in electron probe micro analyser at (a) dark cored region showing coarse precipitation (b) light region devoid of coarse precipitation

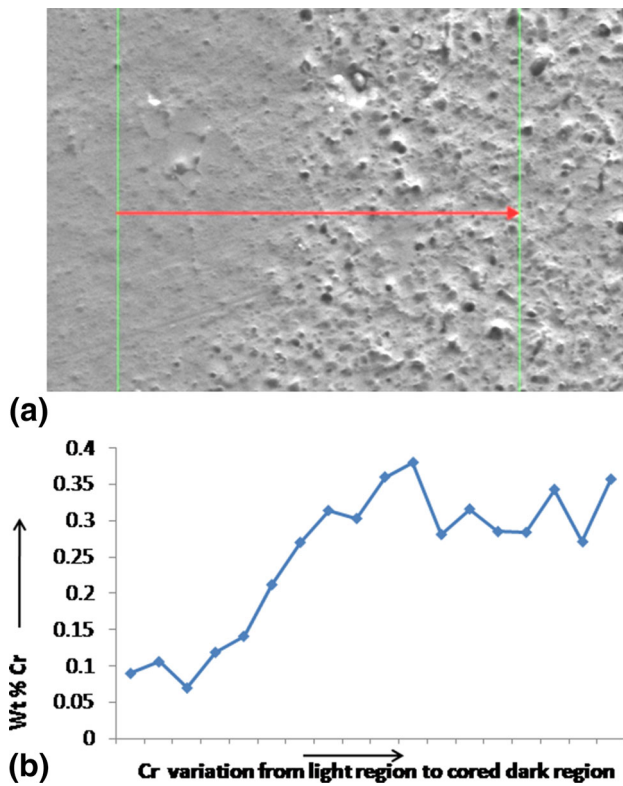
Fig. 10. The chemical composition obtained by the EPMA analysis is given in Table 1. The results show the segregation of chromium in the cored region. Figure 11 shows the line scan from light region to cored region (as marked by green lines in Fig. 11a) and distribution of chromium across the line (Fig. 11b). The TEM observations indicate the precipitation of $MgZn_2$ along the grain boundaries and in the matrix (Fig. 12).

Fig. 11 Photomicrograph taken in EPMA showing (a) the area considered for obtaining line scan from light region (uncored) to dark region (cored) and (b) distribution of chromium from light region to dark cored region

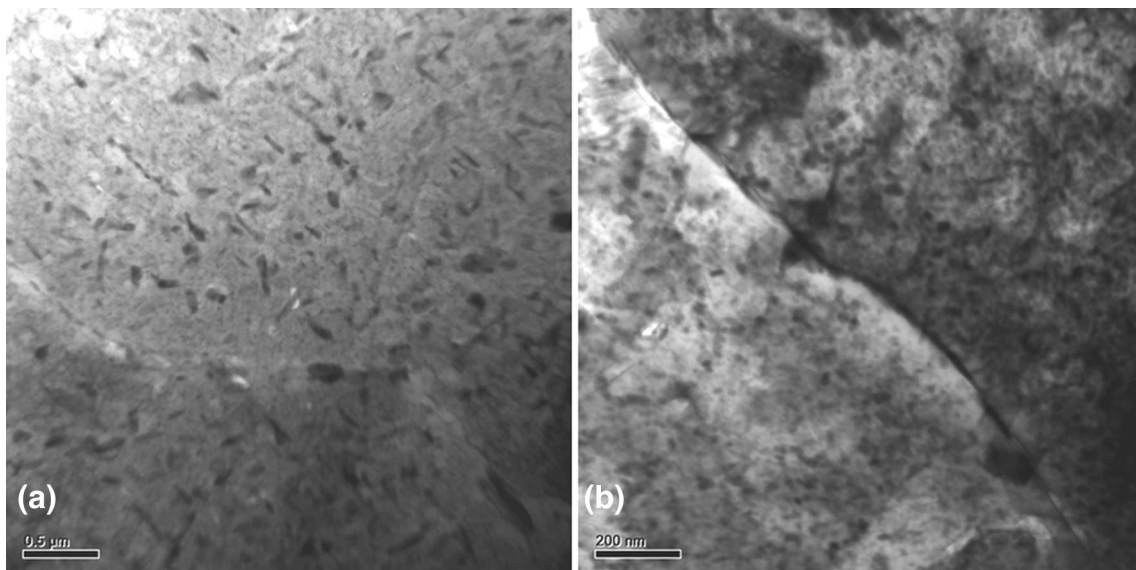
Fig. 12 Transmission electron micrographs showing the precipitation at the grain boundaries and in the matrix. The precipitates correspond to $MgZn_2$

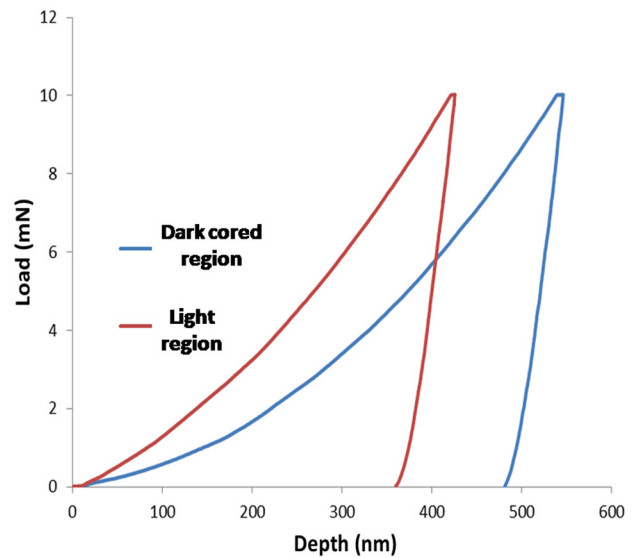
hardness was 2530 MPa. The load-depth curves at dark cored region and light region are shown in Fig. 14. Load-depth curves indicate that the depth of penetration in the

Fig. 14 Load-depth curves from dark cored region and light region obtained from nano-indentation test

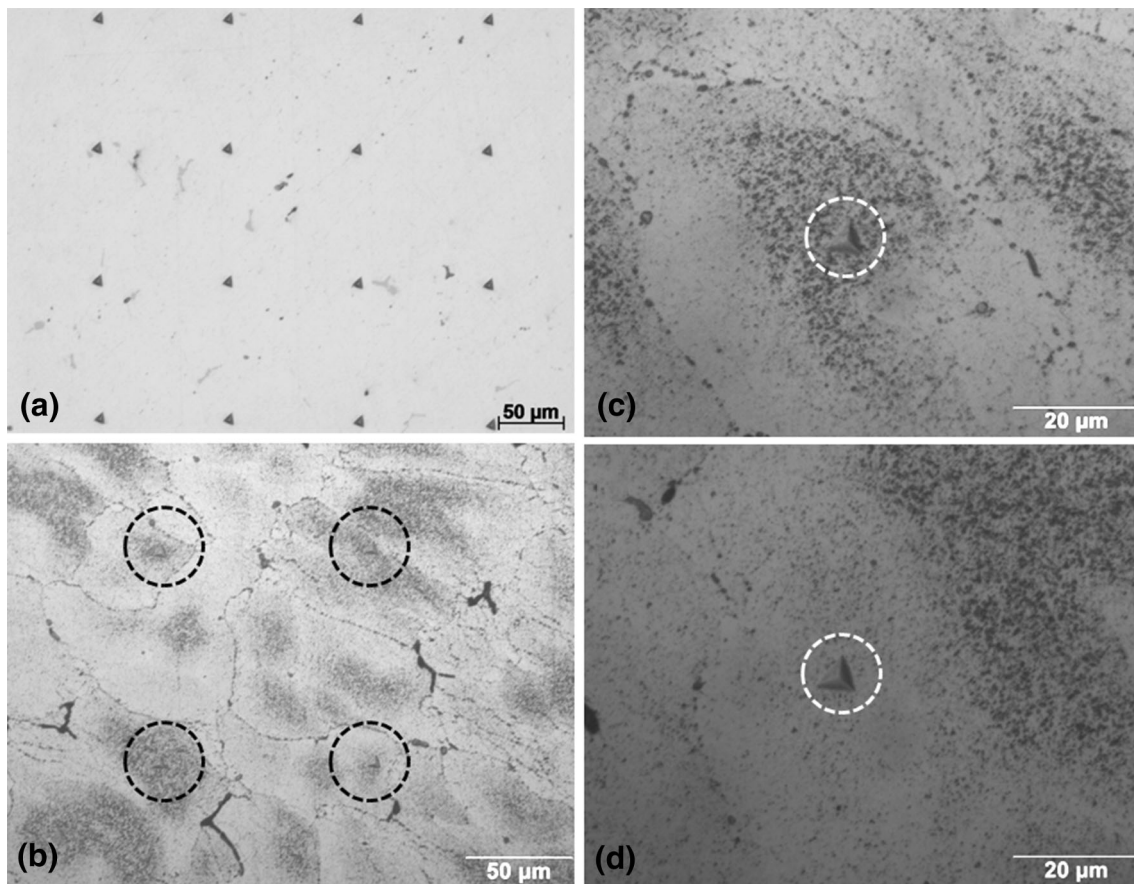
micrographs at dark cored region and light region. The nano indentation results indicated the average hardness of the dark cored area was 2190 MPa and for light areas, the

Fig. 13 The optical photomicrographs nano indentations (a) matrix of indentation, (b) indentations at dark cored region and light region, (c) high magnification view of indentation at dark cored region (d) high magnification view of indentation at light region. The indentations are marked by circles in the photographs

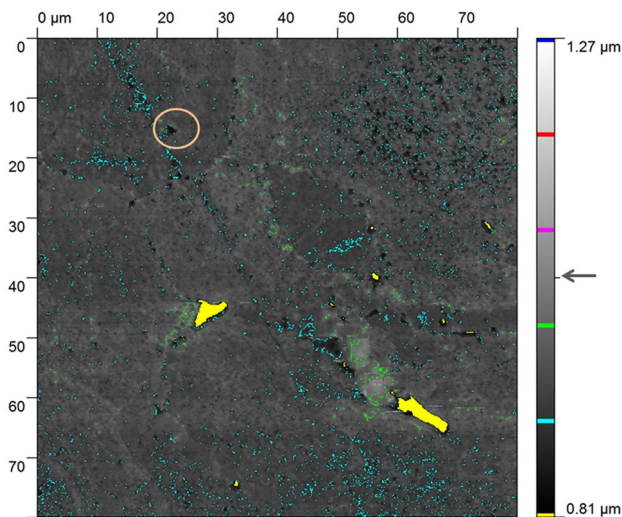
dark cored region was higher than light regions in the microstructure. AFM image of the microstructure of the alloy is illustrated in Fig. 15. The image shows coarse precipitation (indicated by the localized blue dots in the cored regions) in cored microstructure.

Fig. 15 AFM image of the microstructure showing the dark cored region with coarse precipitations, nano indentation is marked by a circle
