Failure Analysis of AISI 304 Stainless Steel Sleeve Used in High-Pressure Hose Assembly of Actuation System of a Satellite Launch Vehicle

V. Murugesan · P. S. Sreejith · Sushant K. Manwatkar ·
S. Sankar Narayan · S. V. S. Narayana Murty · P. Ramesh Narayanan

Submitted: 7 September 2016/in revised form: 30 November 2016/Published online: 10 January 2017
© ASM International 2017

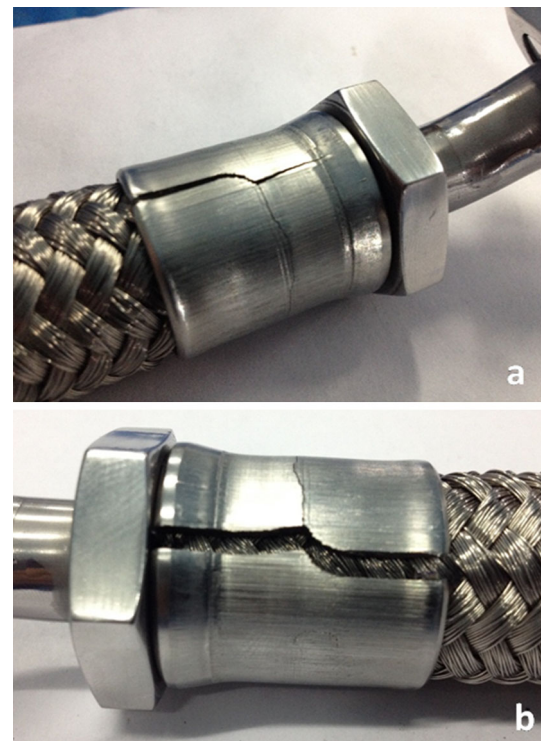
Fig. 3 Digital photograph showing the cracking of sleeve in hydraulic pressure set-up (a) and after removal from the set-up (b)

of the AISI 304 hose sleeves was found to be cracked as shown in Fig. 3a. The cracking was observed after carrying out the pneumatic test (at 10 bar pressure for 5 min) when the assembly was being prepared for hydraulic pressure set-up. The hose was removed from the hydraulic pressure set-up and kept aside. The crack was found to grow after the removal from the test set-up and was found to be completely opened up after some time (~ 2 h) as shown in Fig. 3b. Detailed metallurgical analysis was carried out on the cracked sleeve to find out the reasons for cracking. This paper describes the details of the failure that occurred in the swaged joint during the process of qualification of the hoses, identification of root cause and actions taken to avoid similar failures.

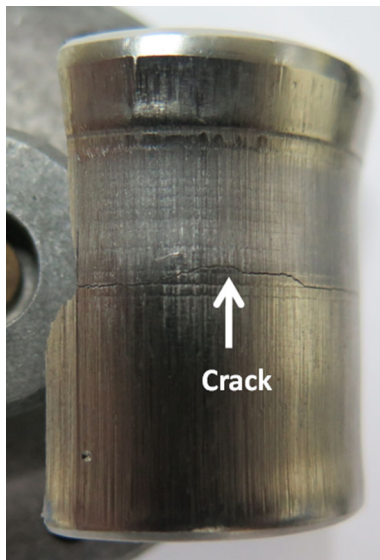
Fig. 4 Photograph showing the circumferential crack on the sleeve

Visual observations of the cracked sleeve revealed a rough surface with die mark lines along the length of the sleeve (Fig. 4). The primary crack was initiated from the outside

diameter (OD) of the tubular sleeve. The primary crack was circumferential and deviated along the length during propagation causing complete separation of the longitudinal crack (Figs. 3 and 4).

sensitized microstructure of the material. The plastic strain on the surface will be more, if the die used for swaging operation has a rough surface. The rough surface along with longitudinal die marks on the sleeve indicates that the dies used for swaging operation had a poor surface finish which introduced large plastic strain on the surface of the sleeve.

The SS304L grade steel was selected to avoid the problem of chromium carbide precipitation at grain boundaries. The swaging procedure was modified to minimize the strain at the failed location of the sleeve of the hose assembly, and the surface quality of dies was ensured. With the change in material grade and modified procedure, subsequent hose assemblies have passed all of the stipulated qualification tests listed in Table 1.

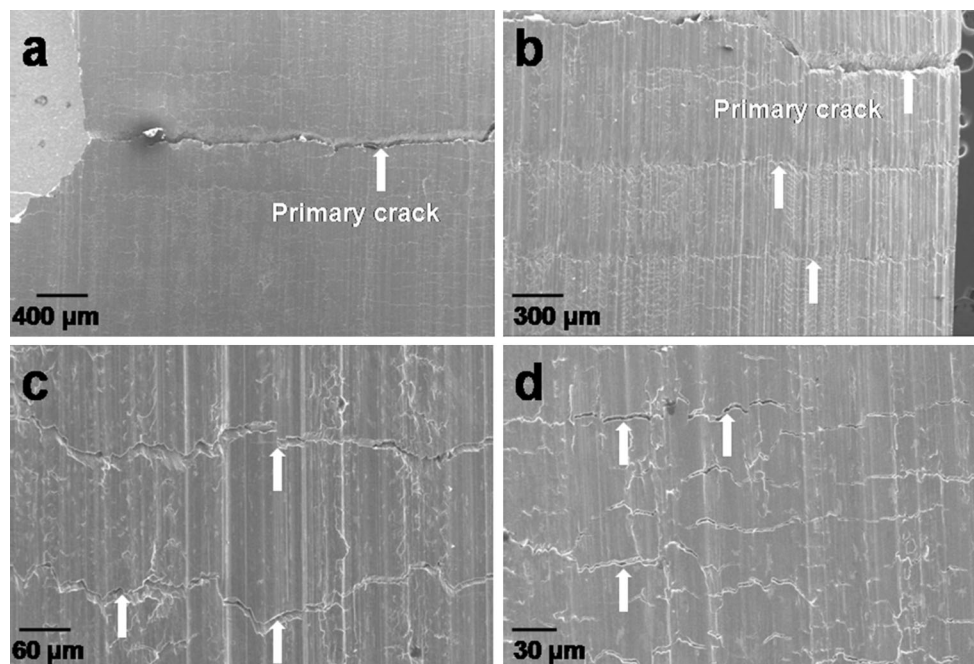
Fig. 5 SEM images showing the circumferential micro-cracks near to the primary crack

SEM observations on the surface of the sleeve near to the crack location revealed circumferential micro-cracks near to the primary crack as shown in Fig. 5. Figure 5a shows the primary crack (indicated by arrow). Figure 5b shows the primary crack at the top of the image and two micro-cracks below the primary crack. Figure 5c shows a higher magnification view of the two micro-cracks shown in Fig. 5b. Figure 5d shows a micrograph of numerous fine micro-cracks on the surface.

sleeve and propagated inwards. The longitudinal die marks observed on the surface of the sleeve along with numerous micro-cracks observed near the primary crack (as indicated by SEM observations shown in Fig. 5) and optical

microscopic observations (Fig. 13c) at the OD side suggest that they were generated on the surface during the swaging operation. The reasons for formation of micro-cracks on the surface are attributed to the combined effect of large plastic strain developed on the OD surface of the sleeve and

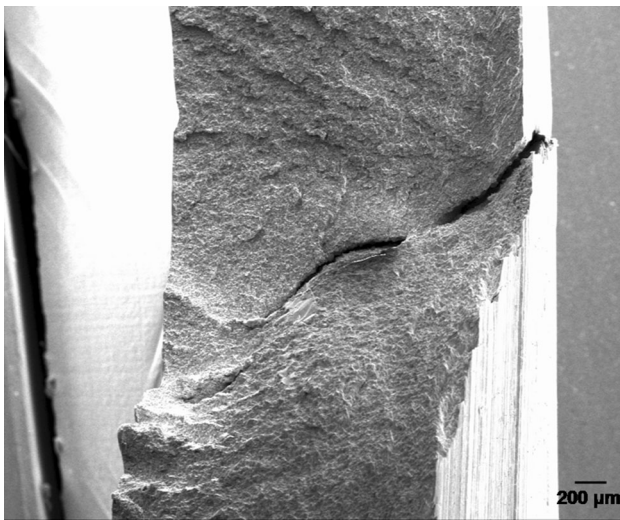
Fig. 6 SEM image showing a full view of the fracture surface through the complete thickness of the sleeve

The fracture surface of the deviated crack which has opened up and separated into two parts was observed under SEM. Figure 6 shows the full view of fracture surface covering the complete thickness of the sleeve. It also shows the location of the crack path deviation from a circumferential crack to the longitudinal crack. At the location of crack path deviation, a large-size silicate inclusion stringer and uniformly distributed sulphide stringers were observed (Fig. 7). The high-magnification view of the large-size silicate stringer and sulphide stringers is shown in Figs. 8 and 9, respectively. The fracture surface had shown a predominantly intergranular mode of failure (Fig. 10).

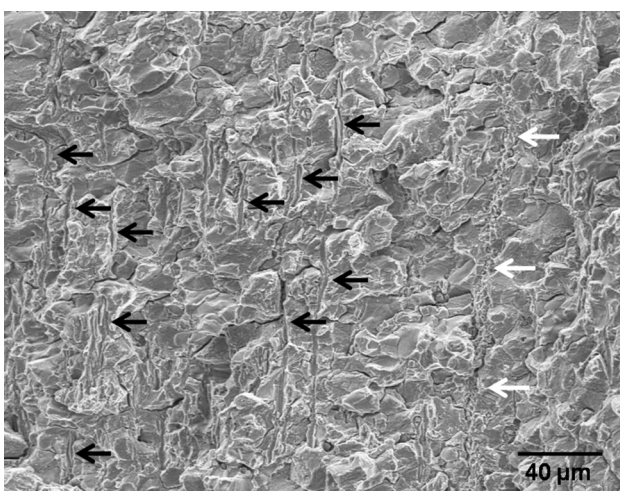
Fig. 7 SEM image showing an isolated large-size silicate inclusion (indicated by white arrows) and uniformly distributed sulphide inclusion stringers (indicated by black arrows) at the location of crack path deviation

Most silicate inclusions have several oxide components, for example MnO, FeO, CaO, Al_2O_3 and SiO_2 . Silicate inclusions have a low index of deformability at lower temperatures and thus are brittle during cold working of the steel [4]. The presence of isolated long silicate stringers up to 2.2 mm size in the sleeve material was more detrimental

because they provide a very long and continuous weak interface for crack propagation. Isolated long silicate stringers were responsible for the identified deviation of the primary crack and subsequent crack propagation leading to fast fracture. The cracks have propagated in an intergranular manner due to the hard and brittle continuous chromium carbide precipitation along the grain boundaries and residual stresses present in the component along with assembly stresses.

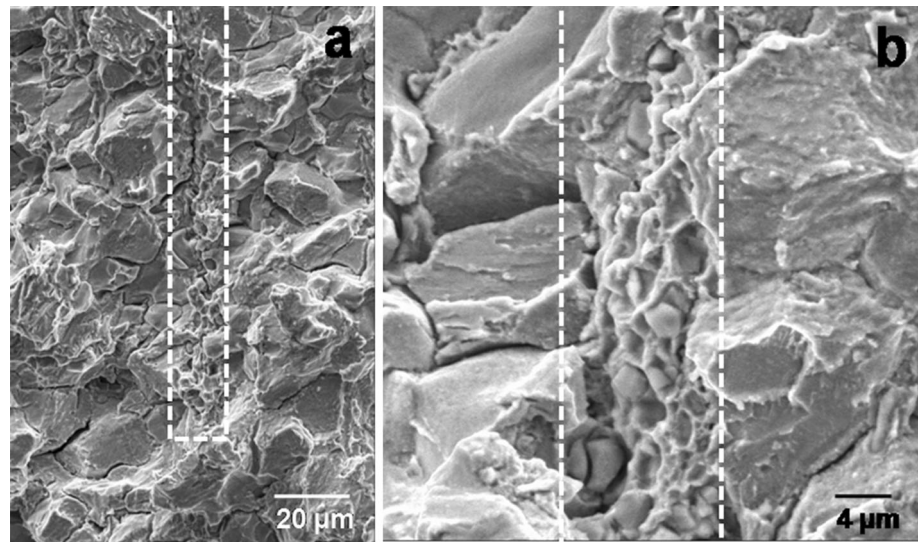
Fig. 8 High-magnification SEM images showing an isolated large-size silicate inclusion on the fracture surface

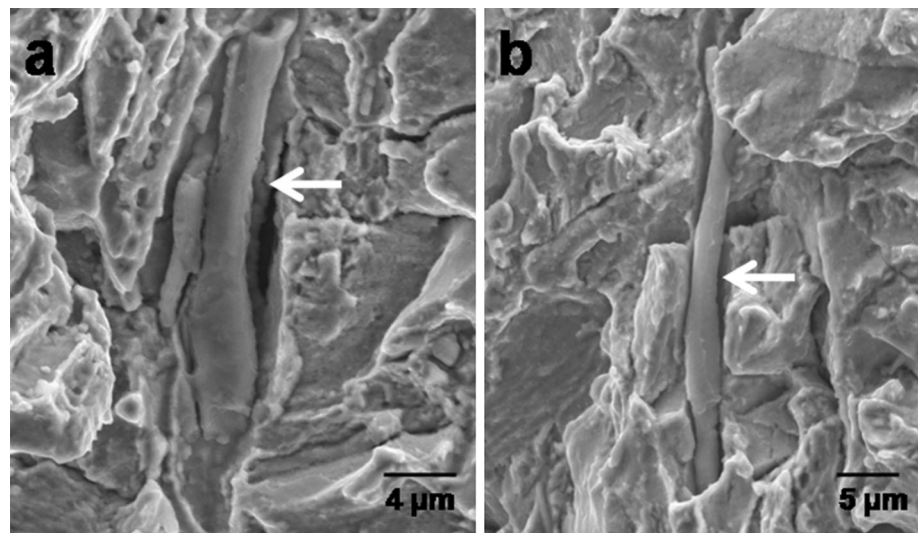
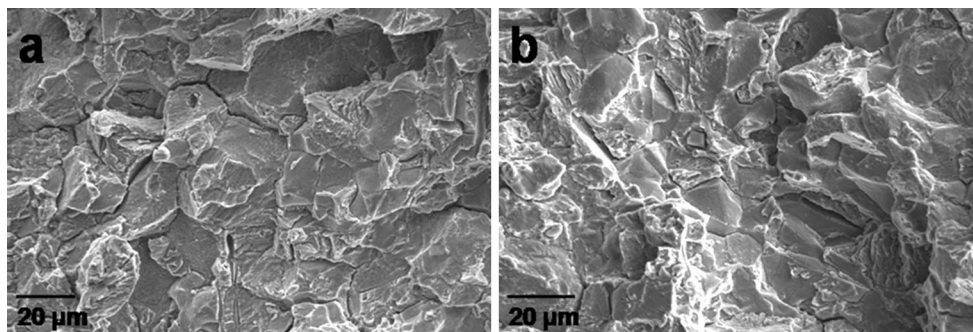
Fig. 10 SEM images on the fracture surface showing the intergranular mode of cracking

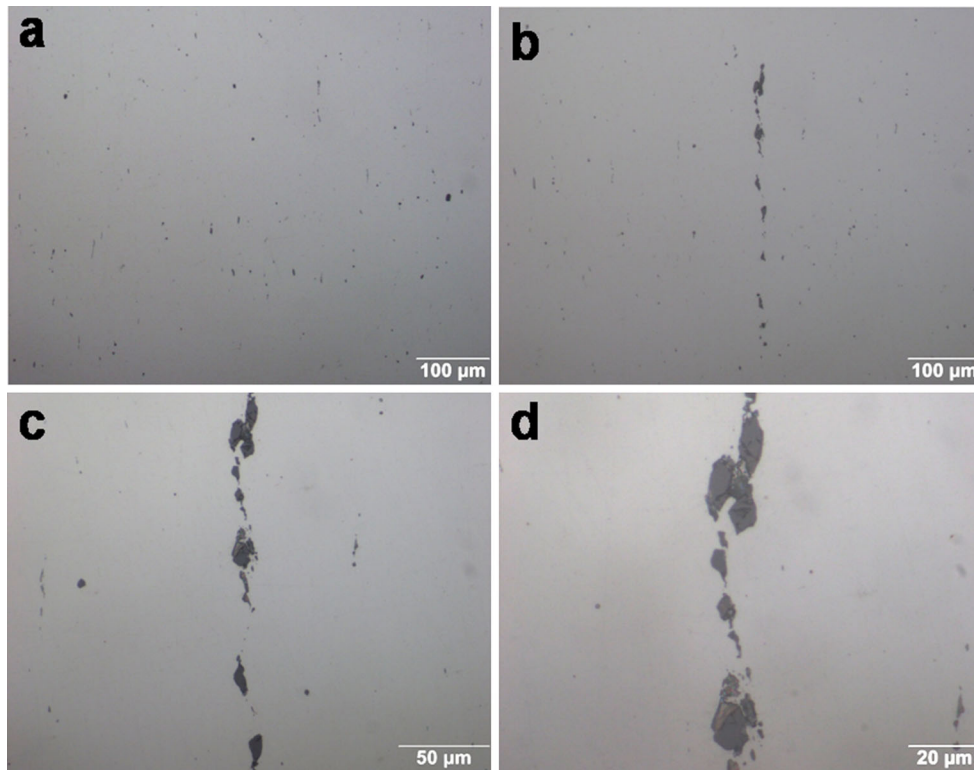
Metallographically prepared specimens were observed under optical microscope for inclusion content. The observations revealed the presence of uniformly distributed sulphide inclusions and oxide inclusions in the material as shown in Fig. 11a. Isolated long silicate inclusion stringers were also present in the material (Fig. 11b–d). Very long silicate inclusion stringers of size 2.2 and 1.16 mm size were also observed in the microstructure and are shown in Fig. 12a and b, respectively.

Fig. 11 Optical micrographs in the unetched condition showing (a) sulphide and oxide inclusions, (b) silicate inclusion stringer, (c, d) silicate inclusion stringers at high magnification

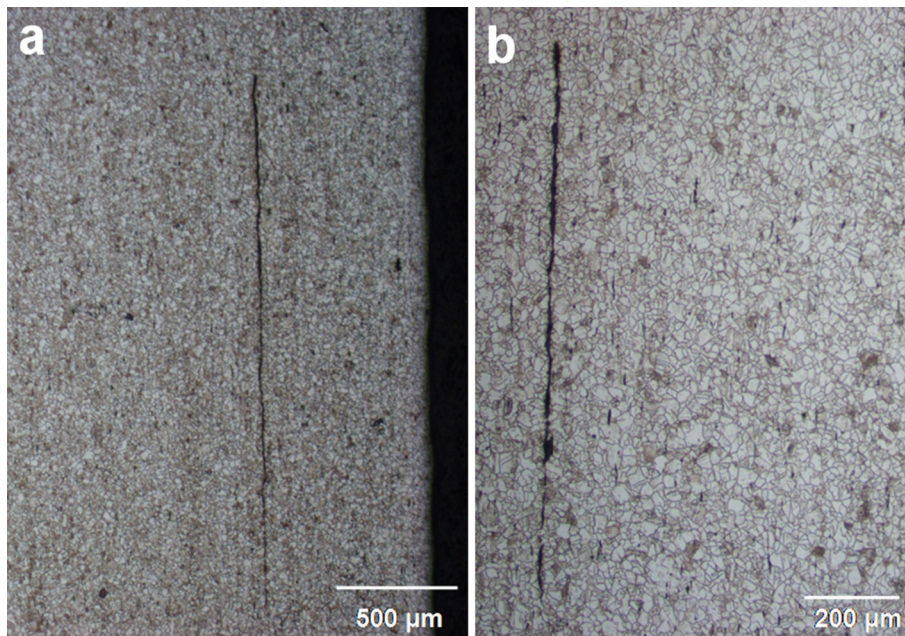
Fig. 12 Optical micrographs showing very long silicate inclusions

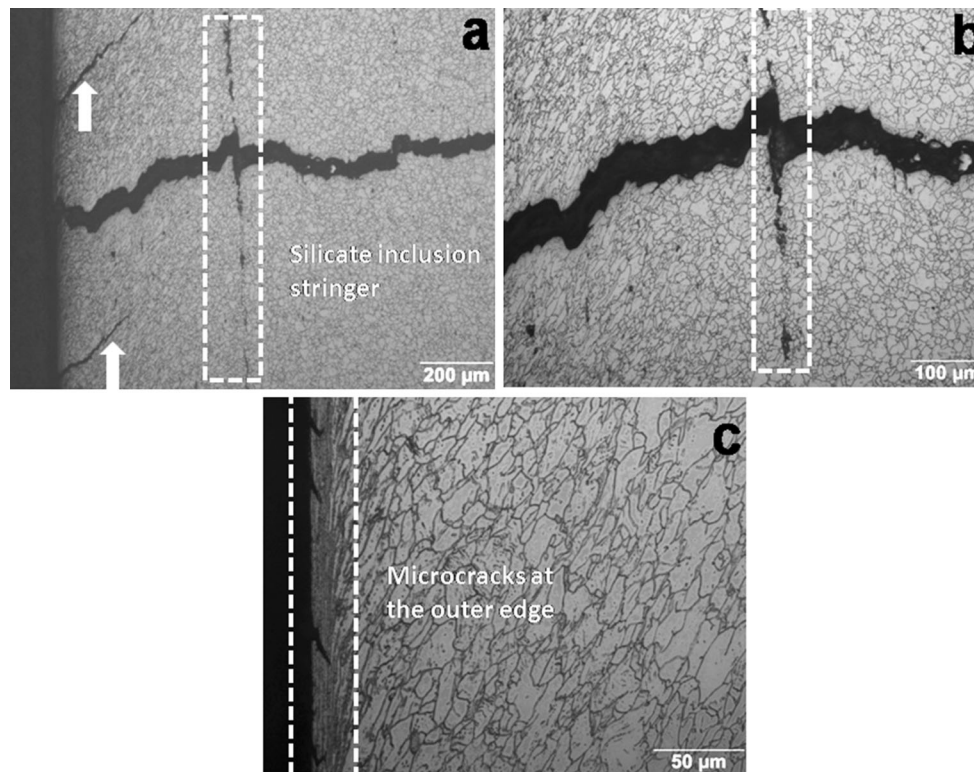
Microstructural observations at the crack location revealed that the crack originated from the outer diameter (OD) of the sleeve and propagated inwards. Two micro-cracks of 250 and 400 μm size originating from OD were also observed near to the primary crack as shown in Fig. 13a. Small deviations of the primary crack were noticed at the intersection of the crack path with a silicate inclusion stringer (Fig. 13a and b). Very fine micro-cracks of 20–30 μm were noticed at the outer edge of sleeve at higher magnification. Deformed and elongated grains were noticed at the OD edge up to approximately 400 μm from the surface. Equiaxed grains were observed at the interior of the sleeve (Fig. 14). Cracking was completely along the grain boundaries throughout the crack path as shown in Fig. 15a. The grain boundaries were decorated with chromium carbide particles (Fig. 15). Microhardness measurements indicated hardness of 470HV_{100gf} at outer edge and 340HV_{100gf} at the middle of the sleeve.

Fig. 13 Optical micrographs showing (a) two micro-cracks of size 250 and 400 μm indicated by arrows near to the primary crack and silicate inclusion stringer along the crack path, (b) little deviation of the crack at the intersection with silicate inclusion stringer, (c) numerous small size micro-cracks of size 20–30 μm at outer edge of the sleeve

The plastic strain on the sleeve is indicated by deformed and elongated grain at outer edge as shown in Fig. 14. The larger plastic strain and small size micro-cracks formed on the OD surface of the sleeve can be seen in Fig. 13c. Larger plastic strain at the OD surface has also resulted in higher hardness to a magnitude of 470 $\text{HV}_{100\text{gf}}$. The Vickers hardness of AISI 304 steel tends to increase proportionally with increases in cold working as reported by Singh et al. [1]. This indicates that the OD surface of the sleeve has undergone extensive cold reduction on the surface, whereas the extent of cold reduction decreased towards—the interior surface as shown in Fig. 14. This is reflected as variation in grain elongation and flow from the OD surface to the inside of the sleeve. Microscopic observations indicated that deformed and elongated grains were present up to 400 μm . This results in the generation of residual stresses due to the gradient in the plastic strain along the thickness direction.

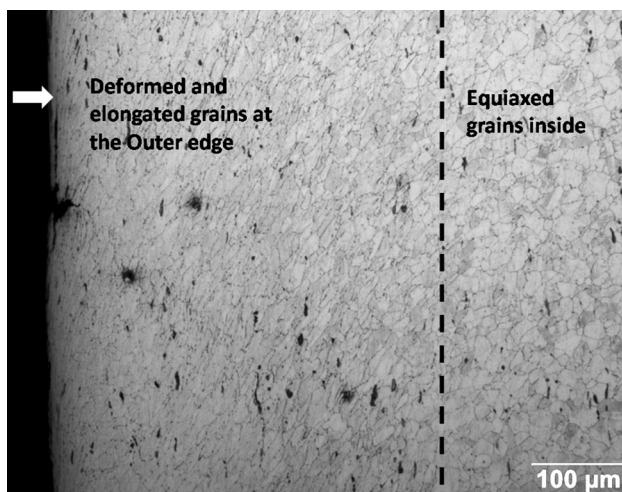
Fig. 14 Optical micrographs showing deformed and elongated grains at the outer diameter up to approximately 400 μm inside and equiaxed grains at interior of the sleeve

suggested for minimizing the plastic strain at the failure location and reducing the induced residual stresses.

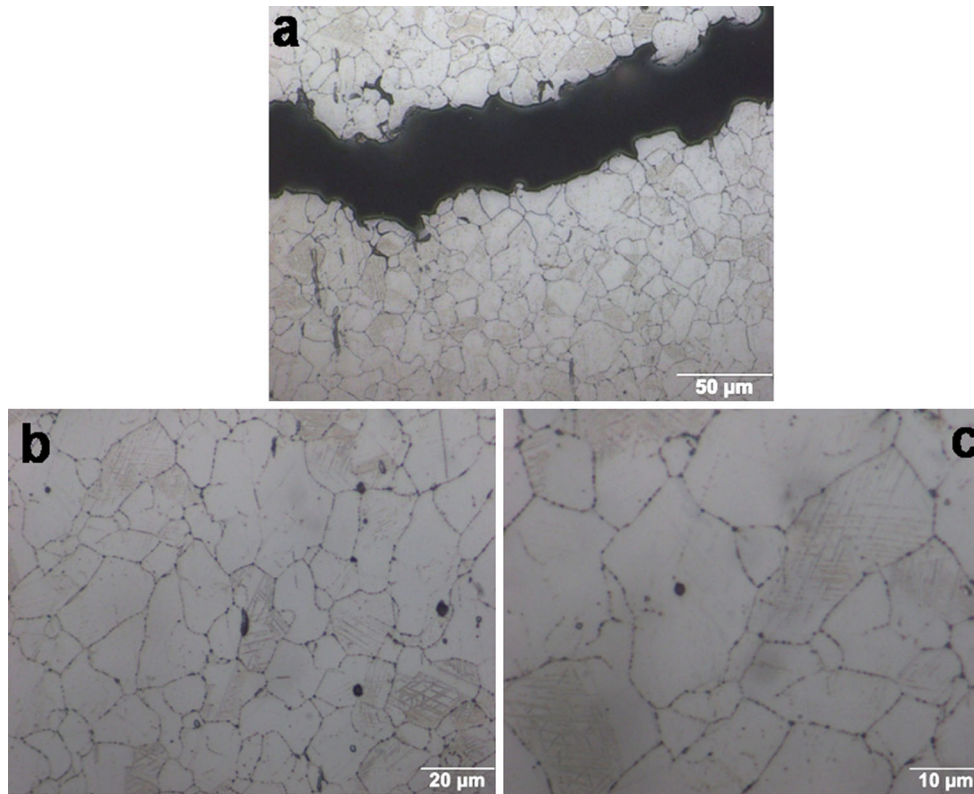
Fig. 15 Optical micrographs showing (a) cracking along the grain boundaries, (b, c) chromium carbide precipitation at the grain boundaries

The chromium carbide precipitation along the grain boundary is called the sensitization of the steel. Sensitization is one of the embrittlement (loss of ductility) phenomena in austenitic stainless steels. In austenitic stainless steels, chromium carbides dissolve completely in the matrix at approximately above 1035 $^{\circ}\text{C}$. When the steels cooled slowly from these higher temperatures or reheated to the temperature range of 425–815 $^{\circ}\text{C}$, chromium carbides are precipitated along the grain boundaries. During annealing of austenitic stainless steel, it is cooled rapidly by water quenching to prevent the sensitization. The rate of carbide precipitation varies significantly with the carbon content in the steel. AISI 304 steel containing 0.05% carbon can be free of sensitization under the cooling conditions which produced heavy sensitization in the same alloy with 0.08% carbon [8]. Hence to avoid the problem of sensitization, extra-low-carbon stainless steel AISI 304L is commonly used. AISI 304L grade steel has carbon content of 0.03% compared to 0.08% carbon present in normal AISI 304 steel [9, 10].

Based on the above observations and discussion, the failure of AISI 304 steel sleeve was due to the large plastic strain, the presence of residual stresses along with assembly stresses and embrittlement caused by sensitized microstructure. The continuous grain boundary network of chromium carbide precipitation led to cracking of sleeve by brittle intergranular mode. The presence of silicate inclusion stringers was responsible for easy crack propagation and deviation of the primary crack.

Subsequent to the failure, the material of the sleeve was changed from SS304 to SS304L grade material conforming to material acceptance criterion with respect to inclusion rating, microstructure and mechanical properties.

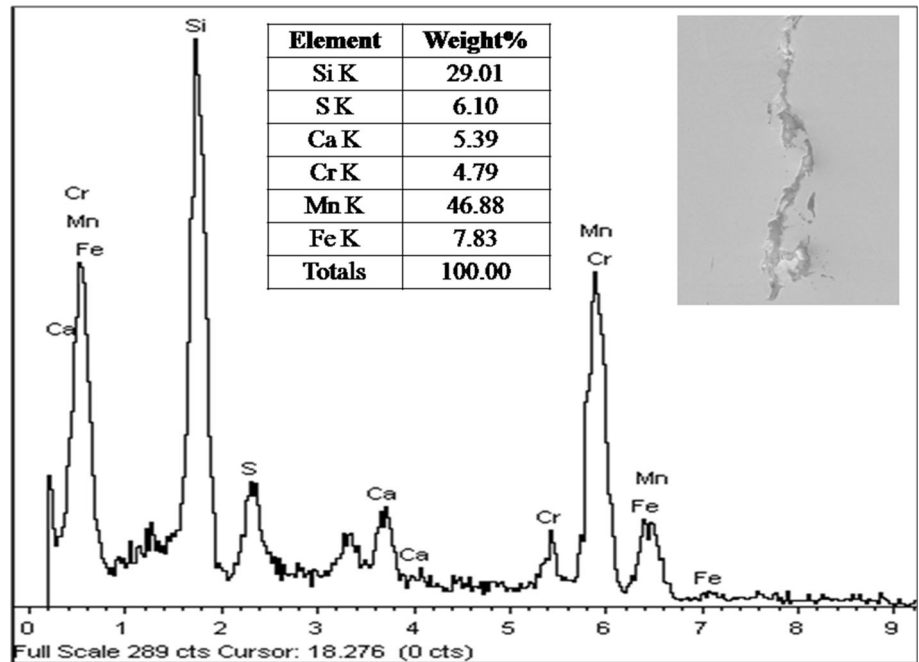
Fig. 16 EDS spectrum showing chemical composition of silicate inclusion

EDS analysis on the silicate inclusion stringers revealed the presence of calcium silicates along with manganese sulphide (Fig. 16). The sulphide inclusions were confirmed

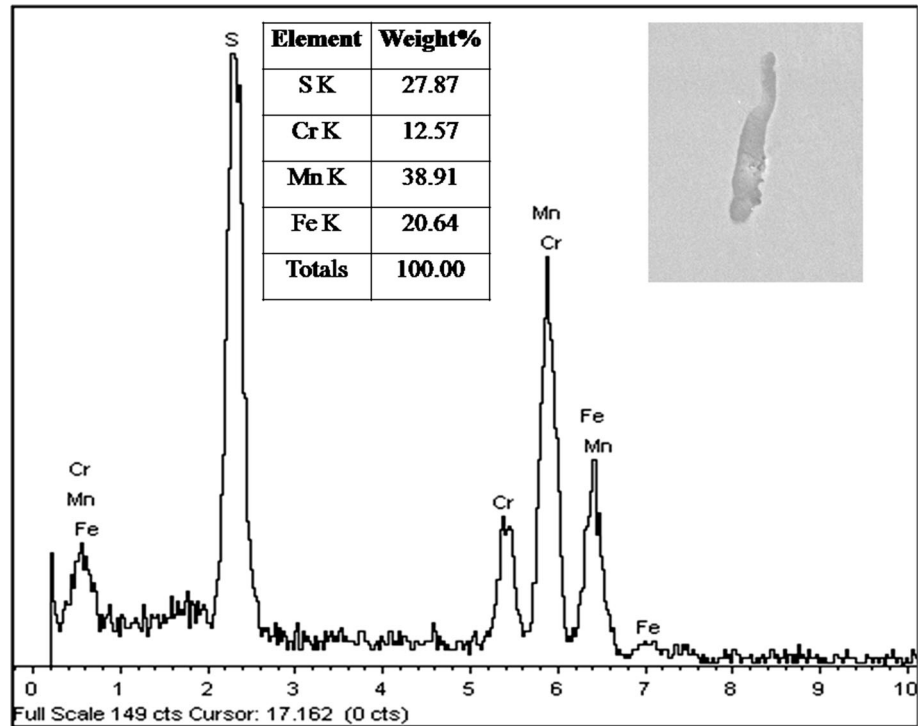
Fig. 17 EDS spectrum showing chemical composition of sulphide inclusion

to be MnS composition as shown in Fig. 17. The precipitates at grain boundaries were confirmed to be chromium carbide precipitates (Fig. 18).
