Transverse Cracking of HF-ERW Pipes

Abstract Transverse to pipe axis cracks across the weld line of high frequency-electrical resistance weld (HF-ERW) pipes of IS 10748 Grade 2 and size 406.4 mm outside diameter and 7.75 mm wall thickness were observed. Analytical techniques such as ultrasonic testing, optical microscopy and scanning electron microscopy with energy-dispersive spectroscopy were used for analysis and determination of the root cause.

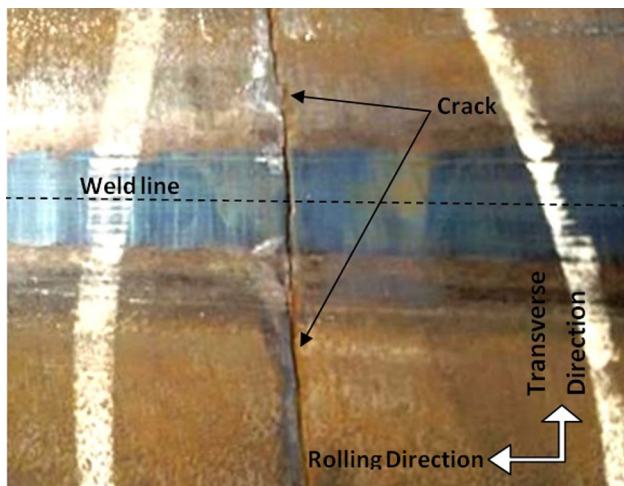
Fourteen pipes from 3 different coils of 2 heats had been observed with the transverse crack across the weld line (Fig. 1). Specimens transverse to the crack (parallel to rolling direction) were drawn for metallographic examination. The optical microscope did not reveal any harmful inclusions in the crack vicinity. Subsurface cracks near the weld line were detected by ultrasonic testing and confirmed by the metallographic examinations.

Fig. 1 Transverse cracks across HF-ERW weld line

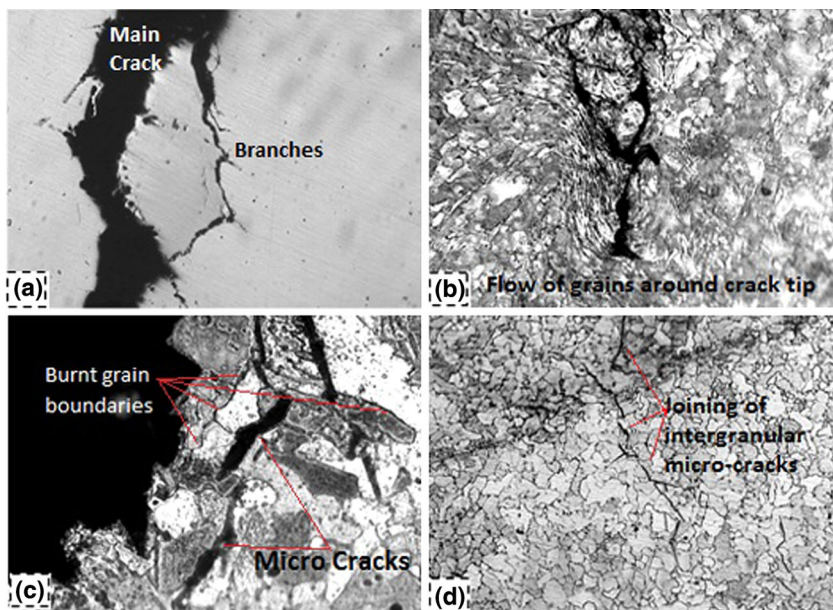
The specimens transverse to the crack (parallel to the rolling direction) were drawn, polished and etched with 2% Nital. The microstructural examination was carried out through thickness under an optical metallurgical microscope. The crack morphology is presented in Fig. 3a–d. Figure 3a shows a main crack having branches on an unetched surface. The crack was intergranular as shown in Fig. 3c and d. Figure 3b shows a flow of grains around the crack tip developed due to cold deformation imparted during cold sizing operation. Figure 3c shows burnt grain boundaries and intergranular micro-cracks near a large crack.

Fig. 3 Morphology of transverse crack

The presence of iron-oxide in the crack vicinity as revealed by EDS spectra (Fig. 5a) can be explained by overheating of slabs due to prolonged soaking time. The overheating resulted in burning of grain boundaries as seen in Fig. 3c. Since alkali oxides were not found in the crack vicinity, possibility of crack formation during continuous casting of slabs was not considered. The corner cracks present at slab edges would have elongated during hot

During cold sizing, when such transverse micro-cracks were located close to each other, they joined together and resulted in the metal collapse as seen by the flow of grains around the crack tip (Fig. 3b).

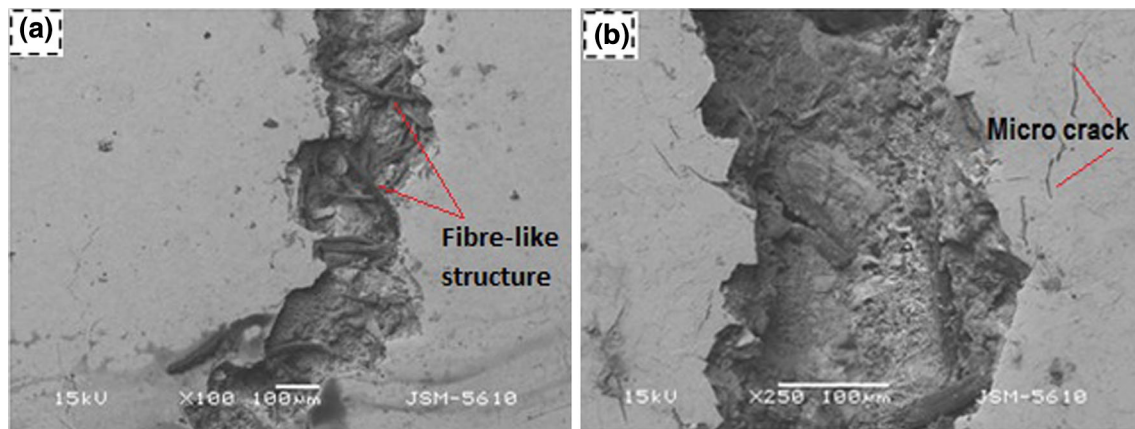
Backscattered SEM images revealed a fiber-like structure inside the crack (Fig. 4a) and micro-cracks (Fig. 4b).

Fig. 4 SEM images at higher resolution in the crack vicinity

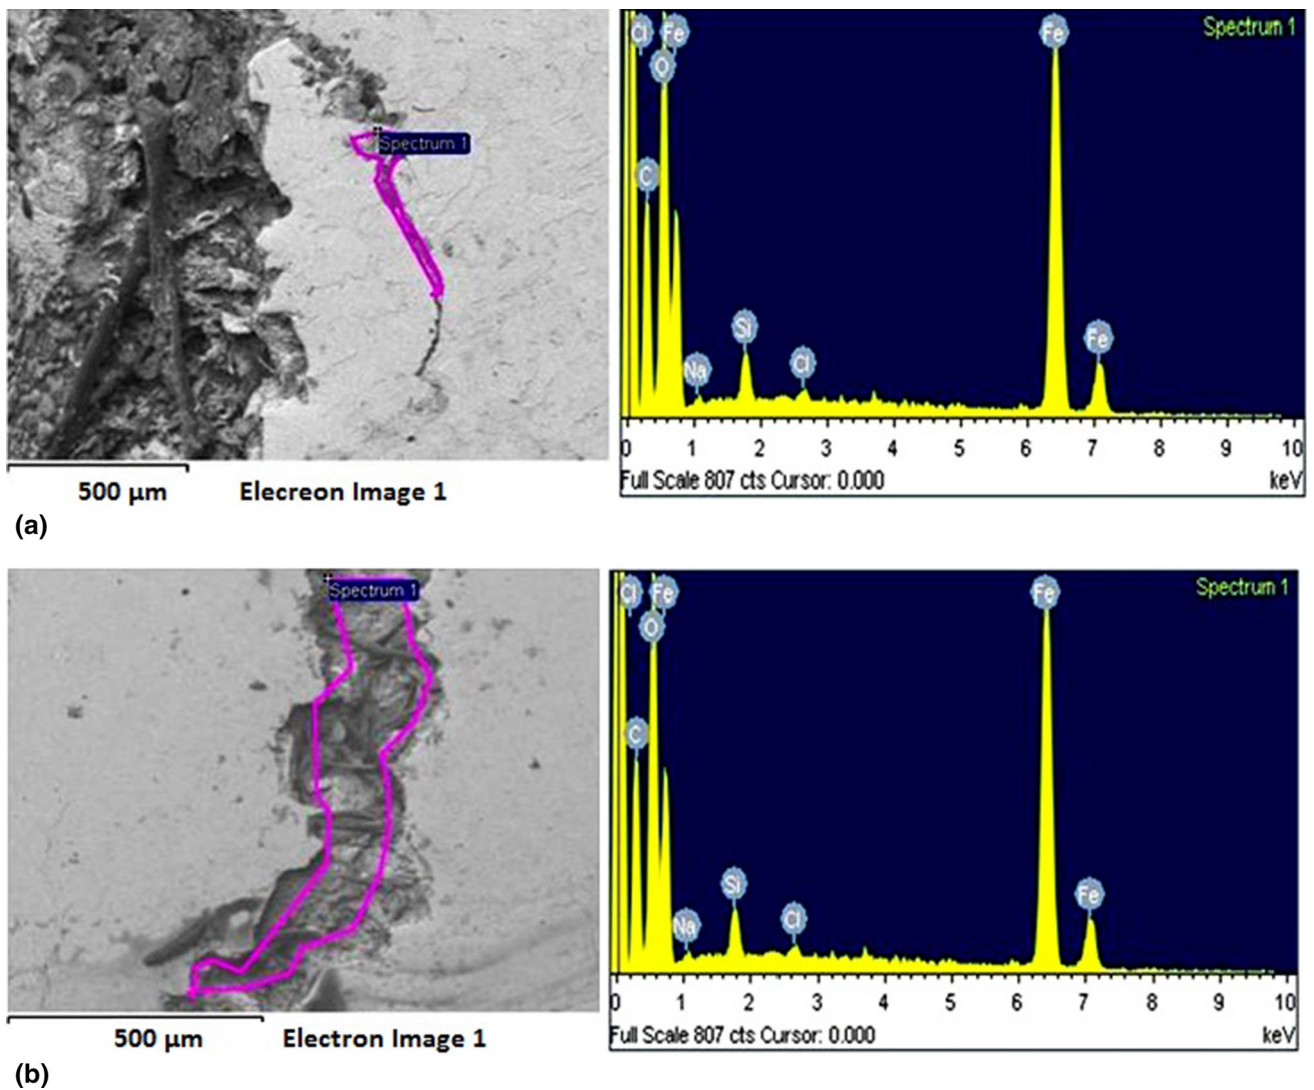
The specimens used for optical metallography were subjected to SEM-EDS to reveal the presence of any foreign substance in the crack vicinity. EDS spectra showed the presence of iron and oxygen (Fig. 5a) and carbon, sodium and chlorine (Fig. 5b). Peak of carbon indicates the presence of hydrocarbons as found in cutting oil. The peaks of Na and Cl were ignored as they might be due to water entrapment into crack during specimen preparation. Figure 6 shows the microstructures of the weld line, HAZ and base metal.

Fig. 5 SEM images with EDS spectrum, (a) EDS spectrum showing presence of iron oxides in the crack vicinity, (b) EDS spectrum showing presence of iron oxides and carbon in the crack vicinity

rolling and resulted in transverse micro-cracks at the coil edges. When such corner edge crack is deeper, it would not eliminate during hot rolling and form oxide fold after hot rolling. These micro-cracks got opened up due to cold deformation and heating of edges during HF-ERW process. The cutting oil used as a coolant during pre- and linear-forming sections got penetrated into the crack. The burning of cutting oil at fin-pass produced hydrocarbons which appeared as a fiber-like structure of carbon as seen in SEM-EDS (Fig. 5b).

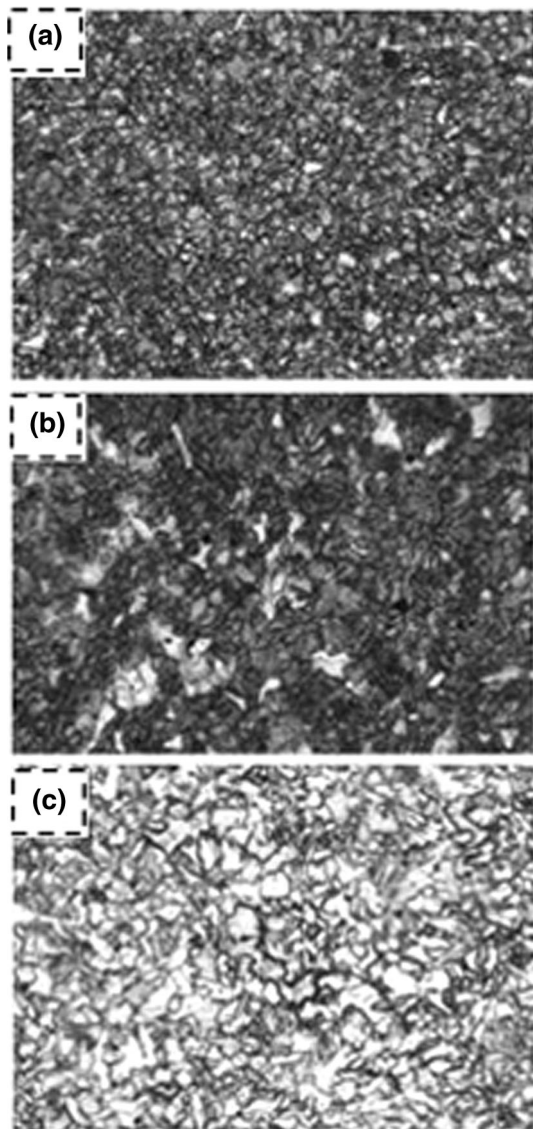
Fig. 6 Ferrite-pearlite microstructure of weld, HAZ and base material at $\times 200$, (a) weld, (b) HAZ, (c) base

No abnormality was observed during HF-ERW pipe manufacturing process. Microstructures of the weld line, HAZ and base metal were as expected based on the past experience. No hardness gradient was observed as the hardness of weld line, HAZ and base metal was in the range of HRB 82-83, HRB 83-84 and HRB 81-84, respectively. Therefore, only possibility which resulted in the transverse crack across the weld line was the presence of micro-cracks at the edges of hot rolled coils. These micro-cracks were revealed by ultrasonic testing near the weld line on pipes (Fig. 10).

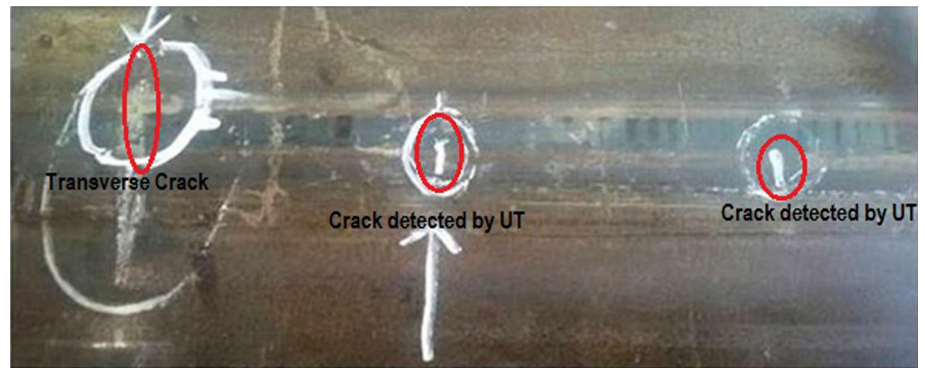
Fig. 10 Cracks detected near coil edge by ultrasonic testing

To prevent the formation of corners cracks at slab edge, prolonged soaking of a slab at higher temperature should

be avoided. In the case of breakdown or other reasons, such slabs should be identified and segregated separately. Before hot rolling of these slabs, a proper scarfing and inspection should be performed. The edges of coils should be inspected randomly by means of macro-etching to see the presence of micro-cracks.
