# Maintenance Error Detection Procedure and A Case Study of Failure Analysis Locomotive Diesel Engine Bearings

Submitted: 19 September 2017 / in revised form: 9 January 2018 / Published online: 15 February 2018  
© ASM International 2018

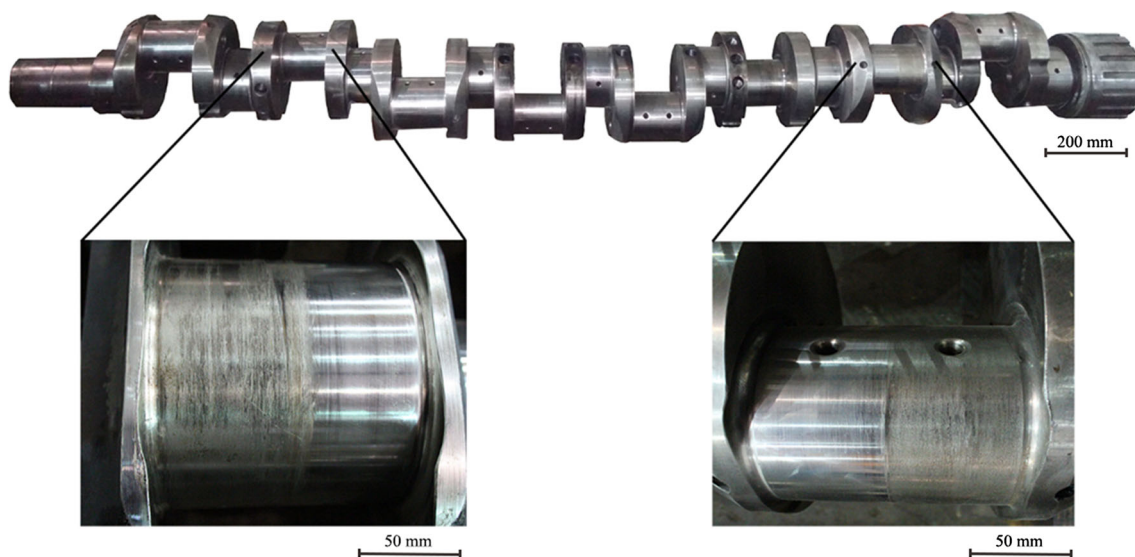
**Fig. 3** Crank shaft failure

Firstly, visual inspection was performed on the crank and the engine's bearing. Figure 3 shows failed engine crankshaft. Severe marks of abrasive and adhesive wear were observed.

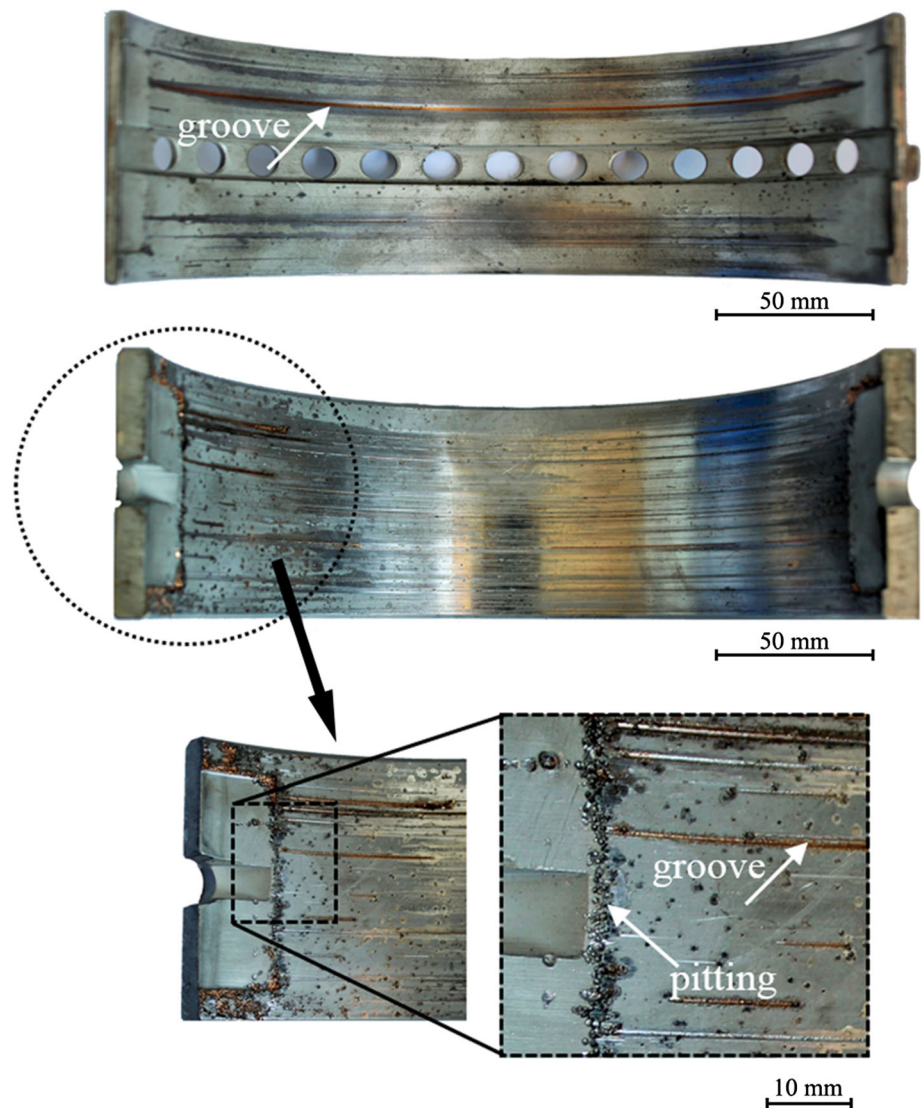
Figure 4 shows some of the engine's bearings taken from the failed engine. The image demonstrates multiple scratches along the bearing in the direction of the crank's motion. These scratches were fairly deep, and some of them were so deep that resemble deep grooves. In addition to these grooves, the image shows obvious pitting zones. The engine's oiling system contains many particles and contaminants. The pitting zones show the area with the

**Fig. 4** Macroimage of bearing failure

sign of erosive wear. Presumably, this erosive wear in the engine's bearing parts happened due to the problems originating from the high-pressure oiling system. Oil with particles and contaminants circulates in the engine at a pressure of approximately 5 bars. These pitting zones are concentrated around the oil inlet and outlet areas. The dimensions (width and depth) of the scratches and grooves vary. Although the difference could be appreciated even with a visual inspection, a more detailed analysis was done by using SEM. Usually, this type of wear regime occurs in the presence of harder particles that likely have caused the severe abrasive wear observed in the engine's bearing parts. In order to determine the origin of wear, SEM analysis and previous bearing failure cases were investigated to compare the engine's bearings visually [8].

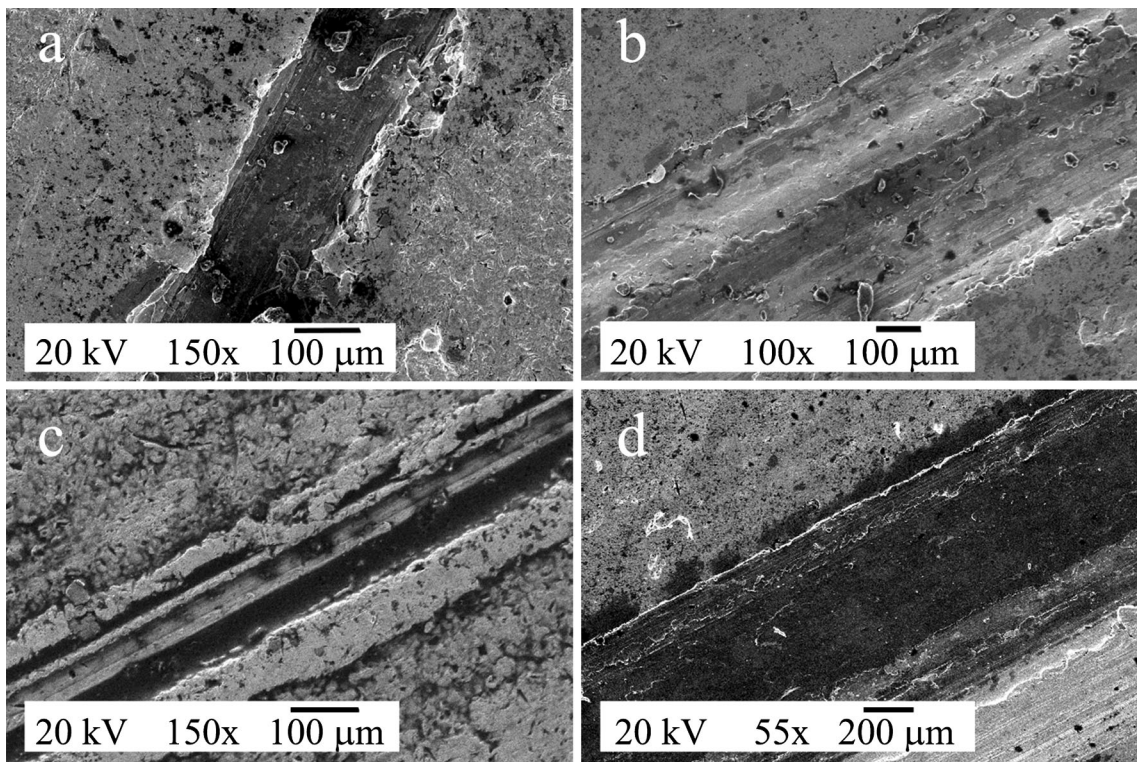
According to ISO 7146 [9, 10], abrasive wear is caused by contamination of the systems. This contamination might include damaged particles, natural contaminants (such as dust, soil, etc.), deteriorated chemicals and foreign materials. These contaminants flow with oil inside the hydrostatic oiling system and might cause severe scratches and grooves. These particles might also adhere to the bearing surface or deform it. Figure 5 shows the SEM microimages of the examined samples. These SEM images prove that there were many scratches with different sizes and depths: (a) width of scratches was about 200  $\mu\text{m}$ , (b) 500  $\mu\text{m}$ , (c) 150  $\mu\text{m}$  and (d) 800  $\mu\text{m}$ . The depicted morphology of the grooves shows that the bearing surface was chipped off by the abrasive particles. In some areas, the

**Fig. 5** SEM images of wear morphology

scratched material became smeared on the side of the grooves as illustrated in Fig. 5c and d.

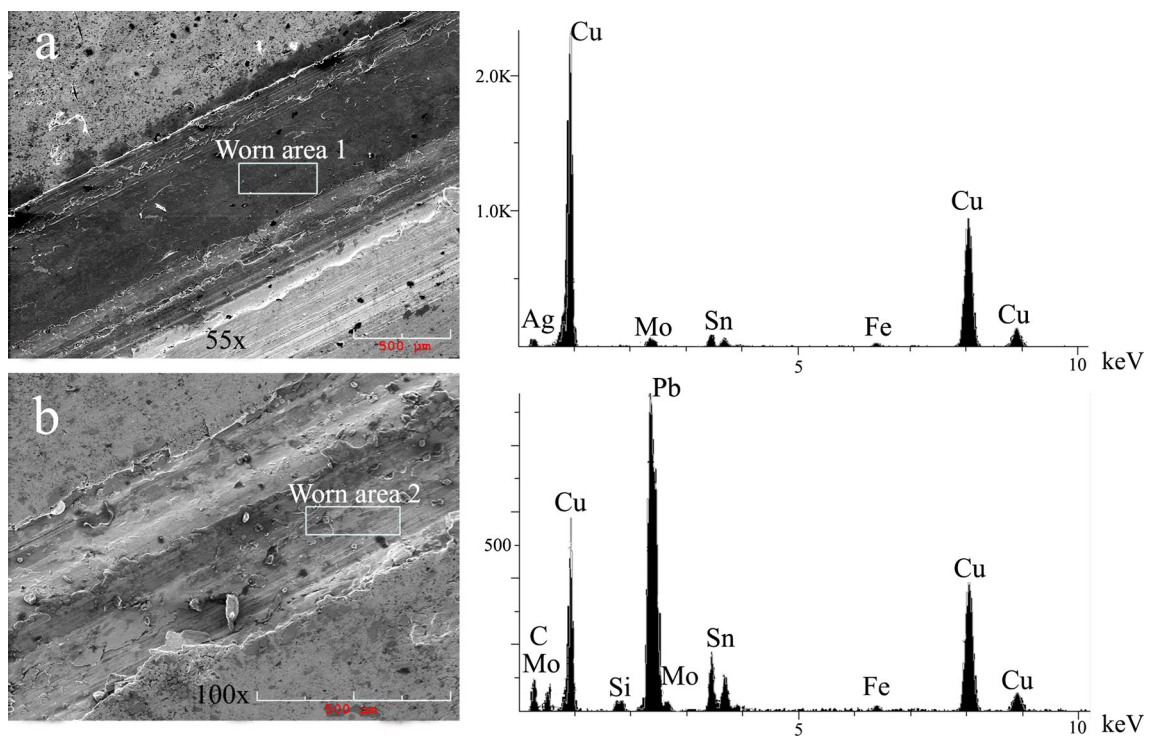
**Fig. 6** EDS analysis of wear sections

character and chemical composition of the grooves. Figure 6 provides the EDS samples. Figure 6a shows where (%75.8 Cu, %7.2 Sn, %6.5 Pb and others) elements are concentrated, while Fig. 6b shows where (%36.6 Pb, %29.2 Cu, %13.7 Sn, %8.5 Mo and others) elements are concentrated. The difference in the results of these samples showed that the depth and the level of the wear area were quite different from each other. Figure 7 demonstrates that the examined bearing alloy contains 3 stages. Same analysis procedure was applied to the section of bearing alloy. The EDX analysis of the bearing section provided with the

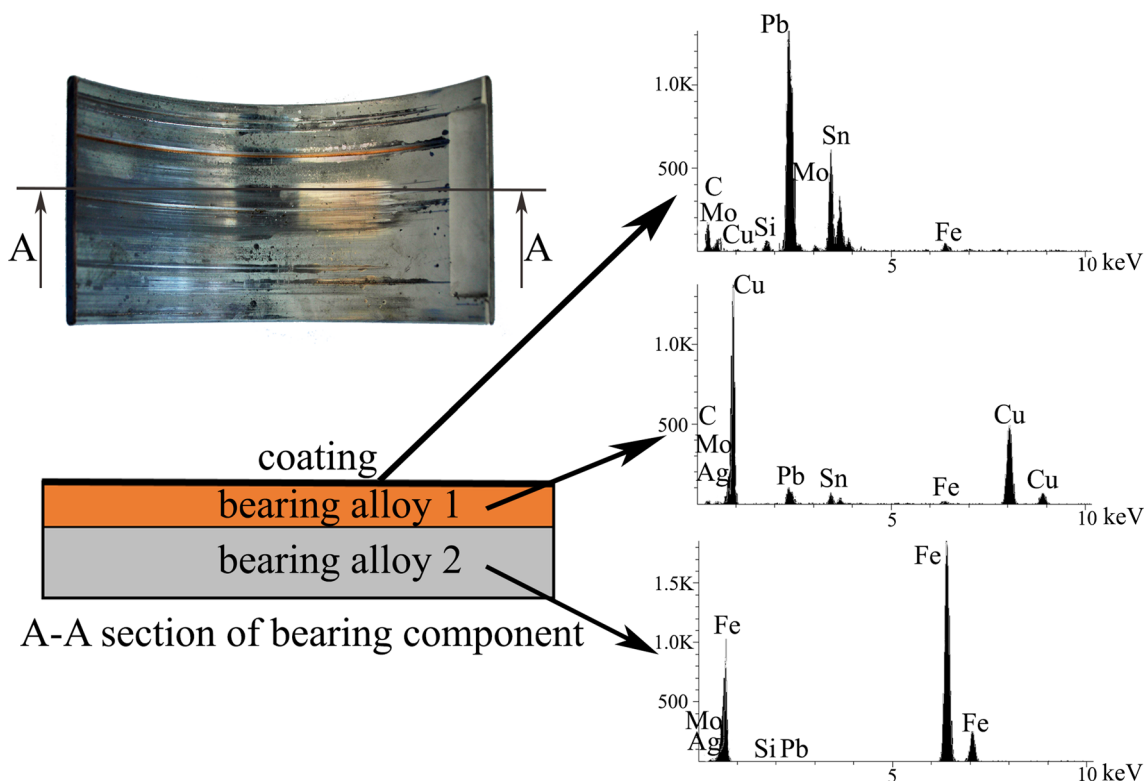
Fig. 7 EDS analysis of the cross section of the bearing component

reference results to compare with the worn areas. The EDX analysis of the bearing section is illustrated in Fig. 7. Bearing component was made from three chemically different layers, coating of the bearing alloy contains (%39.6 Sn, %37.4 Pb, %10 Mo and others) elements, the bearing alloy 1 contains (%68.5 Cu, %13.2 Pb, %8.7 Sn and others), and the bearing alloy 2 contains (%92.5 Fe, %3.4 Pb and others) elements. The EDX results in Fig. 6a are in agreement with the chemical composition of bearing alloy 1 in the EDS analysis. From this analysis and Fig. 6a, we might conclude that the wear happened because of the removal of the coating of the engine bearing. This type of wear was excessive for a regular case and can be classified as a severe abrasive wear. In Fig. 6b, the results of the EDS analysis chemically comply with those from the EDS analysis of coating of the bearing alloy and alloy 1. It was concluded that these marks can be classified as scratches or surface deformation because the particles tore the coating of the bearing locally and adhesive wear was also observed.

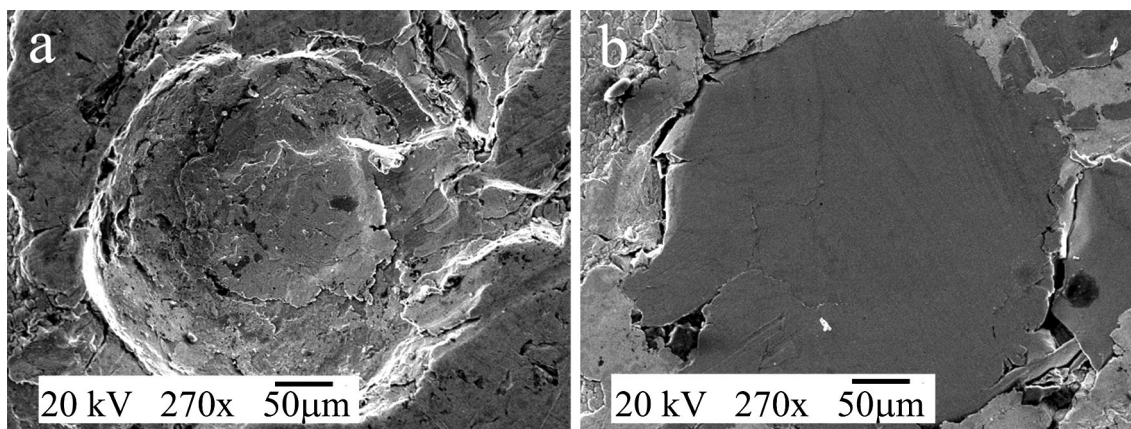
Fig. 8 SEM images of pitting morphology

The macroscopic examination of the bearing alloy also exhibits some pitting zones. After SEM examination of the pitting zones, crater like features became evident. Specifically, Fig. 8a shows a spherical cavity and Fig. 8b shows a similar kind of cavity filled with another material. These two cavities have similar dimensions and are probably formed by spherical particles. Most likely, one spherical particle was bouncing in Fig. 8a, while a similar type of particle became stuck in Fig. 8b. The results of the EDS analysis performed in the cavity areas (Fig. 8a) were similar with those performed for the bearing alloy coating (%59.8 Mo, %15.6 Sn, %4.9 Fe, %3.2 Cu and others). However, the results presented in Fig. 8b are different from those obtained for the bearing alloy coating or bearing alloy materials (%95.7 Fe, %0.9 Si and others). Thus, it was concluded that based on the EDS results the particles must be external.

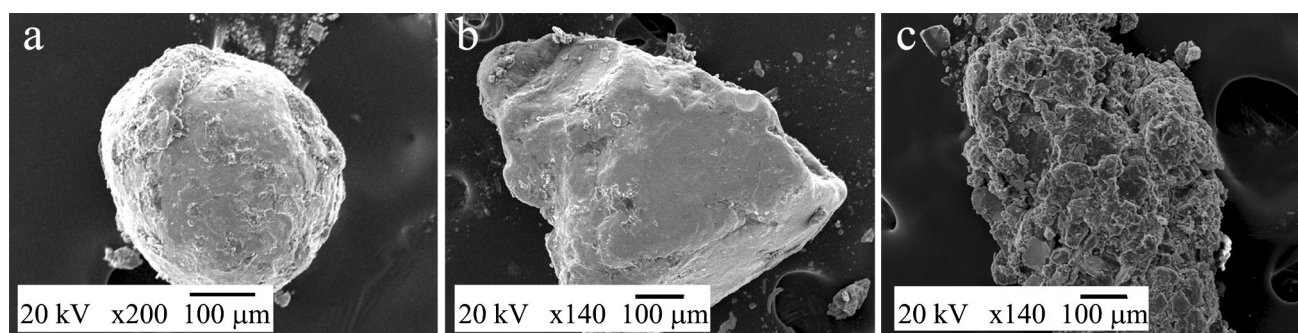
**Fig. 9** SEM images of particles

brought to the electron microscope for examination. Figure 9 shows the SEM image of particles that were taken from the oil filter. These particles were some of the contaminants found in the lubrication system. Probably, these contaminants caused pitting and scratches. To test this theory of failure, morphology and chemical content of these particles were examined. Figure 9a shows regular spherical particles. This particle was chemically different (%89.3 Fe, %2.1 Si, %3.3 Pb and others) from the bearing alloy and coating. Chemical composition of this particle was quite similar to that in Fig. 8b. When the dimensions of the spherical particle were examined, they were in agreement with previously examined particle dimensions, grooves dimensions and pitting zone dimensions. From this, a theory was established that these particles were accelerated by the oil pump and became stuck in the bearing material. Thus, these hard particles started and propagated the observed abrasive wear. At this point, the identification of the source of these particles was necessary to determine the source of the problem. The origin of this ferrous particles could be in service or fabricated. Their regular spherical shape points to its manufacturing method. The measured dimensions for regular spherical particles vary from 300 to 1000  $\mu\text{m}$ . According to shot peening standard that was used for cleaning purposes of locomotive engines (SAES390), nominal size of particles is 1000  $\mu\text{m}$  and %96 of the particles size must be over 850  $\mu\text{m}$  [9]. Figure 9b shows a different particle though. Not only does this particle not have a regular shape but their EDS results (%84.6 Fe, %2.4 Pb, %1.3 Si and others) also are different from other examined materials. We assume that this particle was ejected from one of the engine parts with the effect of plastic deformation. This particle can be classified as a regular worn particle. Meanwhile, Fig. 9c shows an agglomerated particle that was formed by tiny wear particles and oil additives. EDS analysis of this particle was (%44 C, %21.9 O, %19.6 Fe, %4.2 Pb, %3.8 Si and others). This particle can be classified as a regular contaminant of oil.

Although the origin of the particles could be natural (sand, soil rocks, etc.), the SEM tests show that these particles are ferrous and have a spherical shape. This findings support the idea that the particles were manufactured by powder metallurgy. Additionally, these type of particles cannot be worn particles that split from the engine block or the engine cylinders because, usually, such worn particles are oddly shaped as seen in Fig. 9b. After established theory, the engine company investigated the origin of the particles. They concluded that the particles were shot peen particles which were used by one of the suppliers for cleaning purposes. Used shot peen particles were not sifted and had variable sizes. While larger particles were cleaned from the system by a regular cleaning procedure, smaller particles could not be cleaned efficiently and acted as abrasive particles causing the engine's wear. The high-pressure oil pump further aided the wear process by accelerating these particles. The oil filter could not hold these particles, and this is why it was pierced in many places by the effect of shot peen contaminants. As a result, these particles abraded and deformed the engine's block and the wear speed increased dramatically and bearing seizure occurred.

1. Ultrasonic cleaning of the engine parts after maintenance eliminates possible residual shot peen particles.

2. If shot peen method is required for cleaning, shot peen particles must be sifted before using them for cleaning purposes and a standard chosen [11] to clean with the traditional methods.
