Failure Analysis of High-Pressure Compressor Blade in an Aero Gas Turbine Engine

R. K. Mishra · Vaishakhi Nandi · R. Raghavendra Bhat

Submitted: 13 January 2018 / Published online: 13 February 2018
© ASM International 2018

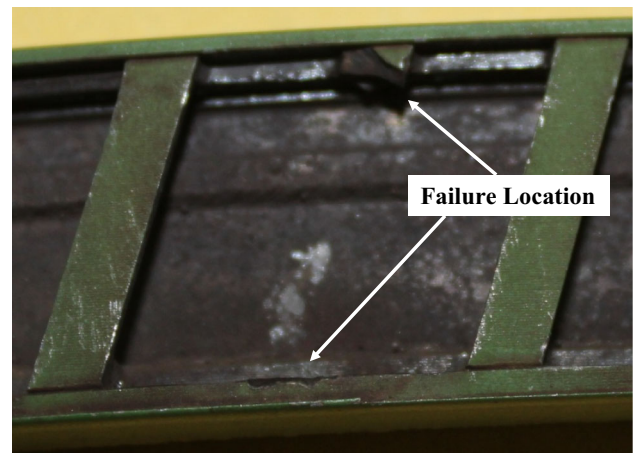
Fig. 2 Dislodgement of platform ladder in the HP compressor last stage

Engine tear-down examination could reveal the extent of damage in different modules of the engine. Heavy damages were seen on last two stages of HP compressor assembly. The platform ladders between the rotors have been dislodged from their positions and are missing as shown in Fig. 2. One of the blades in the last-stage rotor is found sheared off as seen in Fig. 3, and extensive damages are seen in other blades. The remnants of the blade and platform ladders could not be traced. In the HP turbine module, scratches and nick marks are found in many vanes and rotor blades. Few turbine blades have suffered metal chip-off on aerofoil section; one such blade is shown in Fig. 4.

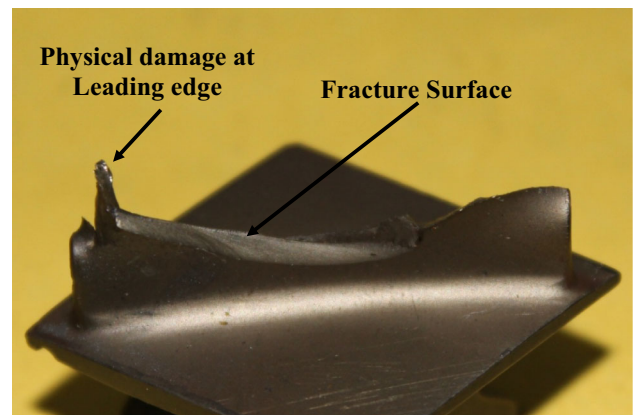
Fig. 3 Sheered-off blade in the HP compressor

Photograph showing the fracture surface of the compressor blade is indicated in Fig. 3. Macro-examination under stereomicroscope showed the presence of beach marks that indicates toward failure of the blade due to fatigue. The orientation of the beach marks indicates that the fatigue had probably originated from the damage at the leading edge of the blade. To examine the mode and initiation of failure, the fracture surface was examined under scanning electron microscope (SEM).

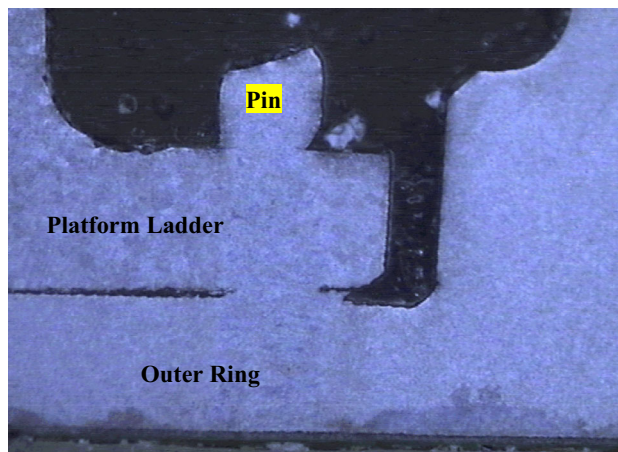
Fig. 6 Photomicrographs showing different view of the weldment between compressor ladder, outer ring and a sharp pin structure

Macro-/micro-examination of the ladders showed the presence of weldment at the location where the ladders were in contact with the outer ring. The weldment is apparent and is indicated in the photomicrographs in Figs. 5 and 6 that were captured using stereomicroscope. It appears that there is some sharp pin structure insertion through the outer ring and the ladder and the structure are fused resulting into the weldment observed in this area.

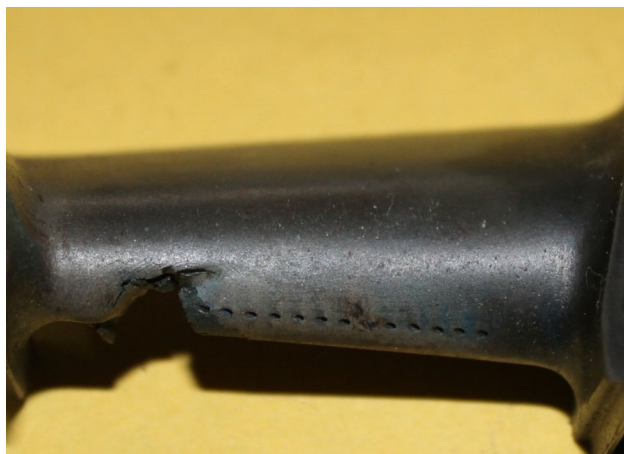
Fig. 4 Metal chip-off in HP turbine rotor blade

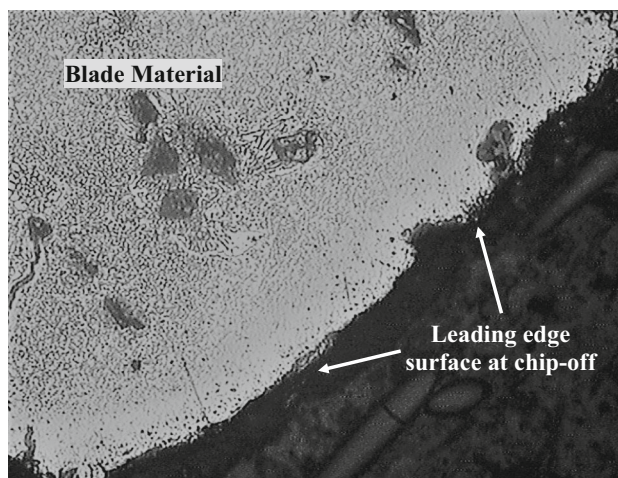
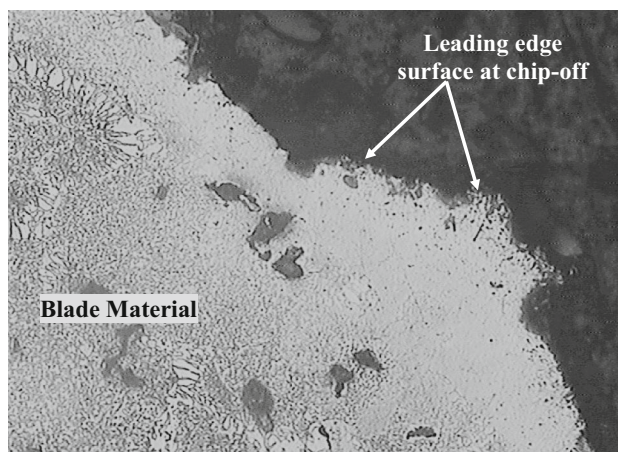
Fig. 7 Photomicrographs captured at the location showing chip-off of blade material at the leading edge of the HP turbine blade, with ×200 magnification

The HP turbine blade which has suffered metal chip-off was subjected to microscopic examination, viz., overheat check. Only at the location where chipping-off of the material was noticed at the leading edge of the blade, dissolution of gamma prime/dash precipitates was observed as shown in Figs. 7 and 8. At other locations, i.e., away from the chipping-off area; the leading and trailing edges, surfaces of the cooling channels and the interior of the blade did not reveal any significant dissolution of gamma prime/dash precipitates as evident from Fig. 9. Evidence of overheating and microstructure in these locations is acceptable as per the guidelines.

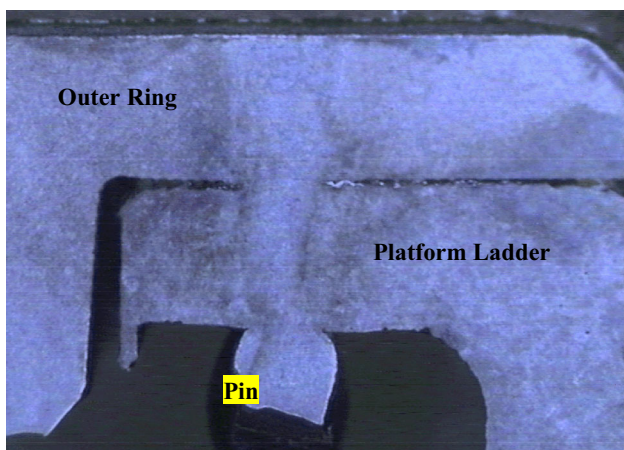
Fig. 5 Photomicrographs showing weldment between compressor ladder, outer ring and a sharp pin structure

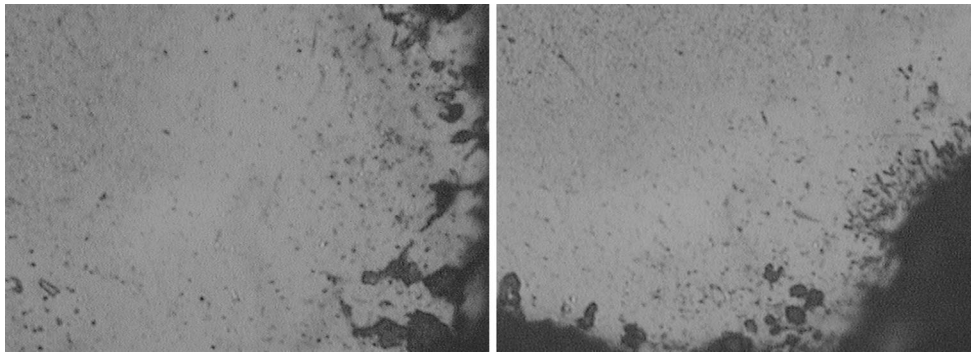
Fig. 8 Photomicrographs captured at the location showing chip-off of blade material at the leading edge of the HP turbine blade, with $\times 1000$ magnification

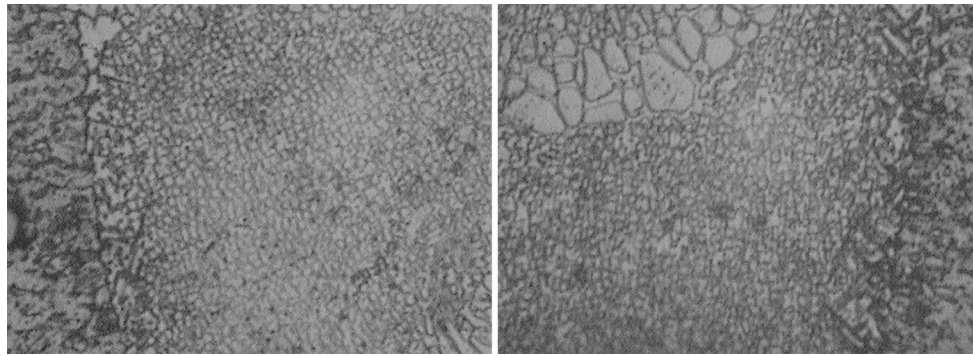
Fig. 9 Photomicrographs captured at locations away from the area showing chip-off of blade material at the leading edge of the HP turbine blade

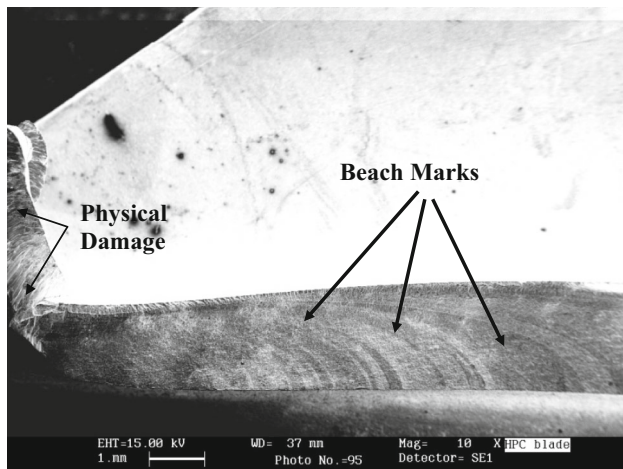
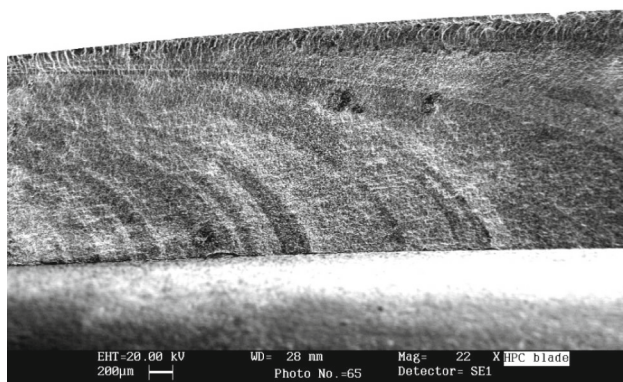
Fig. 10 Low-magnification SEM images of the fracture surface of the compressor blade

Low-magnification SEM images of the fracture surface of the compressor blade are given in Fig. 10. Beach marks indicating fatigue failure was observed on the fracture are evident in Fig. 10. High SEM analysis showed in Fig. 11 indicates that the fracture surface was covered with thick

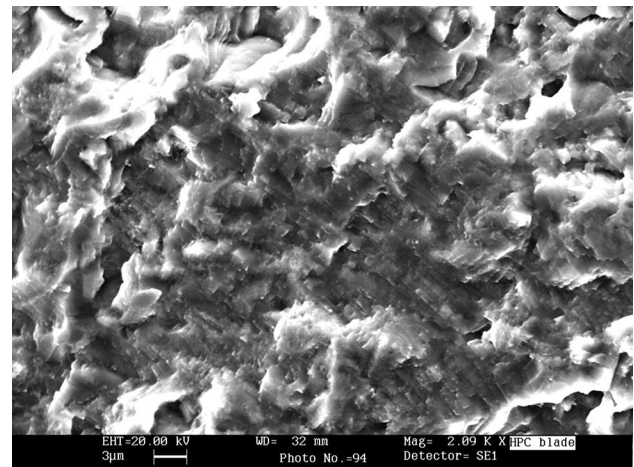
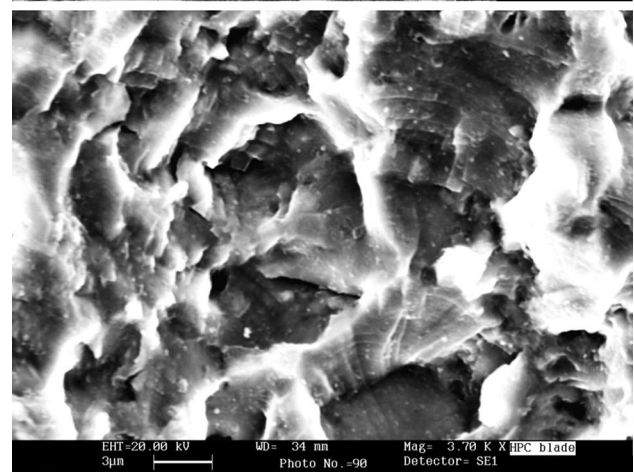
Fig. 11 High-magnification SEM images showing fatigue striations on the fracture surface of compressor blade

oxide products that were obscuring majority of the fracture features underneath. However, careful examination showed striations, typical of fatigue failure, on the fracture surface of the blade [18, 19]. From the orientation of the beach marks and fatigue striations, it was apparent that fatigue

had originated from the leading edge of the blade. Physical damage was noticed at the leading edge of the blade at the location corresponding to the failure origin.
