Failure Analysis of Insulator Iron Cap in Low Stress State

Keywords Insulator iron cap · HVDC · Failure · QT450 · Defect

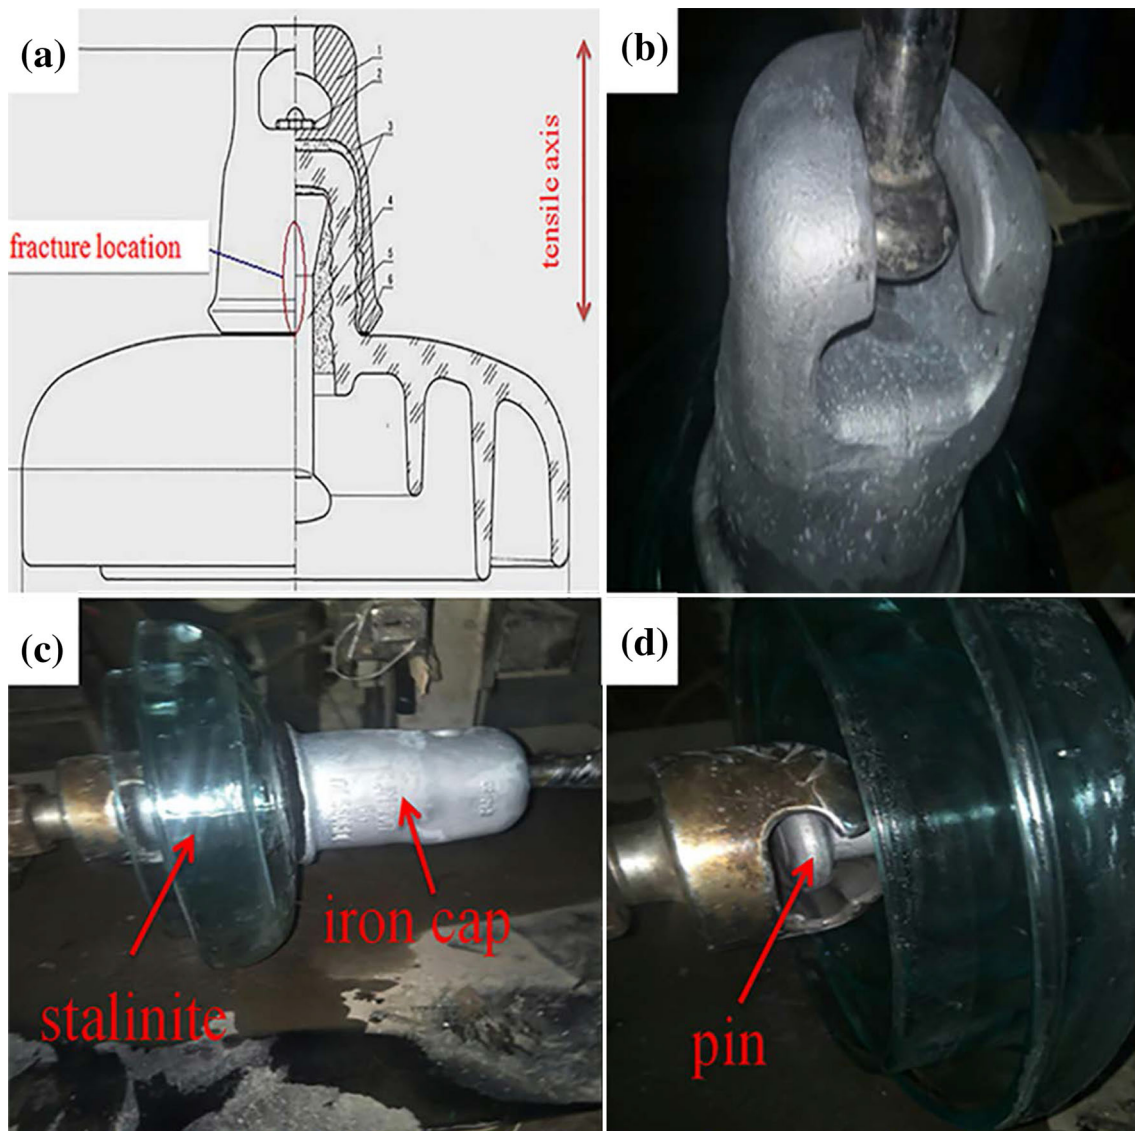
Fig. 1 Schematic diagram and actual photographs of the insulator cap testing: (a) sketch of insulator cap; (b), (c), (d) pictures of real product in loading test

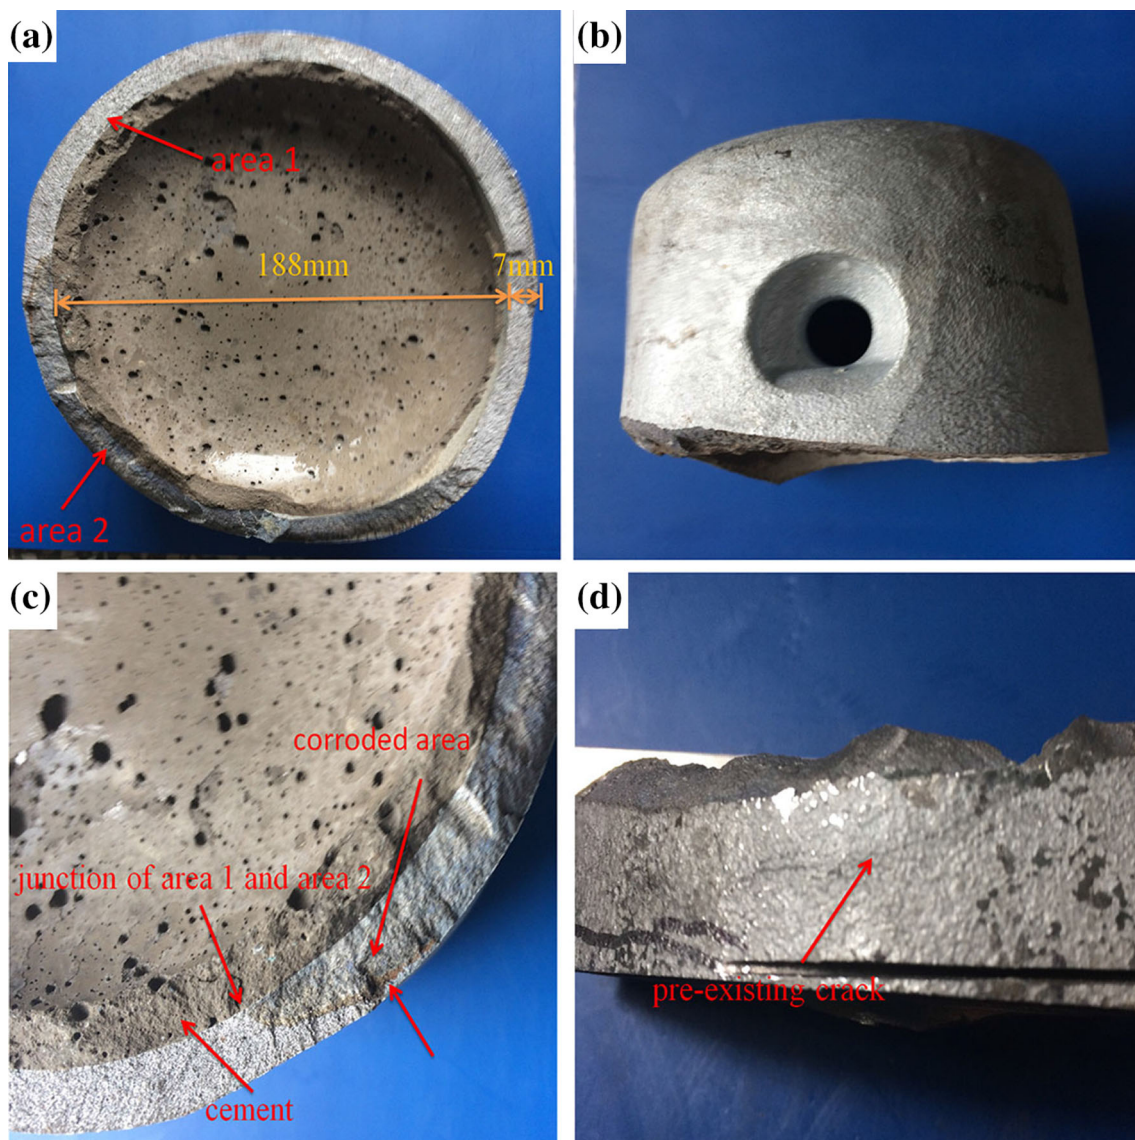
The macroscopic fractographs are shown in Fig. 2. It is indicated in Fig. 2a and b that the axis of the insulator cap is nearly parallel to the direction of tensile loading, and perpendicular to the fracture plane, suggesting this component failed due to tensile stress. In addition, the fracture position is located in the arc transition area, which is 75–80 mm from the top of the insulator cap. In Fig. 2c, two types of fracture areas were observed. One was a shining and smooth area, marked as Area 1, whose small crystalline particles are clearly visible. The other one was the jagged area, marked as Area 2. In addition, in Area 2, not

only are there gray regions, but also partly blue and yellow regions. It is more notable from Fig. 2c that the rust line is exactly located at the junction of two kinds of areas, as well as the crack source at the tip of junction. Such rust was not found in the Area 1, suggesting the rust had possibly existed before loading test. Figure 2d shows a fragment from Area 2 after loading test, and there is a long crack in it. The tensile stress of the QT450 was calculated as follows, according to the material design criterion (assuming the stress of material is uniform everywhere).

Fig. 2 Macrographs of fracture location: (a) complete fracture plane, (b) section of fracture plane, (c) the junction of Area 1 and Area 2, (d) a fragment from Area 2 after loading test

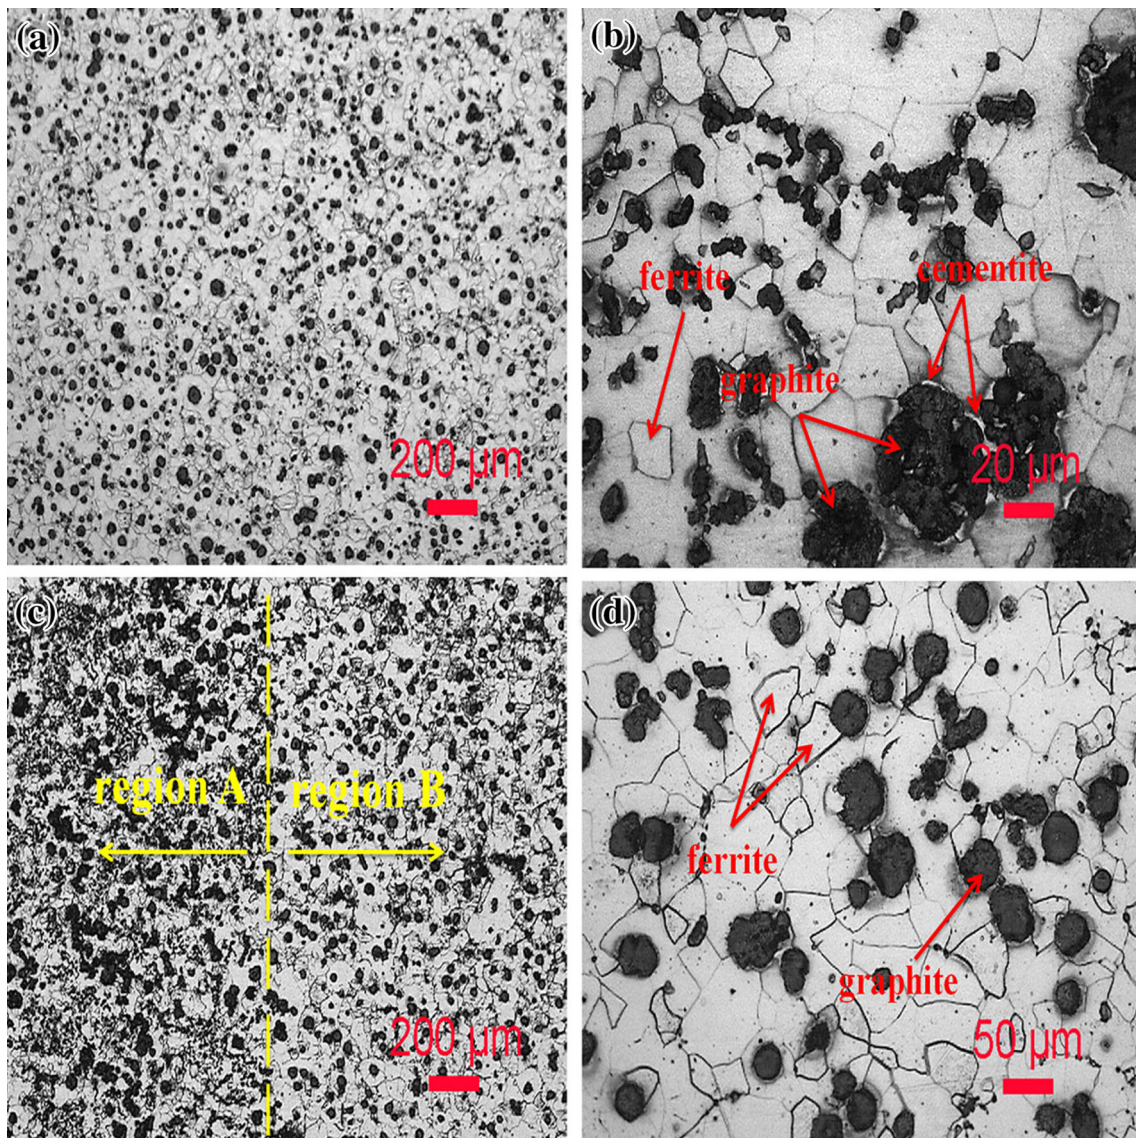
Fig. 3 Photomicrographs from the optical microscope, (a) and (d) transverse cross section; (c) and (d) longitudinal cross section

Figure 3 shows the transverse and longitudinal micrographs obtained by optical microscope. The transverse plane is perpendicular to tensile axis, while the longitudinal

plane is parallel to it. The microstructure of this fracture was mainly composed of ferrite, graphite, as well as bulk cementite distributed around the graphite. It is clear from Fig. 3c that an interface divided image into region A and B. And, the graphite was reunited in region A, in which the size and distribution of graphite were uneven. The size and

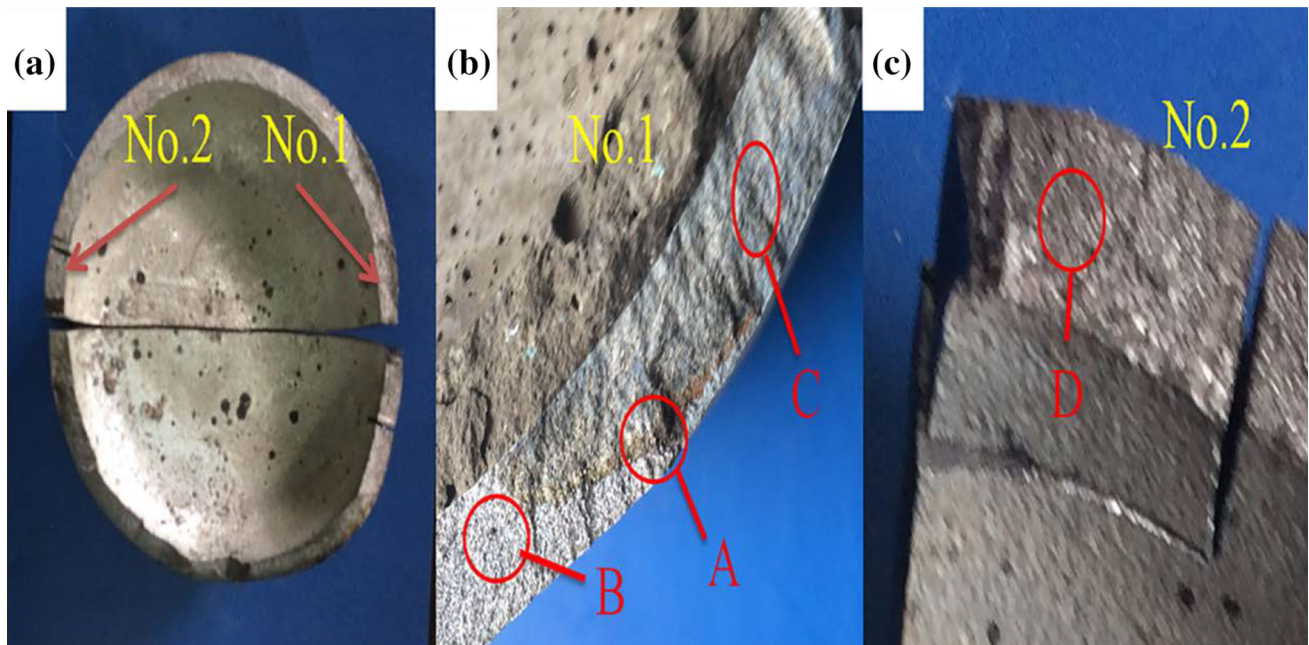
Fig. 4 The selected positions of SEM samples: (a) position of No. 1 and No. 2 samples on the fracture surface; (b) Areas A, B and C selected in No. 1 sample; (c) Area D selected in No. 2 sample

Figure 4 shows the SEM images of fracture surface of selected samples (No. 1 and No. 2). The Sample No. 1 included Rusted Area A, smooth fracture in Area B and Non-Rusted Area C. In addition, Areas A and C were located in the jagged fracture. Area B was normal plastic fracture because of dimples found in the Fig. 5. In case of Area A (see Fig. 6), the cleavage fracture feature was

to deeply penetrate into the body, leading to the rust line formation (see Fig. 4b).

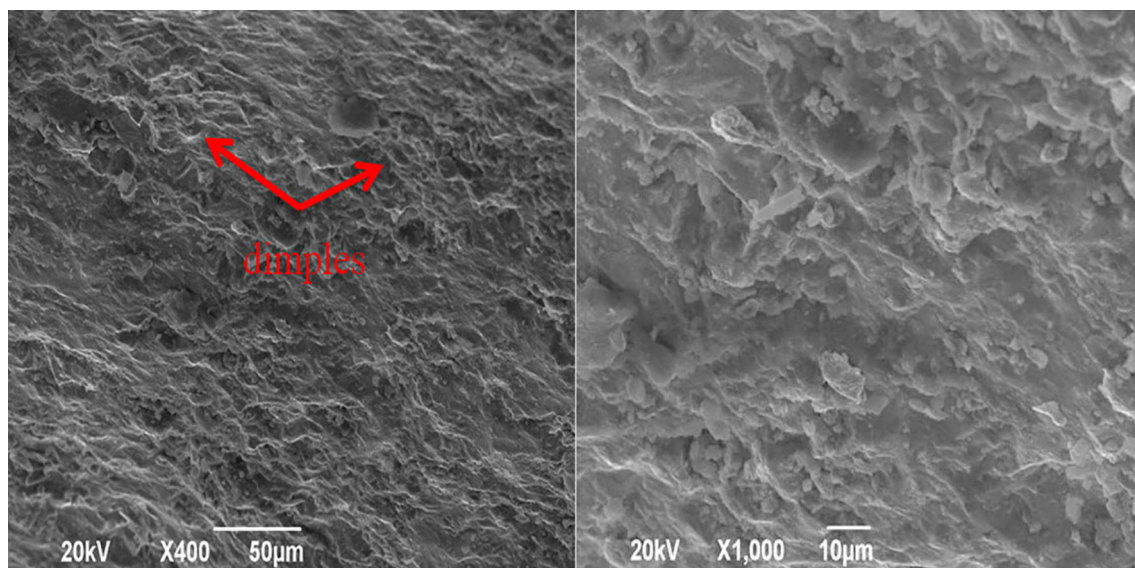
Fig. 5 SEM photomicrograph of No. 1 sample in Area B

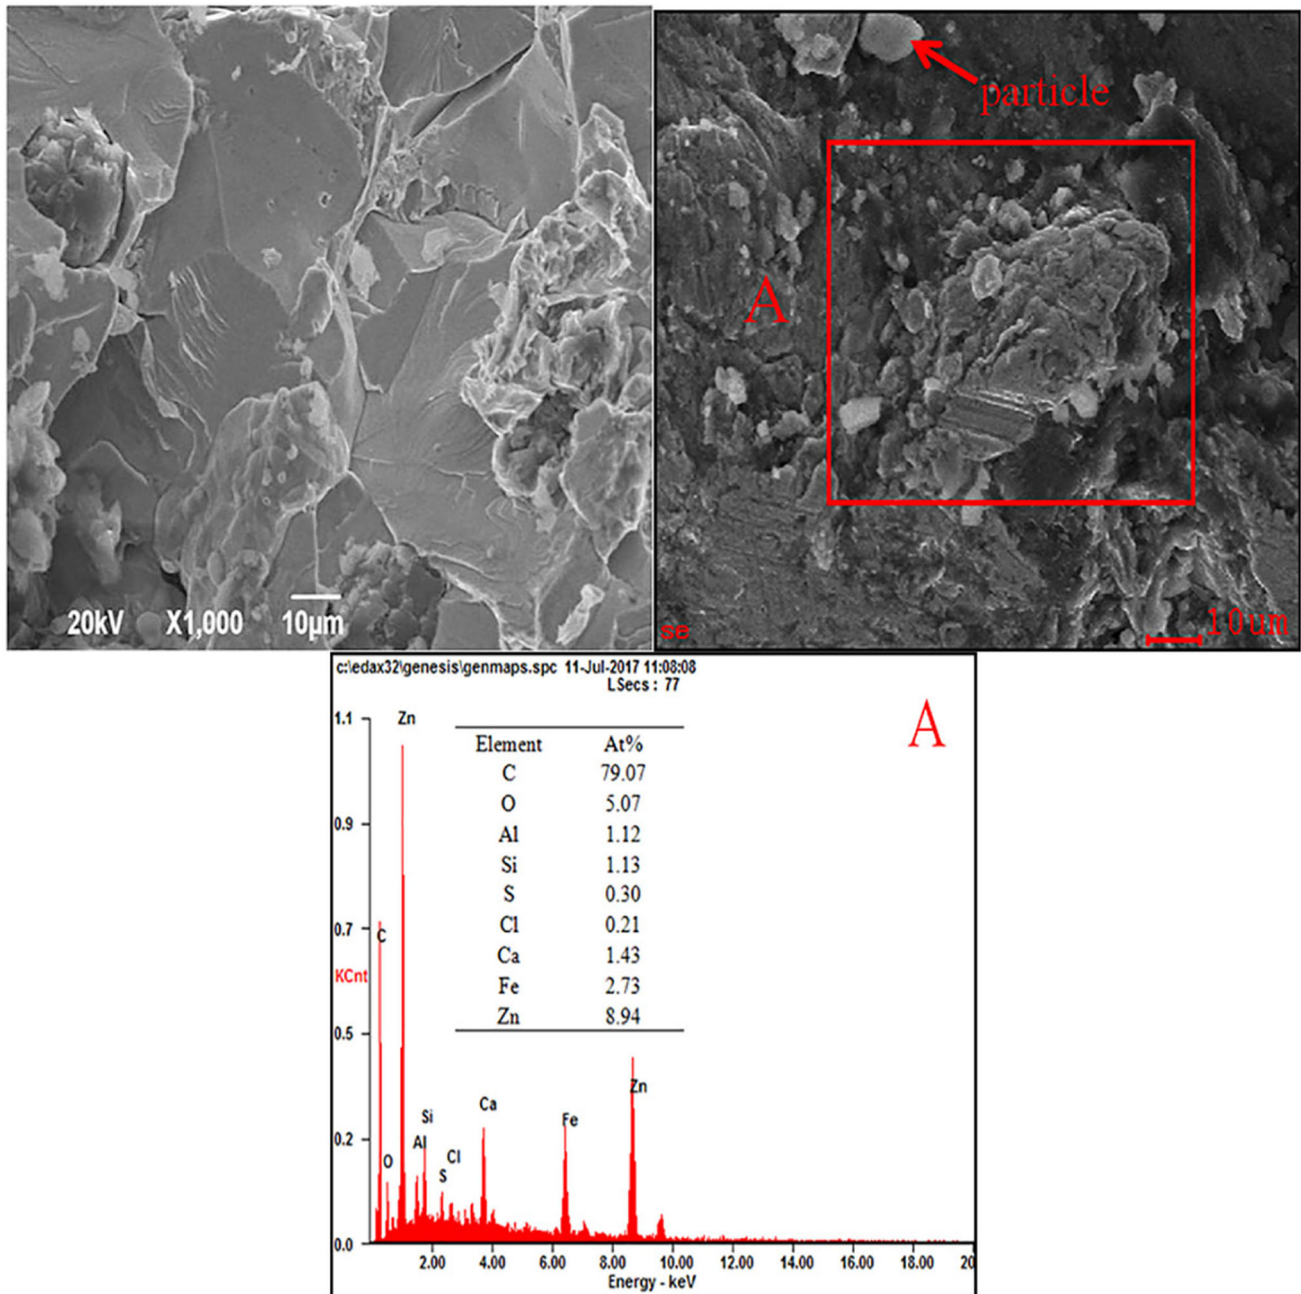
observed, suggesting a brittle fracture occurred in Area A. In addition, some granular particles were found. The EDS result of these particles in Fig. 6 showed that the content of carbon was 79.07 at.%, and much higher than that in ferrite (2.73 at.%). In addition, the elements, such as oxygen, aluminum, chlorine, calcium and zinc, were not the compositions of QT450. Instead, these elements were from the cement, hydrochloric acid, and galvanization. Among them, the discovery of chlorine element showed that a corrosion ever occurred in Area A, resulting in expanding

Fig. 6 SEM photomicrographs and EDS spectra of No. 1 sample in Area A

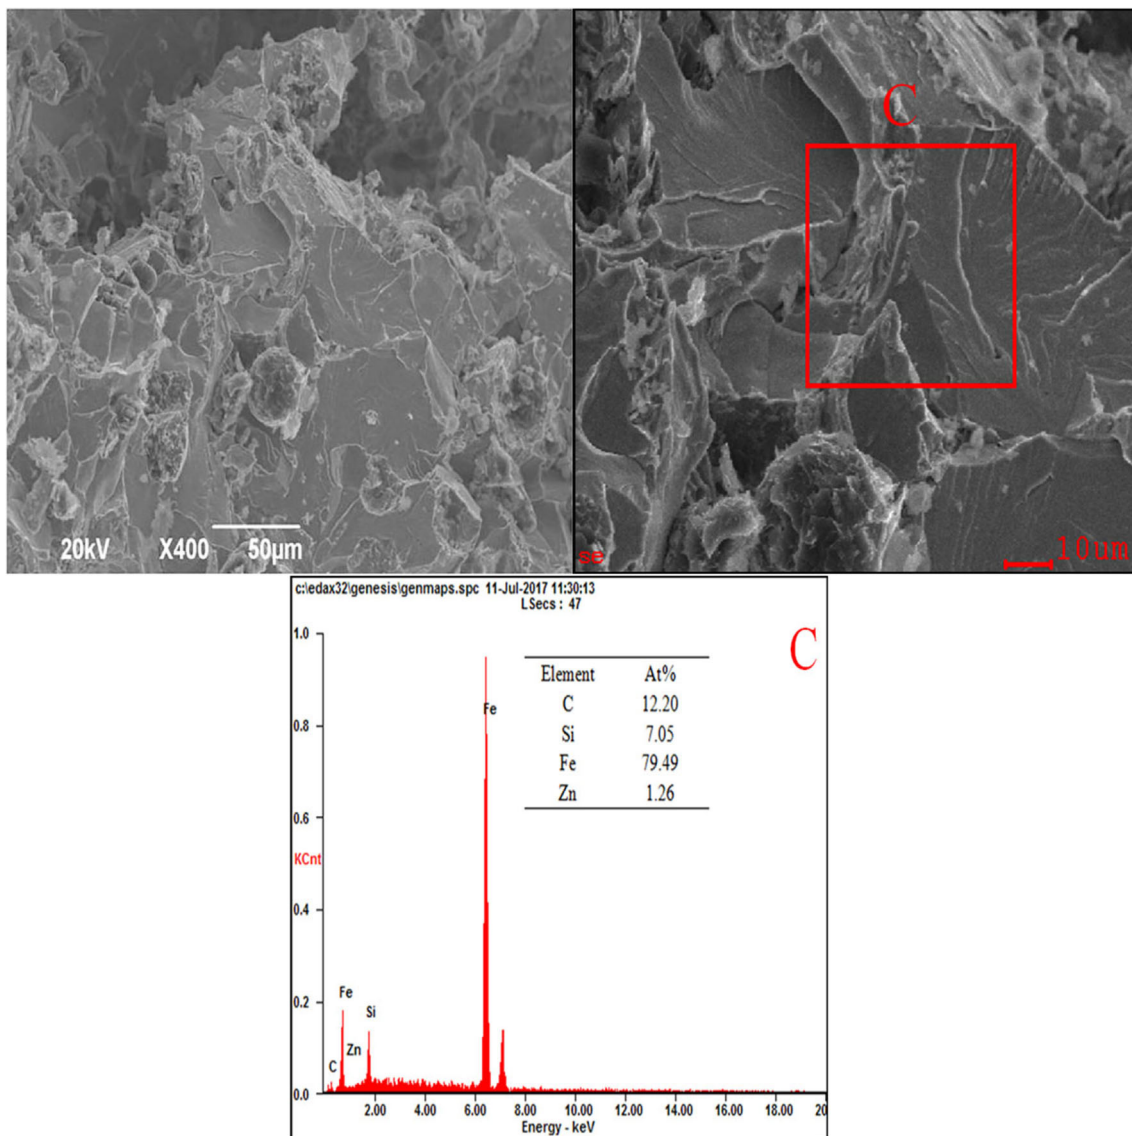
Fig. 7 SEM photomicrographs and EDS spectra of No. 1 sample in Area C

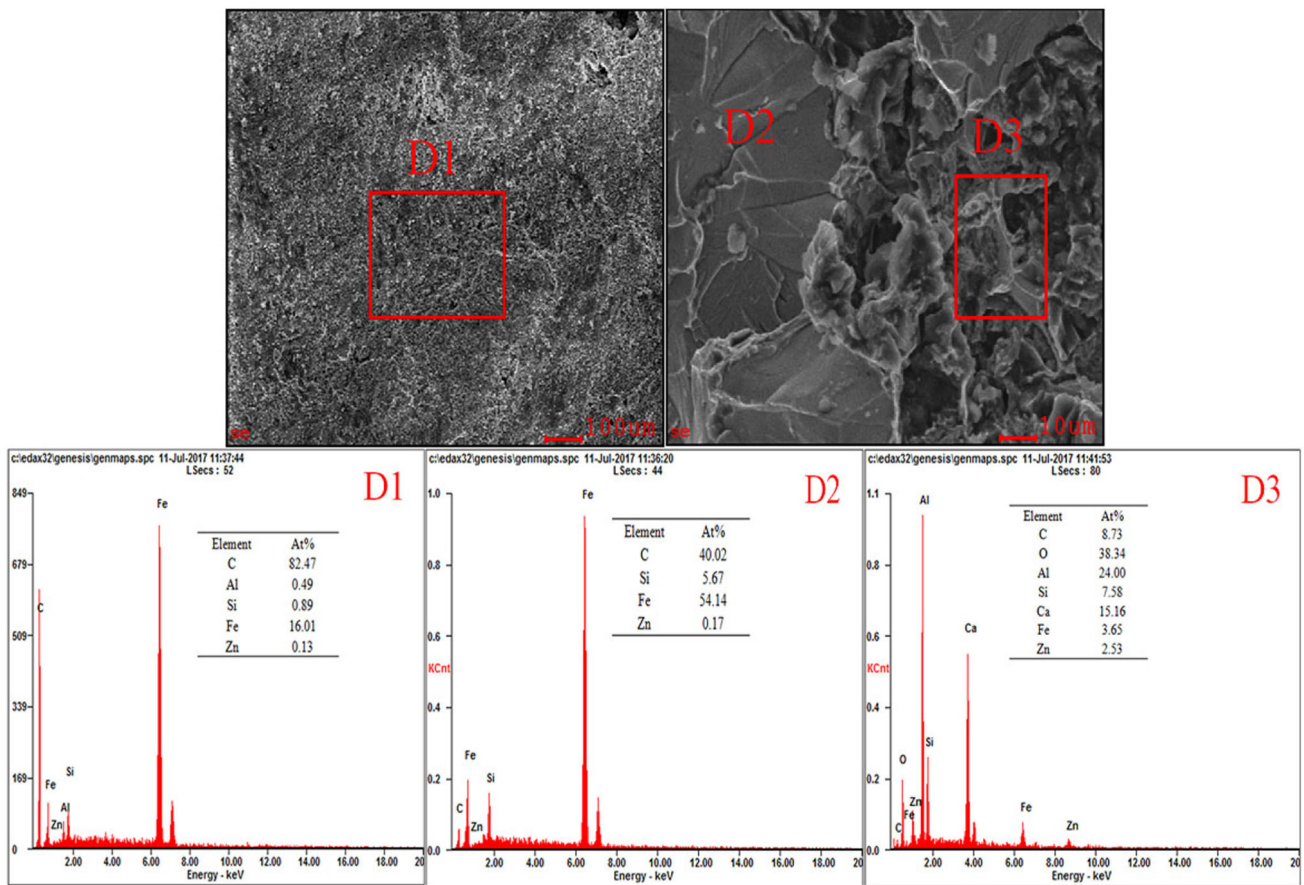
the size of the defects. Then, a large amount of zinc had already penetrated into it, before tensile loading test. In Fig. 7, the cleavage fracture feature contained a small amount of zinc was found. In Fig. 8, Area D included a graphite enrichment region, brittle fracture, as well as cement regions, marked as regions D1, D2 and D3, respectively. It was obvious in Fig. 8 that the content of carbon in D1 exceeded that in ferrite. In region D2, the cleavage brittle feature was observed too, and a small quantity of zinc was examined. The cement was located in region D3. In addition to the basic elements consisting of cement, the content of zinc increased obviously comparing with region D2. And, region D3 was originally a corrosion pit, but the non-solidified cement filled it in after pouring.

Then, non-solidified cement mixed with zinc on the insulator iron cap surface, resulting in the content of zinc increase.

Fig. 8 SEM photomicrographs and EDS spectra of No. 2 sample in Area D: (D1) graphite-rich Area; (D2) QT450 substrate; (D3) cement connecting with insulator iron cap
