Root Cause Failure Analysis of Pinch Roll Bearing at Hot Strip Mill

Kaushal Kishore · Goutam Mukhopadhyay

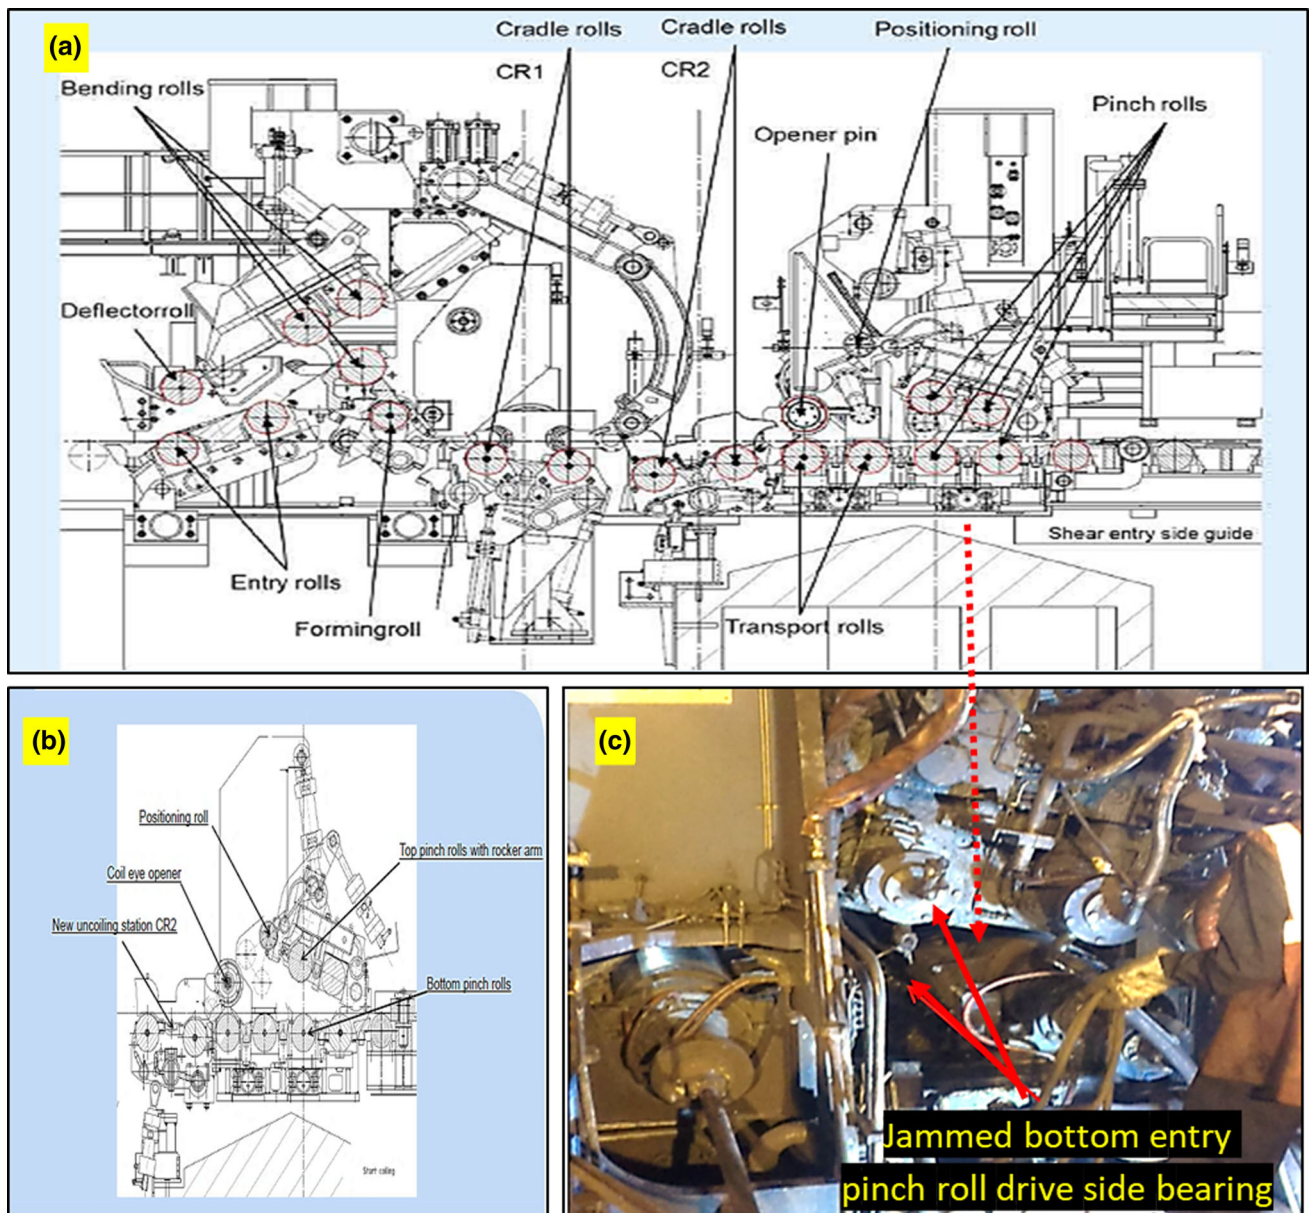
Figure 2a shows the schematic of the overall arrangement of rolls in hot strip mill. There are a number of rolls with specific functions. There are bend rolls, deflector rolls and entry rolls, and all of these fundamentally allow the workpiece to enter the forming roll in the desired alignment where reduction in thickness takes place. There are two sets of cradle rolls used for coiling of the steel sheets. Uncoiling takes place with the help of pinch rolls. There are top pinch rolls and bottom pinch rolls, and they work in conjunction to maintain the continuity of the hot rolling process as shown in Fig. 2b. These are driven by a motor-connected bearing assembly. Failure occurred in the bottom entry pinch roll in its drive side as shown in Fig. 2c.

The bearing was found to be jammed and broken into multiple pieces. It failed after 5 months of service as against an expected life of at least 1 year. This reduction in service to less than half of its expected life is the motivation behind an in-depth failure analysis to understand its root cause and take corrective actions to prevent such failures in the future.

Fig. 2 Location of failure: (a) schematic showing arrangement of rolls in hot strip mill, (b) schematic of pinch rolls, (c) on-site image of location of failure

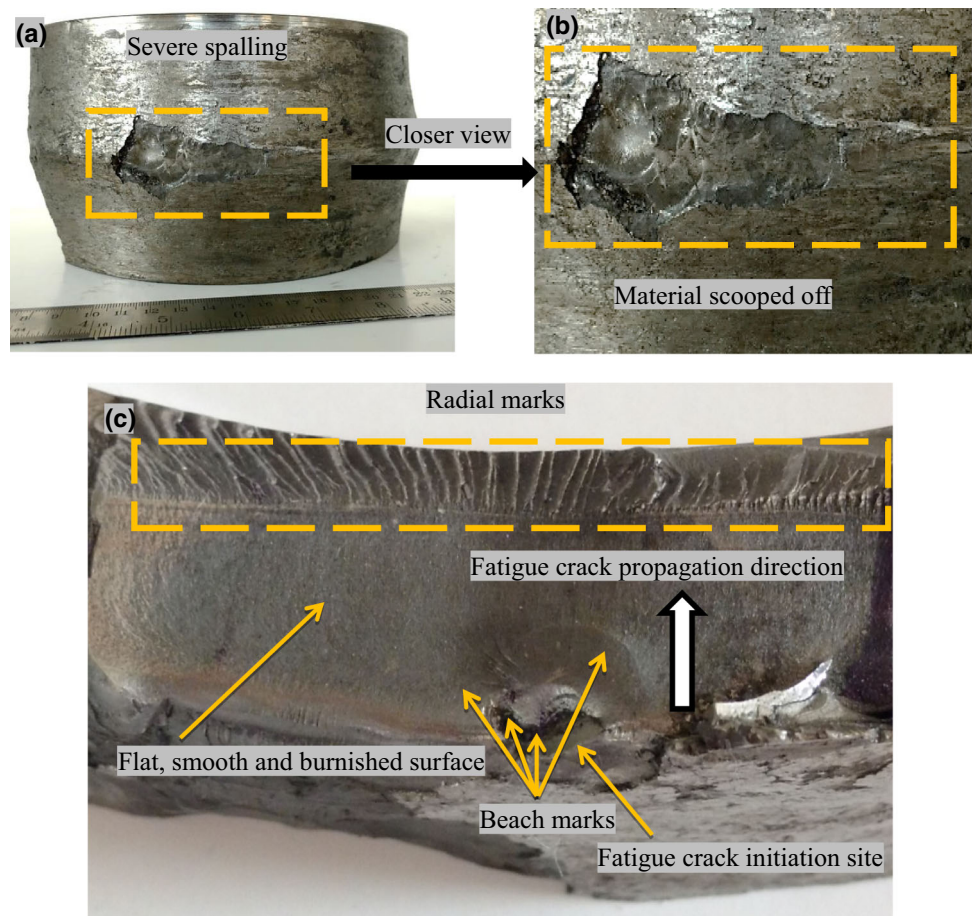
Since the pinch roll bearing failed and was found to be broken into multiple pieces, only those portions/pieces revealing key information regarding failure are presented in this manuscript. Figure 4 shows key aspects of failed inner ring. Figure 4a shows the outer surface of inner race which is in direct contact with the rotating rollers. It has a split mark at the center where the separator is placed and keeps two sets of rollers apart. Uniform rubbing marks were observed along the entire length of the inner race. Severe spalling was observed, and a closer view is shown in Fig. 4b. Spalling is the progressive scooping off of the material and is generally associated with rolling contact fatigue in bearings. It should be noted that there was no bluish/golden coloration, suggesting that significant

Fig. 4 Visual images of failed inner race: (a) outer surface of inner race, (b) closer view of spalling, (c) fracture surface

temperature rise did not occur during the service. Moreover, there were no pronounced dent marks or brinelling, thus ruling out contamination and sudden impact loading, respectively. No corrosion residue was observed that might accelerate fatigue.

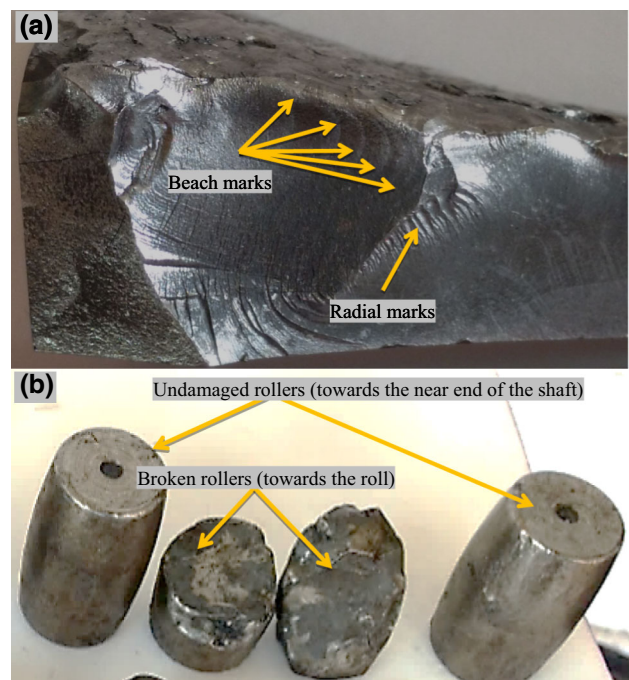
Visual images of the failed outer race and rollers are shown in Fig. 5a and b, respectively. Figure 5a shows the fracture surface of the outer race, which exhibited beach marks on a highly smooth surface. On traversing from left to right, there is a change in contrast from darker shades to lighter shades. These features indicate fatigue mode of failure. Beyond beach marks, radial marks were observed which suggests that final fracture occurred in a brittle manner. Figure 5b shows representative samples of severely damaged and relatively undamaged rollers. It is clearly evident that those rollers located toward the near end of the shaft were virtually undamaged, whereas those present near the roll were broken and damaged to a great extent. This clearly indicates non-uniform loading was experienced by the bearing elements.

Fig. 5 Visual images showing (a) fracture surface of outer race (b) representative damaged and undamaged rollers

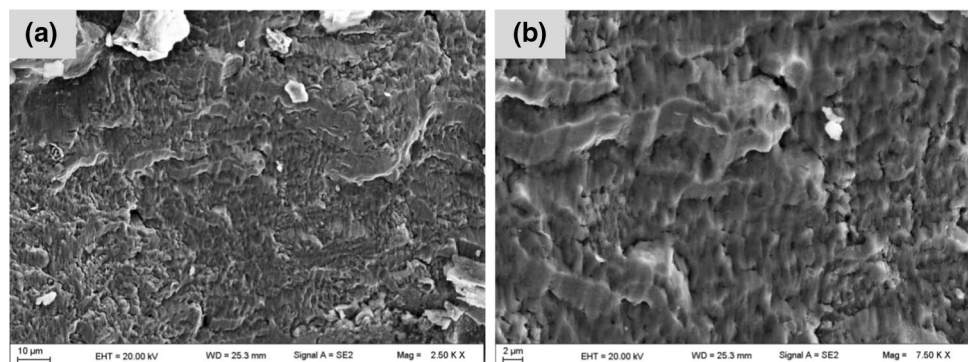
Figure 6 shows SEM fractographs of the inner race which revealed striation marks confirming fatigue mode of failure. The spacing of the striation marks, i.e., distance between adjacent striation marks, indicates crack propagation at each cycle of fatigue loading (da/dN).

Fig. 6 SEM fractographs of inner race at: (a) $\times 2500$ and (b) $\times 7500$

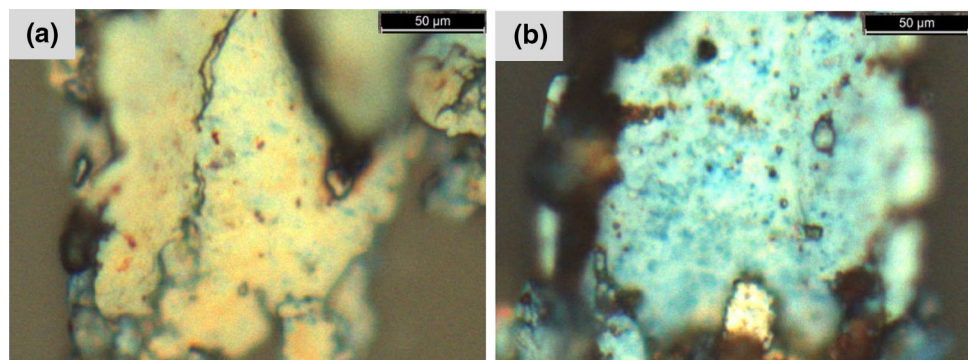
Figure 7a and b shows two representative ferrograms of the lubricant used in the pinch roll bearing system. Bearing debris is flat and laminar. Such chunky debris is associated with severe subsurface fatigue. In general, chunky debris with high aspect ratio indicates an advanced stage of

fatigue [8]. Moreover, no dark oxides were observed indicating that there was no abnormal rise in temperature of the lubricant during service and the bearing operated under rated speed. In addition, there was no trace of contaminants or corrosive particles precluding premature failure due to contamination or corrosion, respectively.

Fig. 7 Ferrograms showing two different types of low-alloy wear particles at $\times 500$

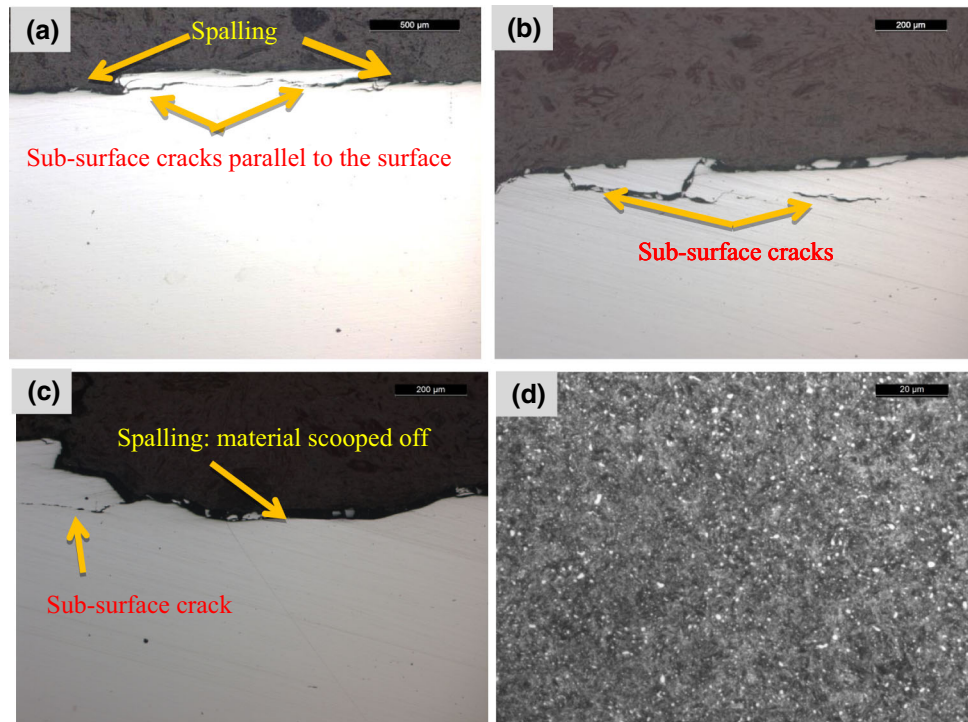
Fig. 8 Optical micrographs of failed inner race: (a) unetched micrograph at location 1, (b) unetched micrograph at location 2, (c) unetched micrograph at location 1- \times 100, (d) etched micrograph- \times 1000

micrographs of inner race at different locations and magnifications. Subsurface cracks parallel to the rolling contact surface were observed and are shown in Fig. 8a and b. Figure 8c shows scooping off of material up to a depth greater than 250 μ m. Such localized scooping off of material from the surface is termed “spalling” and is associated with conventional rolling contact fatigue. Etched micrograph of the inner race shown in Fig. 8d revealed tempered martensitic structure with uniform distribution of carbide precipitates. Such a microstructure is desirable for bearing application.

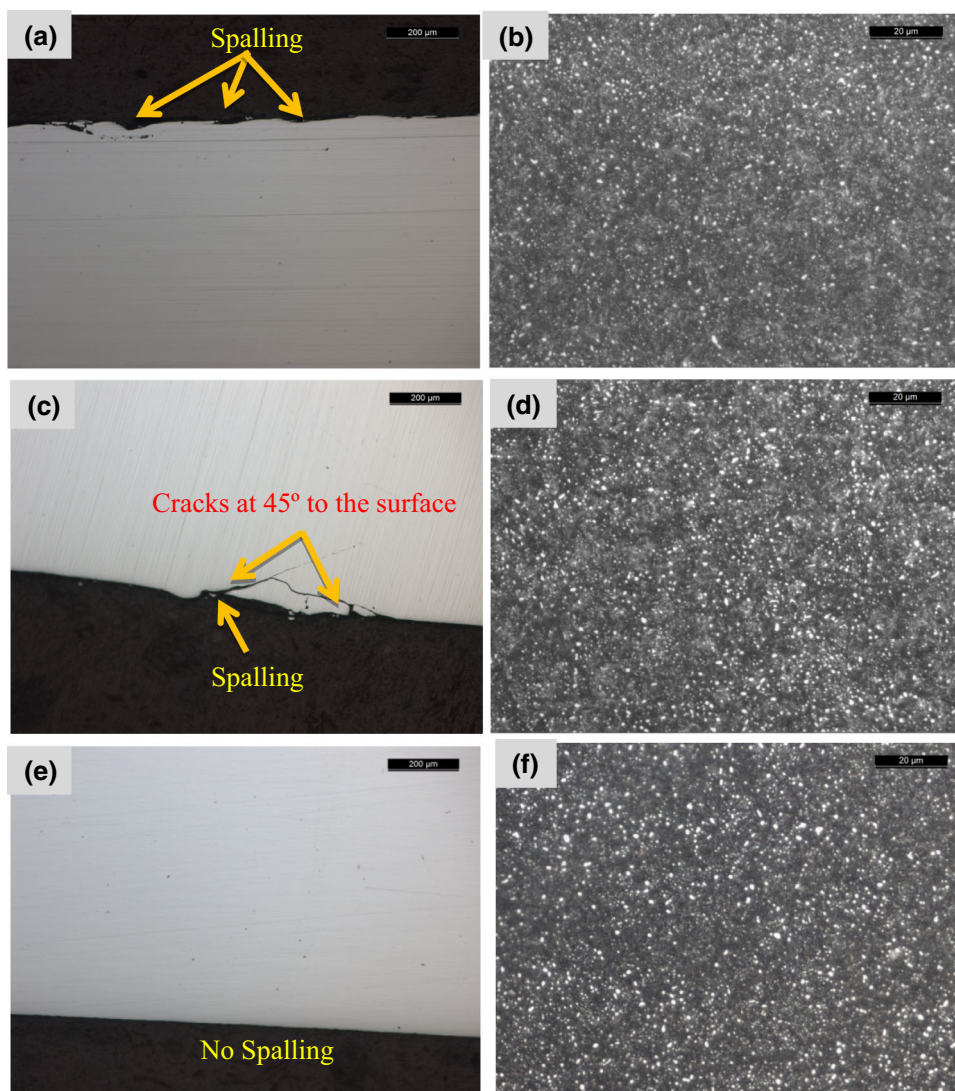
The outer race exhibited a spalled surface and cracks parallel to the contact surface as shown in Fig. 9a. Figure 9c shows the unetched micrograph of a damaged roller located on the right side of the separator. It also has a

spalled surface, though in this case cracks were observed to be at an angle of approximately 45° to the contact surface. Such geometries of surface cracks have been reported in the literature and are associated with rolling contact fatigue. Contrary to the spalled surface of the rollers on the right side of the separator, those on the left side of the separator showed a completely undamaged surface as shown in Fig. 9e. Presence of inclusions can initiate fatigue crack; however, no ratable inclusions were observed in any of the bearing elements. This confirms that the steels used for the manufacturing of the bearing elements are clean, ruling out premature failure due to improper secondary steel making process. Etched micrographs of outer race, damaged roller and undamaged roller are shown in Fig. 9b, d and f, respectively. They show typical microstructure of

Fig. 9 Optical micrographs showing: (a) unetched outer race- $\times 100$, (b) etched outer race- $\times 1000$, (c) unetched damaged roller- $\times 100$, (d) etched damaged roller- $\times 1000$, (e) unetched undamaged roller- $\times 100$, (f) etched undamaged roller- $\times 1000$

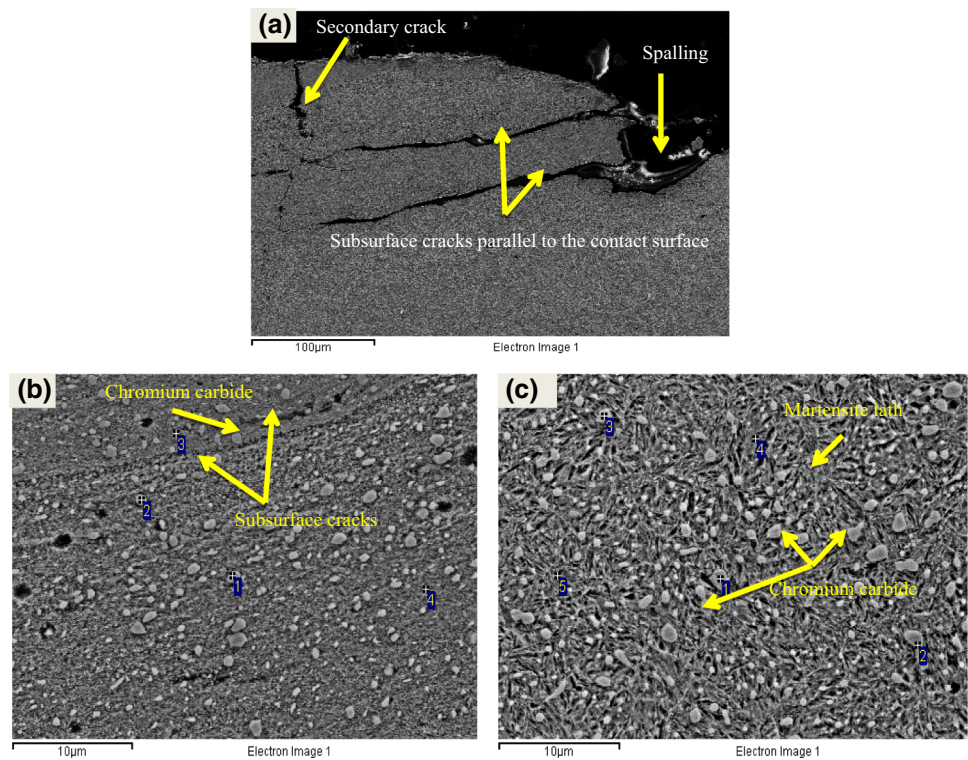
SEM–EDS analysis was performed to resolve the matrix phase, to determine the crack propagation path and to ascertain the nature and distribution of precipitates. Figure 10a shows a SEM micrograph of the spalled inner race. It revealed two nearly parallel subsurface cracks and a secondary crack perpendicular to the surface. A high-magnification micrograph ($5000\times$) near spalled surface is shown in Fig. 10b. It shows crack–precipitate interaction. Cracks tend to propagate around the precipitates rather than

cutting through them. This was confirmed by EDS point scans as shown in Fig. 10b and depicted in Table 2.

Moreover, sharp martensitic laths were not observed near the spalled region, suggesting local tempering during the process there. Figure 10c shows a micrograph of the inner race away from the spalled location. It revealed sharp martensitic lath with a uniform distribution of fine chromium carbide precipitates. This indicates that the microstructure of the bearing elements was as per requirement, though minor deterioration occurred by tempering in the vicinity of the spalled region.

Fig. 10 SEM Micrographs of spalled inner race at (a) $\times 1000$, (b) $\times 5000$: near spalled surface, (c) $\times 5000$: away from spalled surface

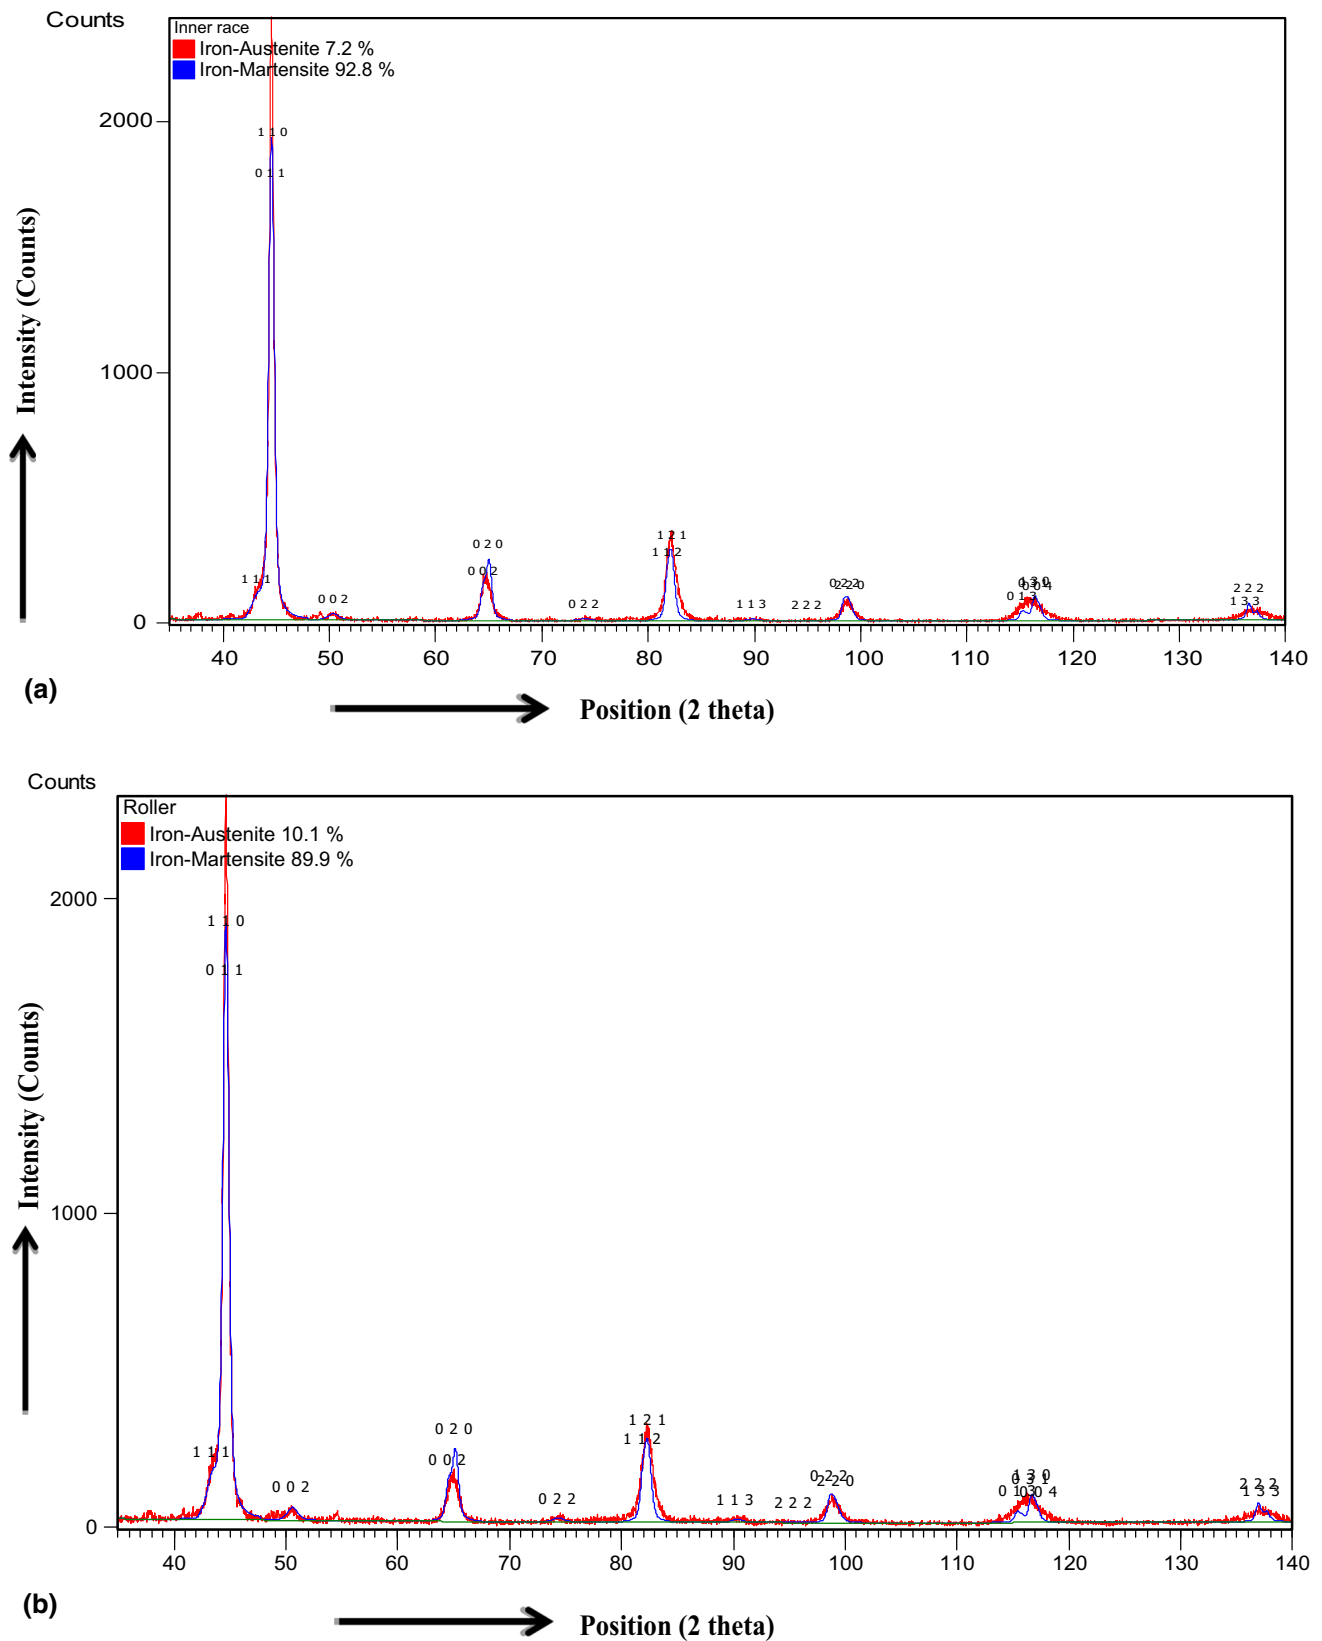
and retained austenite was calculated for each case. Intensity versus 2θ plot for the inner race and rollers is shown in Fig. 11a and b, respectively. Using Rietveld analysis, it was calculated that the fraction of martensite and retained austenite was approximately 93 and 7%, respectively, in inner race. Moreover, percentage of retained austenite was close to 10% in both damaged and undamaged rollers. An excess of retained austenite is known to have an adverse effect on dimensional stability of the material. However, up to 10% of retained austenite may

not have marked effect on the dimensional stability and failure of the bearings [1].

Fig. 11 XRD (Intensity vs. 2θ) plot for (a) inner race; (b) roller
