In Situ Failure Investigation of Weld Cracking in a Linz–Donawitz Vessel

Kaushal Kishore · Rohit Singh · B. Nirmal · Adesh Yadav ·
Manashi Adhikary · Anup Kumar

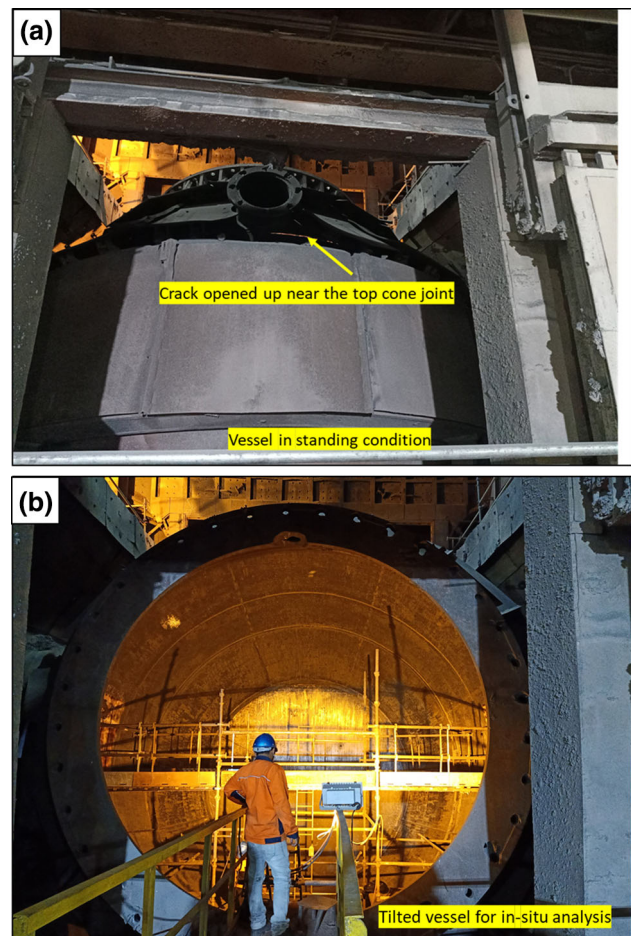
Figure 2a shows the LD vessel that experienced failure during the service. A large crack opened up the top cone weld joint. The shell of the vessel is made up of micro-

Fig. 2 Overall view of the failed LD vessel: (a) in standing condition, (b) in titled condition

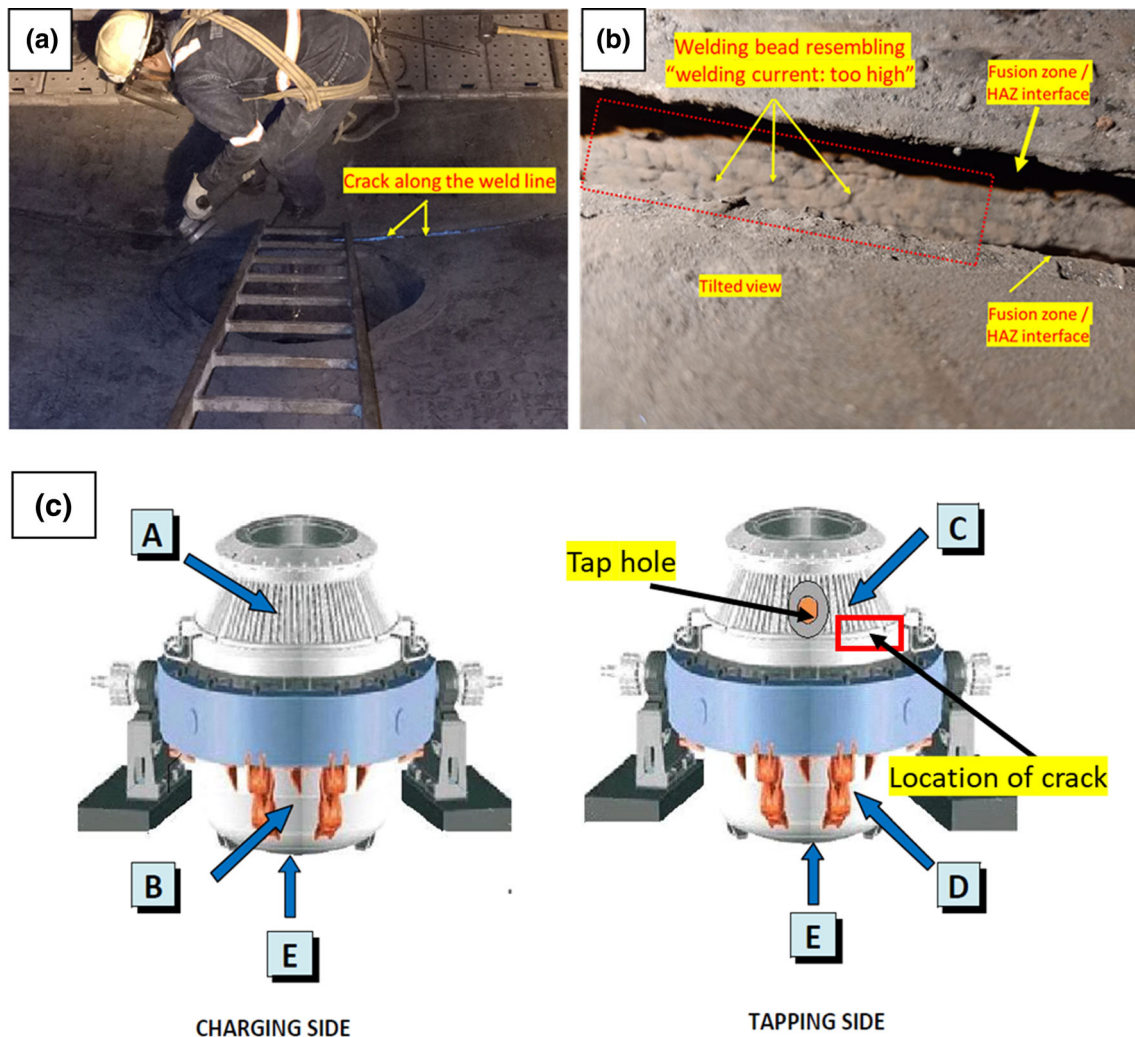
Inside view of the crack that appeared in the vessel is shown in Fig. 3a. Closer view of the crack is shown in Fig. 3b. Weld bead can be seen in the cracked location. It is evident that cracking occurred from the weld joining top cone of the vessel to its vertical portion. Based on the location of the crack, a schematic is shown in Fig. 3c to pinpoint its location with respect to the operation of the LD vessel. Crack appeared adjacent to the tap hole, where there is expected to be a greater fluctuation in the level of thermal and mechanical stresses due to tilting action of vessel and flow of hot liquid steel. No crack was observed in the charging side.

Fig. 3 On-site images of the failed vessel: (a) inside view showing the location of crack, (b) closer view of the cracked vessel showing welding beads, (c) schematic showing the location of crack in the vessel

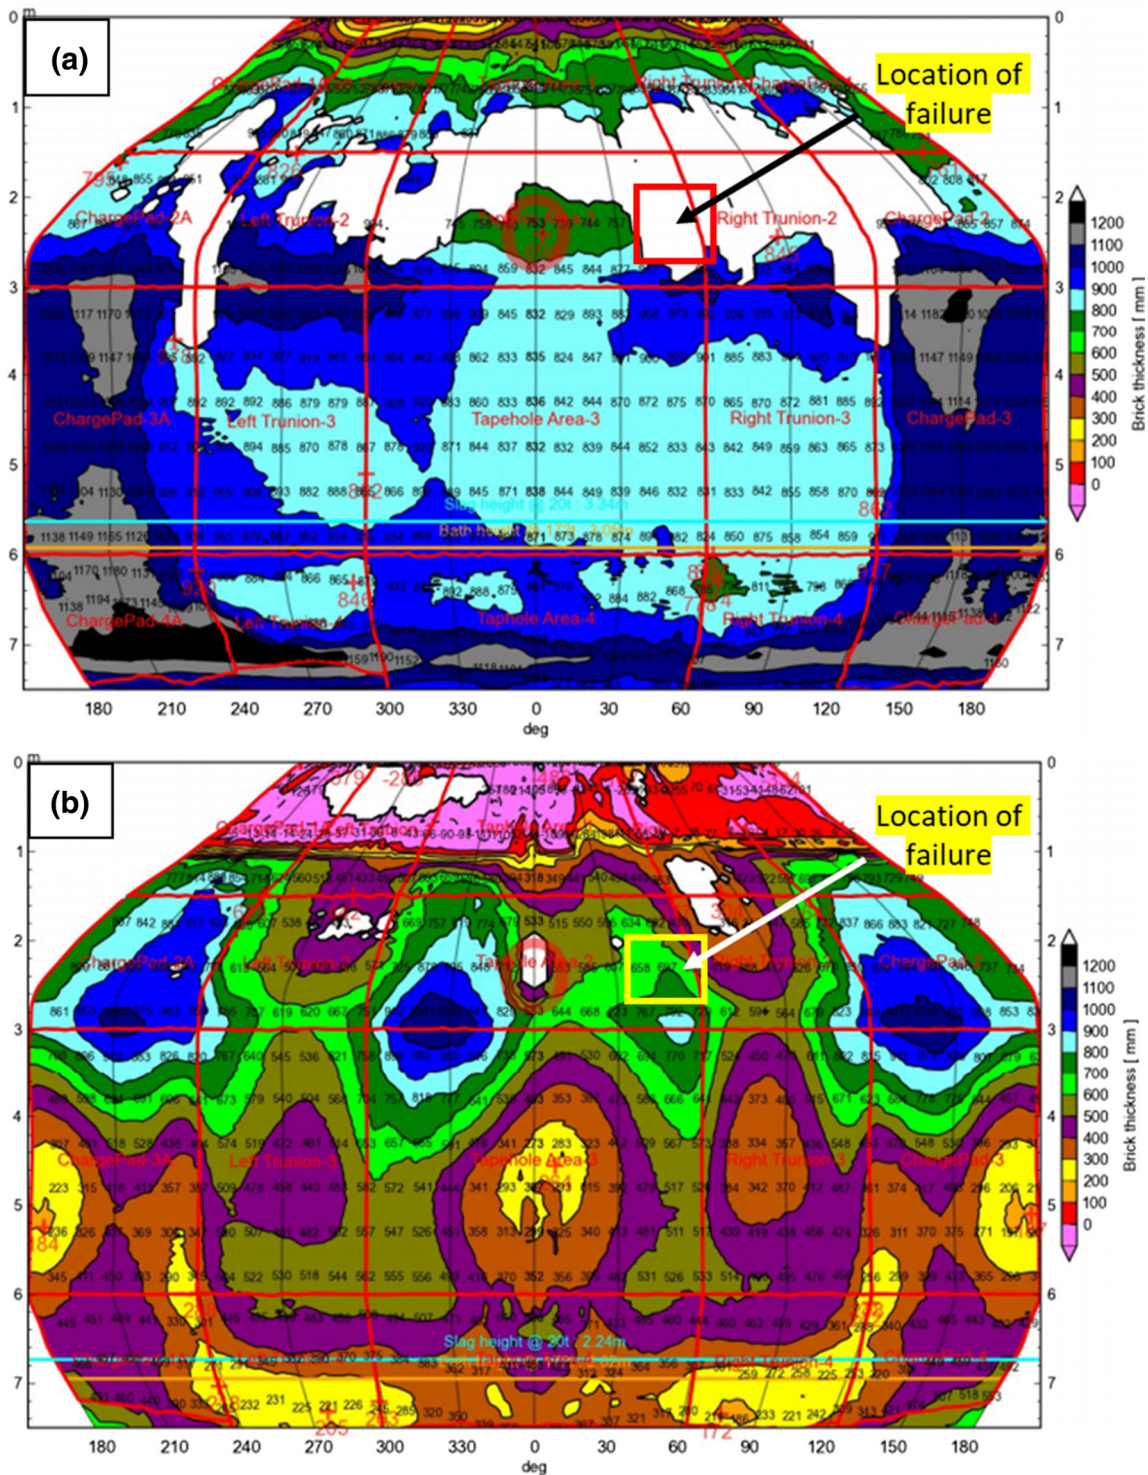
As a lower thickness of refractory below a critical value can result in overheating of the shell of the vessel, it was imperative to examine the condition of refractory. Figure 4 shows the thickness of the refractory lining during early stages of its service life (after 181 heats; Refer Fig. 4a) and after failure (after 6246 heats; Refer Fig. 4b). Although it is evident that there is a significant reduction in thickness of the refractory lining during service life due to slag attack, erosion, etc., at or around the location of failure (to the right of tap hole), the refractory thickness was between 700 and 800 mm, which is well above the alarm value of 100 mm. Thus, the failure of the vessel shell cannot be attributed to the decrease in thickness of the lining.

Fig. 4 Contour map showing thickness of refractory lining at different locations of the vessel: (a) after 181 heats, (b) after 6246 heats (failure)

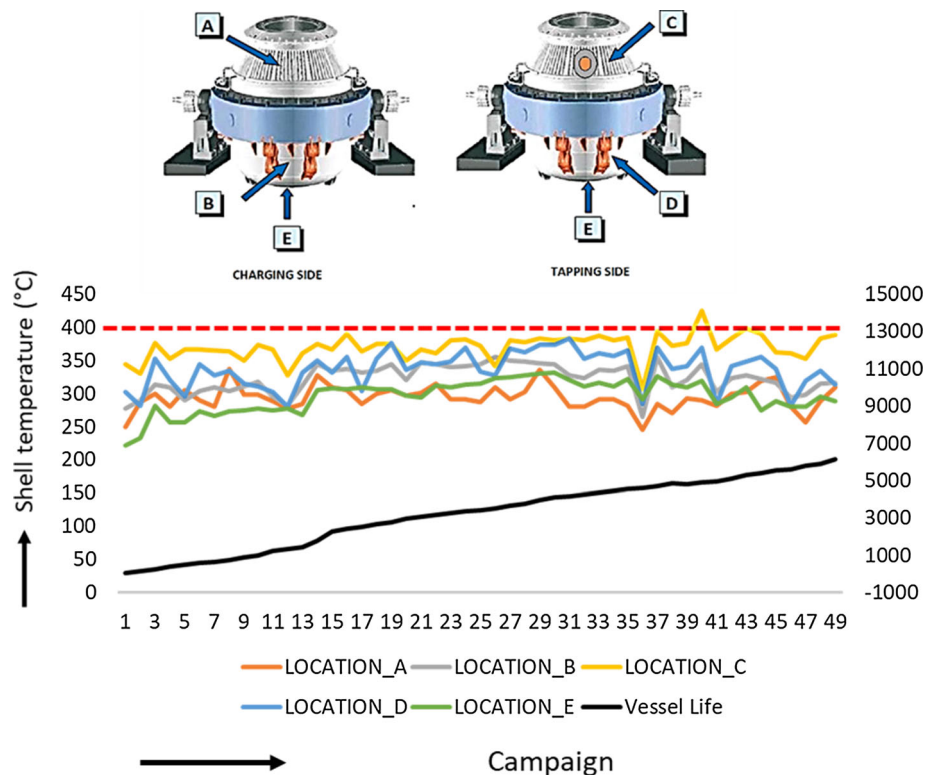
interesting to note that, in general, the temperature of charging side is lower than that of the tapping side. Additionally, the location where crack appeared constantly experienced the highest temperature among all the locations of measurements. On more than one occasions, temperature exceeded the non-permissible value of 400 °C. There is fluctuation in temperature between 300 and 425 °C. A higher peak temperature alludes to a higher fluctuation in temperature and consequently higher thermal stresses therein. The fact that temperature is considerably higher on the tapping side compared to the charging side near the top cone joint can probably explain why failure occurred on tapping side of the joint.

Fig. 5 Temperature of vessel shell at different locations measured using thermography technique during its life cycle

stresses. Top cone joint, being the point where there is change in cross section, is a potential stress concentration site. It inevitably experiences thermal fluctuations during its campaign as revealed by thermography analysis (Refer Fig. 5), and thus, thermal stresses are introduced. This has

- (iii) It is recommended to carry out follow-up research on optimization of post-weld heat treatments between 300 and 600 °C for 2 h (based on the section thickness) and measure micro-hardness profiles and residual stress across the joint. The temperature at which the difference in micro-hardness values between base metal, heat-affected zone and fusion zone is minimum and has predominantly compressive residual stress is expected to perform the best under fatigue loading condition.
- (iv) Corrective actions should be taken based on thermography analysis to bring down the shell temperature within the permissible limit.

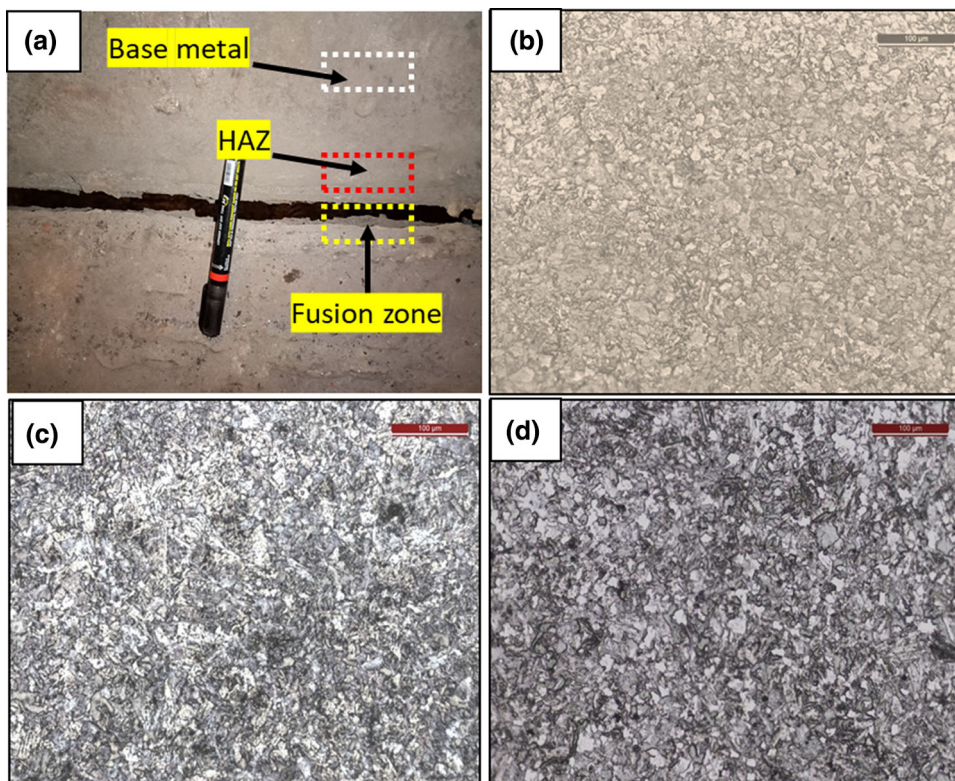
Figure 6a shows the location of microstructural analysis in the cracked vessel. Base metal revealed fine-grained polygonal ferritic microstructure as shown in Fig. 6b. The

presence of carbides and/or carbo-nitrides of Nb, V and Mo (based on chemical analysis but not possible to resolve by optical microscope of replica) would have helped in grain refinement. Heat-affected zone showed the presence of bainite and/or martensite (Ref. Fig. 6c). Due to the inherent

limitation of the quality with replica technique, it is not possible to distinguish between martensite and bainite. Fusion zone consisted of polygonal ferrite and acicular ferrite as shown in Fig. 6d. It is not expected to have any carbide owing to absence of Nb and V in the chemistry of fusion zone/weld pool.

Fig. 6 Optical micrographs of different zones: (a) location of microstructural analysis, (b) base metal, (c) heat-affected zone, (d) fusion zone

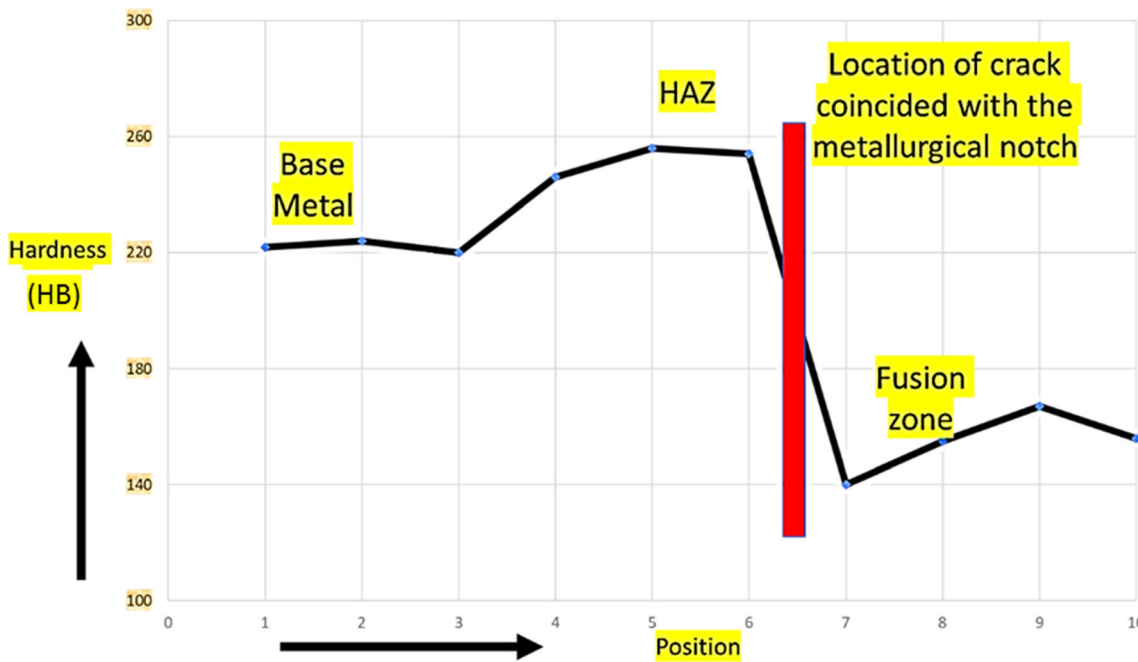
Hardness profile across the weld (including the crack) is shown in Fig. 7. Base metal (BM) has hardness value between 220 and 230 HB despite having predominantly α -ferritic microstructure. Strengthening is achieved by the virtue of grain refinement due to formation of micro-alloy carbides (NbC + VC). Heat-affected zone showed higher hardness (around 250–255 HB) due to formation of

martensite/bainite. As the temperature of the shell in this location was measured to be around 400 °C, tempering and reduction in acicularity would have reduced the hardness slightly than as-welded condition. Fusion zone showed substantially lower hardness because of absence of any micro-alloying element and lower Mn and Ni (solid-solution strengtheners). A temperature in excess of 400 °C as confirmed by thermography analysis would have resulted in softening mechanisms like tempering. The kinetics of tempering would have been the fastest in fusion zone due to absence of alloy carbides to impede the motion of dislocations and reduced grain boundary mobility.

It should be noted that sharp hardness gradient existed at HAZ/fusion zone interface that created metallurgical notch, and therefore, it is the possible site of fatigue crack initiation. Due to significant variation in chemistry and microstructure and thus thermal properties of the HAZ and fusion zone, thermo-mechanical fatigue would have initiated at this site.

Fig. 7 In situ hardness profile across the weld

- (i) Use of welding electrode such as AWS A5.29 E81T5-G H4R containing carbide forming elements (V or Nb) is suggested.
- (ii) After welding and post-weld heat treatment, in addition to ultrasonic and dye penetrant tests, hardness profile across the joint should be

measured to ensure that there is no sharp metallurgical notch formation as in the present case.
