## LESSONS LEARNED

# Solidification Cracking of Longitudinal Submerged Arc Welded Pipes

Rajesh K. Goyal · Ankit Singh · T. S. Kathayat

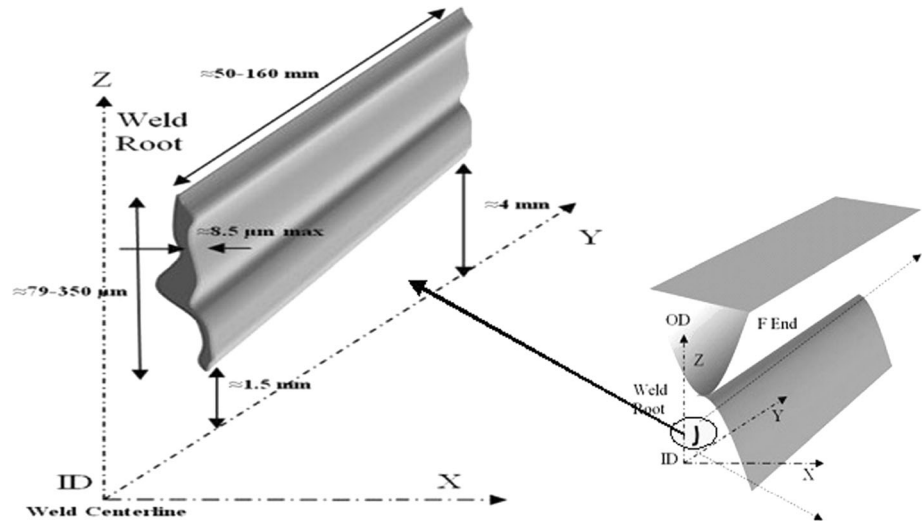
**Fig. 2** Schematic diagram of flaw detected by MUT

centre. Visually, no defects were observed. During real-time radiography (RTR) and x-ray test, no indication of the flaw was observed. Manual ultrasonic test (MUT) was performed at both ends of the pipe to inspect the weld seam that revealed the indications of flaw having 79–350 μm height, 8.5 μm width at the tail end, within around 160 mm length from the end as shown in Fig. 2.

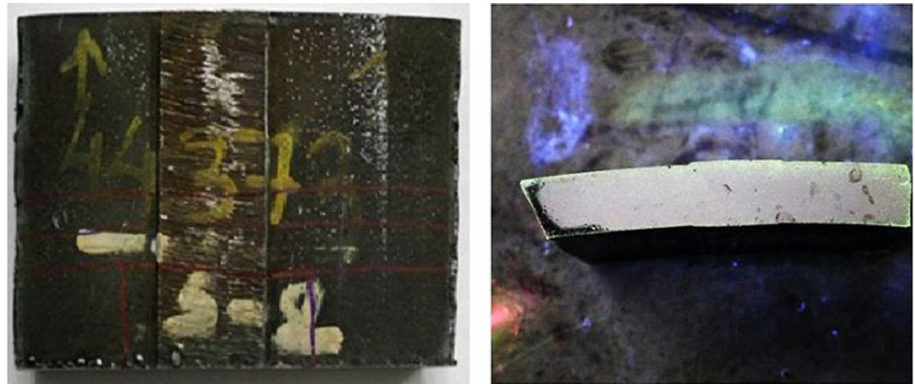
**Fig. 3** Magnetic particle inspection (MPI) on flaw detected portion. (a) Test coupon on which defect was located for further analysis. (b) MPI on transverse cross section

Magnetic particle inspection (MPI) test on samples' weld bead surface and the transverse cut section was unable to detect any significant flaw as shown in Fig. 3.

after the mechanical expansion during MUT. MPI test carried out on the transverse cross section of the weld, with the known position of crack could not reveal the presence of the flaw. The flaw does not get revealed by other NDT methods like RTR and x-ray. The defects are formed at approximately 40–150 mm away from T-end of the pipe. The chemical composition results show that the pipe material meets the chemical composition requirement of API 5L X70M PSL2 grade.

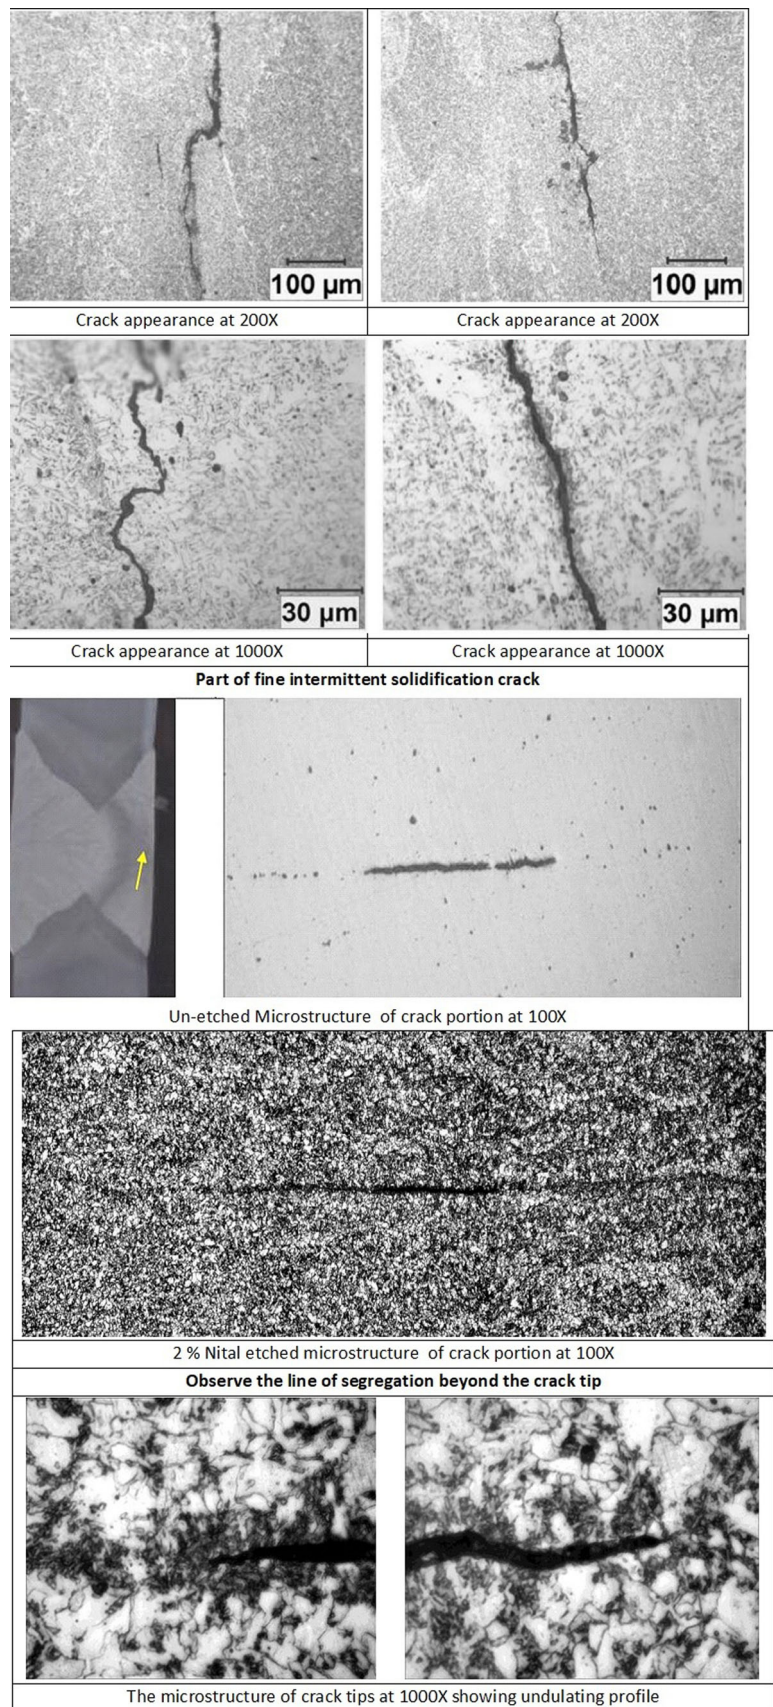
**Fig. 4** Microstructures obtained at crack vicinity

The macro-structural examination across the transverse section showed sound weld quality along with proper fusion. The width-to-depth ratio of the weld (w/d) appears to be normal. Though, the microstructure revealed a crack at the inside weld centreline. Crack was propagating in the transgranular and intergranular manner in some locations as shown in Fig. 4.

The solidification cracks were found to be interdendritic and intergranular with respect to the solidifying grains. Also, the presence of a line of segregation beyond the crack tip (with undulating profile) confirms that the cracking resulted from the presence of manganese, oxygen, aluminium and sulphur in the flux material.

To overcome such problem in the project, nickel wire was used which raises the overall temperature of the weld pool allowing greater duration for solidification to take place and hence, lesser residual stress shall be generated in the weld metal.

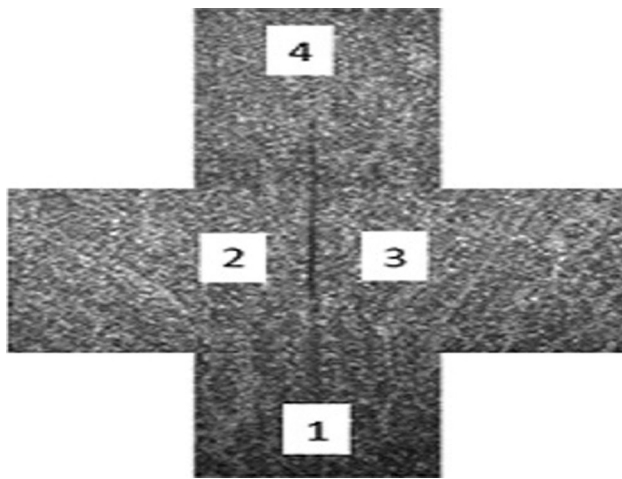
**Fig. 5** Microhardness measurement profile

Microhardness measurement was carried out with 100 gf load around the crack areas which shows higher hardness  $\sim 262$  Hv10 at crack tips locations 1 and 4 and moderate hardness on both sides of crack  $\sim 210$  Hv10 at locations 2 and 3 (Fig. 5).

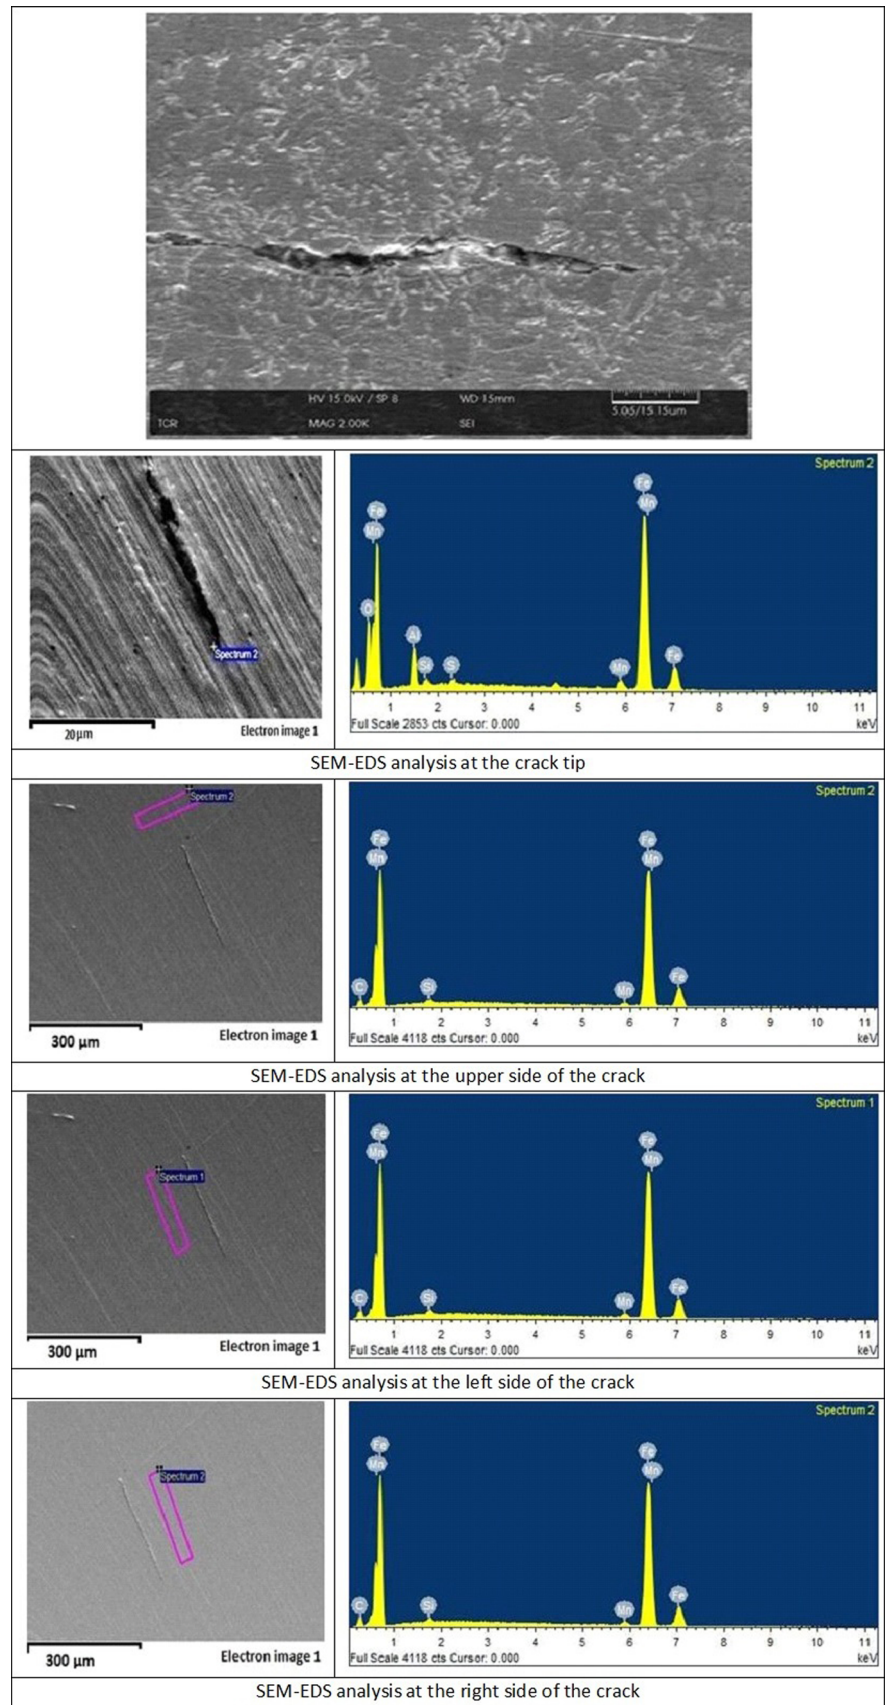
**Fig. 6** SEM-EDS analysis around crack vicinity

The results of scanning electron microscopy (SEM) with energy-dispersive spectrometer (EDS) maps around crack vicinity are shown in Fig. 6. EDS analysis at crack tip shows the presence of oxygen, aluminium, sulphur, manganese and iron which are an indication of the presence of inclusions in the analysed sample.

Most of the microfissures have occurred in heats of plates having more than 530 MPa yield strength (YS). No such cracking was taking place on previous lots of raw material that were having YS at lower side supplied by another steel supplier. SEM and EDS analysis showed the presence of inclusion forming elements at its vicinities like Manganese, Sulphur, Oxygen and Aluminium.
