Failure Investigation of Rear Axle Taper Roller Bearing by Using the Vibration Spectrum

Junaid Ali · Deepak Borse

Submitted: 26 January 2020 / Published online: 9 August 2020
© ASM International 2020

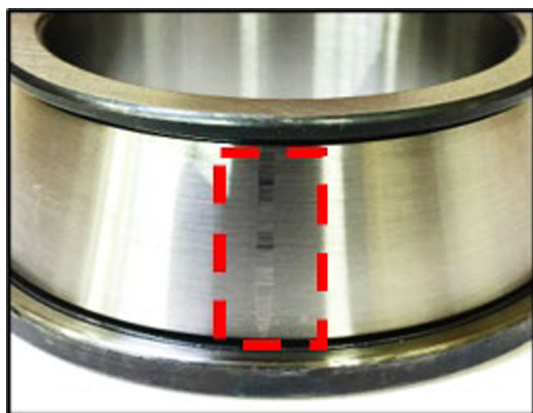
Fig. 2 Damage cone track surface of taper roller bearing

A good bearing was used to collect baseline data for comparative study, and a defective bearing was produced for experimentation. Defect was generated on cone track surface using surface grinder to produce a similar to regular production grinding job-stop damage as shown in Fig. 2. The experimentation was performed particularly for the job-stop type of defect and it is due to the peculiarity and unidentifiable nature in the regular manufacturing process. Such defects depreciate bearing’s service life and produce noise and vibration in application it is fitted.

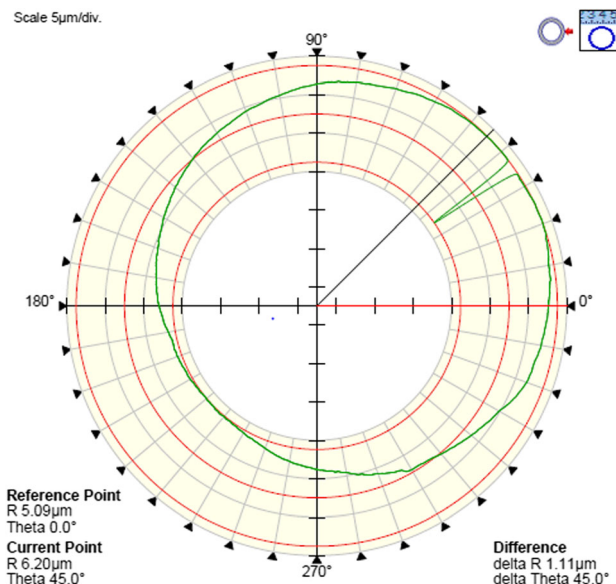
Fig. 3 Defect roundness profile using Talyrond™ roundness measurement machine

Assume a defect as a perfect rectangle vertically along the length of the mating surface of outer and inner rollers, respectively. Defect dimensions are shared in Table 2. Cone track surface roundness profile was measured on Talyrond. Roundness traces are shown in Fig. 3. Measurement scale was 5 μm/Div with Gaussian filter type and filter range of 1–150 μm.

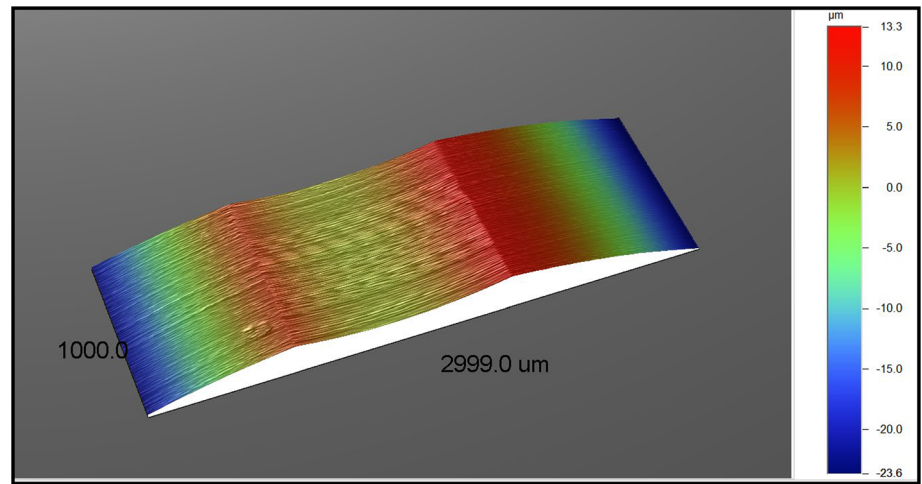
Fig. 5 3D surface profile of defect on cone track surface

Defect surface profile was traced on 3D and 2D profilometers. Defect has approximately 9 μm depth and 2.9 mm width. Surface profile traces are shown in Figs. 4 and 5.

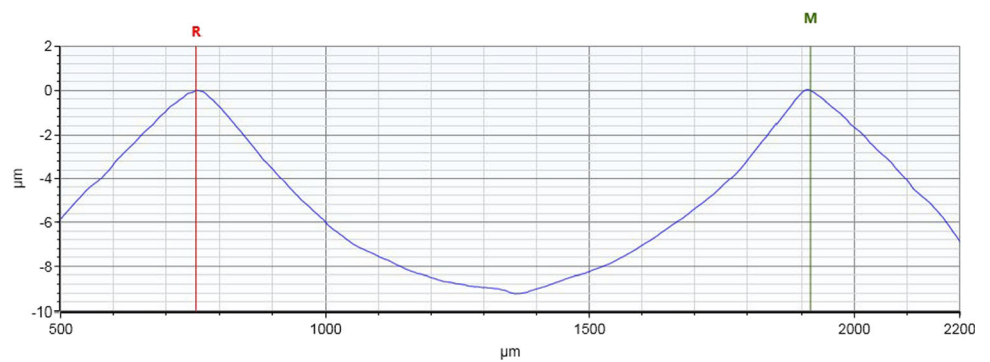
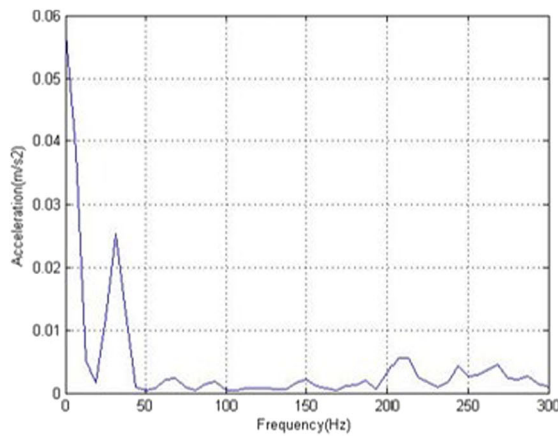
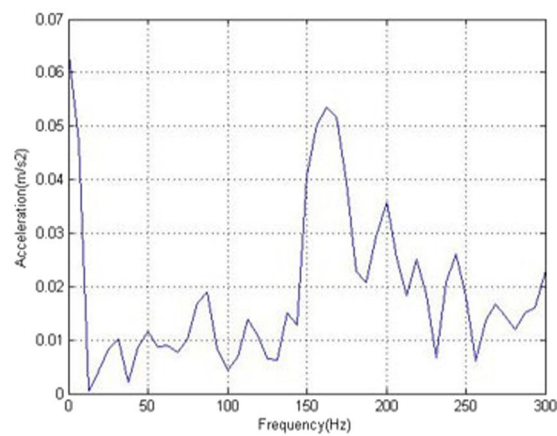
Fig. 6 Good vs. defective bearing—L BAND

Vibration analyzer data are analyzed on MATLAB software, and several graphs are plotted for good and defective bearings. As shown in Fig. 6, the FFT spectrum does not have peaks in the lower band region of frequency band, whereas in defective bearing spectrum a significant rise in peaks can be seen having maximum acceleration peak value of approx. 0.05 m/s². As shown in Fig. 7, in the middle-band spectrum of good bearing a distortion is visible; however, maximum amplitude of 0.025 m/s² of spectrum is significantly low to contribute to the overall vibration of bearing, whereas in defective bearing maximum amplitude of spectrum is as high as 0.09 m/s² which will contribute to the overall vibration of bearing. Moreover, there is a continuous rise in amplitude over 900 Hz, which dimmed drastically in a higher band of the spectrum as shown in Fig. 8. The amplitude of vibration has shown appreciable declination and some peaks appear negligibly low amplitude. Contrary to good spectrum in higher band of defective bearing spectrum, it is visible that amplitude values are high and the maximum amplitude value is approx. 0.26 m/s² at 4000 Hz. Overall, amplitude of

defective bearing has risen significantly from lower band to higher band in contrast to good bearing which is a desired result for the case study. In higher band, a maximum peak of the spectrum, i.e., 0.26 m/s^2 , was achieved at 400 Hz in defective bearing, whereas a peak amplitude of approx. 0.025 m/s^2 in the middle band was achieved for good bearing.
