# Failure Analysis of a Fighter Jet Engine Compressor Blade Due to Foreign Object Damage and High-Cycle Fatigue

R. A. Marín · J. A. Escobar · J. Loboguerrero

Submitted: 26 April 2021 / Accepted: 25 June 2021 / Published online: 20 August 2021  
© ASM International 2021

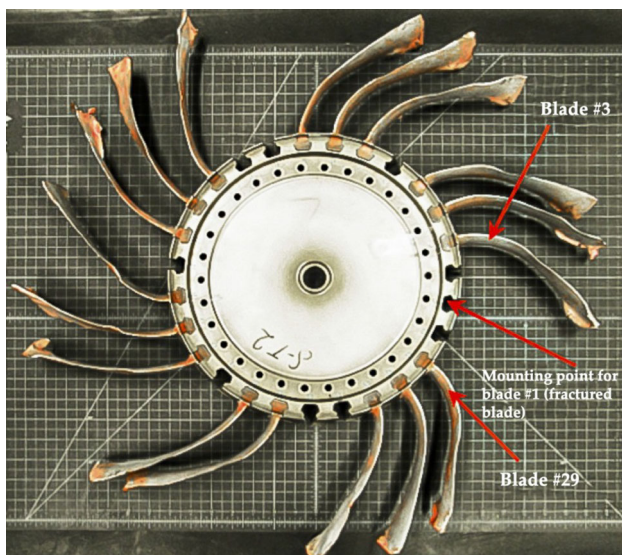
The 17 blades are shown in Fig. 2, mounted on the compressor rotor body. It is apparent that all the non-fractured blades suffered permanent bending deformation whereas the portion of the fractured blade attached to the rotor body remained straight.

**Fig. 2** The compressor second stage with 17 bent blades. The fractured one was blade #1. Each square side is 0.5 in. long

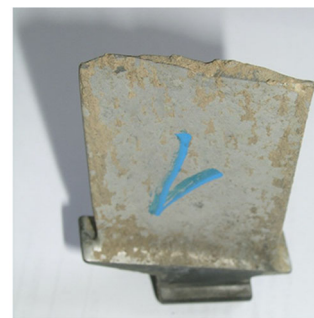
**Fig. 3** Two views of the fractured blade

The recovered portion of the fractured blade is shown in Fig. 3a, unmounted from the rotor. Fig. 3b shows the same element mounted on the rotor with an undamaged blade

**(a)** Photograph of the portion of the fractured blade that remained attached to the rotor.

**(b)** An undamaged blade superimposed on the recovered portion of the fractured blade, mounted on the rotor.

By visual examination, it was determined that the fracture was produced at approximately 40% of the length of the blade, measured from the dovetail (Fig. 3b). This region is particularly sensitive to any defect due to its proximity to a high vibration section of the blade because of engine operation (between 25 and 35% of the length of the blade) [12].

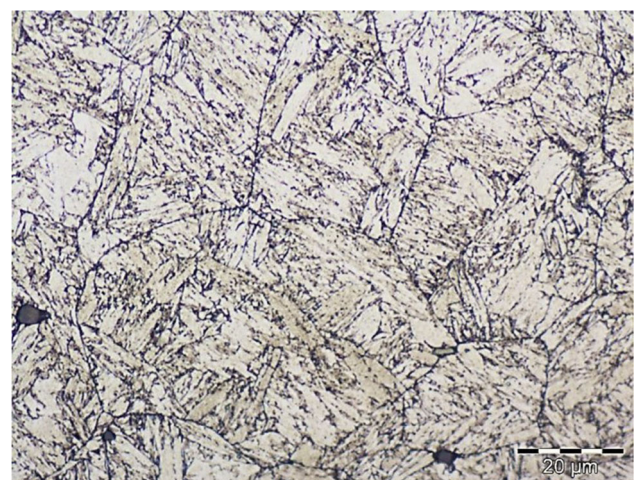
Figure 5 shows an optical microscope image of the fractured blade. A homogeneous microstructure of tempered martensite is observed, with no preferential orientation, and presence of several carbides.

**Fig. 5** Optical microscope image of the trailing edge of the fractured blade at 1000×. Carbides, grain boundaries and tempered martensite are found

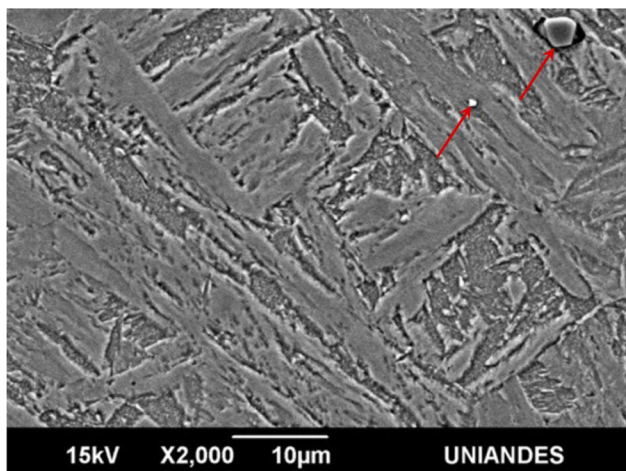
Figure 6 shows a SEM image of several carbide precipitations on the grain boundaries and inside the grains at the leading edge of the fractured blade.

**Fig. 6** SEM image (2000×) of quenched martensitic strips and primary grains at the leading edge of the fractured blade. The arrows indicate some precipitated carbides

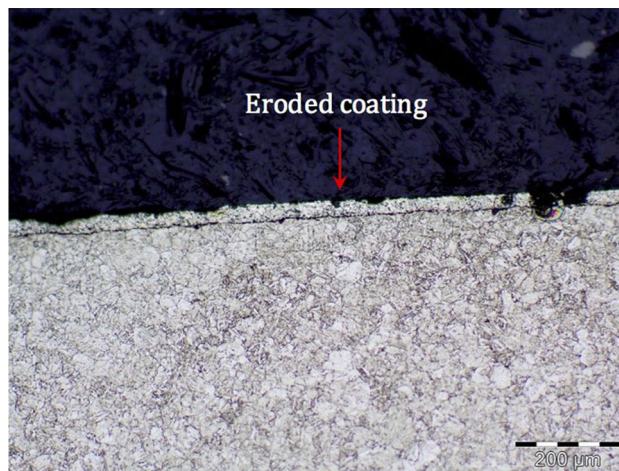
**Fig. 8** Image (100×) of the leading edge of blade No. 3, showing a homogeneous structure and the deposited coating

presents erosion (Fig. 8), probably due to the engine operation. In most places, the coating thickness is reduced to 30 µm, and it was completely lost in some locations.

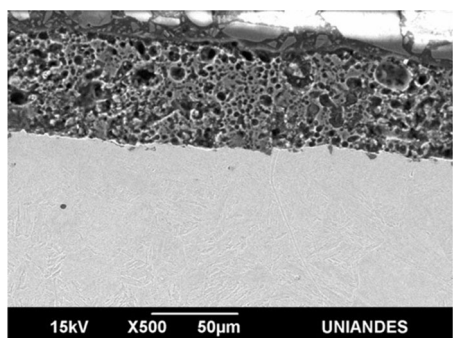
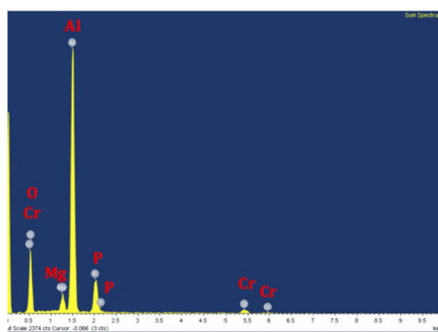
**Fig. 7** Examination of the coating

Additionally, a 60 μm thick surface coating was observed on the same blade. An EDS analysis was performed on this coating. This is shown in Fig. 7a and b. High levels of Aluminum and Magnesium were found because of that analysis.

The structure found on the different zones of the fractured blade did not present any significant morphological variation. This kind of microstructure is characteristic of the forging manufacturing process, followed by a tempering and quenching heat treatment [5, 8, 10]. On the other hand, the coating found in the material is an aluminide coating, which provides a higher corrosion and oxidation resistance [11].

SEM image (500X) showing a 60 µm thick coating

EDS results of the coating, showing a high concentration of Al and Mg

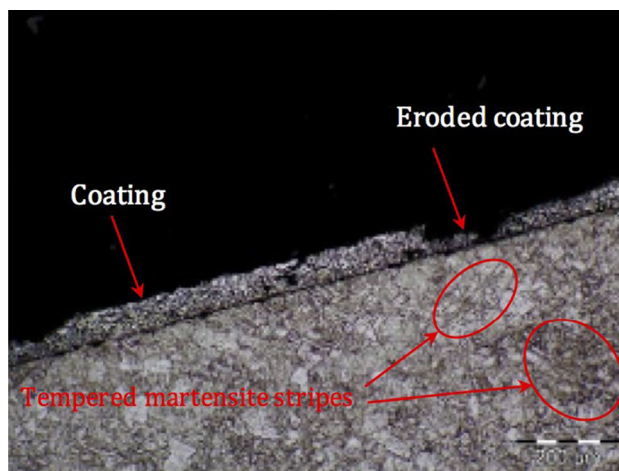
**Fig. 9** Image (100×) of the leading edge of blade No. 26, showing a homogeneous structure of tempered martensite and a coating with eroded sections

The microstructures found on blade No. 26 and on the reference blade are the same and correspond to the one already seen in the previous components. See Figs. 9 and 10. It contains a matrix without orientation of tempered martensite with carbides on the grain boundaries and inside it. The reference blade has a thicker coating, since it has not been exposed to the erosive conditions of the engine operation.

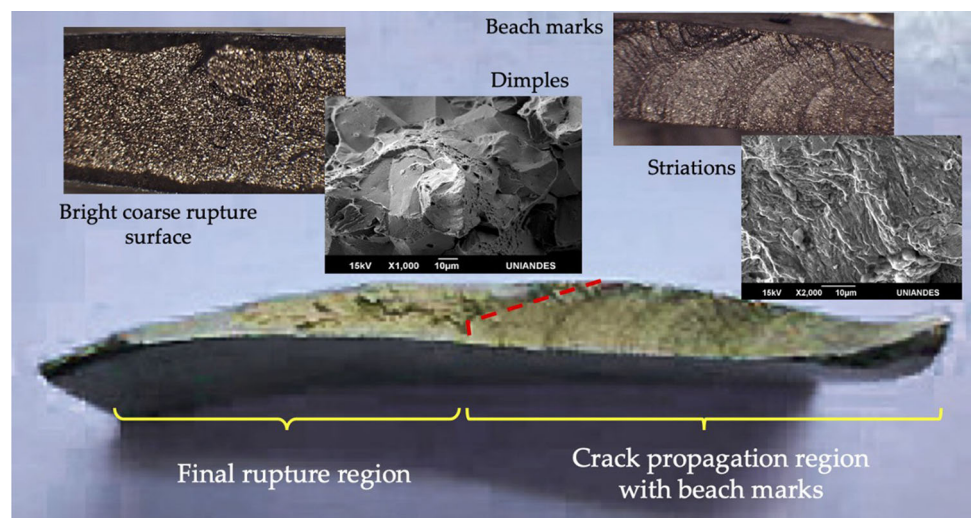
A macrography of the failure surface is shown in Fig. 11. By visual examination, it is apparent that the failure surface has two main regions: one in which the presence of beach marks is evident, indicating that fatigue crack propagation took place, and a second one corresponding to the cross section of the material that failed suddenly after the crack grew to a critical length. Above the crack propagation region, a 19x magnified image of the surface is shown. The beach marks are very evident. Also, a 2000x magnified SEM image of the same surface is shown, with some signs of striation. The reduced level of striation is due to the occurrence of ductile tearing, frequently observed with fatigue crack propagation in martensitic steels.

**Fig. 11** Macrography of the failure surface showing two main regions

Similarly, above the final rupture region, a 19x magnified image of the surface is shown. A coarse and brilliant texture of the surface is evident. A 1000x magnified SEM image of the same surface is shown too, indicating the presence of dimples. These two observations are an indication of intergranular fracture. As shown in Fig. 12, a dent was found on a surface adjacent to the fracture surface, on the pressure side of the blade, next to its leading edge. As shown in Fig. 13, the likely origin of the fatigue beach marks on the fracture surface is

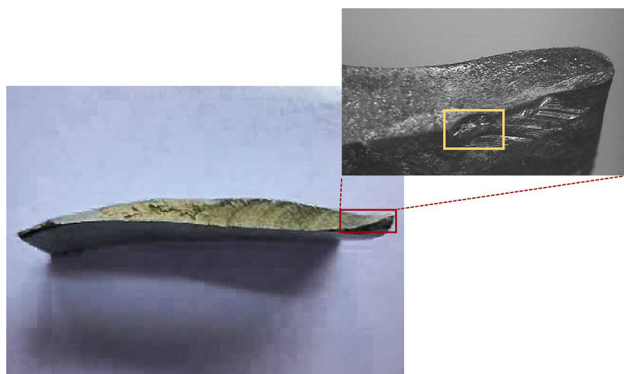
Examination of the failed component shows that the fracture was originated on the pressure side of the blade, at a border point on the leading edge, where flexure is high due to vibration of the component. A dent is present at that location. This kind of dents is caused on jet engine compressor blades by high-velocity impact of hard debris particles. In the aircraft maintenance industry, it is known as foreign object damage (FOD).

**Fig. 12** Location and magnified view of the dent found on the fractured blade

cause of failure, it is recommended to put into practice a very rigorous non-destructive inspection program. The use of radiography, ultrasonic or dye penetrant techniques is suggested.

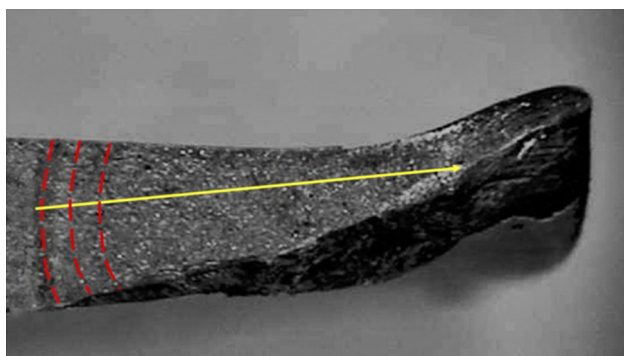
at a location included in the dent.

**Fig. 13** Location of the dent with respect to the origin of the beach marks

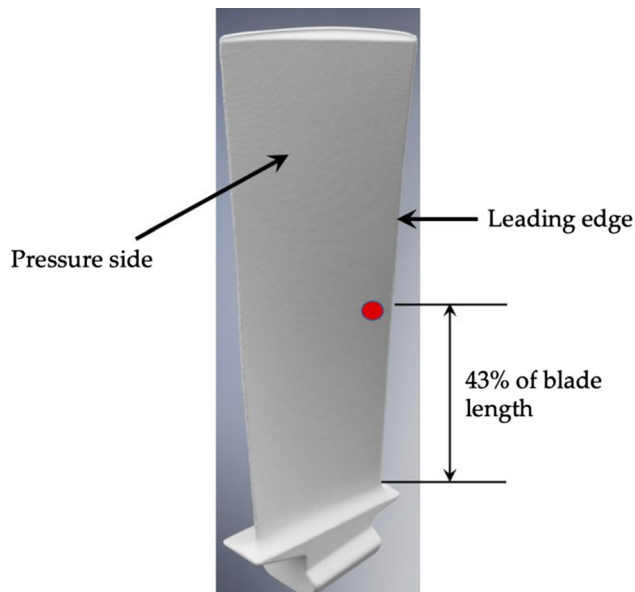
The damage took place at a location on the component where it has been observed before with a substantial probability. The impact took place on a point located at 43% of the total length of the blade (Fig. 3b), measured from its root, on the pressure side of the blade, near its leading edge. See Fig. 14. According to [13], for blades located at the second compressor stage, approximately 10% of the FOD impacts are observed at this location. While this is not a very large probability, it is not negligible either and therefore it is good enough to verify the second condition.

**Fig 14** The red circle indicates the approximate location of the damage on the blade (Color figure online)

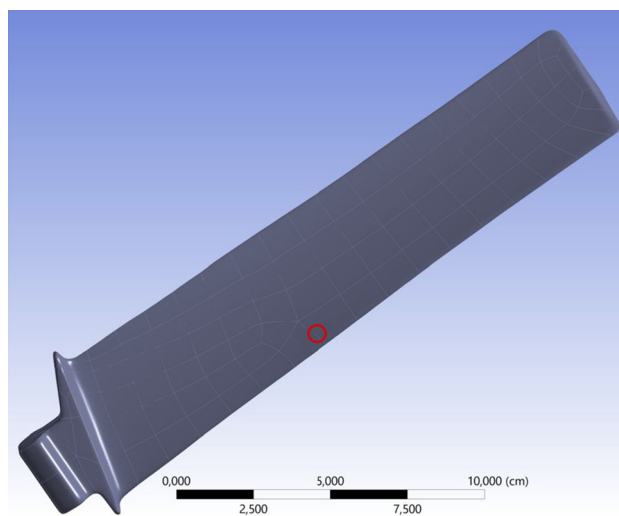
**Fig. 19** Location of the FOD

The foreign object impact occurred approximately at the location highlighted with a circle in Fig. 19. Having identified the failure location in the mesh, we will use the finite elements model of the harmonic response to determine the amplitude of the vibration needed to produce the threshold stresses predicted with Equation 1 in the range between 54 MPa and 180 MPa. The result is that to obtain a stress of 54 MPa at the FOD location, the vibration amplitude must be 0.52 mm, and to obtain a stress of 180 MPa at the same location, the vibration amplitude must be 2.90 mm. Figure 20 shows the stress distribution in the blade surface such that at the FOD location the average stress is 180 MPa. On the other hand, Fig. 21 shows the vibration amplitude observed when the stress at the FOD location is 180 MPa.

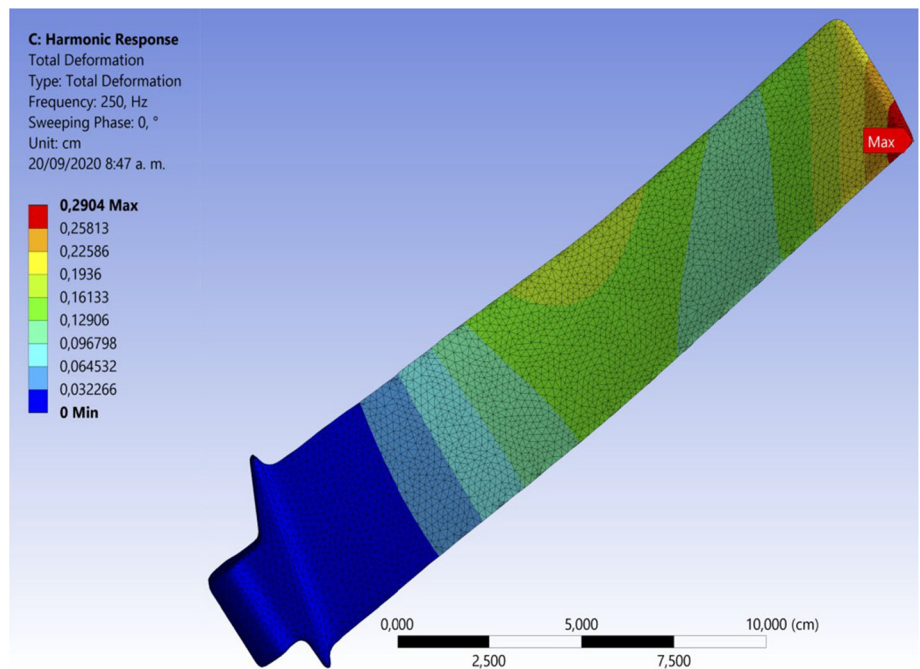
**Fig. 21** Vibration amplitude associated with a stress of 180 MPa at the FOD location

These blade tip deflections are well within the level of blade deflection reported in the literature [12] as caused by vibration under normal operation of the engine. This is an important result since it answers affirmatively the question on whether the stress level at the FOD location is high enough to cause fatigue failure of the blade. With this result and the two observations made at the beginning of this section on the FOD hypothesis, it can be said that, although it cannot be said with total certainty that FOD caused the failure of the blade, it cannot be ruled out either.
