# Operational Failure of Vertical Roller Attached to a Grinding Mill: Root Cause Analysis

M. Ghosh · B. Mahato · B. Ravi Kumar

Submitted: 3 October 2023 / Accepted: 20 October 2023 / Published online: 21 November 2023  
© ASM International 2023

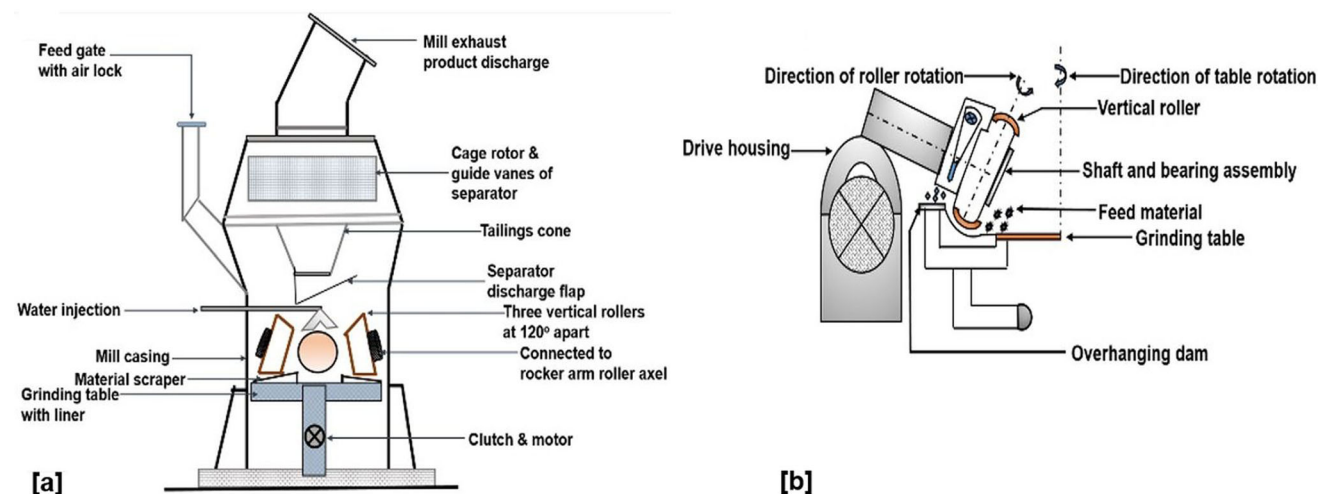
**Fig. 1** Schematic diagram of grinding mill in cement plant (a) position of vertical rollers, where the central one failed in present incident, and (b) isolated vertical roller assembly (Not to scale)

The schematic of grinding mill along with the position of three rollers is given in Fig. 1a. An isolated assembly of a vertical roller has been also presented (Fig. 1b). As depicted in Fig. 1a, the central roller was failed during service. The defective component was removed from the assembly for investigation. The examination of the failed region has been carried out by low power magnifier (10X) to explore general feature and identify sampling locations (Fig. 2).

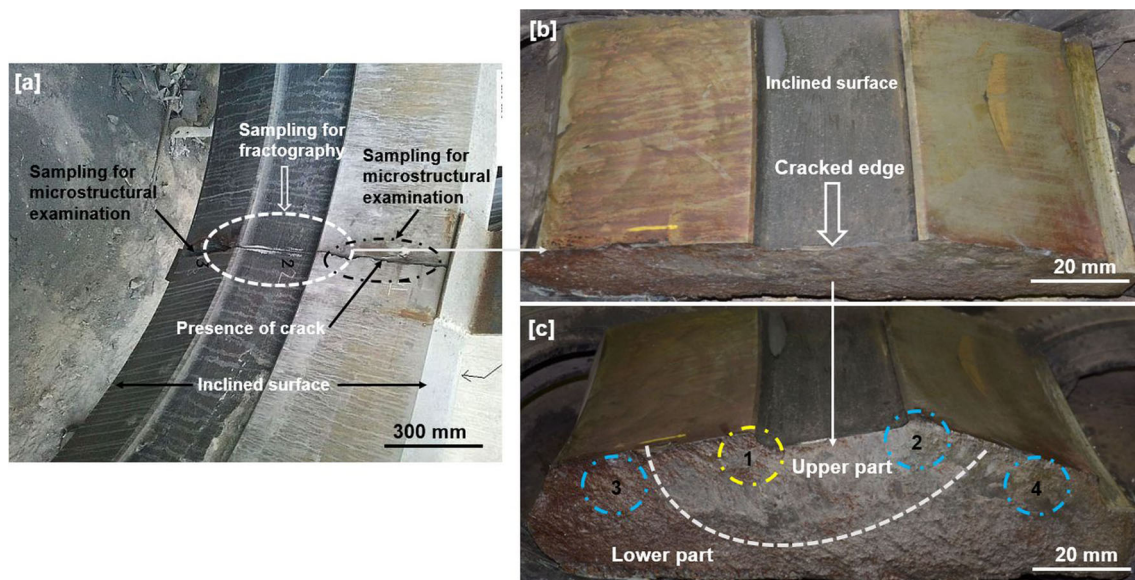
**Fig. 2** Macro-image of damaged component after removing shaft and bearing assembly (a) cracking over the inner surface of roller, (b) bulk sampling from damaged component, and (c) enlarged view of the fracture surface (Color figure online)

Cracking was observed along the longitudinal direction over the inner surface of the broken vertical roller. The crack was nearly straight without any branching (Fig. 2a). Sampling from failed location revealed two different morphologies over fracture surface (Fig. 2c). The upper part, which was close to open end of inner periphery, contained a ‘kidney-shaped’ region (dimension  $\sim 8$  cm major axis  $\times \sim 4$  cm minor axis, encircled by dotted line). Rest of the part (lower region, outside of dotted region) exhibited rough irregular surface. ‘kidney’-shaped

region was bright and smooth with respect to rest of the area. The feature over fracture plane manifested fatigue crack propagation, followed by fast fracture as demonstrated by the ‘dull and rough’ appearance of rest of the fracture surface [6].

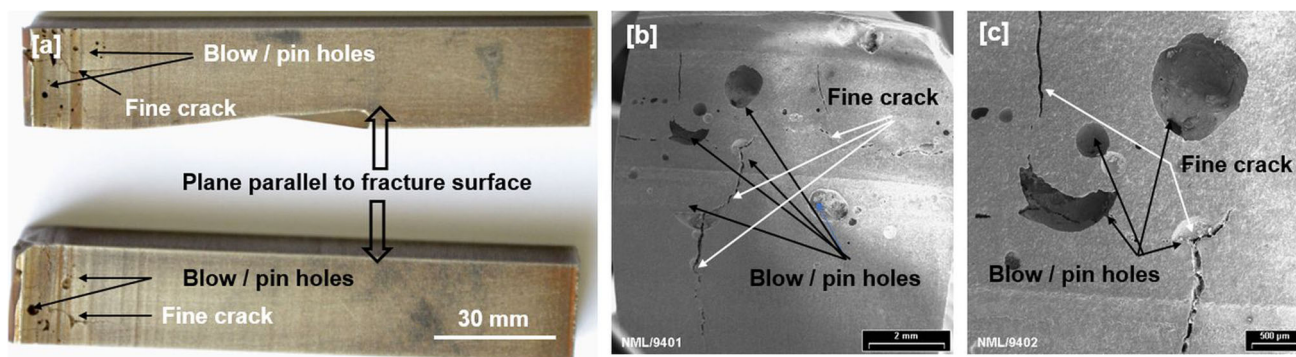
Subsurface region of the inner wall of the vertical roller adjacent to the main crack was examined. The material contained nearly spherical-shaped discontinuities of various diameters and at diverse depth levels from the surface (Fig. 3c–d). The presence of blow/pin holes and pores with dimension 0.2–1.0 mm might be considered as casting defect. Isolated and inter-connected micro-cracks through these discontinuities were also found with multiple branching (Fig. 3a–c).

**Fig. 3** Image of subsurface of cracked region (a) distribution of blow/pin holes over the subsurface of fracture plane, (b) and (c) enlarged view of Fig. 3a for two different locations

quantity of dissolved gases within melt before casting. High amount of heat content within melt also developed enormous solidification stress to facilitate crack formation [9, 10]. The presence of blow holes/pores and tiny cracks at subsurface acted as stress concentration zone and became the nucleation site for main crack formation during service.

- De-gassing of the melt and maintaining of specific alloy composition during casting are prerequisite to achieve desired composition and subsequently properties of the product.
- At the time of deposition welding, pre-heating of the region of interest may be attempted to minimize the temperature difference between arc and substrate.

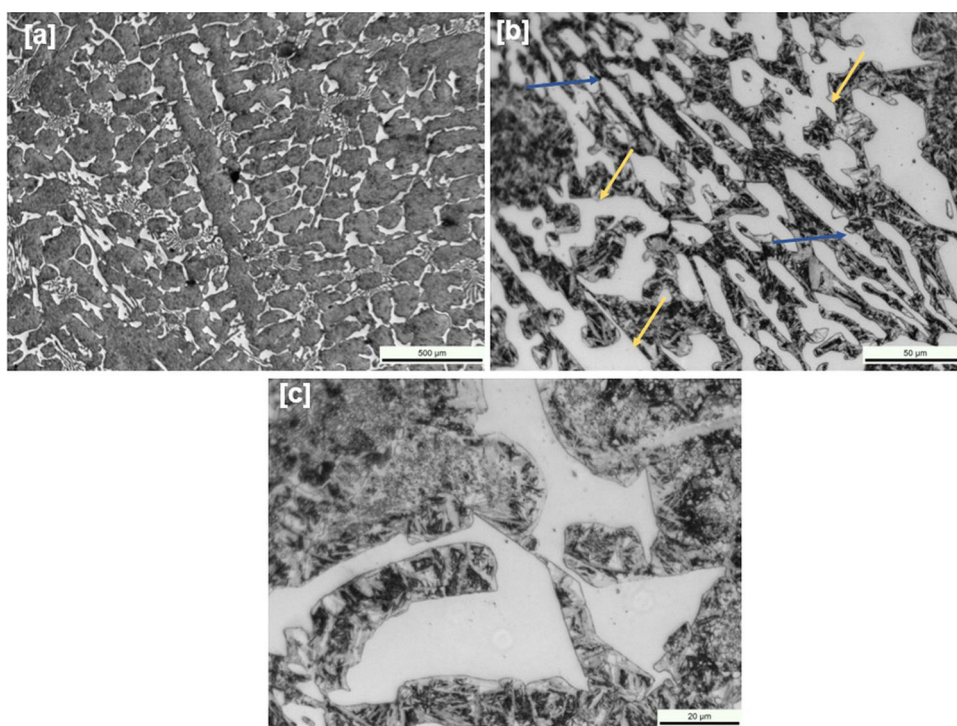
Optical microstructure of the alloy is shown in Fig. 4. Both the specimens exhibited nearly the same feature; hence, the images of one specimen have been furnished here (Fig. 2a). The component represented a particular class of white cast iron. The microstructure consisted of primary dendrite and carbide eutectic (Fig. 4a). Shaded matrix was predominantly martensitic in nature with small amount of austenite (Fig. 4b). The eutectic was a mixture of rod/blade-shaped bright complex carbides (M7C3) embedded within the matrix (Fig. 4c–d). From geometry, two types of carbides were found: One of them was inter-connected, and the other was isolated (Fig. 4b). Isolated carbides were small ( $< 50$   $\mu\text{m}$  length and  $< 10$   $\mu\text{m}$  width). Large size island/inter-connected/irregular-shaped carbides were also present in substantial quantity ( $> 50$   $\mu\text{m}$ ) (Fig. 4c).

**Fig. 4** Optical micrographs of component near damaged location (a) overall solidification structure, (b) large inter-connected (white arrow) and isolated small size carbide distribution (yellow arrow) within matrix, and (c) bright irregular-shaped chunky carbide (Color figure online)

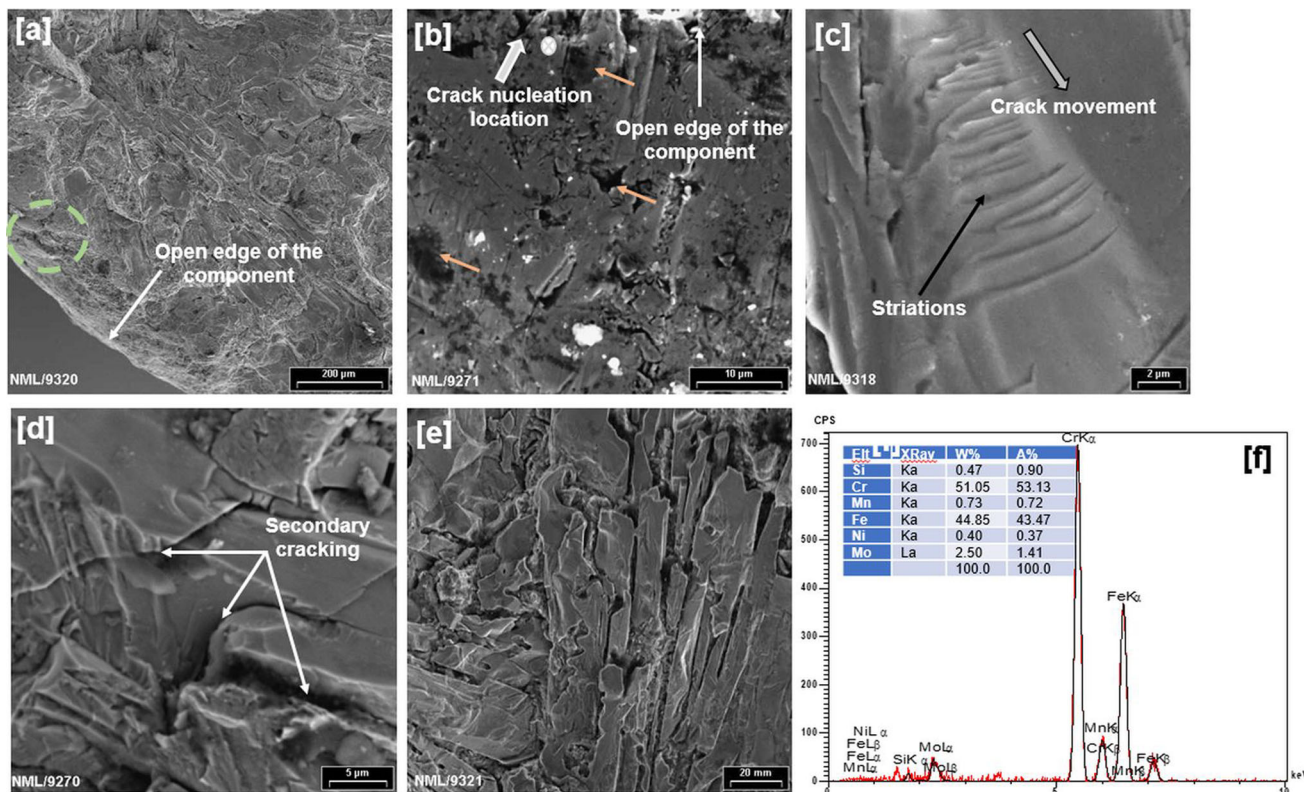
marked difference with respect to others and was further investigated in detail (Fig. 5). Figure 5a presents low magnification image of the location as shown in Fig. 2c. Overall appearance represented the characteristic of transgranular cleavage fracture with limited ductility. The crack initiation location contained large size carbides and

discontinuities (Fig. 5b). Characteristic x-ray spectrum was obtained from the location shown in Fig. 5b (cross-point) and endorsed the presence of complex carbides (Fig. 5f). Under cyclic loading, when the crack propagated, striations were formed over fracture surface and became the signature of fatigue (Fig. 5c). The investigated alloy

**Fig. 5** Fractographs of location marked in Fig. 2c (yellow circle) (a) overall image exhibiting location of fatigue crack initiation (green circle) (b) magnified image of marked region of Fig. 5a showing fracture initiation location, surrounded by chunky second phase and pin holes (small arrows) (c) local striations and crack propagation, (d) secondary cracking in the adjacent region of crack propagation, (e)

fragmentation of complex carbides, and (f) characteristic x-ray spectrum and semi-qualitative analysis of cross-marked region of Fig. 5 (Color figure online)

was brittle in nature. Therefore, state-of-the-art beach marks over a wide zone has not been found during fractographic examination [7, 8]. Secondary cracking/decohesion between precipitate and matrix was evident over fracture surface owing to limited ductility of the alloy and heavy grinding load (Fig. 5d). The complex carbides adjacent to the area of crack propagation were also fragmented endorsing the limited capability of the alloy to accommodate deformation under severe stress.

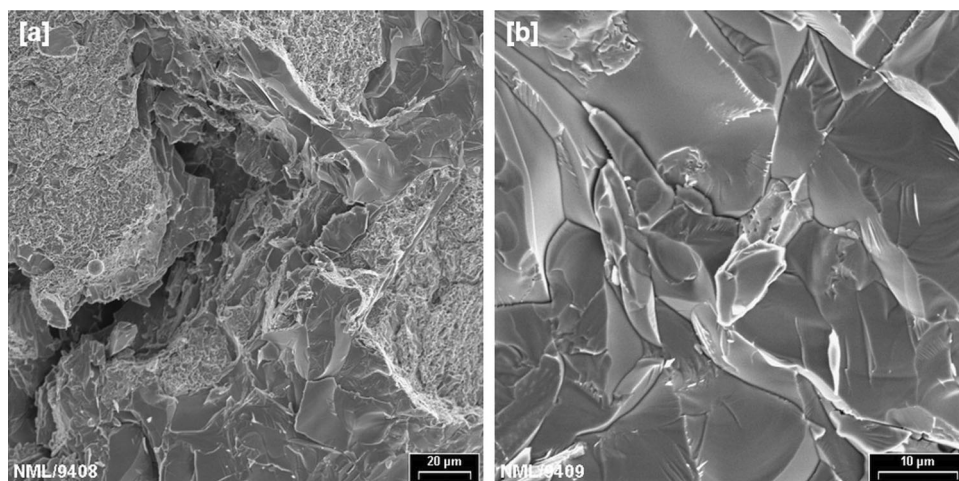
Inter-granular faceted morphology has been observed in fractographs of the impact tested specimens (Fig. 6). The overall appearance of fracture surface of the samples envisaged negligible ductility of the alloy.

**Fig. 6** Fractographs of impact tested specimens (a) intergranular failure and (b) faceted fracture surface

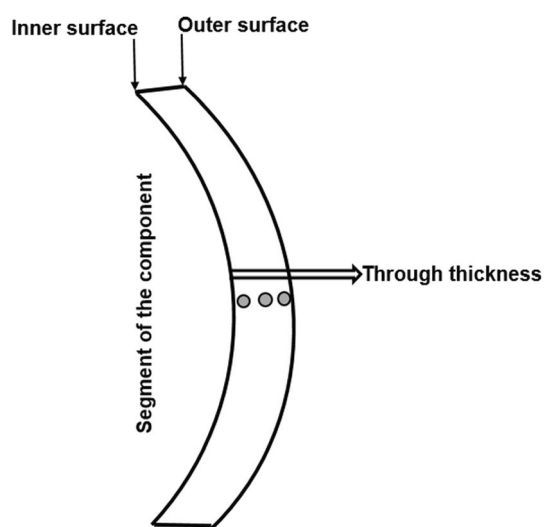
**Fig. 7** Direction of residual stress measurement (arrow mark with schematic locations)

Surface residual stress (RS) has been measured for the damaged component. The measurement was done just below the fracture surface and its surrounding exhibiting very high tensile residual stress of the order of  $\sim 170$  MPa (Fig. 6). Such high tensile residual stress perpendicular to the plane of crack propagation further contributed to fast movement of the crack (Fig. 7).
