# Root Cause Analysis of Failed AISI 440C High Carbon Stainless Steel Used in Aerospace Actuator Systems

Lagudu Yerrinaidu · K. Jalaja · Sushant K. Manwatkar · Rohit Kumar Gupta

Submitted: 18 April 2024 / Accepted: 21 April 2024 / Published online: 24 May 2024  
© ASM International 2024

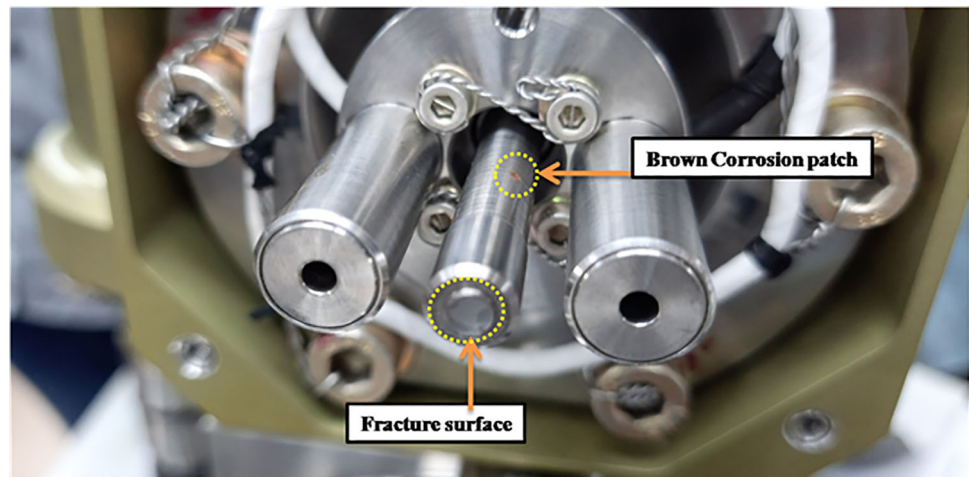
**Fig. 1** Photograph showing the failed HAV spool with failure location with arrow

Hydraulic amplifier valve (HAV) spools are used in flow control devices of launch vehicle actuator systems. In the current case, failure was observed near the undercut region of the HAV spool during the vibration test (Fig. 1). It failed during the vibration check for use in the flight. A detailed investigation has been carried out to understand the root cause of the failure.

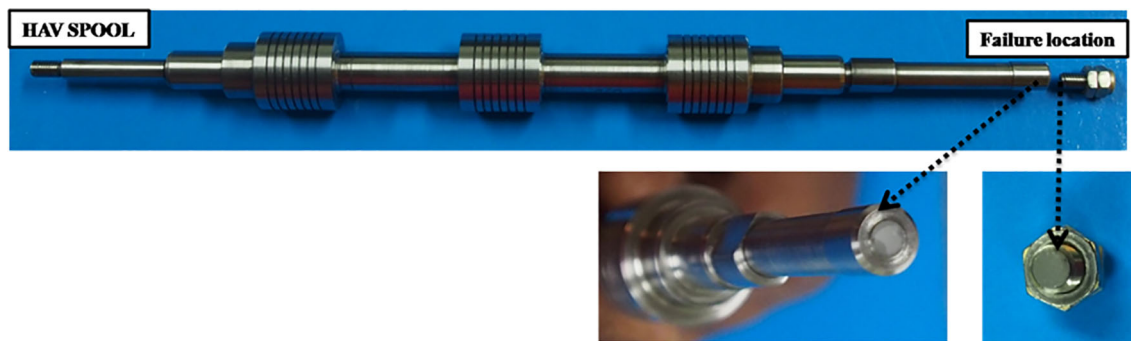
Visual and stereomicroscopic observations showed fracture occurred at the undercut region of the M5 thread portion as shown in Fig. 2. Both spool side and screw side fracture surfaces were having corrosion products as shown in Fig. 3a and b. The undercut region of the fracture surface revealed rough machining marks (Fig. 3c). Brown color corrosion patch was observed on the spool surface portion, which is slightly away from the fracture edge (Fig. 3d).

**Fig. 2** Photographs showing fracture surfaces of HAV spool both side and corrosion patch present on the surface

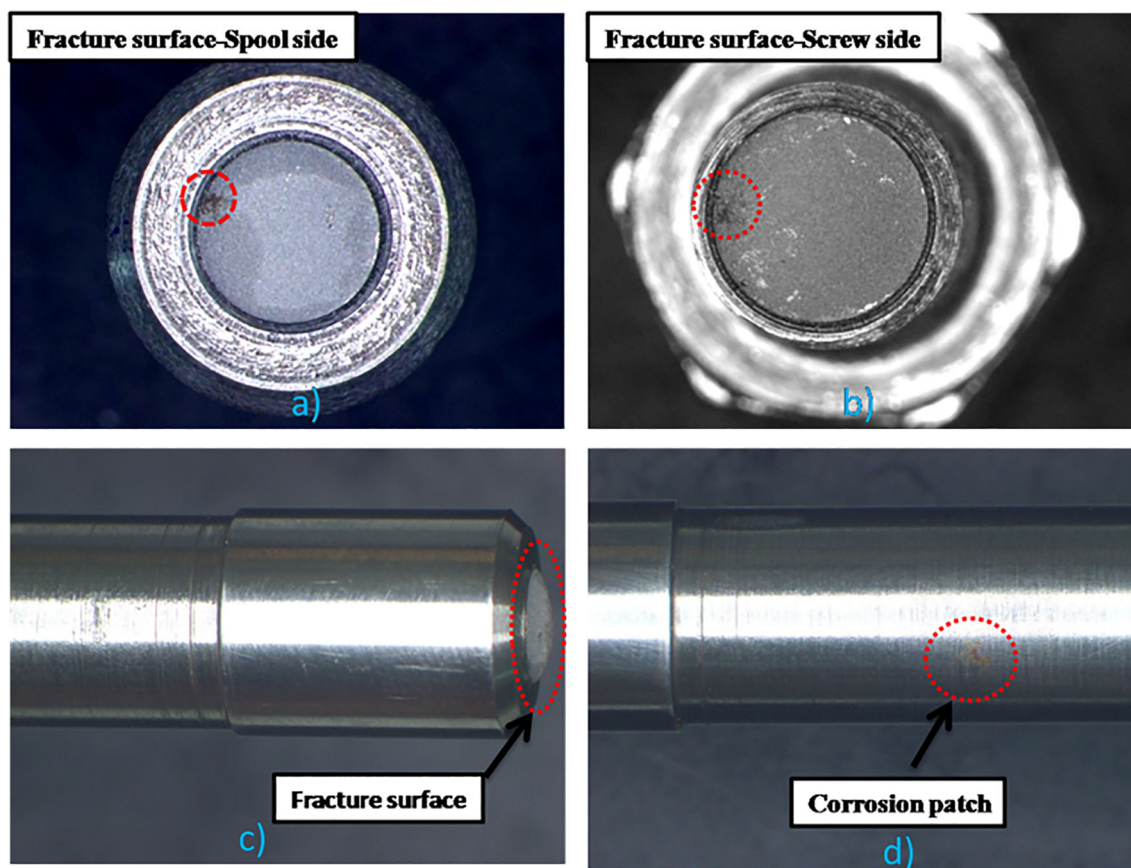
**Fig. 3** Photographs showing fracture surfaces of HAV spool both sides and corrosion patch present on the surface

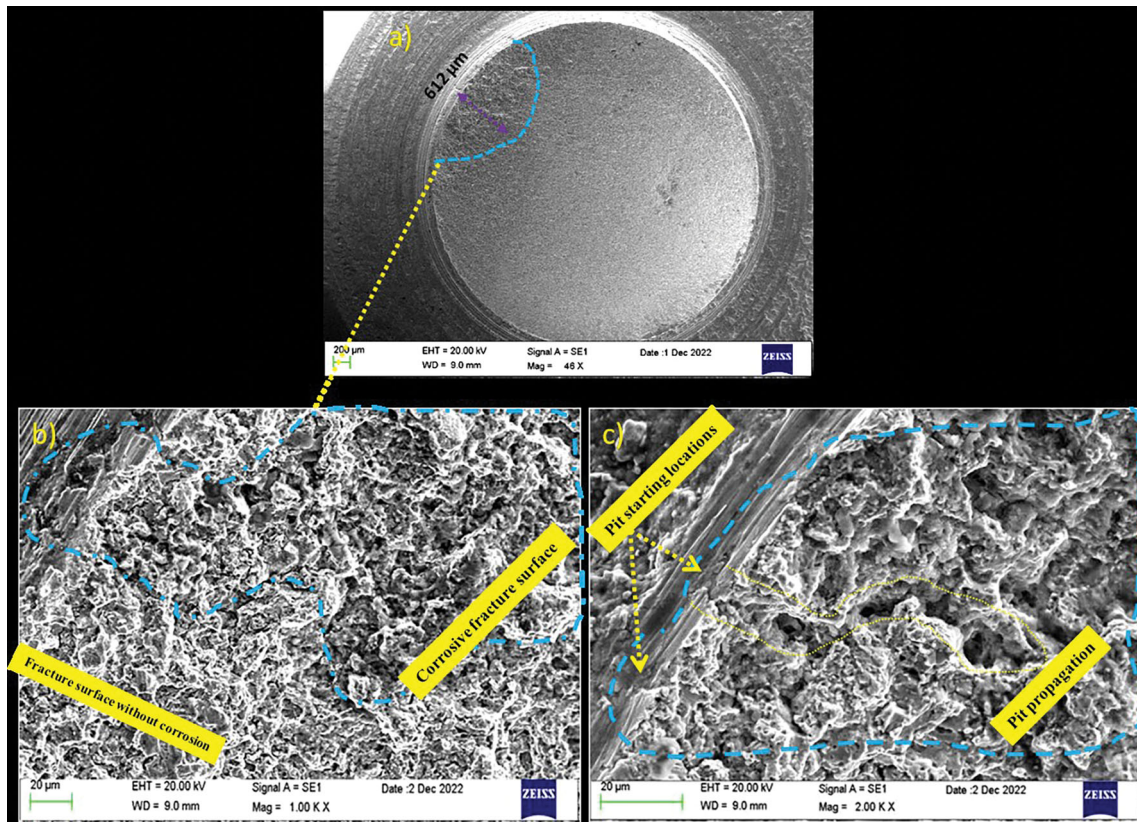
SEM observations on the HAV spool fracture surface revealed corrosion products present near to edge locations (undercut region with rough machine marks). Corrosion pit of approx. 612  $\mu\text{m}$  depth was observed in the fracture location (Fig. 4a, b and c). EDS elemental analysis confirmed the presence of oxygen and chlorine in the pit area (Fig. 5). The fracture surface away from the pit region has dimple features with primary carbide fragmentation in a brittle manner along with spherical secondary carbides (Fig. 6). Rough machine marks and small pits were observed at the undercut region of the fracture edge side (Fig. 7). A corrosion patch was observed on the HAV spool body away from the fracture surface (Fig. 8). SEM&EDS

Based on the SEM observations, it is clear that failure has occurred due to a deep pit at the undercut region. During vibration test, this pit acted as a notch and reduced the load-bearing area; hence, fracture occurred at the undercut region. It is well known that primary carbides form during the solidification of the liquid metal. Some of these carbides will be exposed to the surface during the machining stage. The corrosion pits preferentially initiate around the bigger primary carbides due to the potential

Fig. 4 SEM Fractographs showing the Pit region and away

- (a) Regular inspection at inaccessible corners and undercut regions.
- (b) Corrosion protection using lubrication or keeping in oil,
- (c) Alternatives of 440C like CR-30 and 15-5PH can be used.

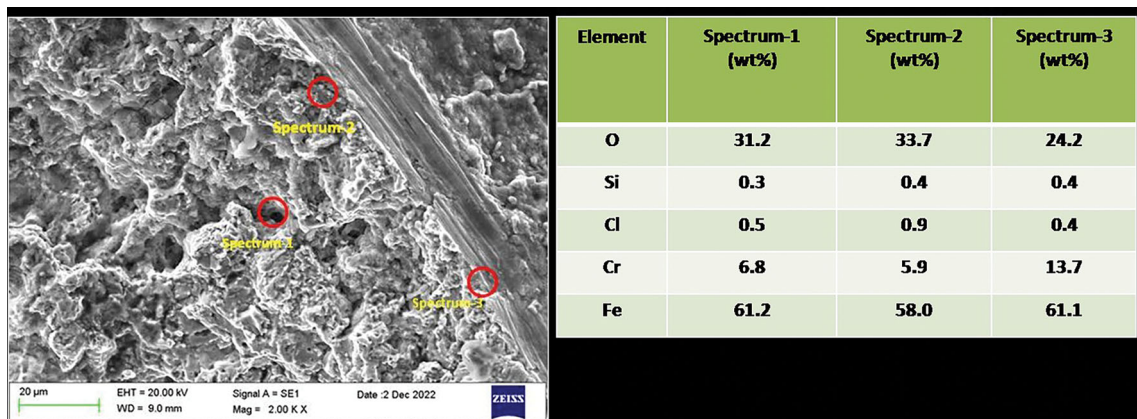
Fig. 5 EDS analysis at pit location of the fracture region

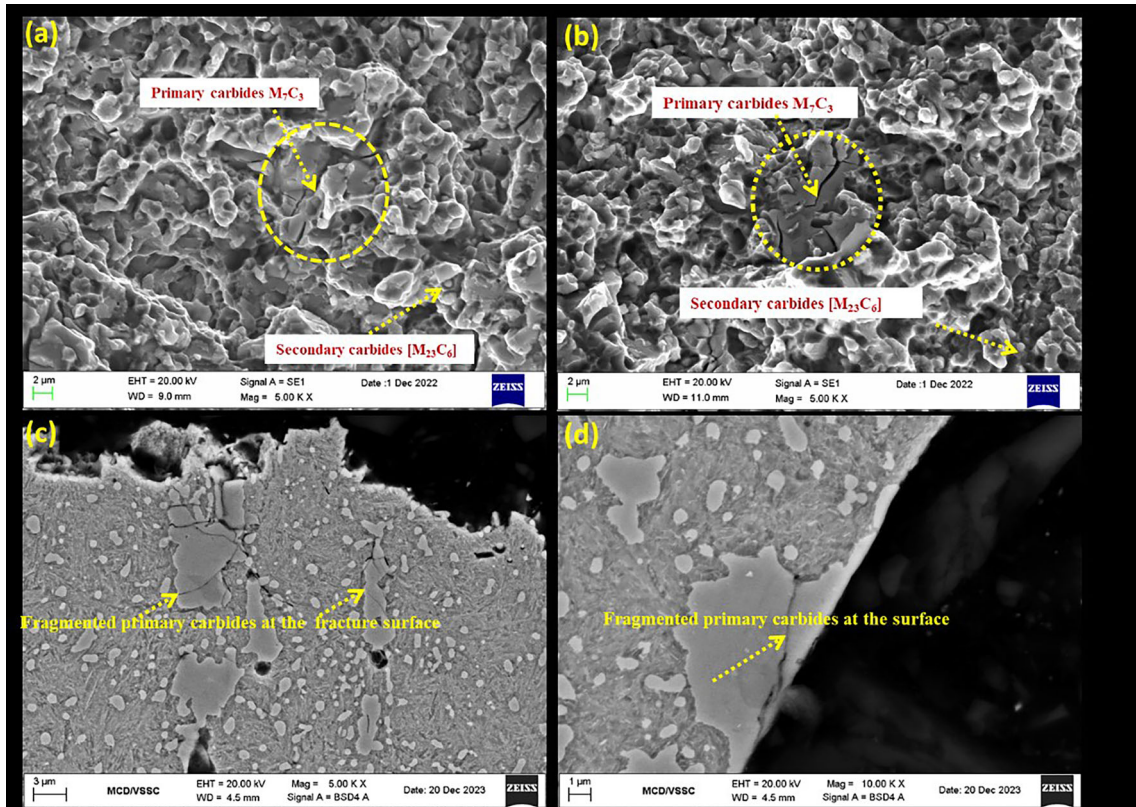
**Fig. 6** SEM Fractographs showing (a, b) Fracture surface and (c, d) Polished surface near to fracture

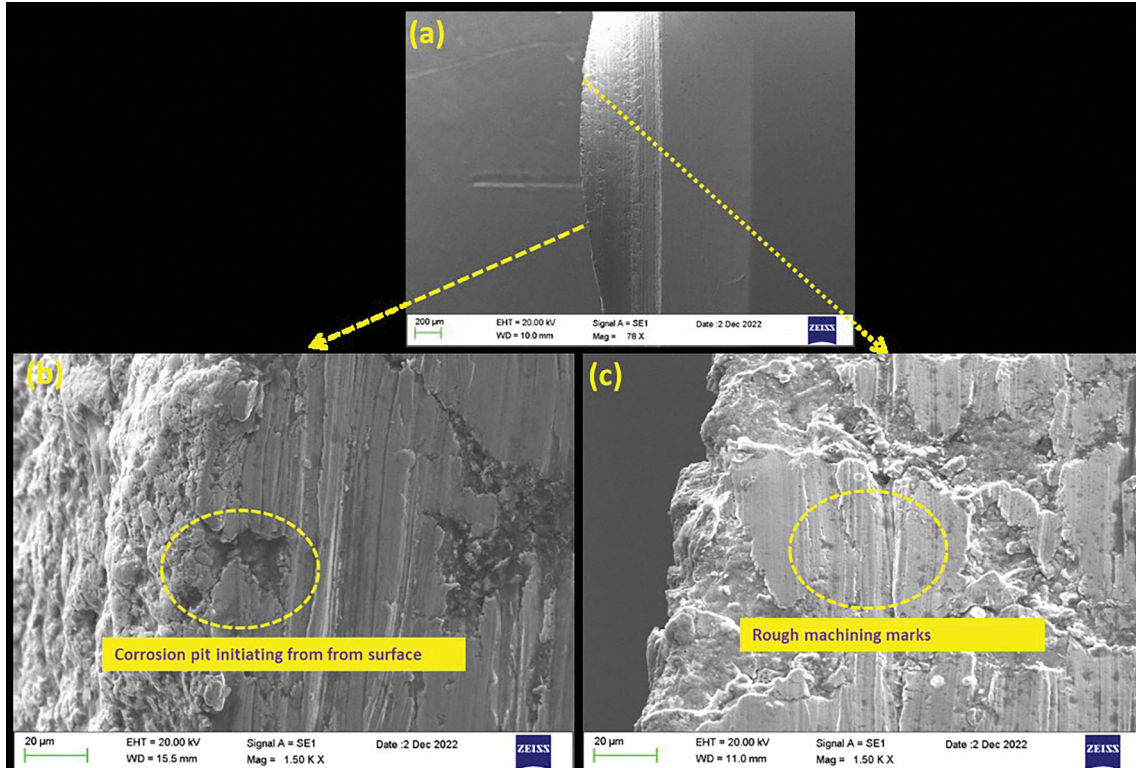
**Fig. 7** SEM Fractographs showing pits and rough machining marks

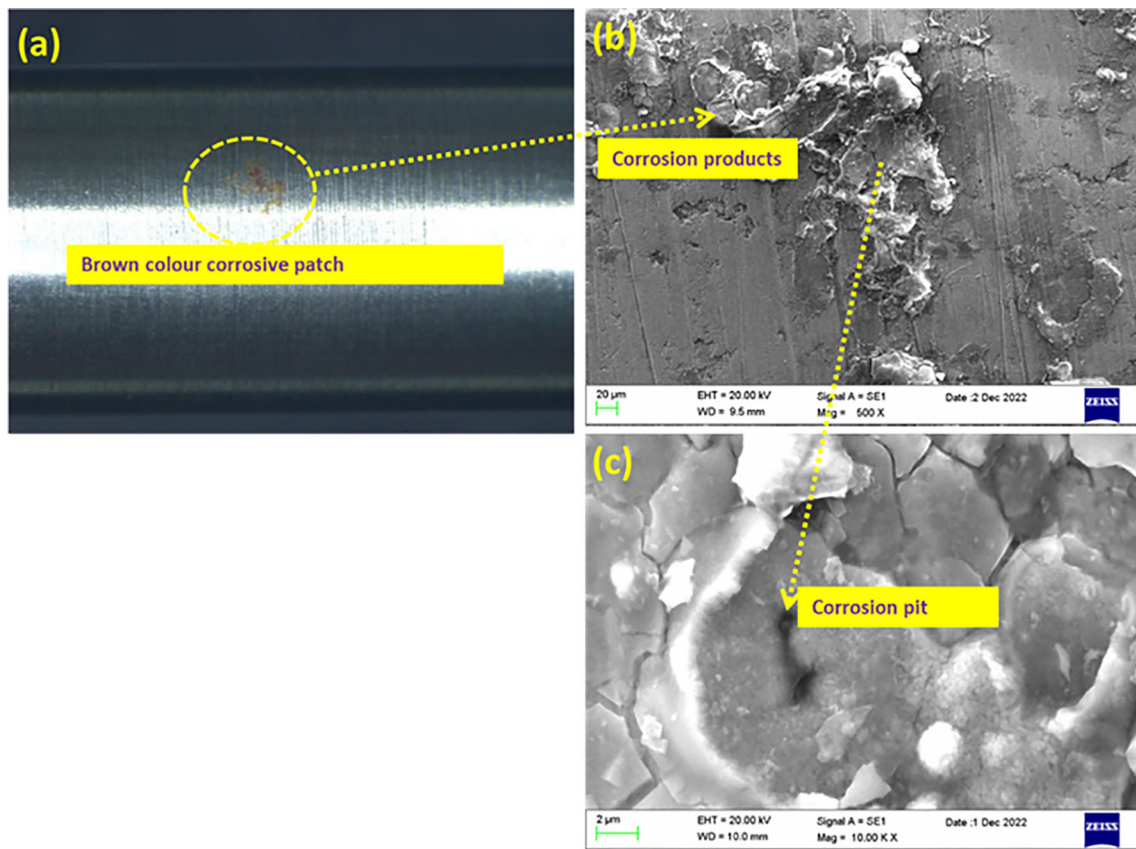
Fig. 8 Pit location away from the fracture edge with corrosion products

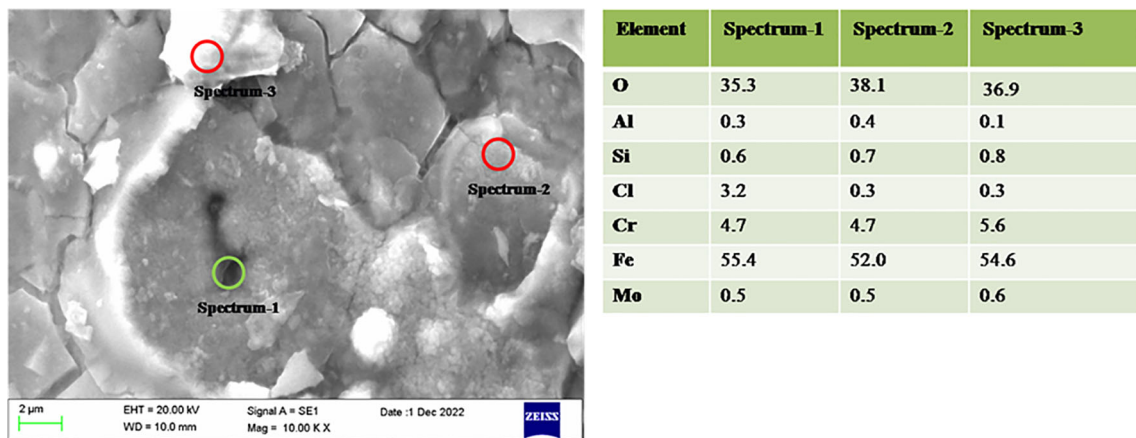
elemental analysis revealed the pit morphology and chemistry. Oxygen and chlorine presence were confirmed at the pit location in the corrosion patch. Chlorine concentration at the pit location is high as shown in Fig. 9.

Fig. 9 EDS analysis on the Pit surface and away for pit

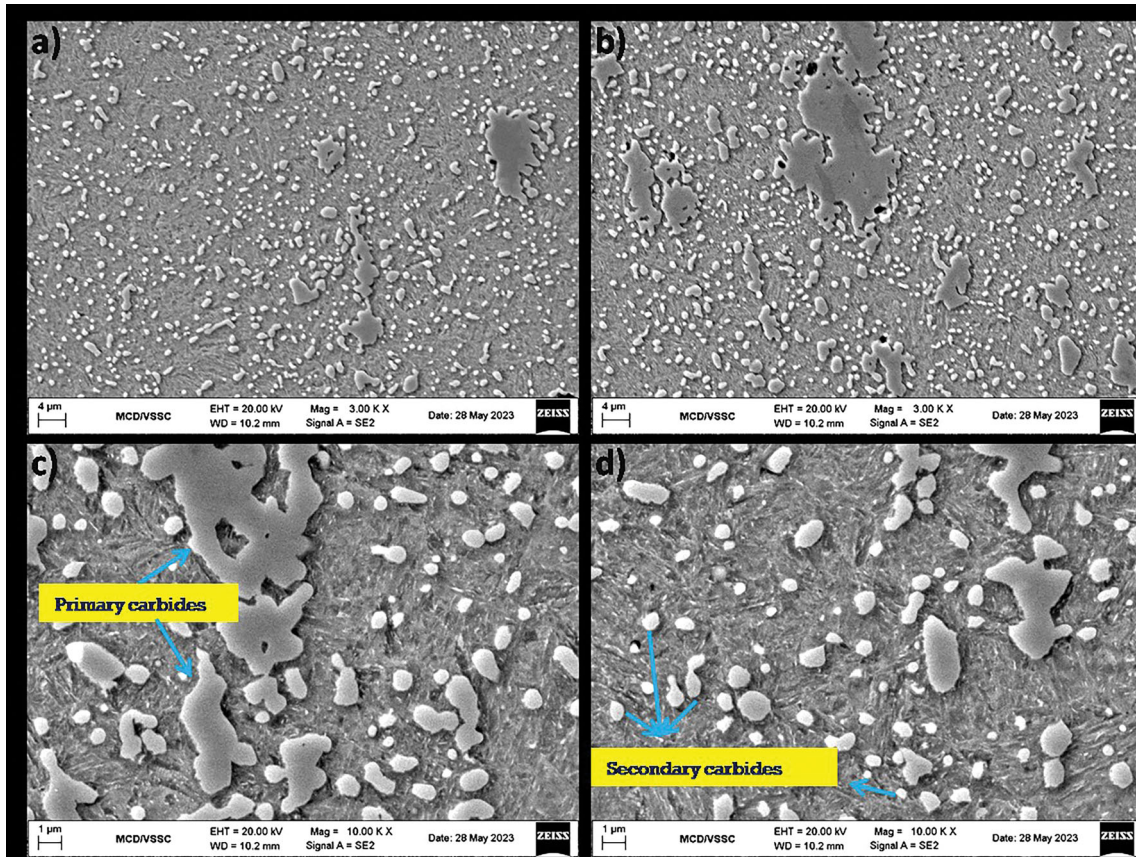
SEM micrographs revealed primary and secondary carbides with different sizes and geometry (Fig. 10 a, b, c and d). Primary carbides are in irregular shapes with different sizes-based Cr/Fe ratio. Secondary carbides are in spherical morphology with different sizes, formed during the tempering stage. EDS area map analysis confirmed the chromium-rich phases with high chromium concentration

**Fig. 10** SEM micrographs showing the primary and secondary carbides

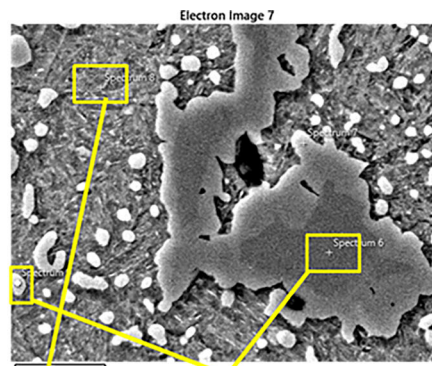
**Fig. 11** EDS Elemental analysis on the chromium-rich phases and martensitic matrix

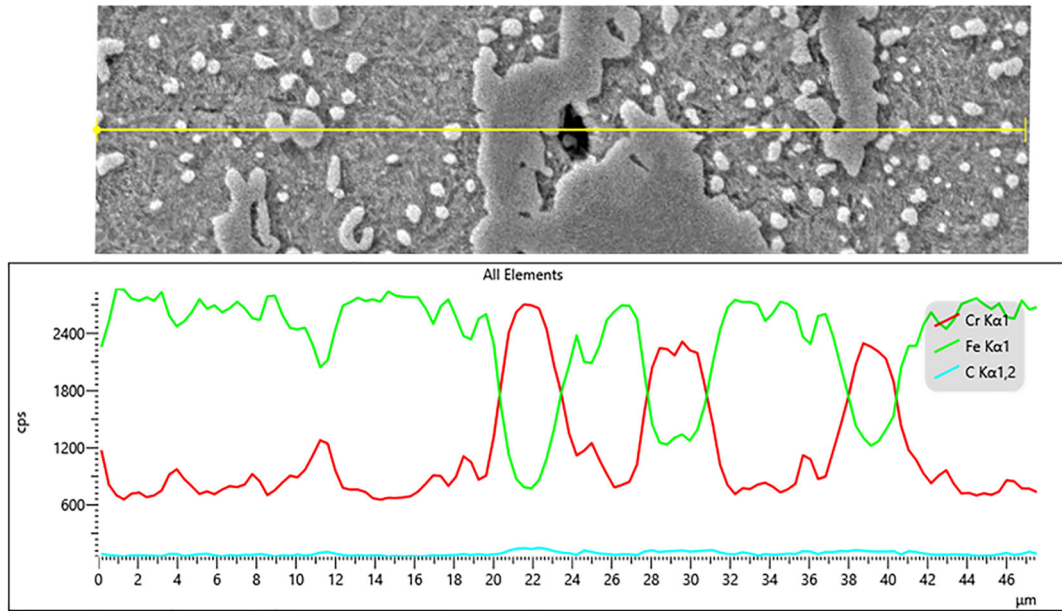
(Fig. 11). Line scan analysis confirmed the Cr variation at the martensitic matrix and carbides (Fig. 12).

Fig. 12 EDS line scan analysis showing Cr distribution

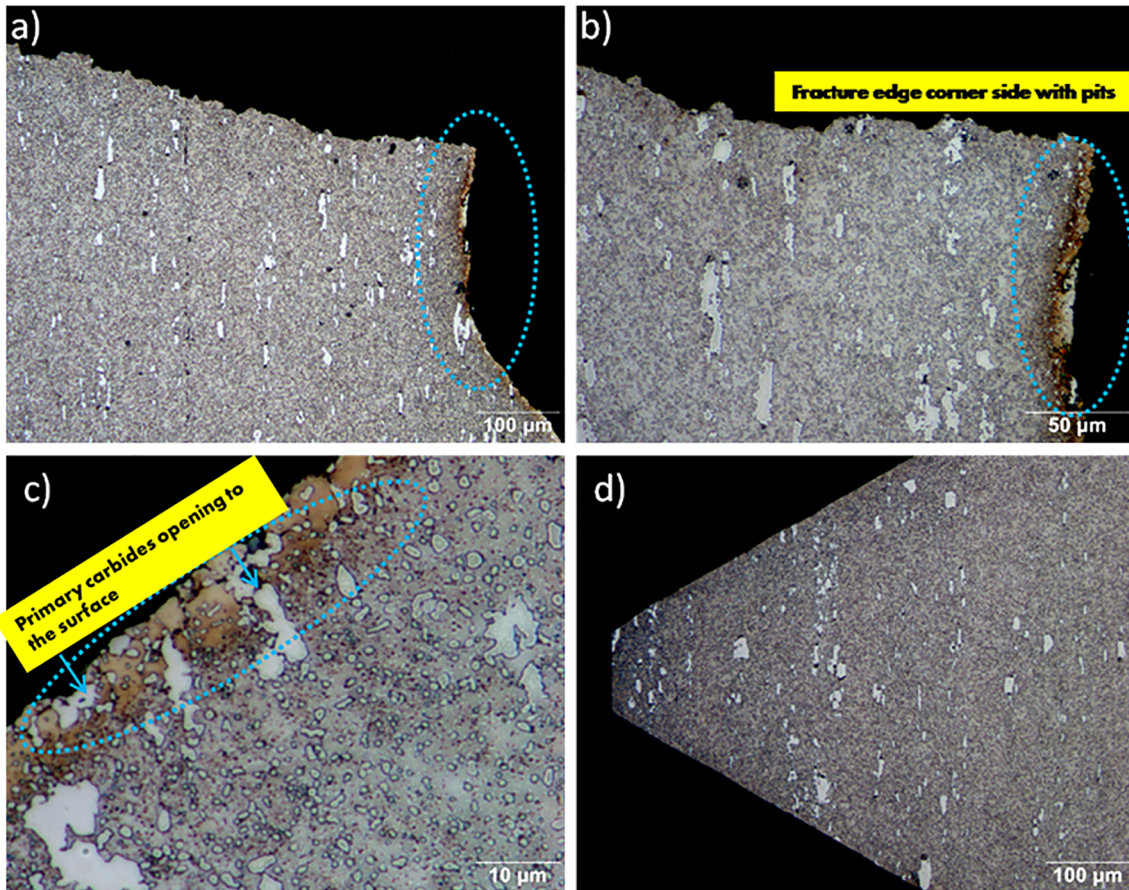
Fig. 13 Optical micrographs of the fracture surface of HAV spool M5 threaded side

consists of plate martensite, primary and secondary carbides. Most of the primary carbides align perpendicular to the fracture edge. Some of the carbides get fragmented during fracture. No secondary cracks near the fracture edge and corrosion were observed at cross section change location of the HAV spool as shown in Fig. 13a and b. Primary carbides opened to machined surface and pitting corrosion was initiated near to primary carbides (Fig 13c). During the formation of primary carbides, chromium from the matrix is taken, and subsequently, martensite matrix is leaned with elemental chromium. By any chance if the passivated chromium oxide layer gets damaged, pits will nucleate around the primary carbide since there is not enough chromium to heal the damages. Primary carbides opening to the surface during machining will create problem as the carbides are brittle compounds (Fig. 13c).

However, no damage was found in the threads, which were made by machining process (Fig. 13d). Microhardness measurements are in the range of 595–610 VHN.

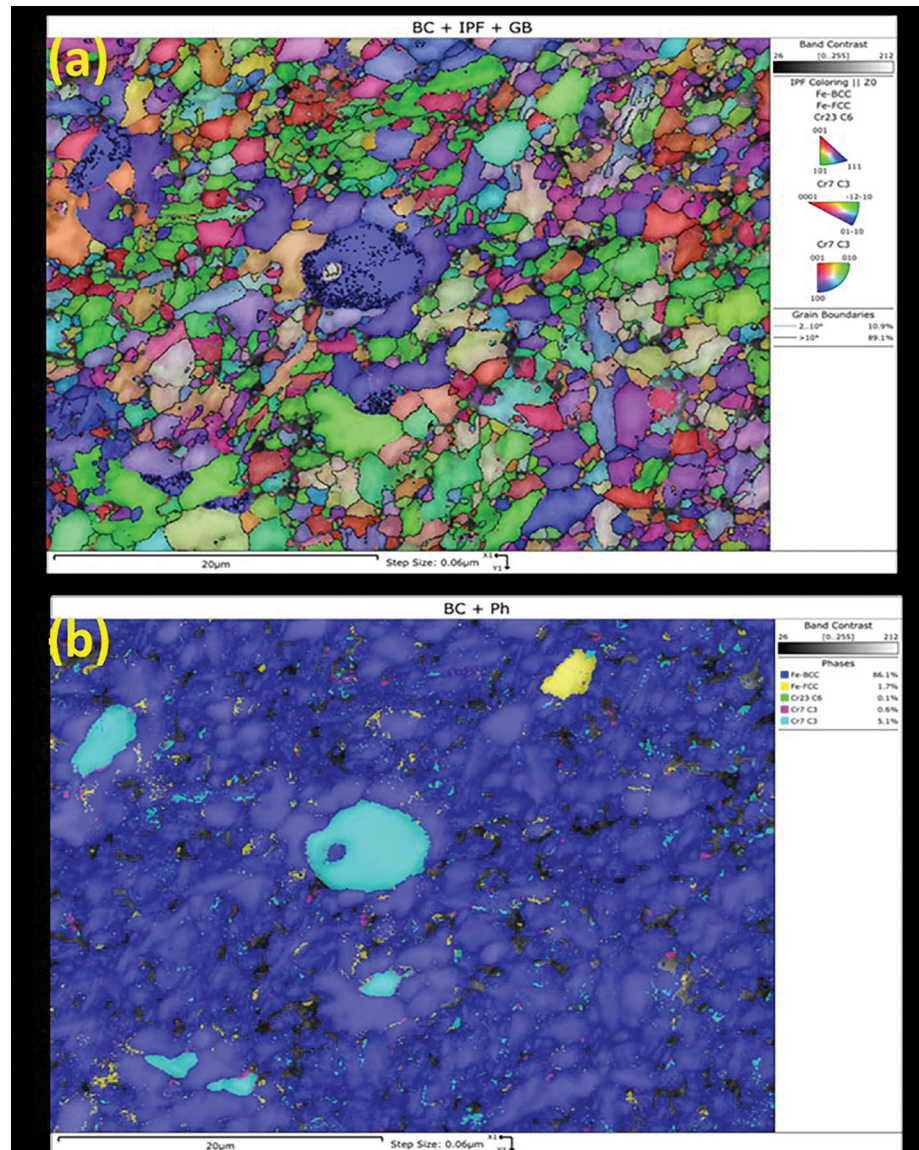
**Fig. 14** EBSD maps showing (a) BC + IPF + GB (b) BC + Ph

EBSD analysis was performed on the specimen away from fracture. BC(Band Contrast) + Ph(Phases) maps have shown the presence of  $M_{23}C_6$ ,  $M_7C_3$  carbides and small fraction of austenite (Fig. 14b). Primary carbides are bigger in size than secondary carbides. BC + IPF + GB map shows plate martensite oriented randomly (Fig. 14a).
