## Reply to “Discussion 2 on ‘Introspection on improper seismic retrofit of Basilica Santa Maria di Collemaggio after 2009 Italian earthquake’ by G.P. Cimellaro, A.M. Reinhorn and A.De Stefano” by Enzo Cartapati

Gian Paolo Cimellaro<sup>1</sup>, Andrei M. Reinhorn<sup>2</sup> and Alessandro De Stefano<sup>1</sup>

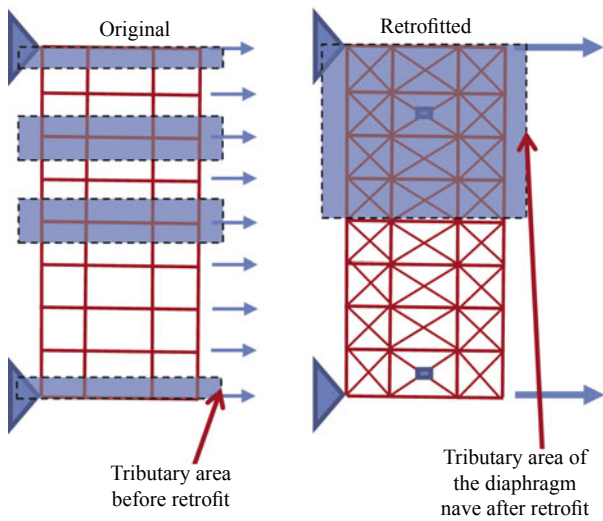
The authors visited the church right after the earthquake as shown by the pictures in the MCEER report (Cimellaro *et al.*, 2010), but they did not find any evidence of the crush of the pillars due to the axial loads. If this would have been the case, some evidence of such a movement should appear on the lateral walls and in other parts of the church, which instead show evidence of a lateral movement that the central pillars were not able to support. As shown in Fig. 1 and in Cimellaro *et al.* (2010), the retrofit intervention generated an increment of the tributary mass which increased the seismic forces tributary to the central pillar of the nave.

Figure 10 in the paper represents only a sketch of the collapse mechanism. For the scheme of the correct position of the reticular truss, the authors invite the discussor to read the MCEER report. The discussor emphasizes the fact that “*there was a significant continuity on the two horizontal structures*” and this might be the main reason for the collapse according to the authors, as explained above and shown in Fig. 1.

**Fig. 1 Increase of the tributary mass due to the retrofit**
