Damage characteristics and seismic capacity of buildings during Nepal M_s 8.1 earthquake

Abstract: The extensive damage to buildings caused by the Nepal M_s 8.1 earthquake has attracted much attention by the international community. After the preliminary scientific investigations on the different affected areas in Nepal, the construction and damage characteristics of five different types of buildings commonly existing in Nepal were discussed and the reasons of their disaster performance were analyzed. Types of buildings investigated include reinforced concrete (RC) frame structures, rubble structures, brick-wood structures, raw soil structures, and brick-wood structures of historic buildings. In addition, the weak links of the seismic design were pointed out, which was very important for the post-earthquake reconstruction and recovery, and gave a preliminary explanations for the damage experienced.

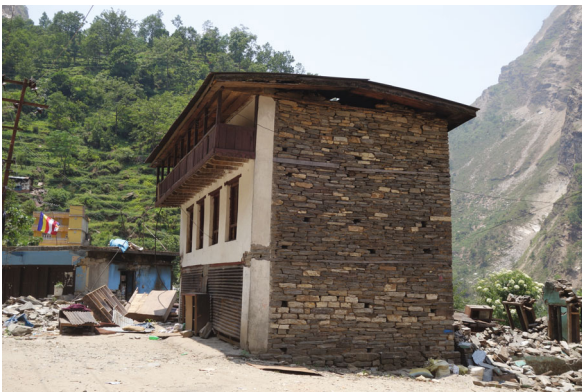
In general, for these rubble structures, the vertical loads are mainly supported by the rubble walls and partly by the timber frames, while the horizontal loads are mainly supported by the walls, as shown in Fig. 2.

Fig. 2 Typical rubble structure

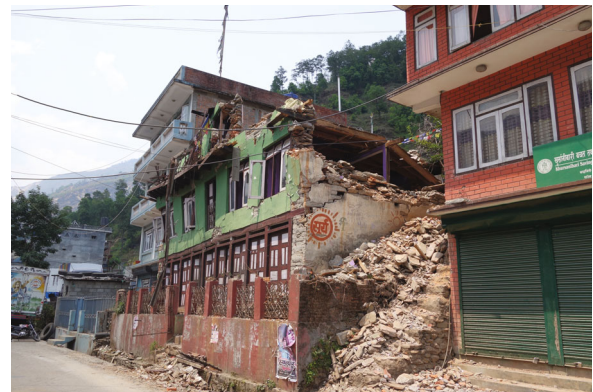
The general damage patterns consist of an initial drop of top of the gable, the connection of the gable and the longitudinal walls yields, followed by collapse of the gable the longitudinal walls, as shown in Fig. 3. Without the effective connection, the timber frames cannot support the walls. However, the internal timber frames can prevent the walls falling down inward to some extent, so most of the damaged walls collapse outward. When the timber frames collapse, the roof falls down and the buildings completely collapse (Fig. 4).

Fig. 3 Partial collapse of a rubble structure in Intensity VIII area

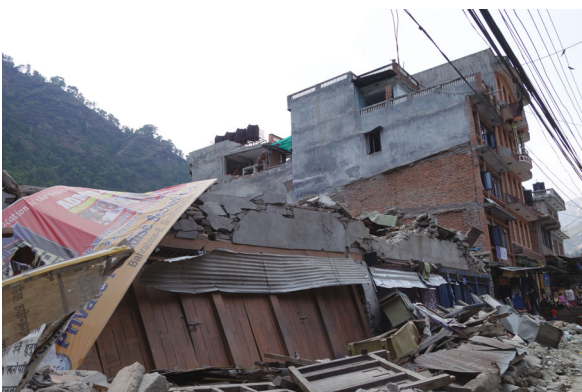
Fig. 4 Complete collapse of a rubble structure in Intensity IX area

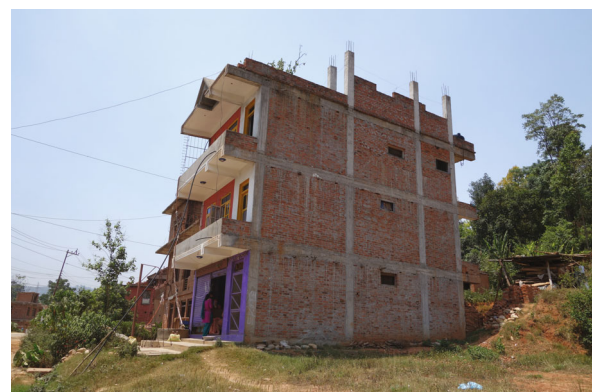
are half outcropped on the roof. The thickness of the cast-in-place floors and roof panels is about 100 mm. In almost all structures, the sectional dimensions of the beams are larger than those of columns, which obviously does not obey the seismic conceptual design principles, i.e., strong column and weak beam, as well as the minimum sectional dimensions of components, i.e., usually the sectional dimension of beams 300 mm × 230 mm, columns 230 mm × 230 mm. The infill walls of the enclosing walls are constructed by the solid bricks of 220 mm × 100 mm × 50 mm, the thickness of which is 220 mm while that of the inner walls is 100 mm. The story height is 3.0 m, and the spacing between the columns is usually between 3 m and 3.9 m (Fig. 5).

Fig. 5 Typical RC frame structure

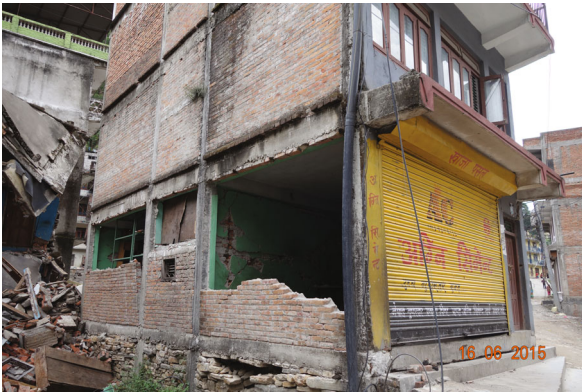
The frame structures are mostly three to five stories. The damage generally began with the infill walls (Fig. 6), and then the column capitals of the bottom frames damage, prior to the column bottom. The major reason is that almost all frame columns are directly cast in place till the beam bottom during construction (as shown in Figs. 7 and 8), and there are no dense stirrups around the joints during design, so the column capitals are easily to shear off (see Fig. 9). In addition, the upper parts of the infill walls firstly drop due to the window openings, and the bottom parts could bear the frame lateral force together with the frame columns, so the damage of the column bottom is usually lighter than the capitals. However, the lateral resistance capacity of the joints are much poorer than that of China (GB 50011-2010, 2010; GB50010-2010, 2010).

Fig. 6 Damage of the bottom infill walls of a RC frame structure

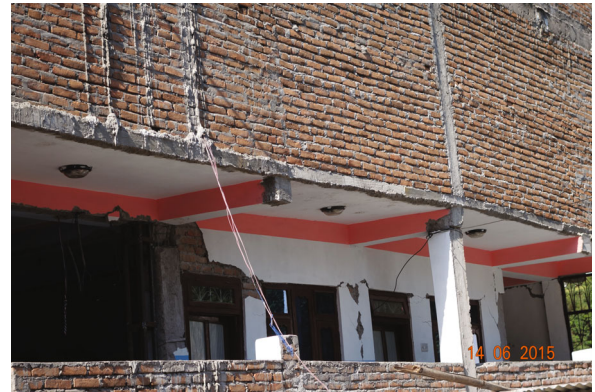
Fig. 7 Frame column cast into the bottom of the frame beam

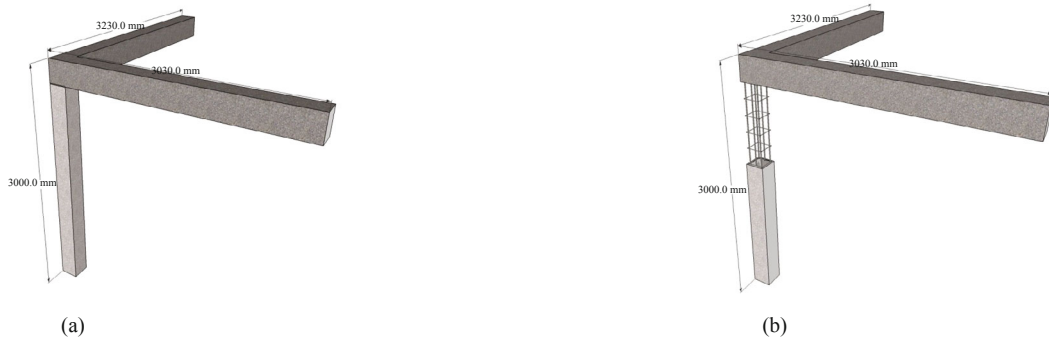
Fig. 8 Column - beam connection of RC frame structures

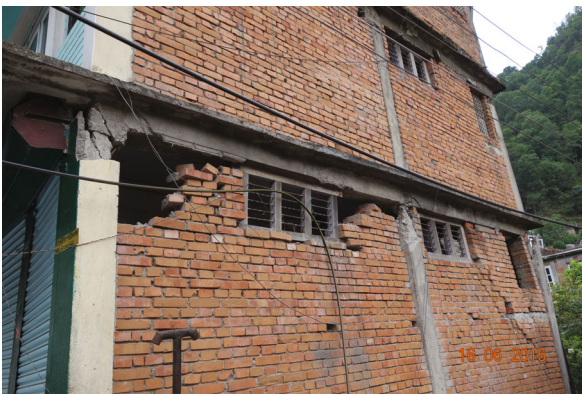
Fig. 9 Serious damage of the column capitals at the bottom of RC frame structure

dense stirrups around the beam-column joints, which caused some serious brittle failures (Sung *et al.*, 2013; Fakharifar *et al.*, 2014; Chaulagain *et al.*, 2014). Besides that, there were no construction bars in both the frame columns and the enclosing walls, which resulted in the walls being prone to leaning outward or collapsing, and rarely participating in the lateral force resistance with frame columns.

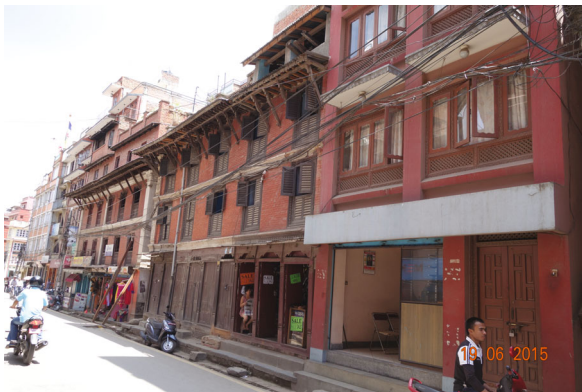
Fig. 10 Traditional brick-wood structure in the city of Katmandu

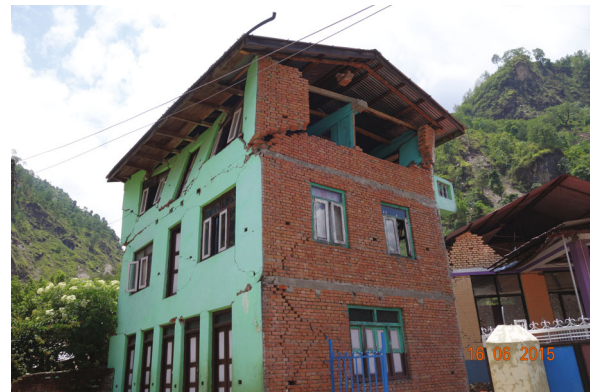
Fig. 11 Serious damage of a brick-wood structure in high intensity regions

In the lower intensity areas, it is very common that the top of the gable walls of the brick-wood structures dropped. Since the transverse walls and longitudinal walls are not confined by the ring beams and without bar connections, the top gable walls cracked and partly collapsed, and the shear inclined or cross cracking occurred at the bottom resulting in collapse. Due to the lower grade of mortar or mud used in some structures, the cracks extended along the brick joints and few cracks cut off the brick, indicating poor shear resistance capacity of the brick walls.

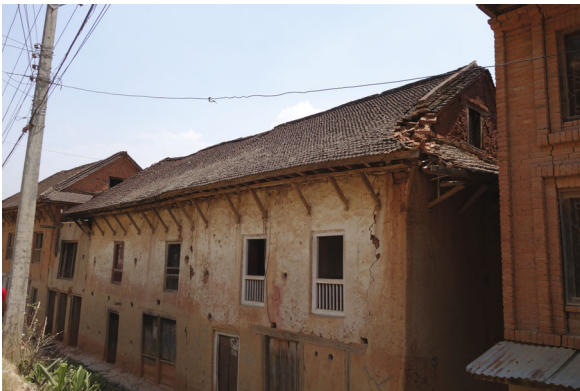
The seismic capacity of the raw soil structures is poorer than the brick-wood structures. Due to the internal timber frames, the overall stability is good, but the strength and ductility of the adobe bricks are poor, in addition to the lack of connections under wall construction, the seismic capacity is poorer than the brick-wood structures while better than the rubble structures (Fig. 12).

Fig. 12 Moderate damage of the brick-wood structure in Intensity VII areas

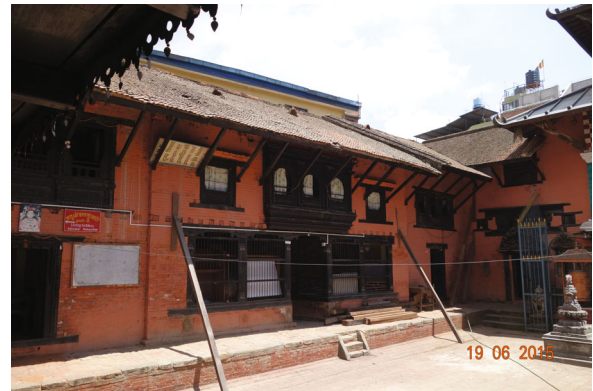
Since there are no reliable connections between the brick walls and internal timber frames, and there is lack of the connecting construction between the longitudinal and transverse walls (Sun *et al.*, 2014; Wang, 2008; Zhang and Jin, 2008), the damage pattern usually shows that the walls collapse outward and the corner cornice damage until the buildings is completely collapsed (Fig. 13 and Fig. 14). Some Hindu temples were constructed only by the brick pedestal and brick walls with the loess sand mortar, multi cornice structures, which were seriously damaged during this earthquake, as shown in Fig. 15.

Fig. 13 Leaning outward of the wall in Hindu temple of living Buddha in Katmandu

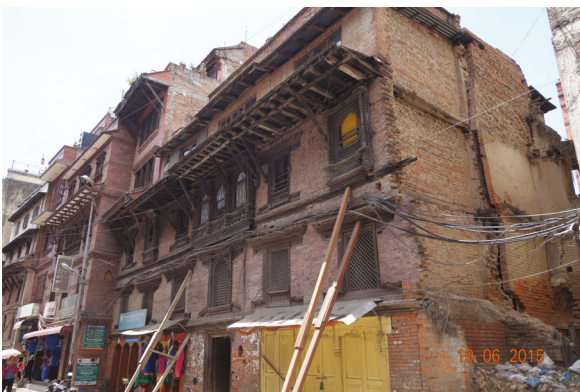
Fig. 14 Inclining outward and partial collapse of the wall in a traditional brick-wood structure in Katmandu

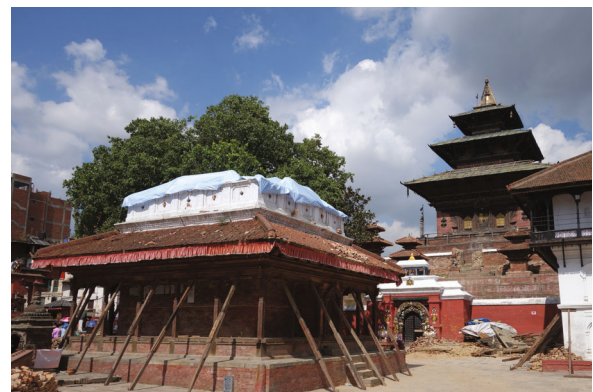
Fig. 15 Collapse of the temple in Durbar Square, Katmandu
