Microstructure, Fatigue Behavior, and Failure Mechanisms of Direct Laser-Deposited Inconel 718

ALEX S. JOHNSON,¹ SHUAI SHAO,¹ NIMA SHAMSAEI,^{2,4}
SCOTT M. THOMPSON,² and LINKAN BIAN³

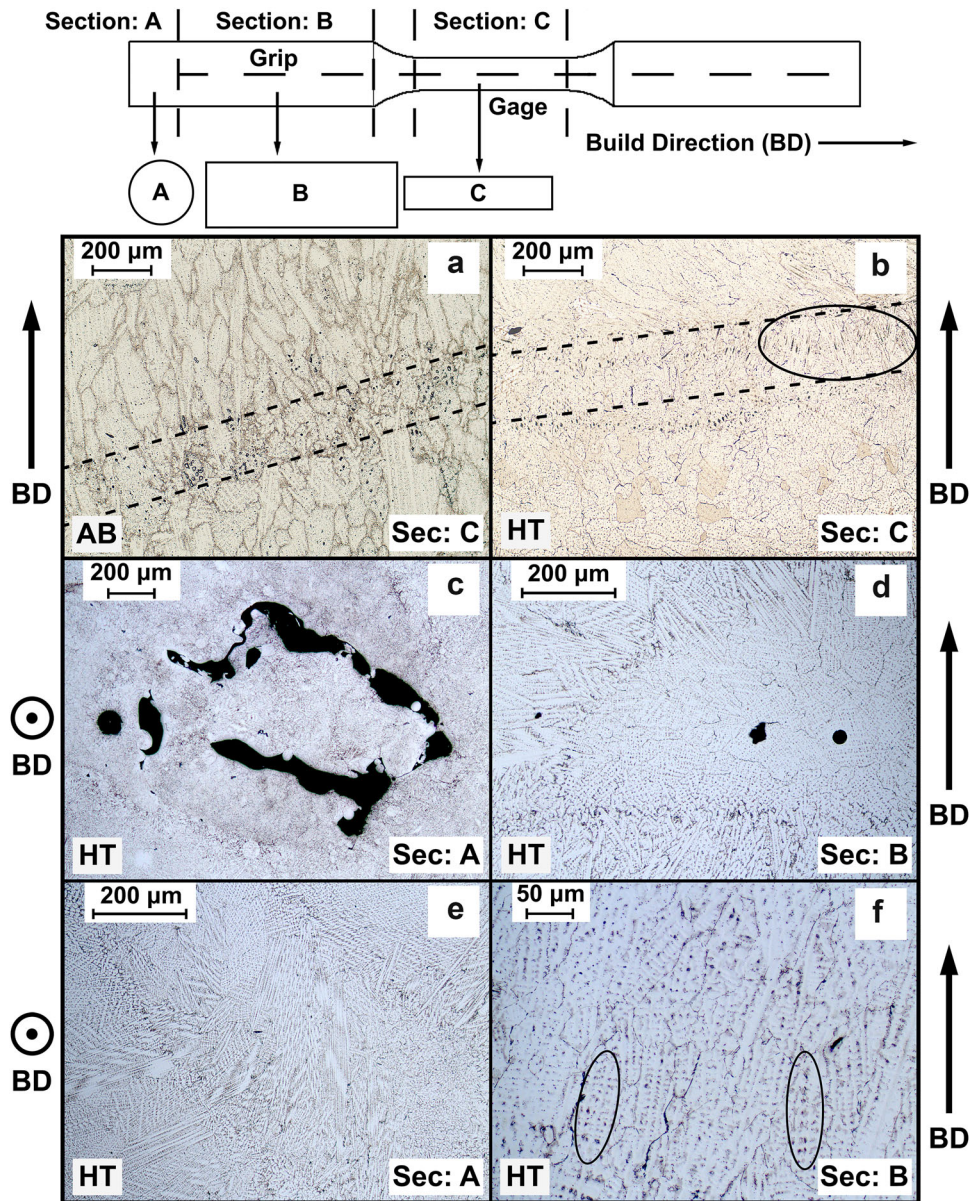
section and the gage section. These sections were cut in half longitudinally, i.e., Sections B and C in Fig. 1, respectively, to view the inner sections of the specimens. For the heat-treated sections, a circular cross section of the substrate-sided grip section was also examined, i.e., Section A. The gage section of the as-built specimen was found to contain large and elongated grains (Fig. 1a, average of $\sim 170 \mu\text{m}$ in size along the elongated direction), with variation in grain size and faint dendritic structure within the grains, as seen in the lower half of Fig. 1a.

After heat treatment, small portions of dendritic structures, specific to the AM process,^{18–22} remained in the gage section (Fig. 1b, circled). After heat

treatment, most of the large, elongated grains initially present in the as-built gage section (Fig. 1a) were found to recrystallize and form smaller, equiaxed grains (Fig. 1b) consistent with the results of Zhao et al.¹⁸ and Liu et al.¹⁹ The average grain size at the heat-treated gage section was found to be $\sim 43 \mu\text{m}$. A clear interlayer fusion zone, characterized by smaller and randomly shaped grains containing dendrites, which interrupts the normal microstructural consistency, seems to persist even after the heat treatment, as seen between dashed lines in Fig. 1a and b.

Lack of fusion between layers is found to be prevalent in the first several layers deposited near the substrate (section A, Fig. 1c). This lack of fusion

Fig. 1. Sectioning diagram and microstructure of heat-treated and as-built AM Inconel 718 specimens. (a) Microstructure of as-built gage section. (b) Microstructure of heat-treated gage section. Regions inside dashed lines are fusion zones between layers. (c) Circular cross section of heat-treated grip section near substrate (Section A). (d) Microstructure of heat-treated grip section showing pores. (e) Residual dendritic structure in heat-treated specimen (Section A). (f) Magnified view of the heat-treated grip section (Section B).

between the substrate and early deposited layers was also reported to occur in the “cross-bonded” specimens presented in Blackwell’s work.²⁰ These defects are most likely a result of higher cooling rates along the non-preheated substrate interplaying with the instability of the melt pool. As the build gets further away from the substrate, the previously deposited layers retain more heat and allow for better fusion of subsequent layers. Therefore, in the gage section, only small spherical pores with a diameter less than 45 μm exist, as seen in Fig. 1d. This is in agreement with Zhao et al.,¹⁸ where pore sizes from 25 μm to 70 μm were observed. As large amounts of porosity and lack of fusion tend to occur in the layers near the base of the build (Fig. 1c), it is recommended that critical structural portions of parts be built in layers further away from the substrate, with part portions near the substrate deemed sacrificial in nature.

The microstructures of specimen regions located near the substrate were found to be mainly composed of a dendritic structure even after heat treatment, as seen in Fig. 1e. More dendrites near the substrate are most likely caused by erratic, localized, and instantaneous cooling rates occurring during the solidification of deposited material.^{18–21} Further from the substrate after heat treatment, the dendrites become more dissolved into the more equiaxed grain structure. An interesting characteristic is presented in Fig. 1f, as was explained by Qi et al.;²² the spotted pattern observed (Fig. 1f circled, and Fig. 1b, lower grains) within grains is likely residual interdendritic Laves phases left over from the heat treatment process. During the employed heat treatment, most of the Laves phases did dissolve into the matrix or transformed into the δ phase. The solution annealing temperature was likely not sufficiently high for fully dissolving these phases back into the material matrix.²²

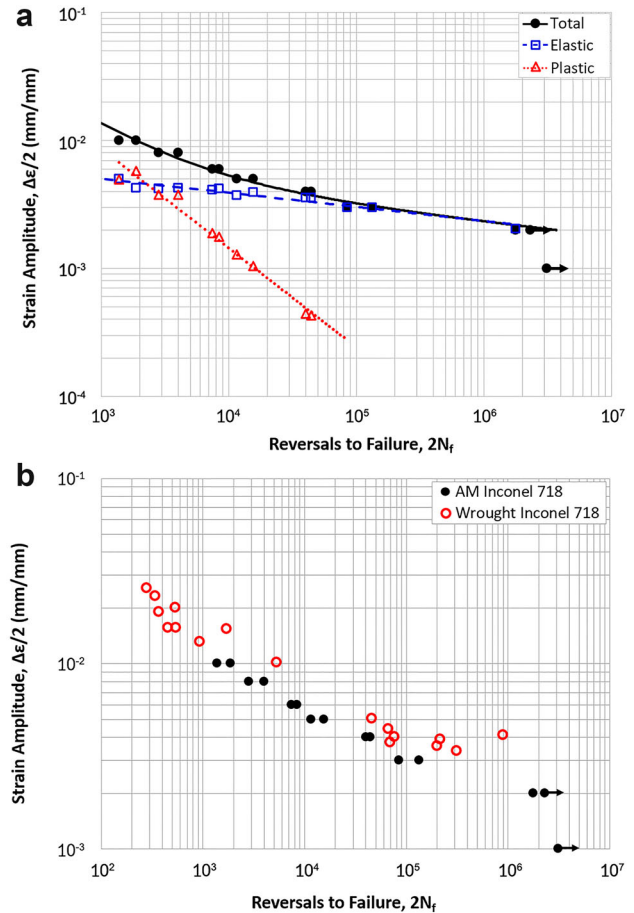
The fatigue data for wrought Inconel 718 reported by Brinkman and Korth¹⁶ are presented in Fig. 2b and compared against the AM data generated herein. Note that the heat treatment process used in both studies was the same. The results demonstrate that the fatigue lives of AM specimens in this study are shorter than those of their wrought counterparts. In the high-cycle fatigue regime, the

Fig. 2. (a) Total, elastic, and plastic strain amplitudes versus fatigue lives data and fits for AM Inconel 718 specimens in this study. (b) Strain-life fatigue behavior of AM Inconel 718 and its comparison to wrought Inconel 718. Arrows indicate runout tests.

AM specimens were found to possess even shorter fatigue lives (up to an order-of-magnitude) relative to wrought specimens. As will be discussed in more detail later, AM defects are most likely the major cause for the reduced fatigue life.

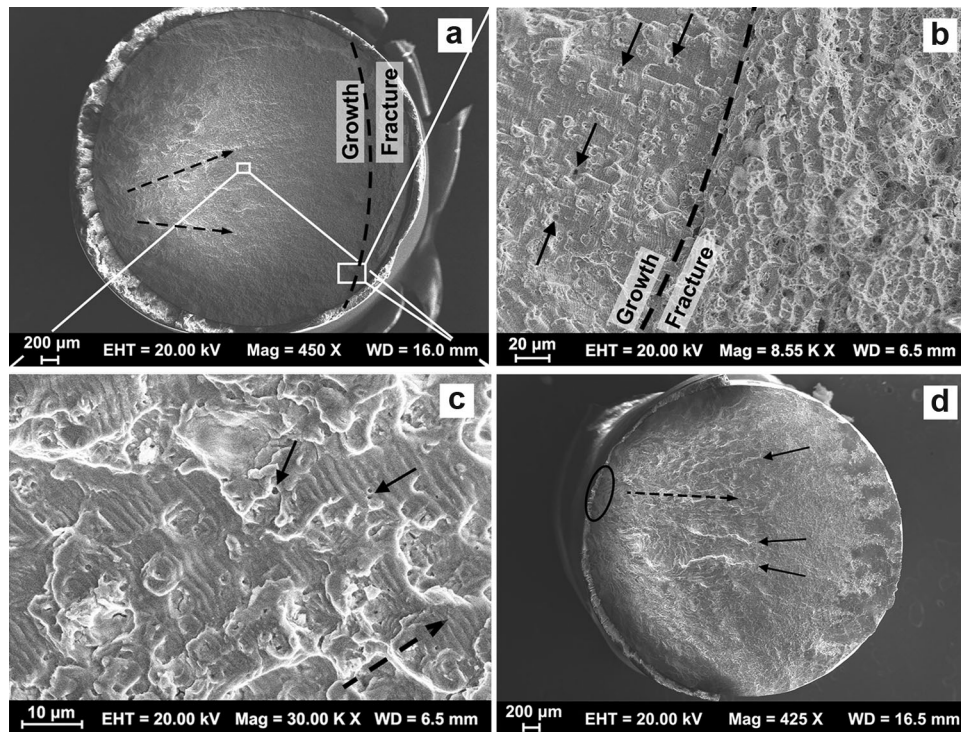
SEM analysis of the resulting fracture surfaces reveals insights into the fatigue behavior of the AM Inconel 718 specimens. Representative fracture surfaces obtained from fatigue tests in high- and low-cycle regimes are presented in Figs. 3 and 4, respectively. All specimens exhibited distinct crack growth and final fracture regions. Crack growth regions are observed by fine striations (Fig. 3c and right box in Fig. 4b) running perpendicular to the crack growth direction (dashed arrows in Figs. 3 and 4). The final fracture regions are distinguished by the high amount of dimpling on the fracture surface (Fig. 3b), indicating ductile final fracture behavior. Most crack growth regions are generally flat and of transgranular mode with clear rivermarks (Fig. 3d, solid arrows) running back toward the initiation point (Fig. 3d, circled). The general fracture surface features mentioned earlier mirror those reported by Amsterdam and Kool,⁷ whom also investigated AM Inconel 718.

Many exposed pores can be observed on the high-cycle and low-cycle fatigue fracture surfaces in Fig. 3b and c and Fig. 4f, as marked by solid black arrows. Inclusion particles also appear on the fracture surfaces as observed in Fig. 4b and d (circled). These particles are in the range of 10–20 μm in length but have different shapes. These surface or near-surface particles served as crack initiation sites for several fatigue specimens investigated herein. For specimens in the high-cycle regime, no pores were found to accompany particles seen in initiation zones. EDS was implemented to investigate the nature of the particles. In Fig. 4, the numbered particles in circles were identified to be (1) carbide, (2) magnesium oxide, and (3) aluminum oxide particles, respectively.

Fig. 3. Fatigue fracture surfaces of AM Inconel 718 from high-cycle fatigue tests. Crack growth directions marked by dashed arrows. (a) Fracture surface of a 0.003-mm/mm strain amplitude test, final fracture region to the right of the dashed line. (b) Transition from crack growth to final fracture (indicated by dashed arc), larger exposed pores indicated by solid arrows. (c) Magnified view of notable striations present on crack growth region, as well as exposed pores indicated by solid arrows. (d) Example of river marks (indicated by solid arrows) for a 0.002-mm/mm strain amplitude test leading back toward the initiation site (circled).

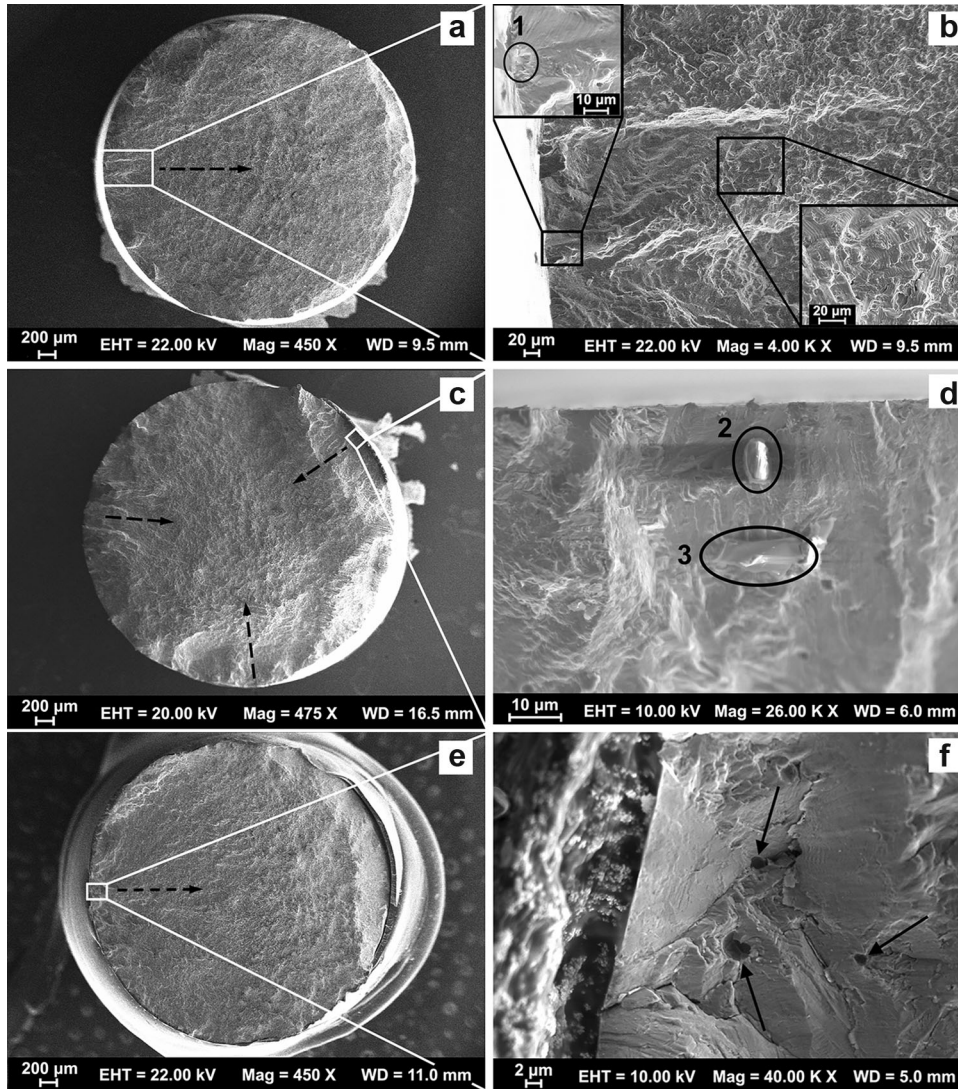
A few of the fracture surfaces were also found to have pores, between 1 μm and 3 μm in size, in near proximity to the surface that initiated the crack, like those observed in the initiation region of Fig. 4e and magnified in Fig. 4f (top arrow). The amount of exposed pores in this area indicates that they may have played a role in early crack initiation. Areas around the pores were analyzed via EDS and found to contain a high amount of carbon. The area around the lower left pore contained a high amount of boron, which is known to enhance the low-cycle fatigue life of nickel alloys.²³ Therefore, the pore

Fig. 4. Fatigue fracture surfaces of AM Inconel 718 from low-cycle fatigue tests. Crack growth directions marked by dashed arrows. (a) and (b) Fracture surface of a 0.01-mm/mm strain amplitude test. (b) Initiation area boxed and magnified on the left of (b). Initiation of the crack (circled). Striations near initiation region (boxed, right). (c) and (d) Fracture surface of a 0.006-mm/mm strain amplitude test. (d) Crack initiation region, where two near-surface particles acted as crack initiators (circled). (e) and (f) Another 0.006-mm/mm strain amplitude test. (f) Crack initiation region, solid arrows indicate pores at the crack initiation site.

surrounded by the carbon laden region is most likely responsible for crack initiation as a result of its brittleness relative to the material matrix.

Such defects, pores, and inclusion particles, as shown in Fig. 4b, d, and f, are possibly sourced from the employed LENS process and feedstock, and are likely the cause of the reduced fatigue performance observed in Fig. 2b as a result of the modulus mismatch between the particles and material matrix. When these particles/or pores exist near the surface of the specimen, they accelerate the initiation of fatigue cracks caused by local stress concentrations. Careful attention must be taken with contaminants in the AM machines and in handling the powder for preventing such particle intrusion. Exclusion of these particles may result in an increase in the

fatigue lives of the AM materials. The challenge then centers on how to prevent contamination during the build process or stopping elements in the alloy from segregating to form particles.
