Xie, X., Xu, J., Luo, J. (2020). Analysis of skid damage to cylindrical roller bearing of mainshaft of aeroengine. *Journal of Mechanical Science and Technology* 34 (8) (2020) 3239–3247.
<http://doi.org/10.1007/s12206-020-0716-0>

Analysis of skid damage to cylindrical roller bearing of mainshaft of aeroengine

Xiangyu Xie¹, Jin Xu² and Jun Luo¹

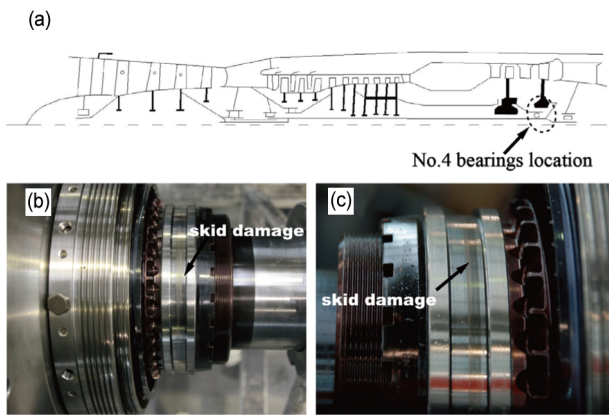
Fig. 1. Cylindrical roller bearing on mainshaft of aeroengine: (a) schematic diagram of installation position; (b) skid-damaged area; (c) alternate angle of skid damage shown in another roller bearing.

The cylindrical roller bearings investigated in this study were the No.4 bearings installed on the mainshaft collected during the test run process and after flight of aeroengine, which was a variant of model WP-13 (Fig. 1(a)). The bearings were assembled to the aeroengine that was subject to 2 hours of test run process or 300 total flight hours. As discovered after investigating twelve sets of the bearings, the typical failure observed was a consequence of skidding (Figs. 1(b) and (c)).

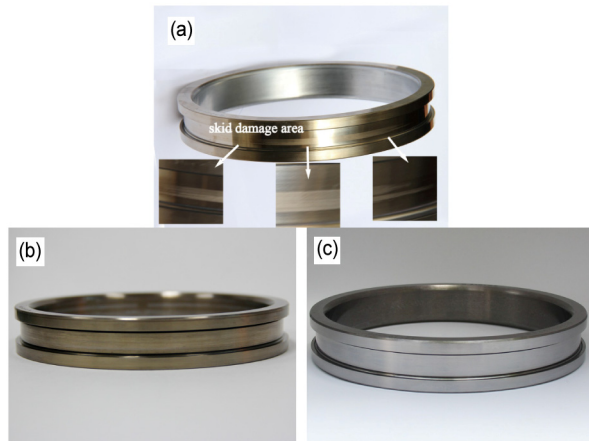
The actuating bearing was disassembled for inspection and investigation. As a result, the worn surface direction of the inner ring was coincided with the bearing rotational direction (Fig. 2(a)). This worn area had a circular shape with no any connections, implying that the inner ring bore an uneven weight and centrifugal load. Meanwhile, the raceway color in the skid

Fig. 2. Surface of inner ring (a) with and (b) without damage; (c) shows a new inner ring.

damaged inner ring and the undamaged inner ring turned brown (Fig. 2(b)) when compared with that of the new one, which was characterized as discoloration possibly induced by oil decomposition (Fig. 2(c)), thus reflecting the complex lubrication of the bearing when in mainshaft service.

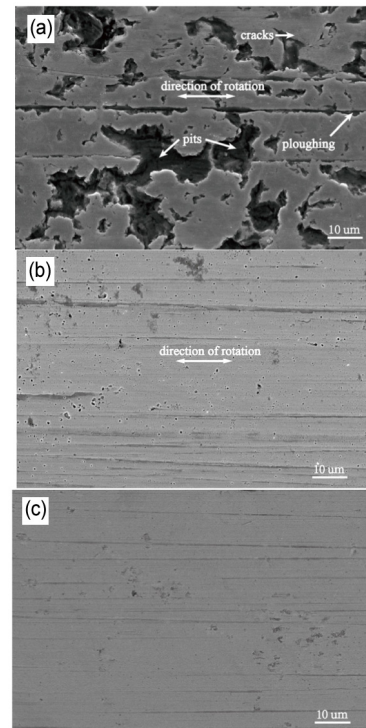
As is evident from the images provided of the skid damaged inner ring (Fig. 3(a)), the inner ring surface was covered in multiple pits. Moreover, the pits shapes differed in appearance and showed no connect with one another. Notably, the micro-pits revealed the occurrence of local metal-to-metal contact. Furthermore, the micro-pits also showed that a small fraction of material had spalled from the inner ring surface, resulting in ploughing at the rotational direction. With regard to the undamaged inner ring, there were long scratches at the rotational direction, with holes presented on the surface (Fig. 3(b)). As for the new inner ring, only pits were observed, which might result from the lapping processing (Fig. 3(c)). In line with the wear theory [23], abrasion is the plastic deformation or separation of material from the contacting surfaces due to a relative motion, micro-ploughing, micro-chipping, micro-fatigue, and micro-fractures may occur. It can be concluded that abrasive wear accounts for the primary cause of skid damage from the above features.

Fig. 3. Microscopic features of the inner ring surface (a) with and (b) without damage; (c) shows a new inner ring.

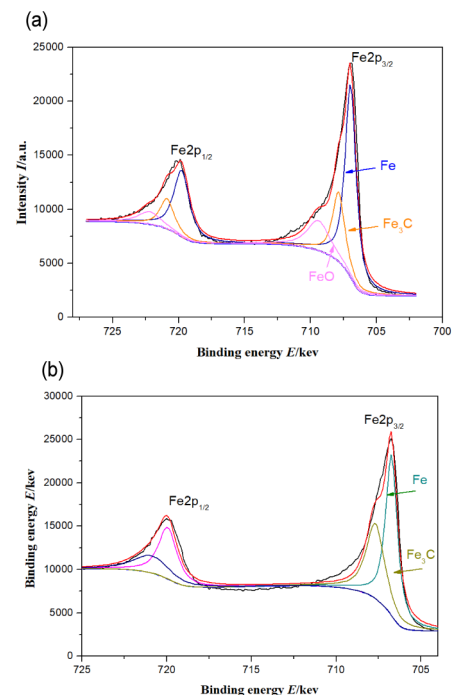
The XPS spectrum of Fe 2p for the skid damaged and new inner ring are shown in Fig. 4. The binding energies of Fe 2p_{3/2} obtained from the new inner ring were 708.1 eV and 706.8 eV, respectively (Fig. 4(b)), which lied between the values obtained for Fe₃C and Fe. For the skid damaged area in inner ring, an extra peak (709.5 eV) was observed in the XPS spectrum obtained for FeO (Fig. 4(a)). Such discrepancy might be attributed to the oxidation on surface, and the presence of this peak and the binding energy were consistent with those reported by other researchers [24], demonstrating the occurrence of oxidation wear during the skidding process.

Fig. 4. The XPS spectrum: (a) skid damaged; (b) new inner ring.

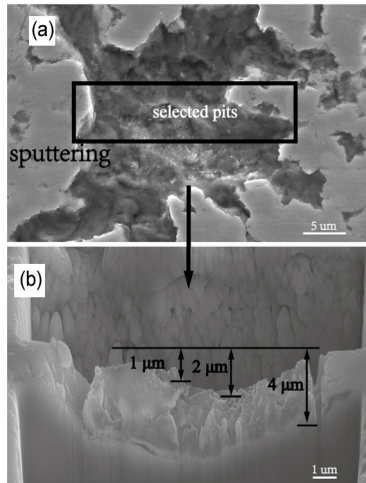
Further, FIB-SEM was applied to examine some selected areas from the skid damaged inner ring to acquire more information. After the pitted areas were thinned through sputtering, the pits depth was ascertained to be 1-4 μm (Fig. 5). Moreover, transverse cracks were present at the bottom of the pits. It was

Fig. 5. Sputtering thinning of pitted areas using FIB: (a) selected pits; (b) measurement of pit depths.

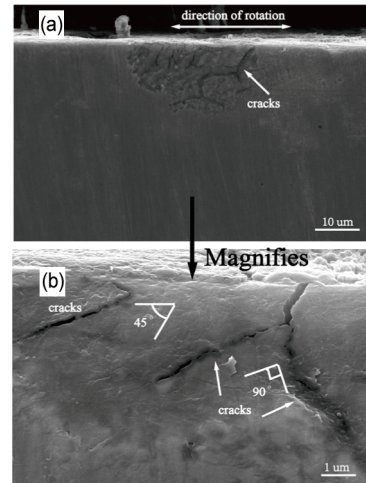
Fig. 7. Cross-section of skid damaged inner ring.

Moreover, the cross-section of the skid damaged inner ring was also observed. The cracks were attributed to surface contact, which were approximately 2-10 μm in width and approximately 20 μm in length (Fig. 7). The cracks were oriented at an angle approximately 45° to the contact surface at the rotational direction. Meanwhile, the longitudinal crack was perpendicular to the extended one, which implied the continuously worsening situation. Such cracks initiated as the small scratches at the beginning, but they grew larger through summation. Noteworthy, the maximum von Mises stress during rolling contact also occurs at a similar depth [25]. The results of microscopic investigation suggested that delamination wear occurred during skidding of the inner raceway. Therefore, it was reasonably assumed that, these cracks resulted from the strains developed on the sub-surface during rolling contact. Besides, the cracks further propagated to the surface and finally lead to

bearing spalling. According to the results [26], for the friction pair made of quenched and tempered steel, cracks initiate on the surface, then propagate to the sub-surface along the rolling direction, and finally become the fan-shaped fatigue pit, which is ascribed to the combination of rolling and sliding motions on surfaces. Moreover, subsurface crack initiate on the subsurface, then expand to both sides parallel to the surface, and finally fracture at both sides to form a shallow pit on the specimen width. Presently, skid damage in aircraft manufacturing and repair plants is controlled by grinding the surface of the inner ring raceway [27]; however, the purpose of grinding the surface of inner ring raceway is not to prevent skid damage.

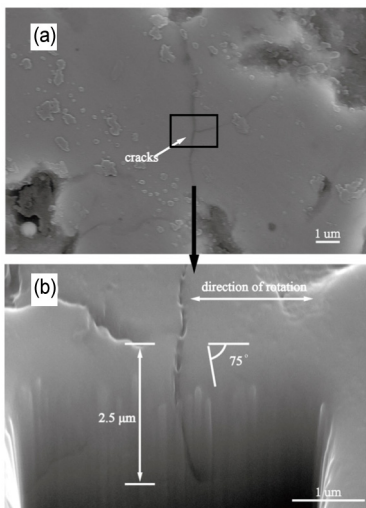
observed that some micro-cracks on the surface of the inner ring had penetrated the pits (Fig. 6(a)). Actually, a longitudinal crack approximately 2.5 μm depth was observed after milling, the angle of which was 75° (Fig. 6(b)).

Fig. 6. Skid damaged inner ring: (a) micro-cracks penetrating the pits; (b) a longitudinal crack.

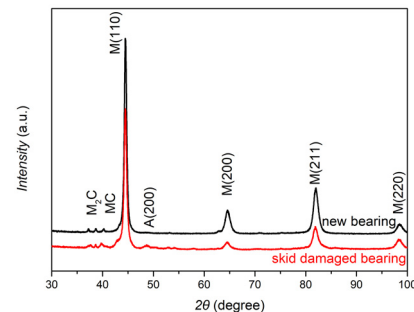
Fig. 8. XRD patterns of skid-damaged and new inner rings.

The XRD pattern of surface with new and skid damaged inner ring are shown in Fig. 8. For the inner ring sample, a mixture of austenite and martensite was found, which was consistent with relevant literature [28]. Nonetheless, the peaks of austenite (200) were observed on the skid damaged surface, indicating austenization, and some carbon were dissolved in martensite matrix during this process, resulting in a decrease of martensite. Surface material transfer occurred simultaneously, therefore, chemical composition changed during the skidding process. The grain size of the top surface of skid damaged inner ring was smaller than that of the matrix structure, and the morphologies of martensite and austenite changed significantly

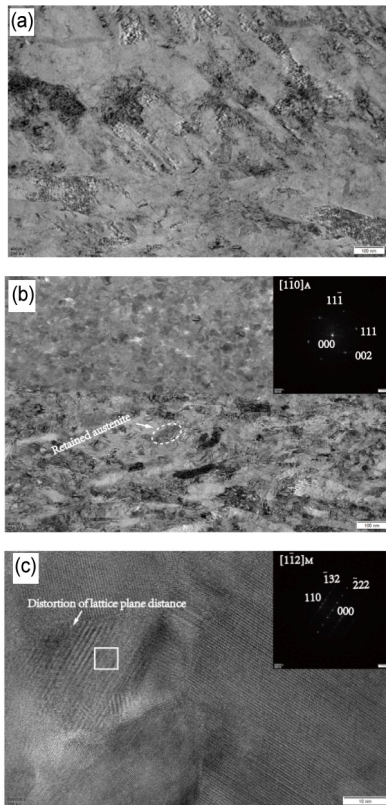
Fig. 9. TEM images of (a) matrix structure; (b) top surface of skid damaged inner ring; (c) HRTEM images of (b).

(Fig. 9(a)). In terms of the top surface of the skid damaged inner ring, part of the original martensite lath disappeared, which formed smaller micro-laths, micro-crystals and micro-twin crystals. In the meantime, the retained austenite phase was dispersed on the martensite (Fig. 9(b)). The substructure of martensite was studied by HRTEM, which revealed the distortion of the lattice-plane distance (Fig. 9(c)). Based on the TEM diffraction patterns of the $[110]$ and $[112]$ zone axis and the Fe-C phase diagram [29, 30], it was inferred that the phase in Fig. 9(b) was γ -Fe formed after skidding, which confirmed that the surface temperature reached the phase transition, causing austenitization under the action of high temperature.

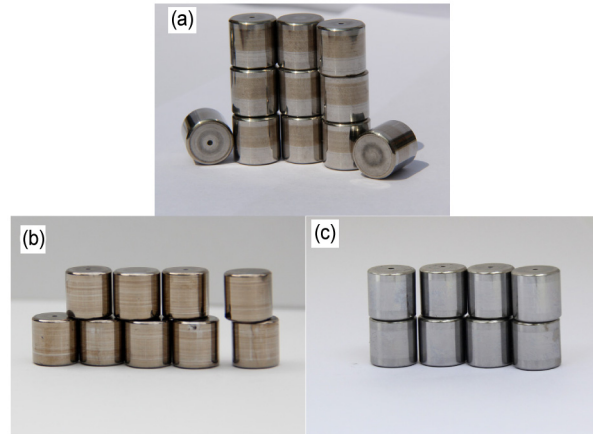
Macroscopic examination showed that, the most prominent features of skid damage on the rollers were bands of oil film, discoloration (a dark brown oxide film), and circular deposition adhesion of the rollers (Fig. 10(a)). In the undamaged roller (Fig. 10(b)), color of the area was darker than that in the new roller (Fig. 10(c)).

Fig. 10. Rollers (a) with and (b) without damage; (c) shows a new roller.

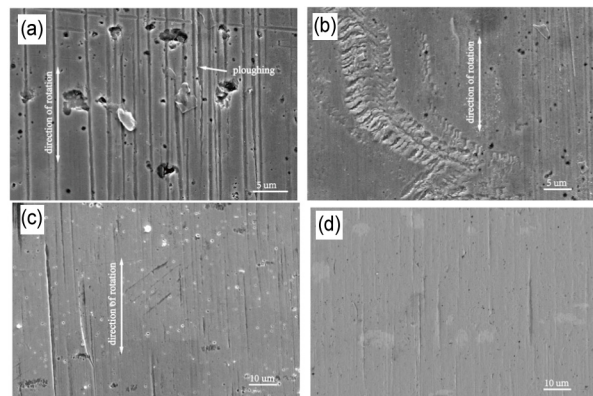
Besides, the damage on the roller surface was significant (Fig. 11). For instance, there were multiple holes across the entire roller surface, along with evident ploughing at the rotational direction of the roller (Fig. 11(a)). The roller might be subject to two-body and three-body wear, and intense plastic

Fig. 11. Roller surface: (a) holes and ploughing; (b) plastic deformation in skid-damaged roller; (c) undamaged roller; (d) new roller.

deformations (with irregular shapes) were also seen (Fig. 11(b)), which might occur due to the local high stress on the convex position of the rough surface when the friction components moved relative to each other [31]. Microscopic observation in both the undamaged and new rollers show less abnormal features, holes, and scratches in the direction of rotation presented on the undamaged roller surface (Fig. 11(c)), which seemed to be inevitable during the high-speed operation process. Some scratches in the new roller indicated that its machining precision was insufficient (Fig. 11(d)). In addition, it was shown that, the roller suffered from abrasive wear in the process of skid damage, and the cause of the roller abrasion was consistent with that of the cause of raceway abrasion.

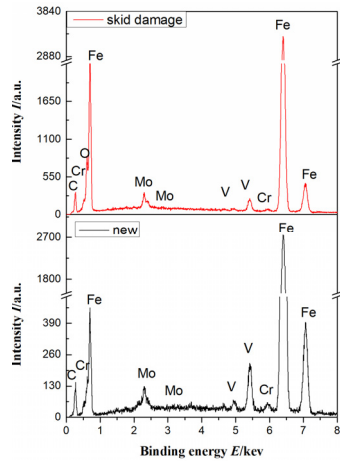
Furthermore, the surfaces of the rollers were examined by EDS (Fig. 12). As a result, for the skid damaged roller, there was excess elemental O (compared with a new roller), implying that the roller experienced oxidation wear. In line with theory [32], plastic deformation may accelerate the diffusion of O into the metal, and a new film will be formed after the oxide film has fallen off. Consequently, high temperature and the impact speed of the inner ring may aggravate oxidation wear, but decrease the extent of oxidation of the roller.

Fig. 12. EDS results of new roller and skid damaged roller.

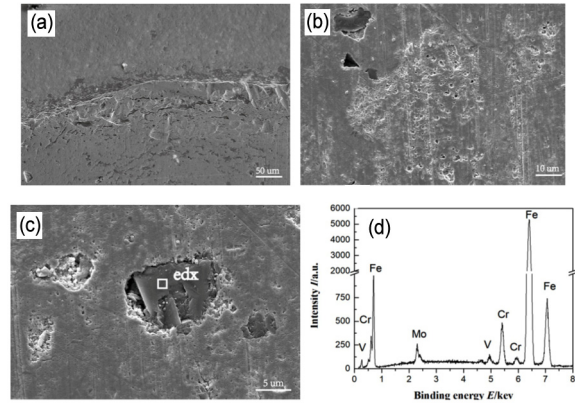
Fig. 14. Skid damaged cage interface: (a) low magnification; (b) multiple holes; (c) several dark objects embedded in surface; (d) edx result of the selected zone of skid damaged cage.

According to the macroscopic examination (on both skid damage and undamaged cage), a scar occurred at the interface between the cage and roller, while a new cage was shiny and in good condition (Fig. 13). Severe wear was revealed from the low magnification inspection of the cage interface (Fig. 14(a)), including scratches and multiple holes on the cage surface (Fig. 14(b)), as well as several dark objects embedded in the surface (Fig. 14(c)). Furthermore, the dark objects were examined with EDS, and the results showed the presence of elemental Fe (Fig. 14(d)). The cage was coated with silver, which provided it with strong corrosion resistance and improved the running properties of the harder bearing materials, but the silver coating and cage material were relatively soft. The lubrication system of the aero-engine mainshaft was filtered via a coarse filter with an average pore diameter of 72 μm , but the oil quality and lubricant status were operating properly. It was predicted that, the dominance of abrasion in a cage under lubrication might be due to the existence of metal particles or material spalling from the raceway and roller of mainshaft bearings.

optimized stress distribution. Under misalignment and most other conditions, edge loading tends to be avoided relative to the current partially crowned roller profiles. Additionally, the problem source of abrasion in the cage is found to be a coarse filter that accumulates the existence of metal particles embedded into the cage surface, and the use of a lower grid filter may eliminate the possibility of contamination in lubrication system. It is believed that, the full-scale tests under controlled conditions can best estimate the working state of mainshaft bearings. In addition, the engine vibration, temperature and content of the lubricant during the tests should be closely monitored to determine the working state of the bearing. Certain limitations should be noted in this paper, namely, the unconventionality of bearings should be reproduced in test under typical engine conditions.

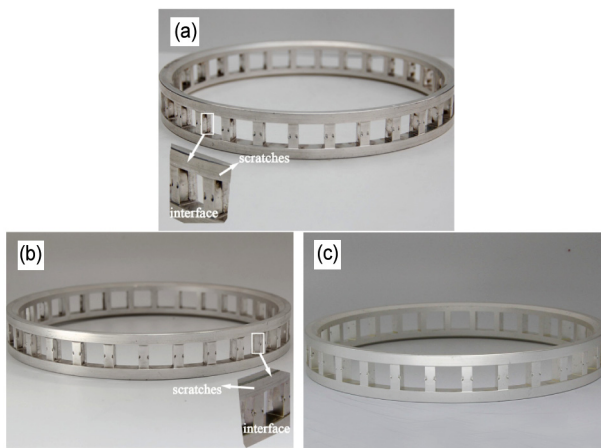
Fig. 13. Macroscopic image of cage: (a) skid damaged; (b) undamaged; (c) new cage.

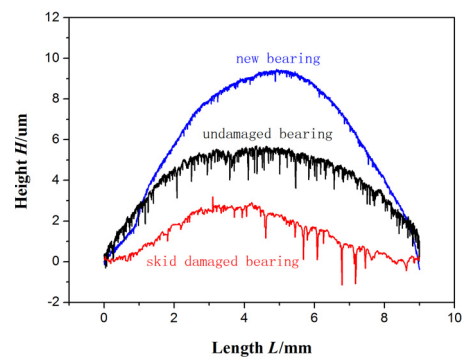
Fig. 15. Profile of inner ring.

It can be seen that the new inner ring had a smoother profile than that of the skid damaged and the undamaged inner ring (Fig. 15). Compared with the new inner ring, the undamaged inner ring experienced significant dimensional reduction. The profile of the skid damaged inner ring turned linear, and which was 8 μm and 3 μm lower than that of the new inner ring and the undamaged one, respectively. Generally, ideal lubrication of a cylindrical roller bearing occurs when an oil film completely separates the rollers from the inner ring, so that there is no metal to metal contact between the roller and the inner ring. Such phenomenon shows that, there is wear during the bearing operation process, and skid damage occurs owing to the worsened working condition.

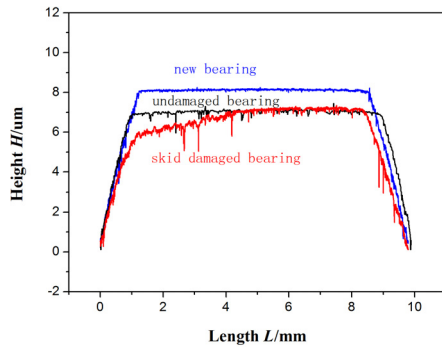
Rollers had significantly different shapes (Fig. 16). For instance, the profile of skid damaged rollers was irregular, and had a maximum height dimension of approximately 2 μm , whereas the new roller and the undamaged one were smooth in height. It was observed that, the partially crowned profile of the new roller was more regular than those of the skid damaged and the undamaged rollers. Further visual examinations revealed that, the oil film bands on the roller had reduced diameter. It was concluded based on the FEM solutions [33], it

Fig. 16. Surface profiles of skid damaged, undamaged and new rollers.

can be concluded that partially crowned profiles of both the new and undamaged roller tend to generate less edge stress under a given load as compared with the skid damaged profile. Rolling elements were exposed to complicated loadings during the flights, for this type of bearing, radial load was in the range of 0 to 5 kilonewton during the flights. Static loadings act on the rolling elements at the steady-state conditions. However, dynamic loadings are more prominent since the conditions are changeable while flying. Each part especially for roller responds dynamically to the forces acting. Moreover, the roller exhibits more intense response in the extreme conditions such as zero load presented and result in bearing slip, then skid damage might take place.

The mechanism for the skid damage in mainshaft bearings of aeroengines is quite complicated, and it is suggested that the skid damage process initiated by the action of different wear mechanisms such as abrasive wear and delamination wear. As stated previously, crowning of rollers and raceways is accomplished to avoid edge loading that can result in failure of the rolling components. However, the current roller profile design is still insufficient due to the characteristics after skid damage. In this regard, a "logarithmic" profile is recommended [35], and it is named because it can be expressed mathematically as a special logarithmic function for yielding a substantially

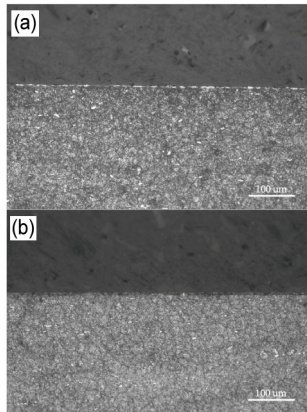
Fig. 17. Metallographic structure of (a) skid damage; (b) undamaged inner ring.

The metallographic structure of the inner ring features was characterized by residual austenite, martensite and carbide. Moreover, thin and discontinuous white bands occurred along the skid damaged inner ring boundary (Fig. 17(a)), but no abnormal structures was found in the undamaged inner ring (Fig. 17(b)). On the other hand, metallographic examination suggested that, the undamaged roller (Fig. 18) contained martensite, residual austenite and carbide, which were evident in the of the roller cross-sections after etching. In the skid damaged roller (Fig. 19), the volume percentage of residual austenite was less than that of the undamaged roller. Further, the continuous white bands were observed along the roller boundary

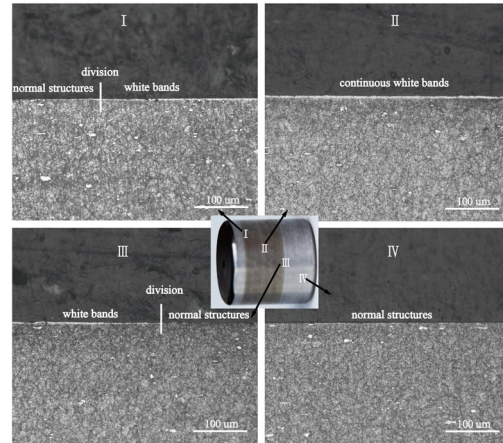
Fig. 19. Metallographic structure of the skid damaged roller.

in parts of the oil film. When moved to the boundary of the oil film, it was evident that the white bands and normal structures of the roller dominated different positions (performed on the transverse sections). The wear volume corresponds to the length of macroscopic oil film bands, which suggested a trend of progressive material loss. When a bearing undergoes repeated rolling and sliding contacts under high temperature and elasto-hydrodynamic lubricated conditions, the microplastic deformations will accumulate, which manifests as the white etched bands [34]. Therefore, combined with the damage characterization, XRD, XPS and TEM results, one can postulate the reasons for certain observations, for instance, the white bands are formed as a result of the plastic deformation mechanism during rolling contact, and the metal to metal contacts of the inner ring and roller increase the temperature to the austenitic temperature. The white bands on the inner ring became discontinuous, which was possibly because of presented features in the pitted area.
