Earthquake damage and related factors associated with the 2016 $M_L = 5.8$ Gyeongju earthquake, southeast Korea

Key words: Gyeongju earthquake, earthquake damage, focal depth, damaged building, local geological conditions, ground motion propagation

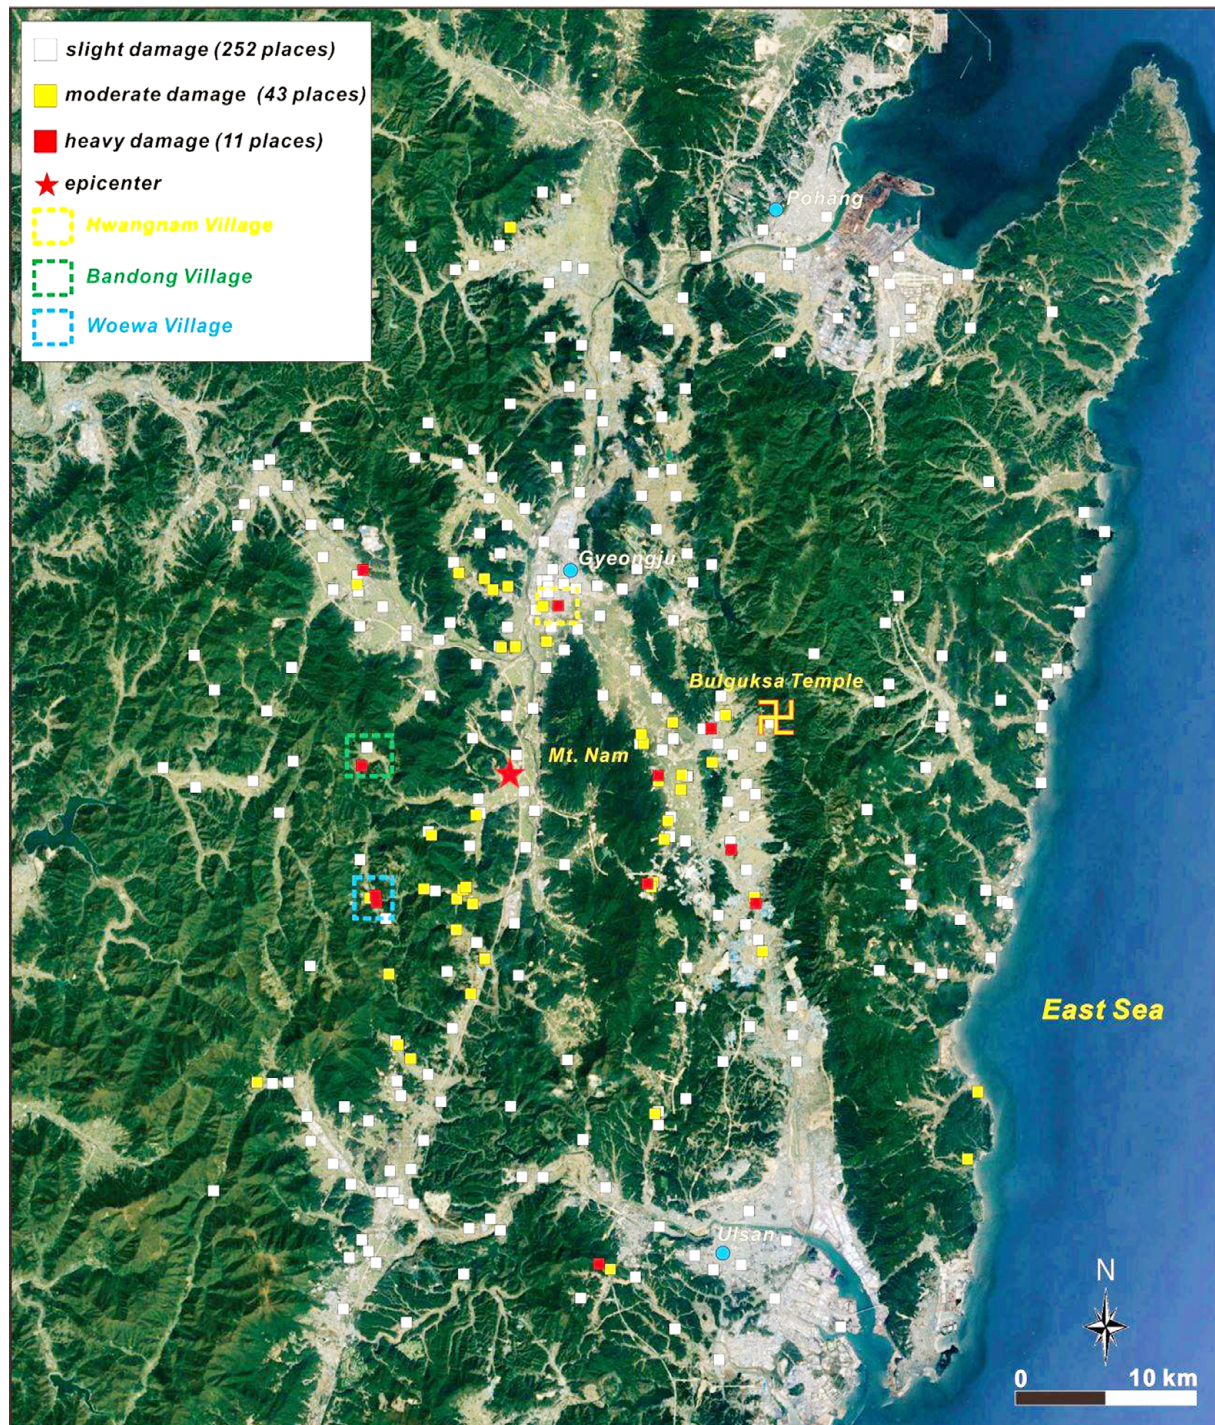
Fig. 2. Distribution map of damaged buildings and houses associated with the 9.12 Gyeongju earthquake (Red star: mainshock, Red square: heavy damage, Yellow square: moderate damage, White square: slight damage). The basic data were provided from Gyeongju City; satellite image from Google Earth.

However, the distribution of damaged buildings was not concentrated around the epicenter, but it was instead relatively scattered over a 17 km radius, almost the same distance as the focal depth (Fig. 2). Furthermore, according to media reports, the earthquake was felt throughout South Korea and even in China and Japan. Therefore, we suggest that the broad distribution of damage and shaking associated with the 9.12 Gyeongju earthquake is related to the relatively deep focal depth. This indicates that the focal depth is closely related to the distribution area of the

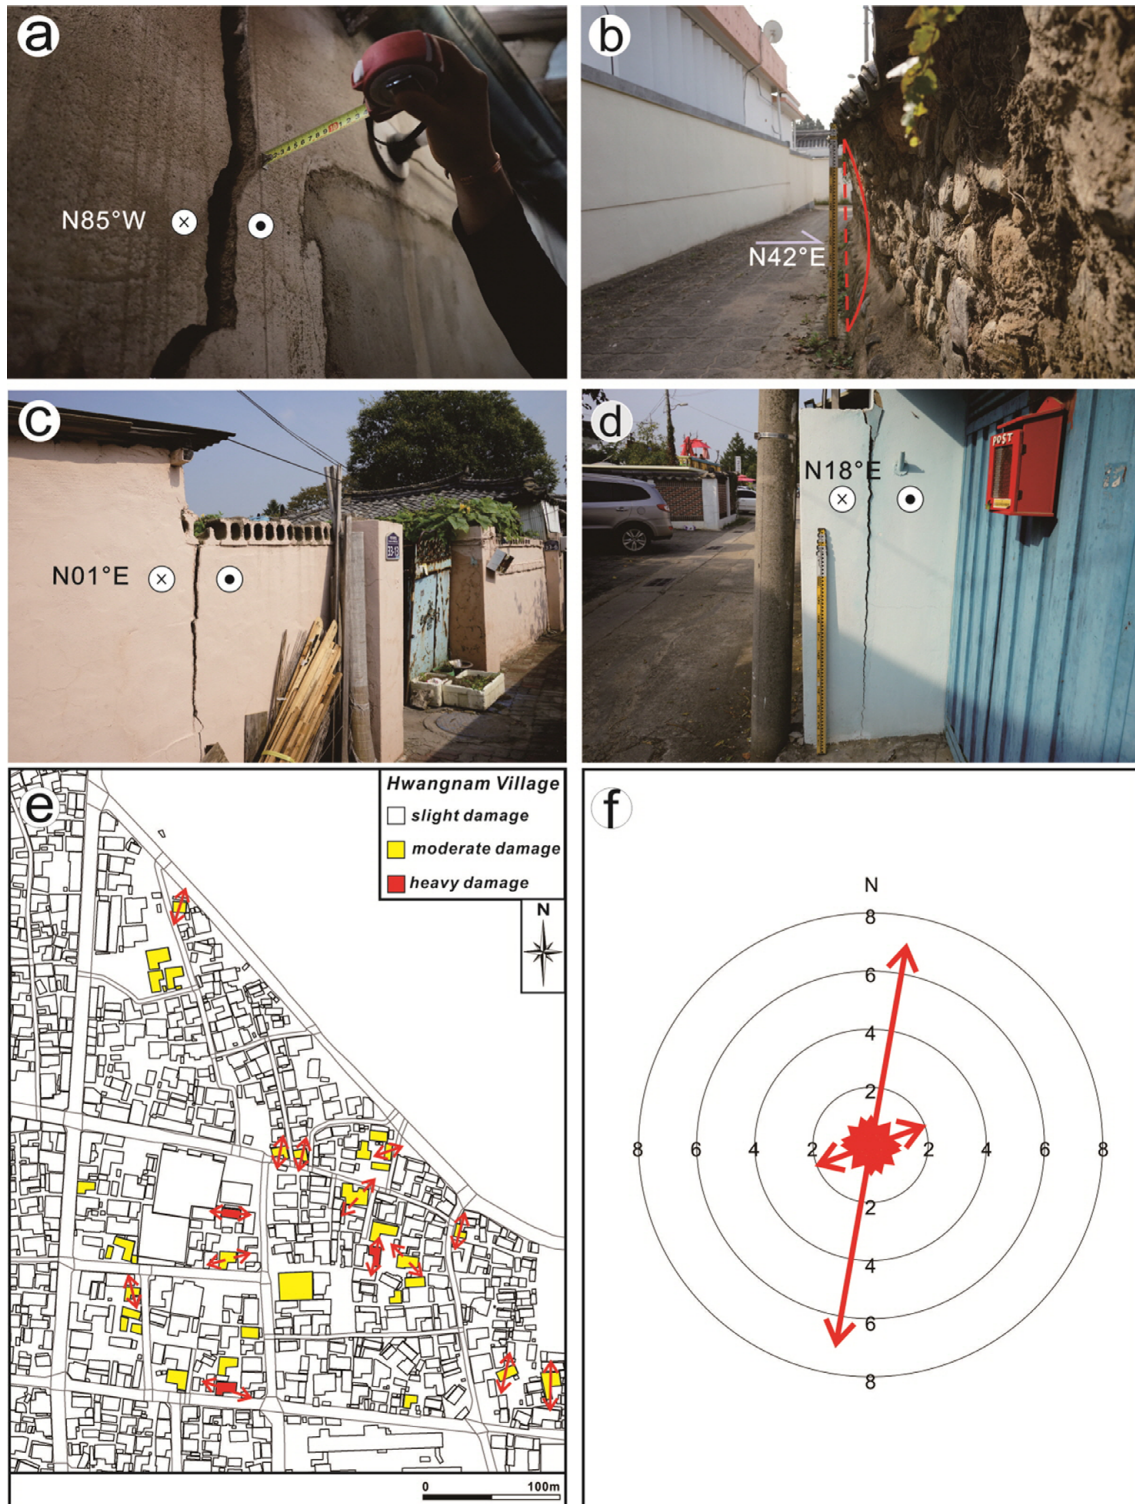
roof tiles, masonry walls, and old walls were easily subjected to damage (Fig. 3). Modern walls are built with bricks or blocks joined with cement and relatively strong. However, old walls are relative weak because they are comprised of stones with mud as the adhesive.

During the field investigations, we measured the orientation and crack widths of tilted and displaced structures. Most of the collapsed lightweight roof tiles were scattered with no consistent direction, because of their weak construction style and materials. Most damaged structures were old style houses and walls including roof tiles. The cracks in the walls were mainly several centimeters

in width (Fig. 3). Interestingly, the tilted and displaced walls showed some preferred orientation, and most of them were oriented in NNE-SSW (Fig. 3). This orientation is similar to the general strike of the Yangsan fault, which may indicate some relationship between damaged structures and horizontal ground motions along the fault as indicated in some previous studies (e.g., Hough, 2018).

Fig. 3. Photographs of damages in Hwangnam Village. (a–d) Displaced and tilted walls generated by the earthquake and the orientation of tilted and displaced structures. (e) Distribution map of the degree of building damage. (f) A rose diagram for the orientation of tilted and displaced buildings in Hwangnam Village. It shows NNE-SSW trend of tilting and displacement, indicating the direction of ground shaking.

One of the most common types of earthquake damage was wall damage (Figs. 3a–d). There are two types of wall in the study

area; traditional and modern. The traditional walls were built with rocks and clay (Fig. 3b), but the modern walls were built with soft concrete bricks cemented with concrete plaster (Figs. 3a, c and d). The damaged walls showed different damage patterns depending on their material and construction methods. The traditional walls were completely collapsed or severely inclined (Fig. 3b), but the modern walls were only slightly damaged with minor cracks or slight distortions (Figs. 3a, c and d).

This indicates that stone walls bonded with clay are more prone to collapse against shaking, because the adhesion of clay is greatly reduced if it dries. Hence, earthquake damage intensities and patterns are entirely dependent on building styles, materials and seismic design, as well as the earthquake intensity. This means that appropriate improvements in construction materials or styles and aseismic design codes could greatly reduce earthquake hazards as already reported from several previous earthquakes (e.g., Zhao et al., 2009). However, these design codes should be carefully developed, considering the tectonic setting, distance from active fault, foundation, building style and seismic activity for safety and economic feasibility.

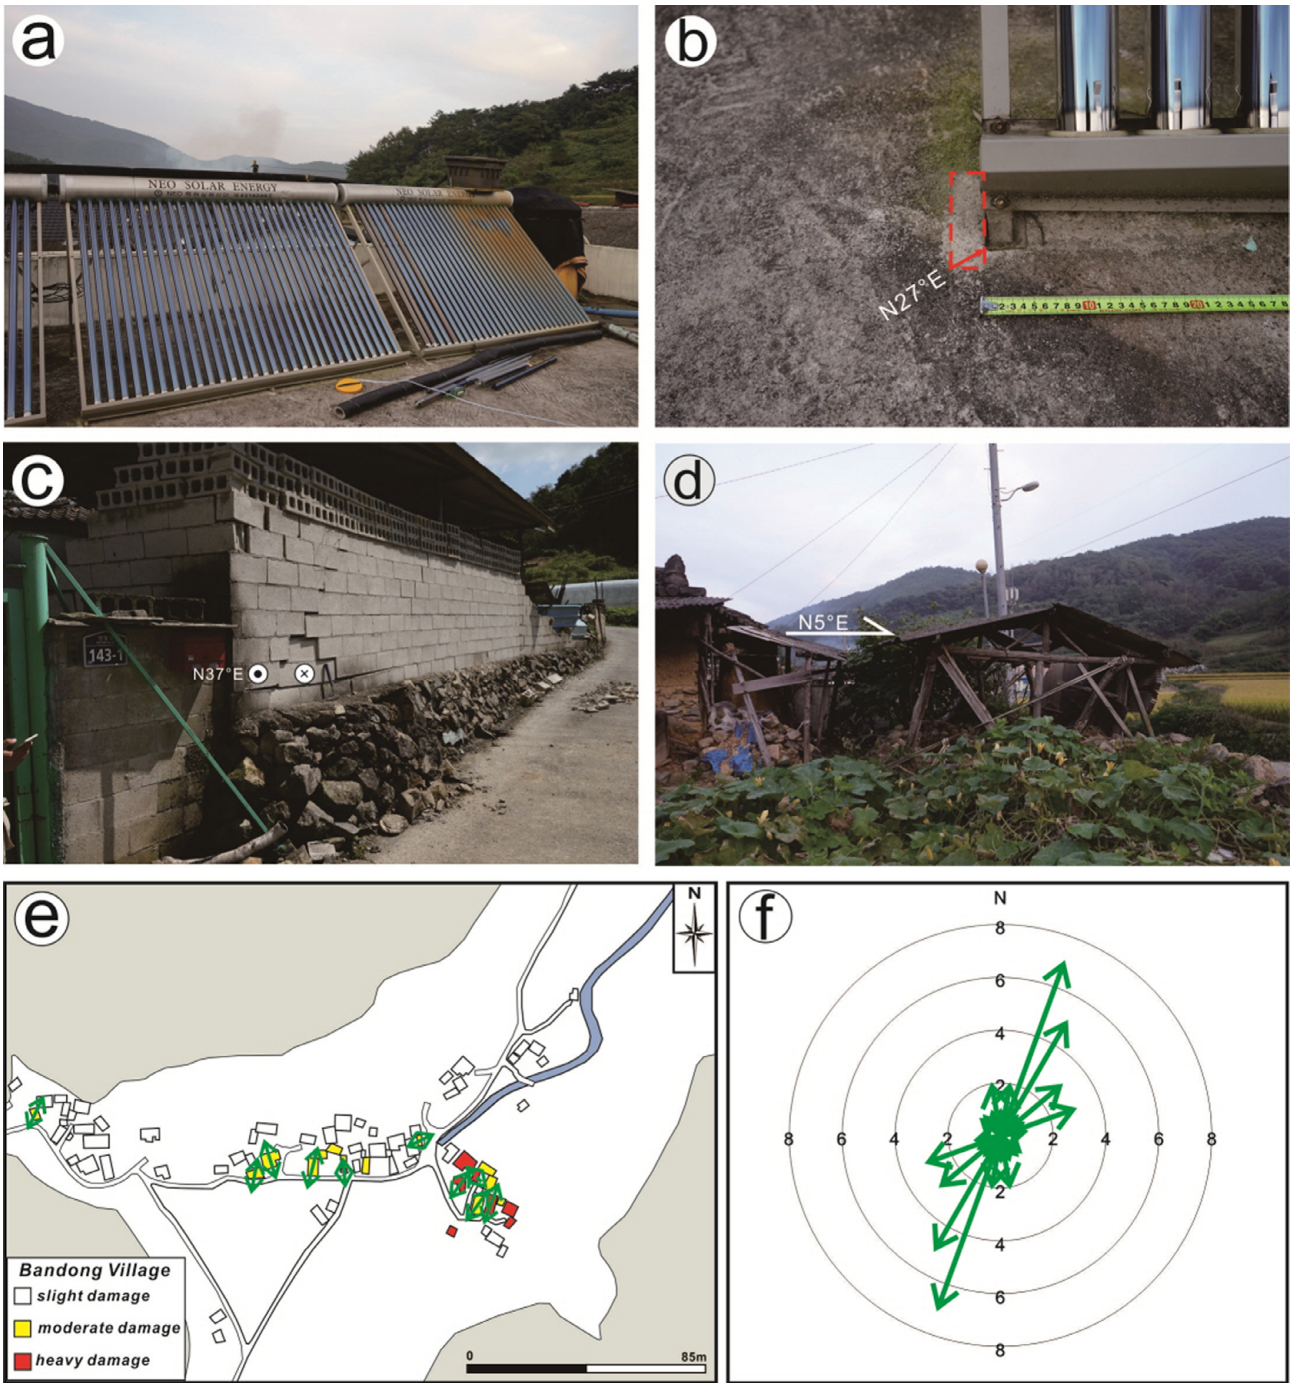
Fig. 4. Photographs of damages in Bandong Village. (a and b) Displaced solar panels on the roofs of residential houses. (c) Displaced masonry blocks in a wall. (d) Inclined farmhouse. (e) Distribution map of the degree of building damages. (f) A rose diagram for the orientation of tilted and displaced buildings in Bandong Village. It shows NNE-SSW and NE-SW trends of tilting and displacement, indicating the direction of ground shaking.

are farmhouses and residential houses, having no efficient seismic design (Fig. 4). Many lightweight roof tiles, masonry walls, old walls joined with stone and mud, and unfixed solar panels were seriously destroyed or damaged by the earthquake (Fig. 4).

panel movement on roofs to understand the shaking pattern induced by the earthquake (Fig. 4). We found that the solar panels were moved approximately 3–5 cm in the NE-SW direction (Fig. 4b), and masonry blocks of farmhouses were displaced approximately 3–4 cm in the NE-SW direction (Fig. 4c). An old farmhouse was inclined approximately 20° toward NNE-SSW

direction (Fig. 4d). Many solar panels, which were not fixed with anchors or bolts, experienced shaking with a similar direction with NNE-SSW and NE-SW trends (Figs. 4a and b). Most damaged buildings measured in the village were oriented NNE-SSW to NE-SW (Fig. 4), and inclined or tilted to the SW or SSW, this indicate ground movement direction.

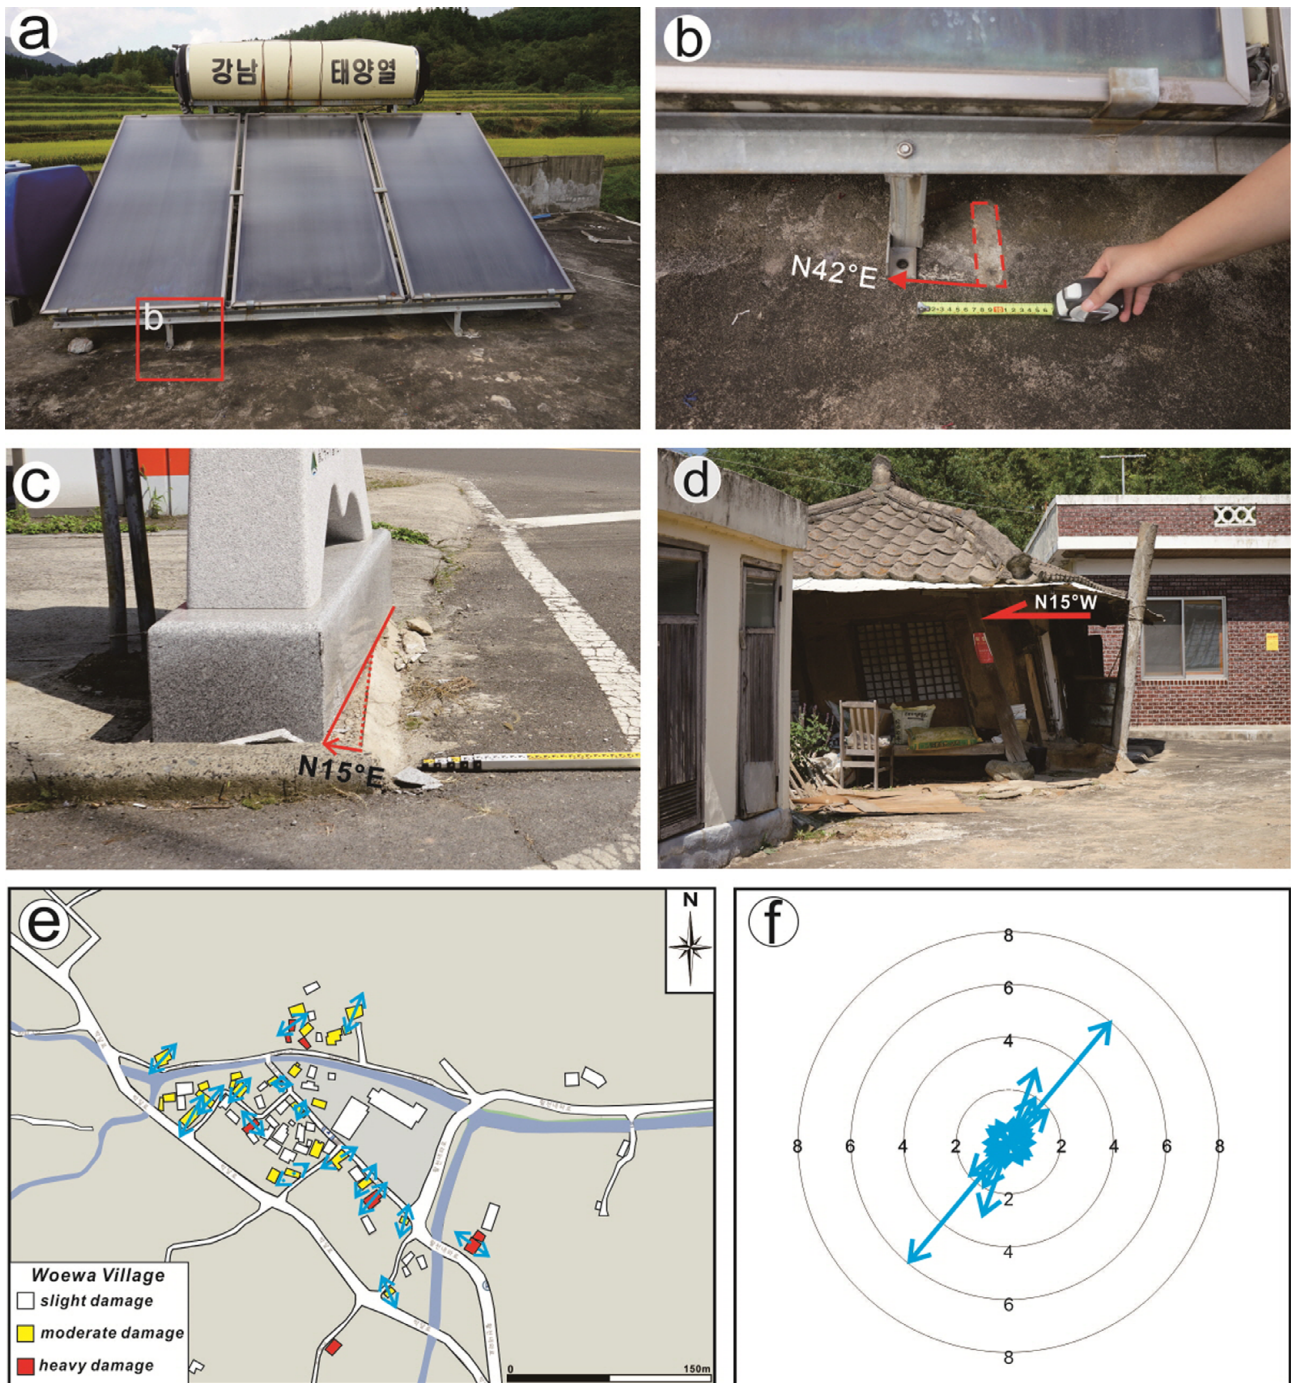
Fig. 5. Photographs of damages in Woewa Village. (a and b) Displaced solar panels on the roofs of residential houses. (c) Tilted stone post at the entrance of the village. (d) Old house severely inclined approximately 15° to the west. (e) Distribution map of the degree of building damage. (f) A rose diagram of orientation based on tilted and displaced buildings in Woewa Village, showing the NE-SW and NNE-SSW trends of tilt and displacement due to ground shaking.

destroyed, suffering moderate to heavy damage due to a complete lack of aseismic design. Many lightweight roof tiles, masonry walls, old stone and mud walls, and solar panels were destroyed or severely damaged (Fig. 5). A solar panel was moved approximately 10 cm in the NE-SW direction (Fig. 5b). Even the very heavy stone post of the village located at the entrance of the village was severely damaged, and was rotated approximately 10° in the NNE direction (Fig. 5c). An old house was found to be inclined approximately 25° in the NNW direction (Fig. 5d). We measured the orientation of the tilted and displaced walls, the inclined houses and the movement direction of unfixed solar panels (Fig. 5). The damaged buildings were oriented in NE-SW to NNE-SSW (Fig. 5), and the predominant orientation of damaged structures was SW or SSW, indicating a similar trend with those of other villages.

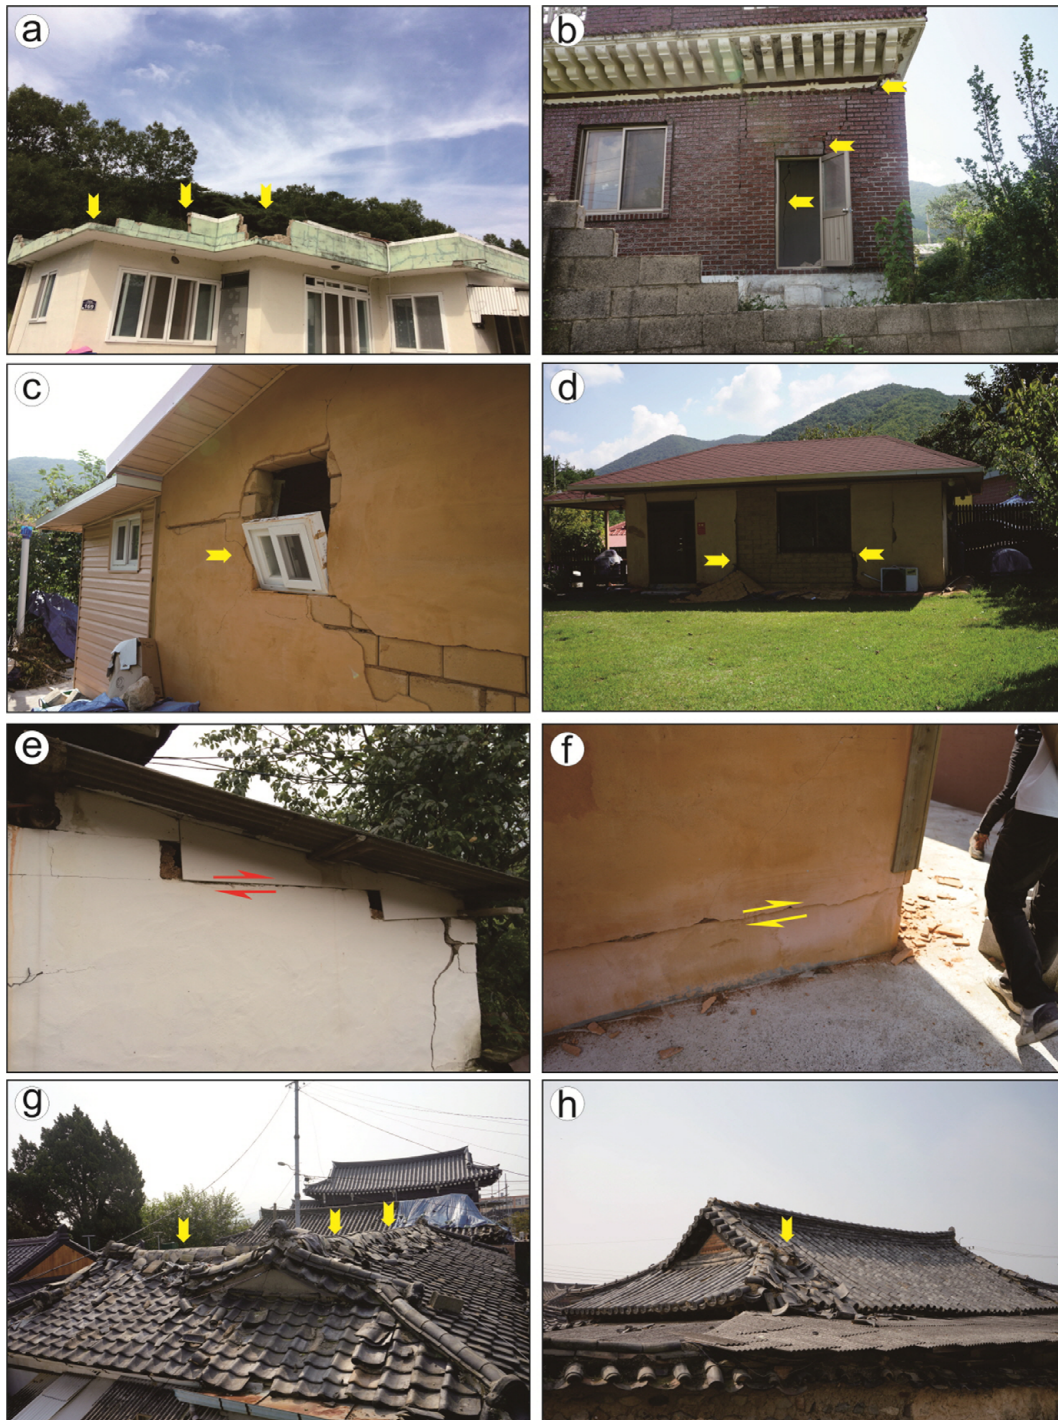
Fig. 7. Photographs of damages with various styles of building and house associated with the 2016 Gyeongju earthquake. (a) Collapsed soft bricks unreinforced and unconfined on the roof of reinforced concrete houses. (b) Cracks and distortions in infill walls with clay bricks between reinforced concrete pillars, showing no damage to reinforced concrete pillars. (c) Destroyed window and wall of an old house. (d) Damaged wall built of traditional dry grass and clay. (e and f) Photographs of cracks between roofs and walls in unreinforced and unconfined masonry of old houses. These cracks between walls and roofs are similar to shear fractures. (g and h) Photographs of collapsed lightweight roof tiles of old houses. These lightweight roof tiles exhibit very weak resistance to earthquake shaking because clay was used as the adhesive.

Reinforced concrete confined masonry buildings and houses were slightly damaged during the earthquake. Some cracks and distortions occurred within infill walls, which were built with clay bricks between reinforced concrete pillars (Figs. 7a and b). However, many walls with soft concrete bricks of the unreinforced and unconfined masonry were heavily damaged (Figs. 7c and d). These structures consist of soft concrete bricks, wooden columns, and concrete pillars without iron rebar. The material comprising infilled walls is a mixture of dry grass and red clay, which is a traditional housing material in Korea (Figs. 7c and d). These structures including plastered walls were severely inclined or collapsed by the earthquake (Figs. 7c and d). In addition, many cracks were found on masonry walls with windows and on mud floors.

Interestingly, many cracks were observed between the roofs and walls because there were no strong linkages between their different structures (Figs. 7e and f). These cracks show very similar patterns to natural shear fractures (Riedel shear style) (Figs. 7e and f). It indicates the shear movement between the ground and building was accommodated between roofs and walls, because different structures behaviour differently to seismic waves.

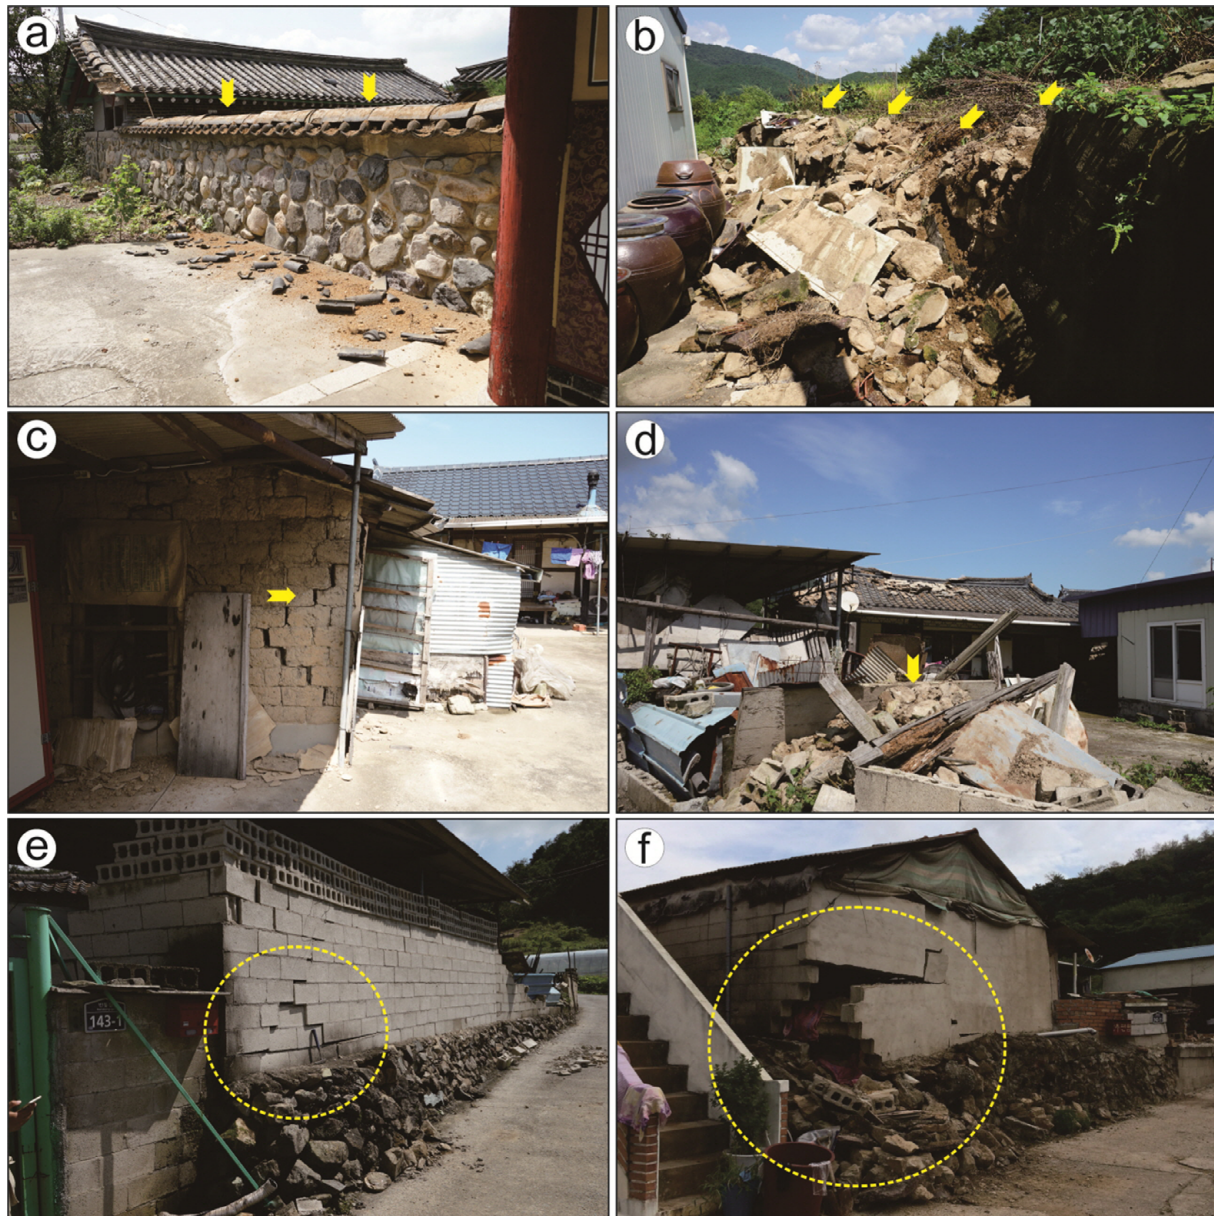
The most common traditional building structures are wooden frames with lightweight roof tiles and clay. In particular, roofs with lightweight roof tiles are very weak against earthquake shaking, because they are weakly attached with clay. Thus, many roof tiles in the affected areas collapsed by of the earthquake-induced shaking (Figs. 8g and h).

Local soil and geological condition can also contribute to the amplitude, spectral content, and duration of strong ground motion involving soil liquefaction, and ultimately alter the resulting damage patterns to man-made structures (Trifunac, 2016). During field investigations on damage patterns of buildings associated with the 9.12 Gyeongju earthquake, we found highly distinct damage intensities depending on location within a small village (Bandong Village), located approximately 8 km away from the epicenter to the west (Fig. 8). Although the buildings had similar structures and materials, the damage intensity was very different in the northern part (Figs. 8a, c and e) and in the southern part (Figs. 8b, d and f) of the village. That is, houses located in the southern part of the village were more severely damaged than those in the northern part (Fig. 8).

Fig. 8. Photographs of damaged buildings associated with the 9.12 Gyeongju earthquake in Bandong Village; approximately 8 km away from the epicenter to the west. (a), (c), and (e) Damages in the northern part of the village. (b), (d) and (f) Damages in the southern part of the village, showing a completely different damage intensity even for similar building structures and materials.

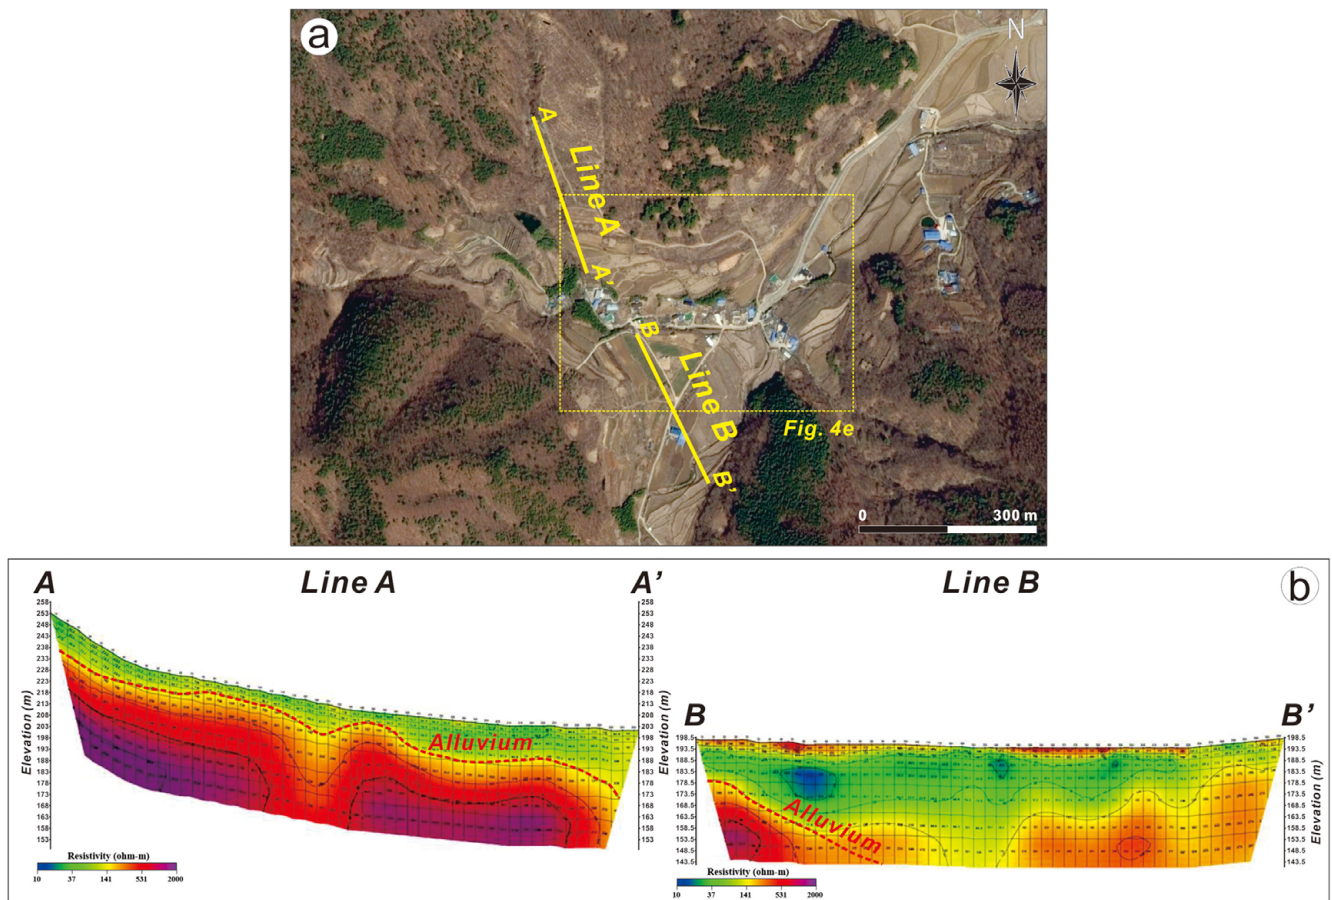
Fig. 9. (a) Design map for 2D electrical resistivity survey on alluvium in Bandong Village. (b) Survey results of Line A and B, showing the difference in alluvial thickness between northern and southern areas. Line A shows the 2D inversion results for the modified pole-pole data acquired at Line A. The rms misfit is approximately 2.2%. The overall resistivity distribution of Line-1 is approximately 40–2500 ohm-m, and has a four-layer structure. The boundary of the alluvial layer for Line 1 and 2 was estimated to be a relatively low resistivity layer (< 141 ohm-m). The thickness of the alluvial layer is approximately 5–20 m, and becomes deeper downstream of the mountain. Line B shows an electrical resistivity distribution of approximately 10–2000 ohm-m. The rms misfit is approximately 2.9%. The alluvial thickness is approximately 15–50 m, and becomes shallower toward the end of the survey line.

alluvium amplified the seismic wave in the southern part of the village causing more serious damage to man-made structures. This suggests that soft sediment as a superficial material causes even greater damage to structures than hard rock. Thus, information on the local geological and foundation conditions and appropriate location of important structures could neutralize from serious hazards or greatly reduce earthquake-related damages.
