A case study of water inrush incident through fault zone in China and the corresponding treatment measures

Ziwei Qian¹ · Zhen Huang² · Jianguo Song³

Received: 7 December 2017 / Accepted: 11 July 2018 / Published online: 19 July 2018
© Saudi Society for Geosciences 2018

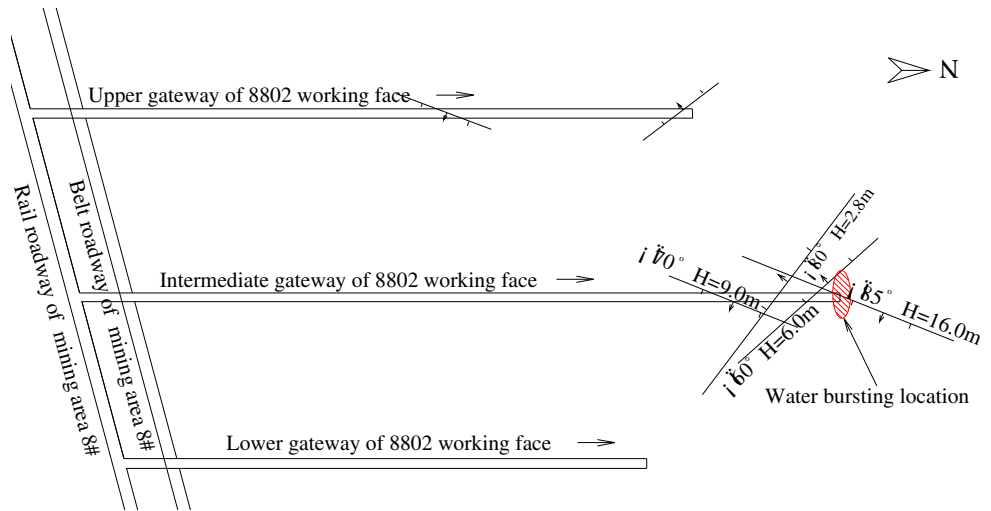
Fig. 2 Top view of the working faces at Tianzhuang coal mine and the locations of water inrush point

The key questions, such as the water source and its mechanism, are important to understand the water inrush accident (Li et al. 2013). As shown in Fig. 2, there is no doubt that this water inrush accident must be associated with the fault, namely the fault zone is the flow channel. Thus, it was evident that groundwater from the aquifer underlying the floor inrush through the fault into the gateway induced the accident. According to the geological data, the fault is a normal fault with an inclination of 85° , and its breaking distance and thickness of the fault zone are 16 and 1 m,

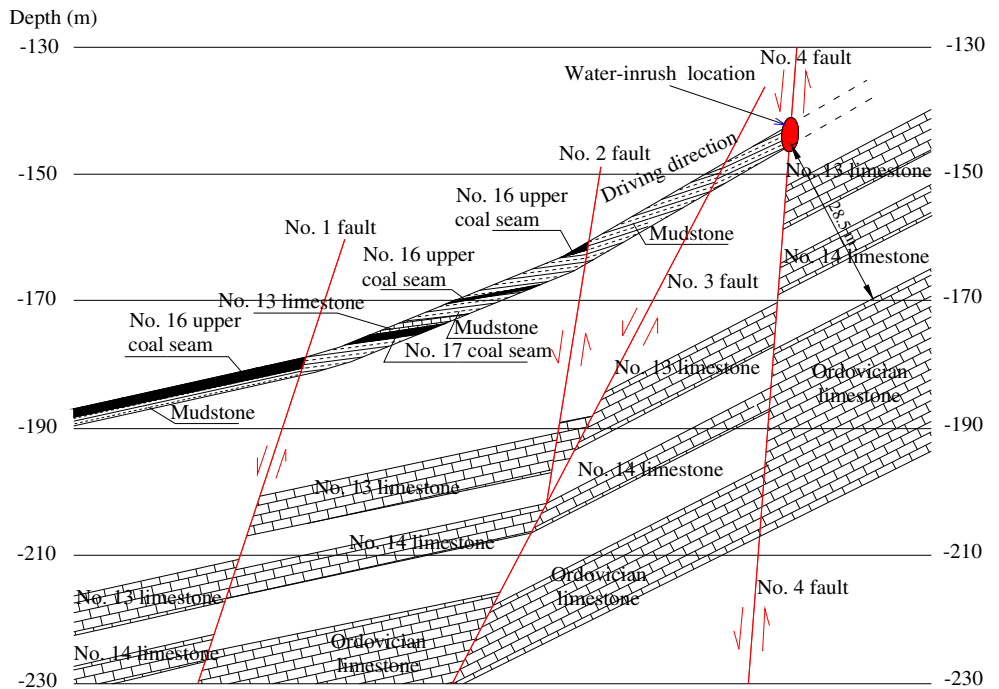
Fig. 3 Top view of geological section map and the location of water inrush point (after Huang et al. 2014)

respectively. Then, the second question to be asked is that where did the water come from. Figure 3 is the top view of geological section map and the location of water inrush point. It can be seen that several faults (i.e., No. 1, No. 2, No. 3, and No. 4 fault) have been exposed in the construction section of the channel with about 80 m distance from the water inrush point, and all the faults are normal faults, which all tend to be consistent. Rock formations under the floor were gradually uplifted induced by the fault, resulting in only about 28.5 m distance between the water point from strong rich water in Ordovician limestone and the gateway. Ordovician limestone is one of the most abundant water bearing stratas in Tianzhuang coal mine and even in North China. The Ordovician limestone is a confined karst aquifer containing an abundant supply of water and with a very high water pressure (Zhang 2005). According to the hydrologic observation wells, the water level in an Ordovician hydrologic observation well which was about 1 km apart from the water inrush point dropped 8 m during the water inrush accident (as shown in Fig. 4), while the water levels in No. 13 and No. 14 limestone observation wells did not change. Under these conditions mentioned above, the water inrush accident occurred owing to that water from Ordovician limestone aquifer gushed to the gateway through the fault.

Based on the above information, it can be concluded that the water inrush source comes from the Ordovician limestone aquifer, the water inrush channel is the fault zone, and the determination of water source and channel is the basis of the design governance scheme.

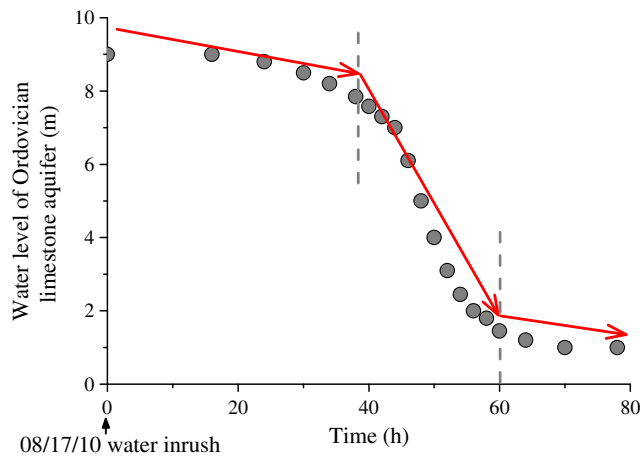
Fig. 4 Water level change curve of Ordovician limestone aquifer

4. Phase IV (steady phase). The water flow rate in this phase was gradually stabilized at a larger value, the inrush water was clear, and the water inrush channel was constant. The water level of the effluent water was kept gradually steady after the continuous large flow of water (Fig. 4). The water level of the Ordovician limestone aquifer was kept at about 1 m in this phase. The effluent flow rate was

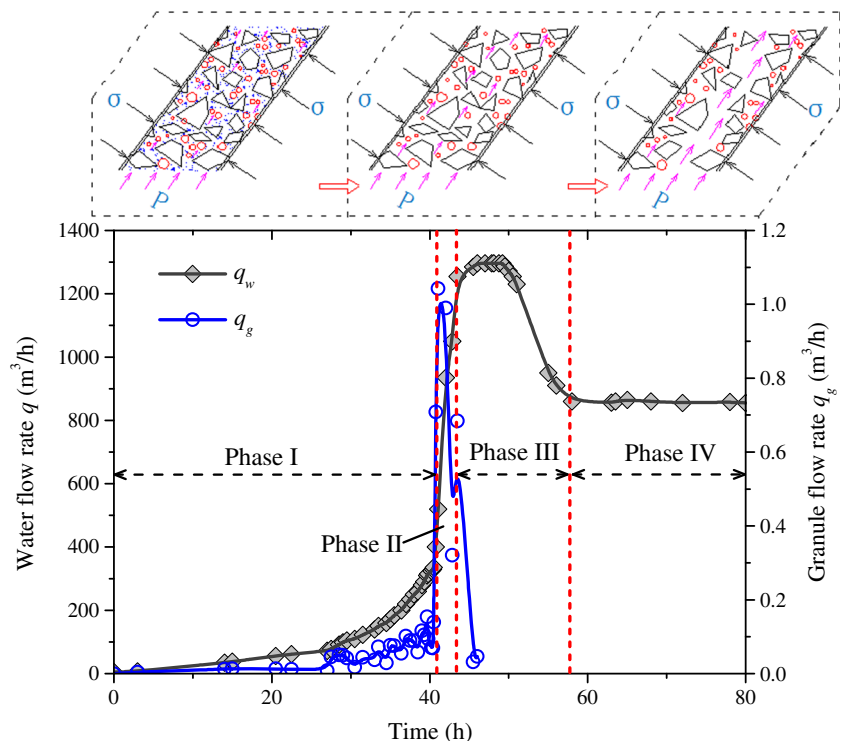
Fig. 5 Variation curves of the water flow rate (q) and the calculated granule flow rate (q_g) during the water inrush accident

Figure 5 shows the variation curve of the water flow rate (q) during the water inrush accident. Water inrush through the fault is also a process of the washout of an existing in-fill in the fault. Laboratory tests are the common methods to investigate the granular loss of fillings (e.g., Zhang et al. 2014; Ma et al. 2017). However, it is difficult to obtain the granule flow rate in an actual water inrush accident, resulting in extremely rare data of the granule flow rate. According to the data, the

According to the Nikuradse experiment curve (Nikuradse 1932), we chose the $d/\Delta = 30$, then the granule flow rate (q_g) can be calculated using Eq. (5), and the calculated result is shown in Fig. 5. Combining the results of the water flow rate (q) and the granule flow rate (q_g) provides information on the water inrush process, which can be divided into four phases:

1. Phase I (flow rate steady increase phase). This phase occurs in the early regime of the water inrush accident. The duration of this period is 40.5 h, the flow rate (q) increased from 3 to 335 m³/h, and the rate of increase of flow rate was increasing as well. The content of solid matter in water was also increasing, and finally a diameter of

204 mm rough tubular water inrush channel was formed. The water inrush from the fault in this phase was turbid with fine sediment and a small amount of gravel. In this phase, the tiny granules in the fault would be eroded and moved to exterior as the time induced by water seepage and lead to the changes of the porosity and permeability parameters (Zhang et al. 2014).

2. Phase II (rapidly increase phase). In this phase (just about 3 h), water flow rate rapid increased from 335 to 1255 m³/h. The increasing water flow rate may cause a greater seepage velocity and carrying capacity of water, which may result in more granules being eroded and moved with the water flow. Thus, solid material content in the second phase was significantly higher than the previous phase, where the largest amount of solid material reaches 1.04 m³/h, a diameter of 346 mm rough tubular water inrush channel was formed. The water inrush from the fault in this phase was turbid with a lot of fine sediment and gravel, and a round outlet was observed in the fault zone. In this phase, the materials within the fault zone were quickly washed out, resulting in the structure damage of the fractured zone and rapid increase of its permeability.

3. Phase III (decrease phase). As the water inrushes from the fault, the water flow rate gradually reduced from 1255 to 860 m³/h. According to the situation of 8602 working face, the inrush water was clear and the water inrush channel has not changed. The decrease of the effluent flow mainly resulted from the continuous large flow of the effluent and the decrease of the water level of the effluent water source (as shown in Fig. 4). In this phase, as a large number of filling granules were eroded and carried away by water as the time, only the rock skeleton and larger granules, which were not eroded and transported, were left. Thus, the granule flow rate (q_g) decreased quickly in this phase.

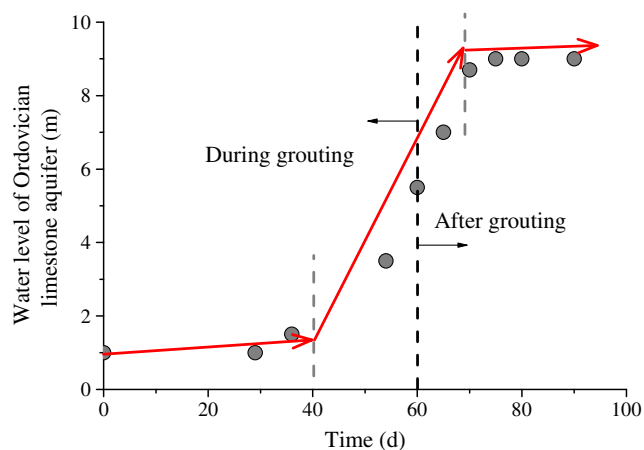
Fig. 9 Variation of the water level of Ordovician limestone aquifer after grouting

Figure 9 shows the variation of the water level of Ordovician limestone aquifer after grouting; the water level rose to 6 m since the treatment completed and rose to 9 m

15 days after that, indicating that the water level of the water source increased continuously after treatment. After that, no water inrush incident happens at the gateway or working face.
