# Leakage and abutment slope stability analysis of Arjo Didesa dam site, western Ethiopia

## Abstract

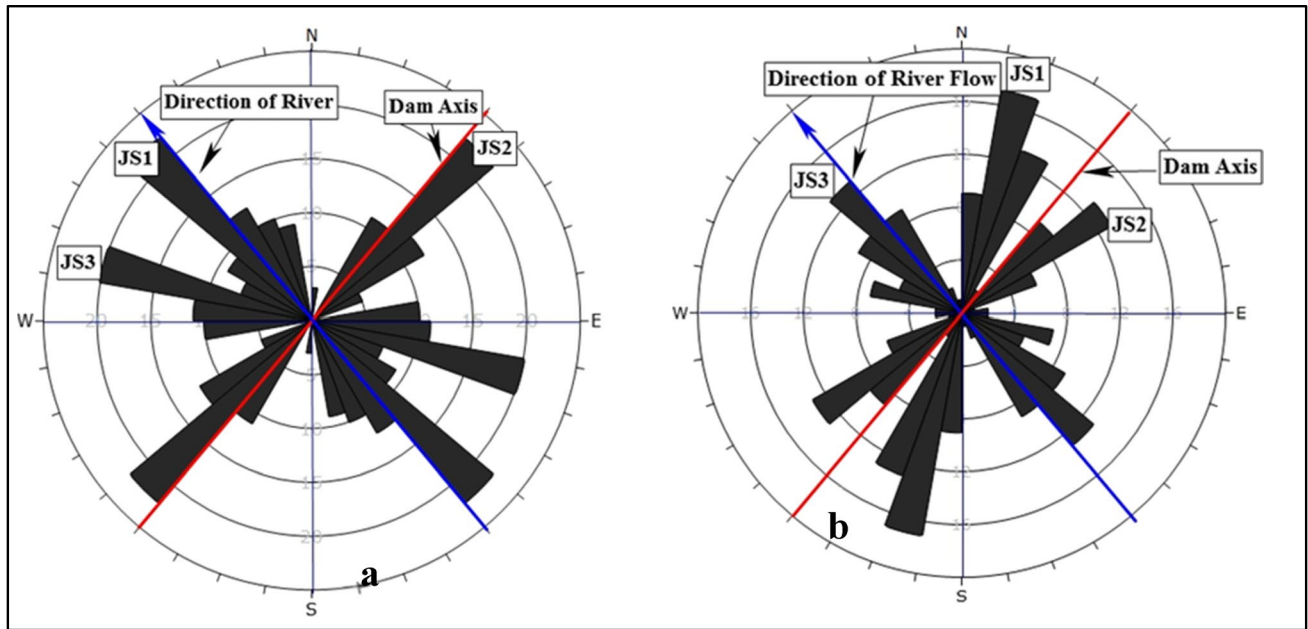
Fig. 4 Rose diagram at (a) left abutment and (b) right abutment (blue and red lines show the direction of river flow and dam axis, respectively)

flow direction favor leakage and infer potential seepage path in a dam site. Based on this study, the orientation of these two joint sets favors leakage in the abutment and through the foundation. Moreover, this analysis has also shown that the orientation of JS2 and JS3 at the left abutment and JS3 at the right abutment favors structural controlled failure mechanisms.

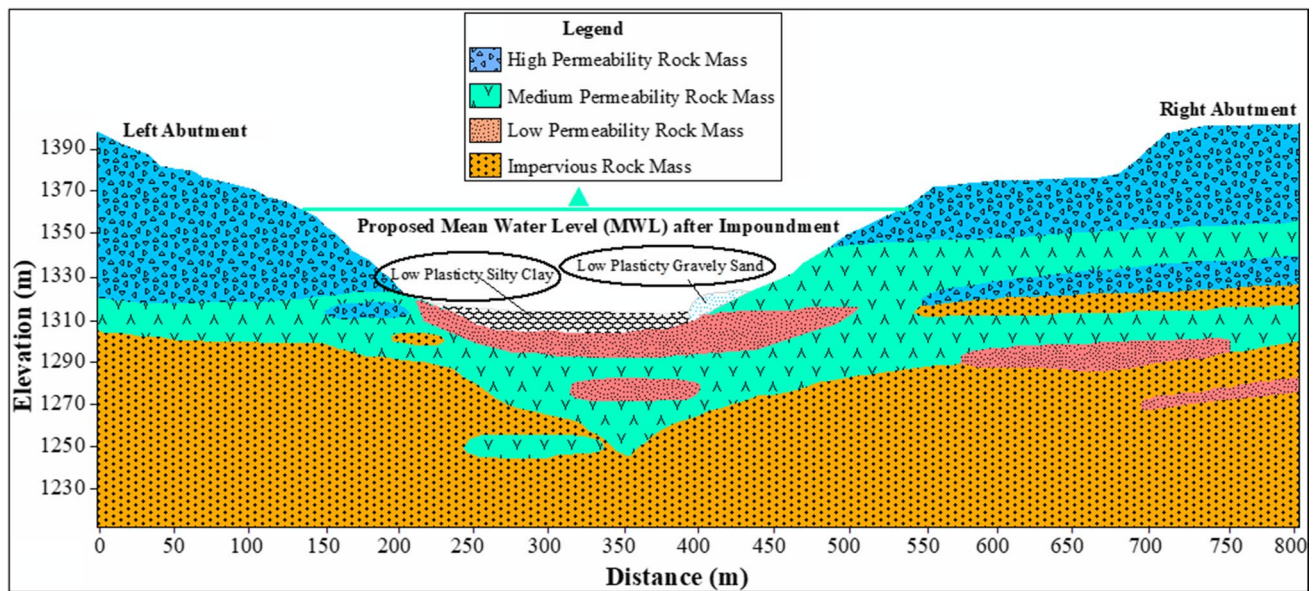
**Fig. 6** Permeability cross-section of rock mass along the dam axis based on Lugeon values based on Ghafoori et al. (2011)

Lugeon value generally decreases to less than 3 at a depth of about 40 m for the left abutment, 53 m for the central foundation, and 43 m for the right abutment (Figs. 6 and 7).

Analysis of Lugeon values with depth in terms of permeability cross-section (Fig. 6) has shown variation in permeability with depth between different sections of the dam site. For example, the left abutment is relatively more pervious than the right abutment of the dam site, implying a higher degree of fracturing and weathering at the left abutment. Moreover, this analysis has also revealed that the Lugeon values rarely show a clear trend with depth (Fig. 6), and hence, curtain grout depth for this section of the dam must be determined with great caution. In general, a detailed analysis of Lugeon values has shown a general decrement to less than 3 Lugeon units at depths of 40 m, 53 m, and 43 m at the left abutment, central foundation, and right abutment, respectively. This implies that all the rock masses which are located over the above-mentioned depths at the corresponding sections of the dam site are pervious and can lead to serious leakage problems. Hence, based on Houlsby (1976 and

1990) and Uromeihy and Farrokhi (2011), curtain grouting is recommended to the depths of 40 m for the left abutment, 53 m for the central foundation, and 43 m for the right abutment to control leakage.

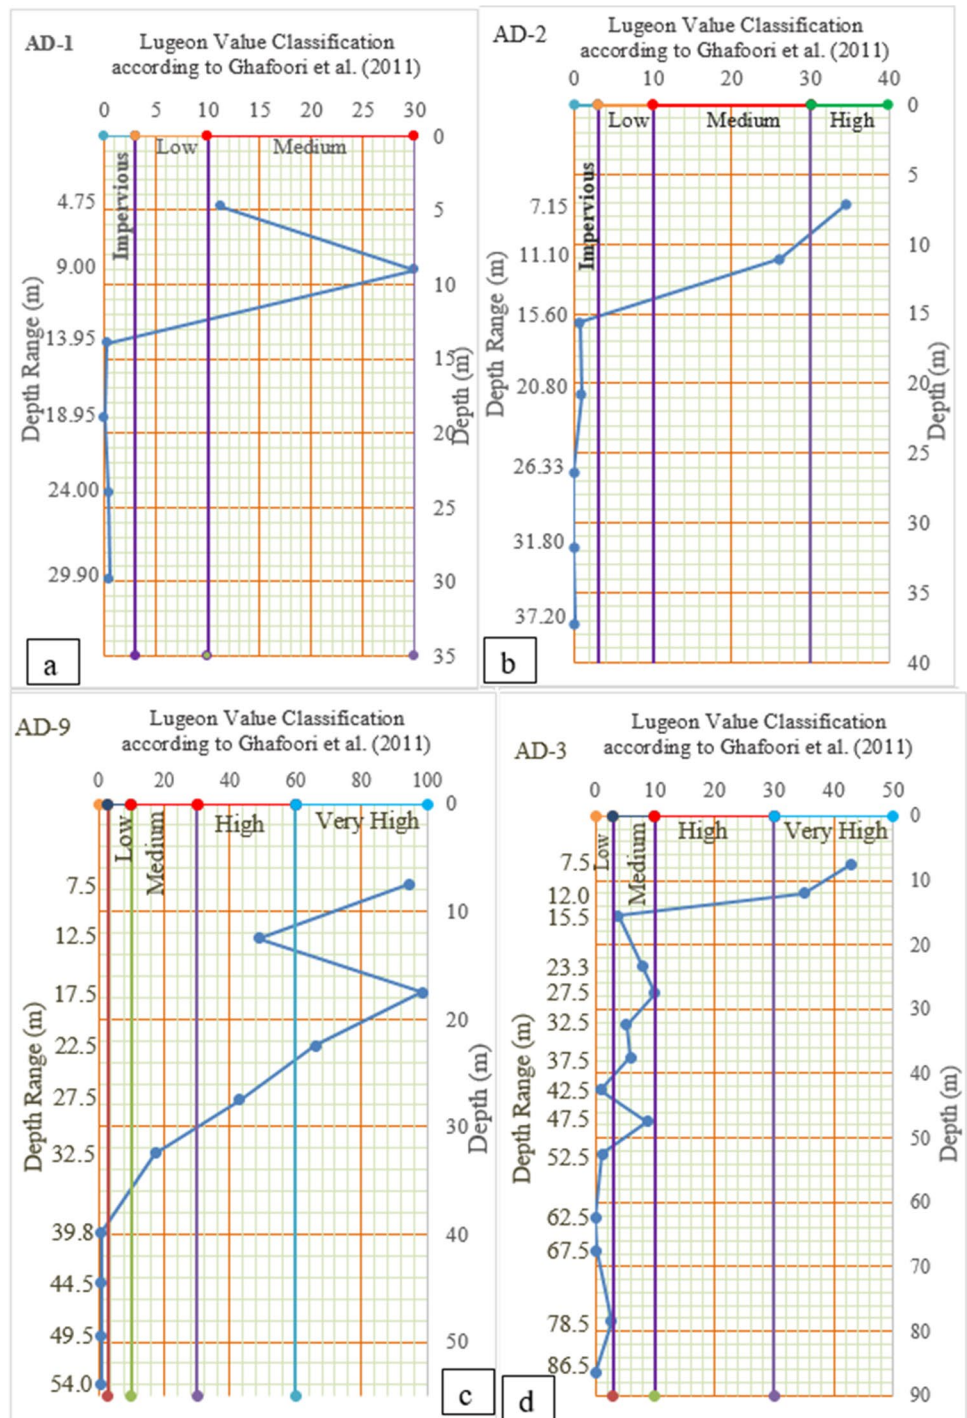
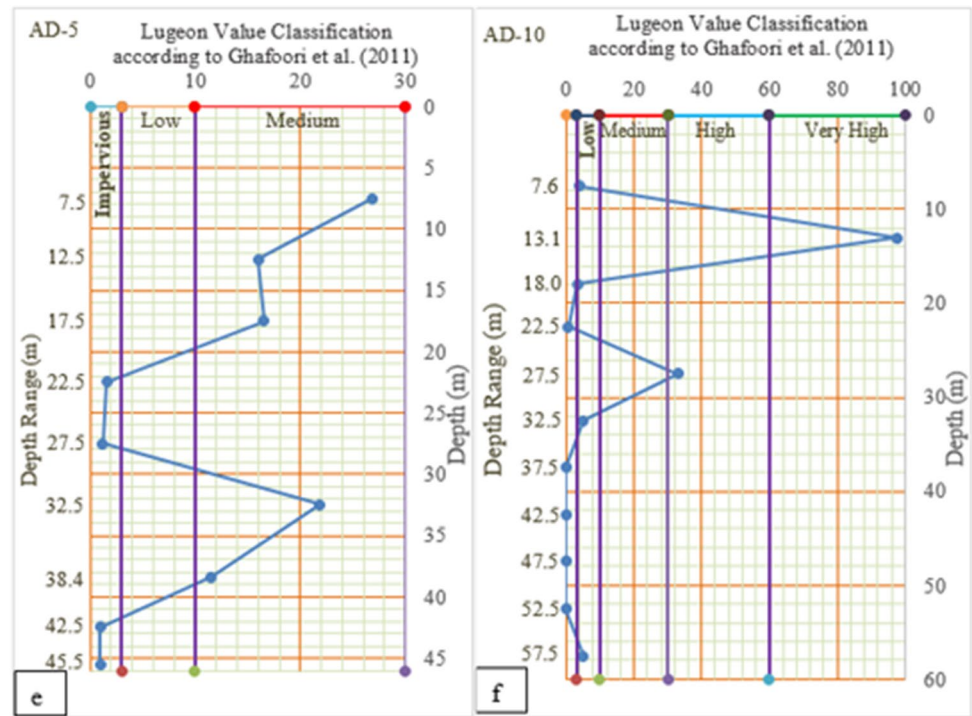
**Fig.7** Plot of Lugeon values with depth for some selected boreholes at the (a, b, and c) at the left abutment, (d) central foundation, and (e and f) right abutment

in close agreement and the majority of determined Lugeon values of rocks along the dam axis decrease with depth (Fig. 6 and Fig. 7a–f). Moreover, the analysis also showed that the

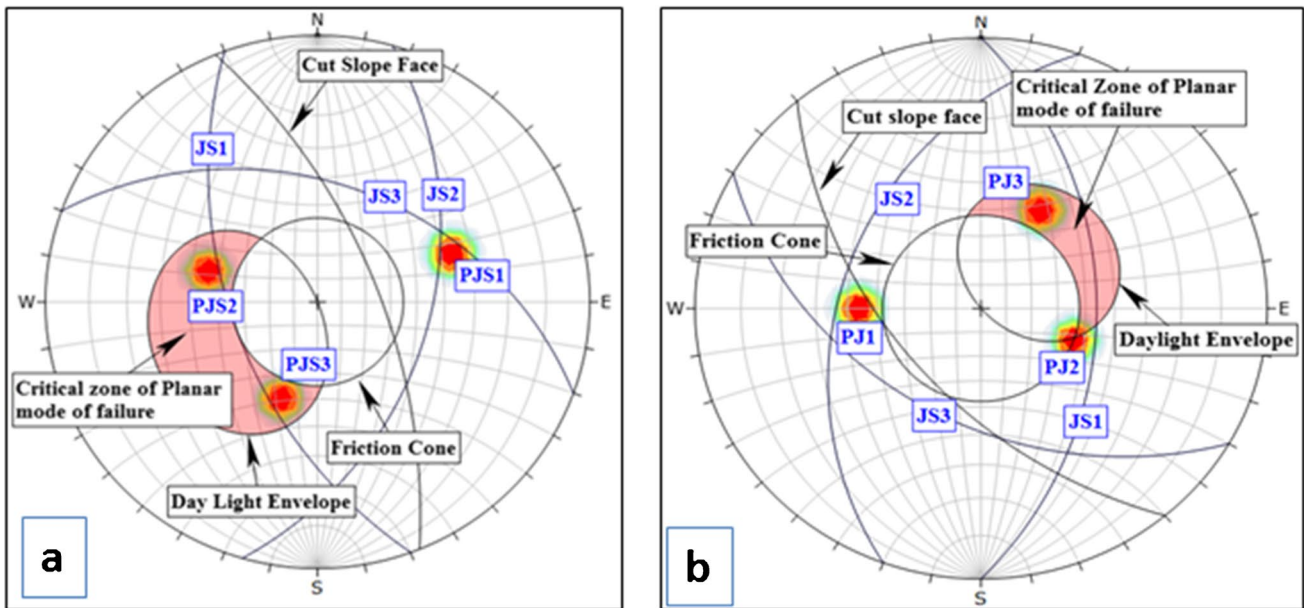
Fig. 8 Kinematic analyses for the planar mode of failure: (a) left abutment and (b) right abutment

in Fig. 8. Accordingly, some sections of the left abutment of the dam are unstable for a planar mode of failure due to joint set 2 (JS2) and joint set 3 (JS3) (Fig. 8a) and the right abutment due to joint set 3 (JS3) (Fig. 8b).

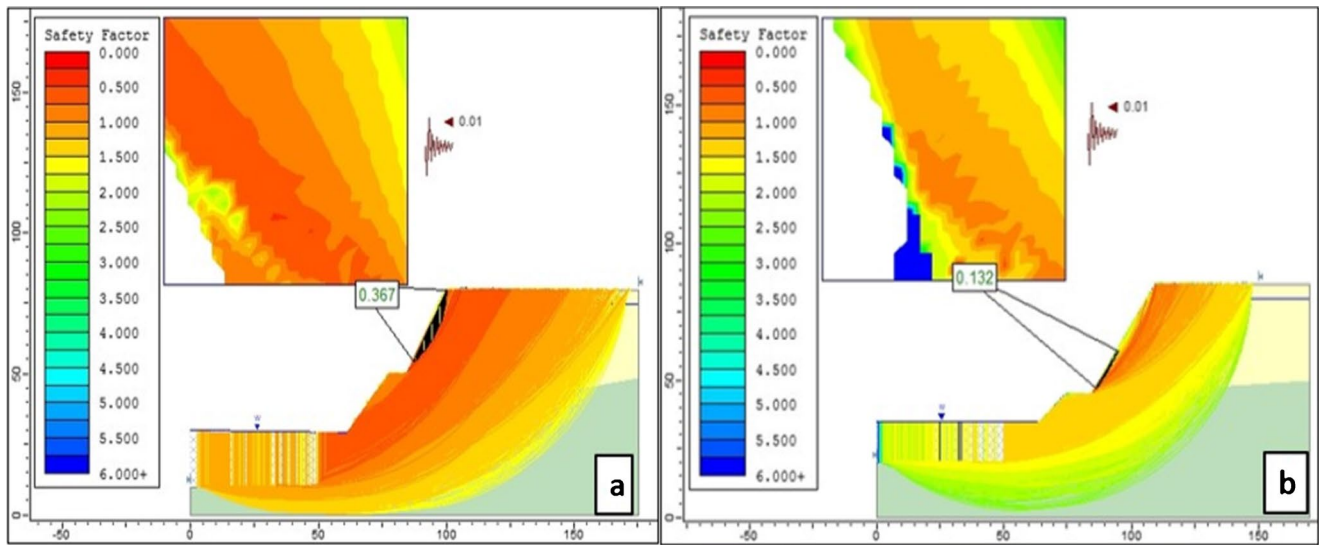
**Fig. 9** Some selected slope stability analysis results using the limit equilibrium method under dynamic saturated conditions at the (a) left abutment and (b) right abutment

According to the results, both abutments of the dam site are unstable during saturated conditions with FOS as low as 0.132 and stable during dry conditions.

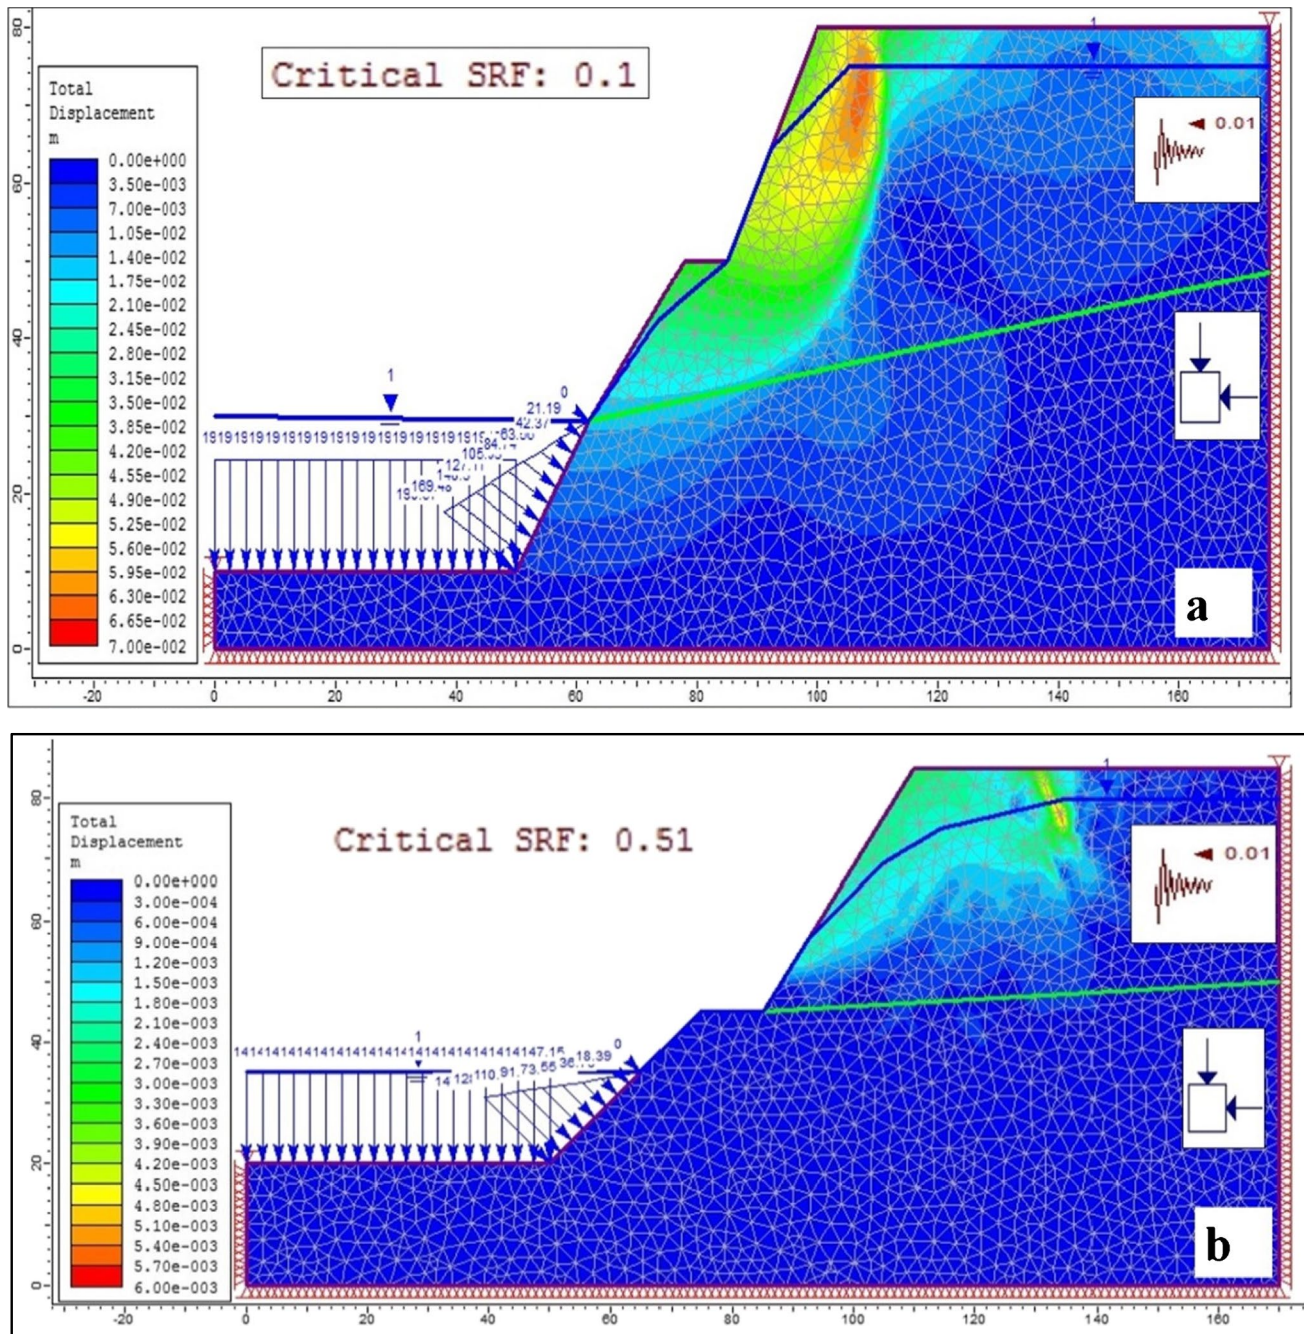
**Fig. 10** Some selected slope stability analysis results using FEM under dynamic saturated conditions at the (a) left abutment and (b) right abutment

The Young’s modulus ( $E_m$ ) was determined based on Hoek and Diederichs (2006), and a Poisson’s ratio value of 0.3 was used based on the study by Gercek (2007). Upon the determination of all input parameters, the analysis was executed, and the results were presented in Table 9 and Fig. 10. Likewise, for LEM, the analysis results of this method also showed that both abutments of the dam site are unstable during saturated conditions (i.e.,  $SRF < 1$ ) and stable during dry conditions (i.e.,  $SRF > 1$ ).

Moreover, the stability of highly weathered and fractured sections of the dam abutments was first conducted using LEM and followed by FEM. The results obtained from both methods are in very close agreement, and both showed unstable slope conditions during saturation. Hence, this scenario illustrates that surface water and groundwater conditions are the major causative factors for slope instability in the study area. Therefore, any proposed remedial measures against slope instability in the dam site should primarily consider the saturation condition into account.
