GPR Investigation of Mining Induced Subsidence and its Effects on Surface Structures: A Case Study of Srinagar City, J&K, India, NW Himalayas

Bikram Singh Bali*, Ahsan Afzal Wani, Gulam Rasool Bhat and Sareer Ahmad Mir

Department of Earth Sciences, University of Kashmir, Srinagar, Jammu and Kashmir, India

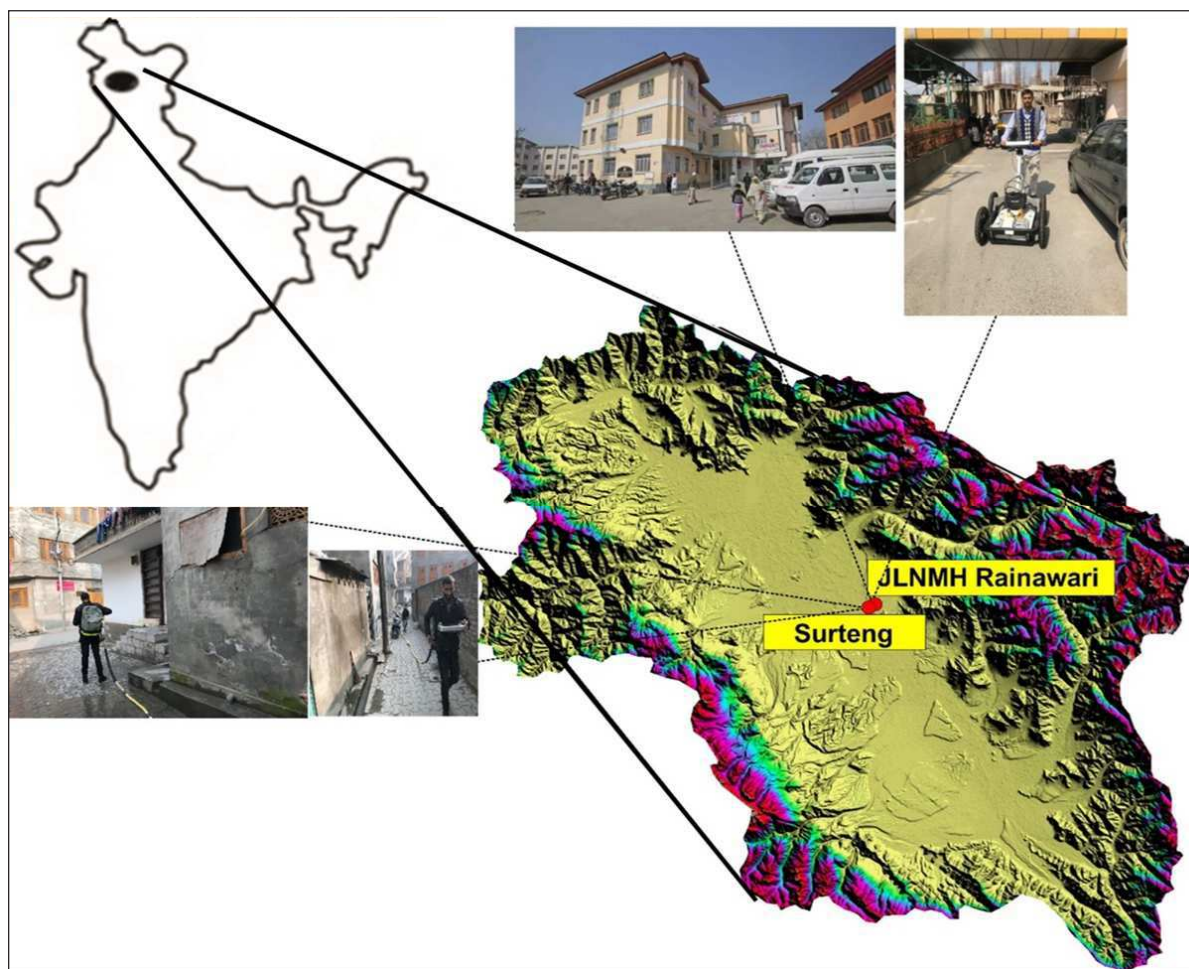
Fig.1. SRTM DEM image shows the location of GPR survey along with field photographs.

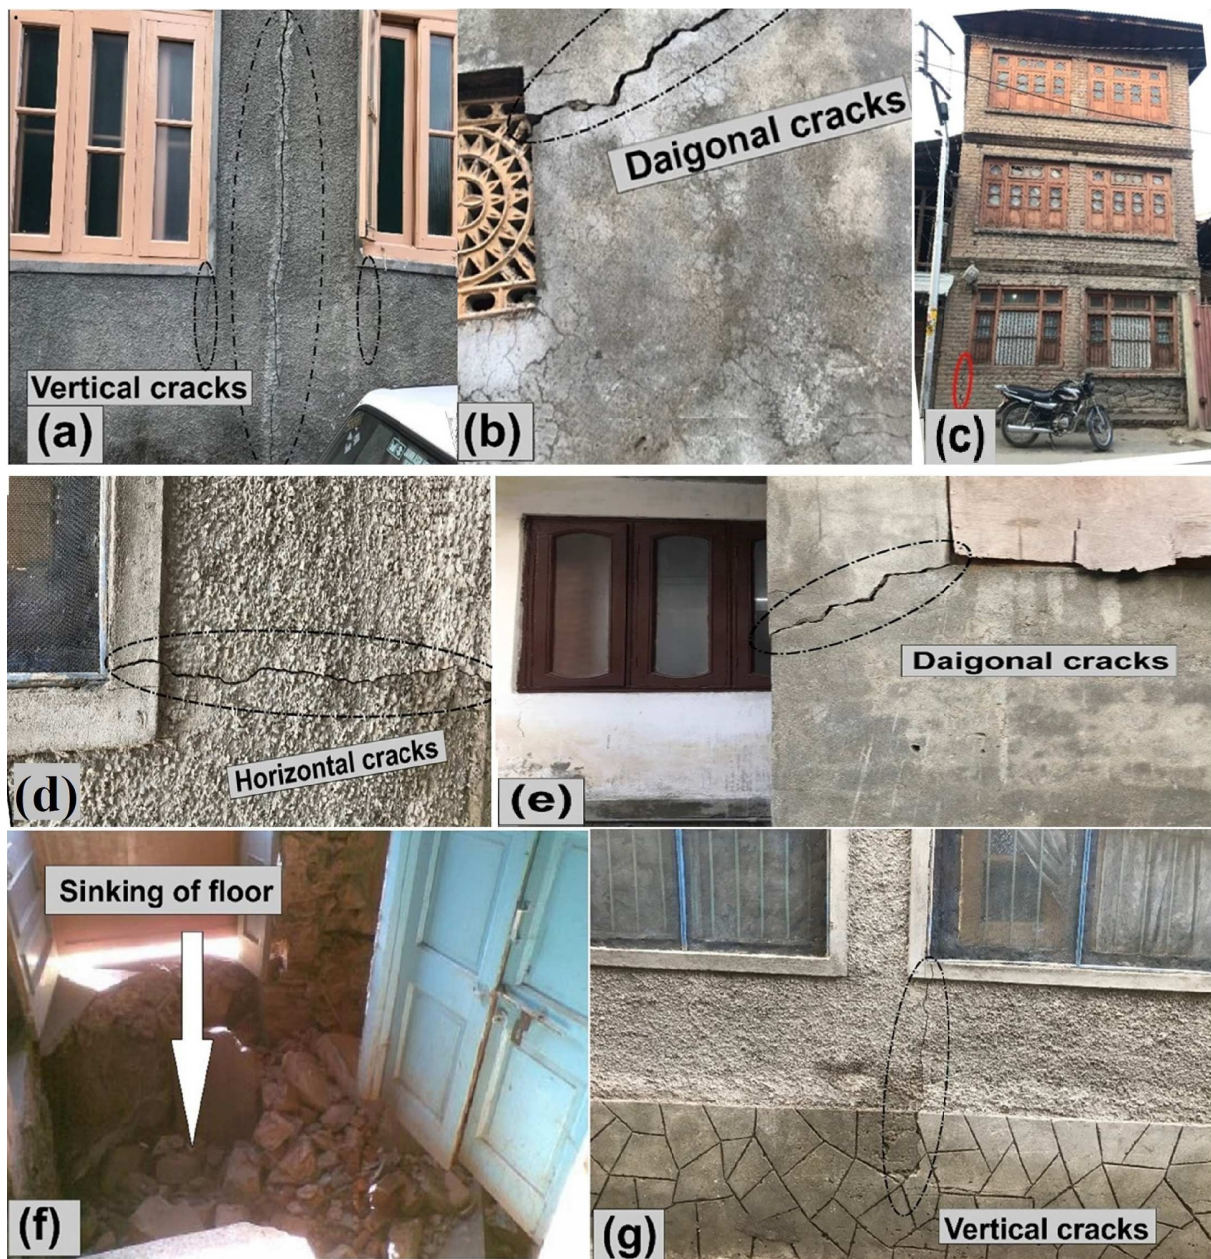
structural damages. Some cracks were small hairline near window panes to very wide up to 4-5 mm and the most common cracks observed are the diagonal to stepped cracks running up or down a wall and follow a line of mortar to create a step like pattern and some cracks go through the bricks rather than following mortar to form a diagonal crack (Fig. 3 b & e). Some cracks were observed running from top to bottom in a more or less straight line, classed as a vertical crack (Fig. 3 a & g). Some cracks follow side to side and the mortar joints. These are classed as horizontal cracks (Fig. 3 d). According to the locals some concrete structures including one in the premises of J.L.N.M hospital (few yards away from the sight of present subsidence) had to be demolished two decades back as their walls and plinth had developed wide cracks. Besides cracks some of the structures have suffered sinking of floors, sags and settlement of basement floors that results in separation of basement concrete floor from partition walls impacting the stability of the building (Fig. 3 f). One of the main issues related to subsidence reported in Rainawari area is tilting of buildings and several houses in the area were abandoned as these are experiencing quite sharp tilting (Fig. 3 c).

Fig. 3 (a) Deformed wall including an upright wide tension crack at Surteng locality indicating that the foundation of this building is dropping. (b) Front view of the wall showing a large diagonal crack developed in the wall visible on both sides and extends up to the window frame. (c) A colloquial masonry structure experiencing displacement and tilting quite sharply due to impact of the subsidence (d) A horizontal crack displacing the wall and the window pane (e) Front wall shows a wide crack that appear downwards from window frame and shows displacement of the upper column with respect to the lower one. (f) Sinking of the floor near the entrance of a masonry structure due impact of the subsidence. (g) A vertical crack running downward from the window and tapers at the foundation level.

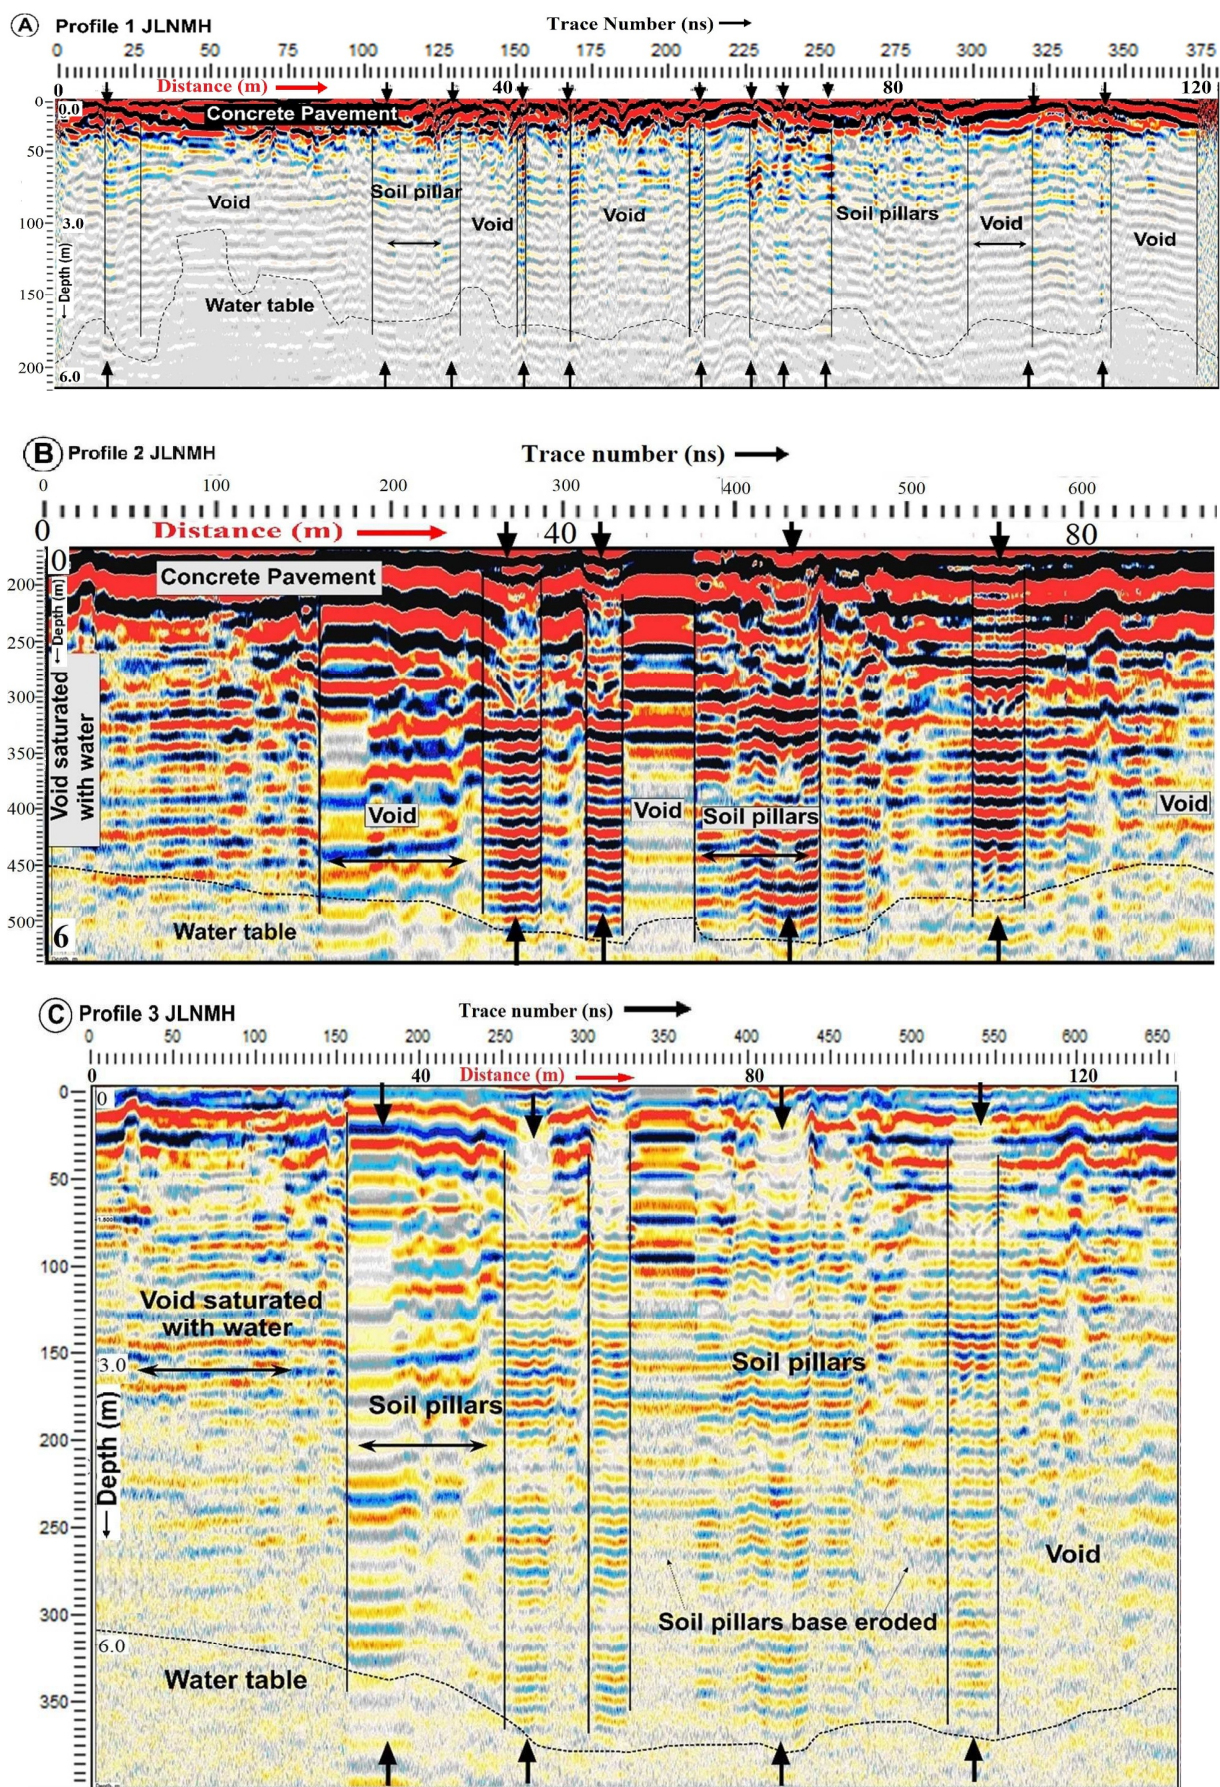
The GPR profiles at site 1 JLN M H Rainawari (Fig.2 & 4 a) were acquired using 200 MHz antenna in the courtyard of the Hospital striking ~NW-SE direction, 205 m in length which yielded a well resolvable penetration depth of 5 m. The GPR results represent room and pillar type structures at near surface (~3 m depth), consisting a series of voids bounded/separated by soil pillars that pose a great threat of seismic liquefaction and erosion owing to shallow groundwater table in the area at 3-4 m. The soil pillars in the GPR profile were marked between 9-15 m, 54-70 m, 82-89 m, 109-113 m, 121-135 m and at 170-183 m horizontal distance marked by solid vertical black lines (Fig. 4 a). The soil pillars are separated by voids and are saturated at base. A thin black dashed line at the base of the images shows water table depth of the site. Most of the soil pillars at base are eroded and weak, which are clearly expressed by discontinuities, offset, warped

inclined reflection truncations in the georadar reflections. The stronger and coherent reverberations found at the top of the image in the form of red and black reflectors mark the concrete pavement in the courtyard of the hospital. GPR profile 2 JLNMH (Fig. 4b) was taken at the backyard of the hospital and is 105 m long and 4 m deep. Similar room and pillar type of structures were observed up to 4 m depth characterized by cylinder shaped soil pillars separated by cavities/voids. The soil pillars were marked in the GPR profile between 25-40 m, 50-55 m, 60-70 m and at 85- 90 m horizontal distance marked by black vertical lines and arrows. The voids/rooms are saturated, eroded, sometimes with dissolved soil pillars and are wider than soil pillars. Thin dashed line at the bottom of the profile reflects the groundwater table which coincides with the profile I. A big saturated void is observed between 0-25 m horizontal distance marker suggesting that the soil

pillar is either completely eroded or collapsed and is replaced by a big cavity. The coherent reverberations up to 2 m at the top of the profile mark the concrete bed (DPC) of the newly constructed structure at the backyard of the hospital.

GPR profile 3 JLNMH was acquired with 100 MHz rough terrain antenna along the gentle slope tapering off towards hospital quarters relatively flat/subsided surface (Fig. 4 c). The profile is 105 m long that yields a penetration depth of 6 m. Cylindrical soil pillars were observed marked between 25-40 m, 40-50 and 55-85 m horizontal distance marker separated by saturated voids. The cavities/voids are saturated at base and a black dashed line at the base of the profile reflects the water table of the area and is at 6m depth. A big void is observed, marked between 0-25 m horizontal distance marker reflects either the soil pillar has been completely eroded and dissolved and

Fig.4. Interpreted JLNMH GPR image profile 1 acquired using 200 MHz antenna configuration in the courtyard of the hospital showing land subsidence and sink holes. (b) GPR profile 2 JLNMH taken at the backyard of the hospital using 200 MHz antenna configuration. (c) GPR profile 3 JLNMH acquired with 200 MHz tapering off hospital quarters illustrating room and pillar structures and subsidence in the shallow stratigraphy of 4-6 m depth.

interlinked two cavities. The soil pillars are of varied height from 4-6 m and are partially eroded and dissolved at base. A network of voids and soil pillars were observed almost in all GPR profiles suggesting that this area was probably used for extraction of soil by room and pillar type of mining methods and most of the voids are saturated at the base.

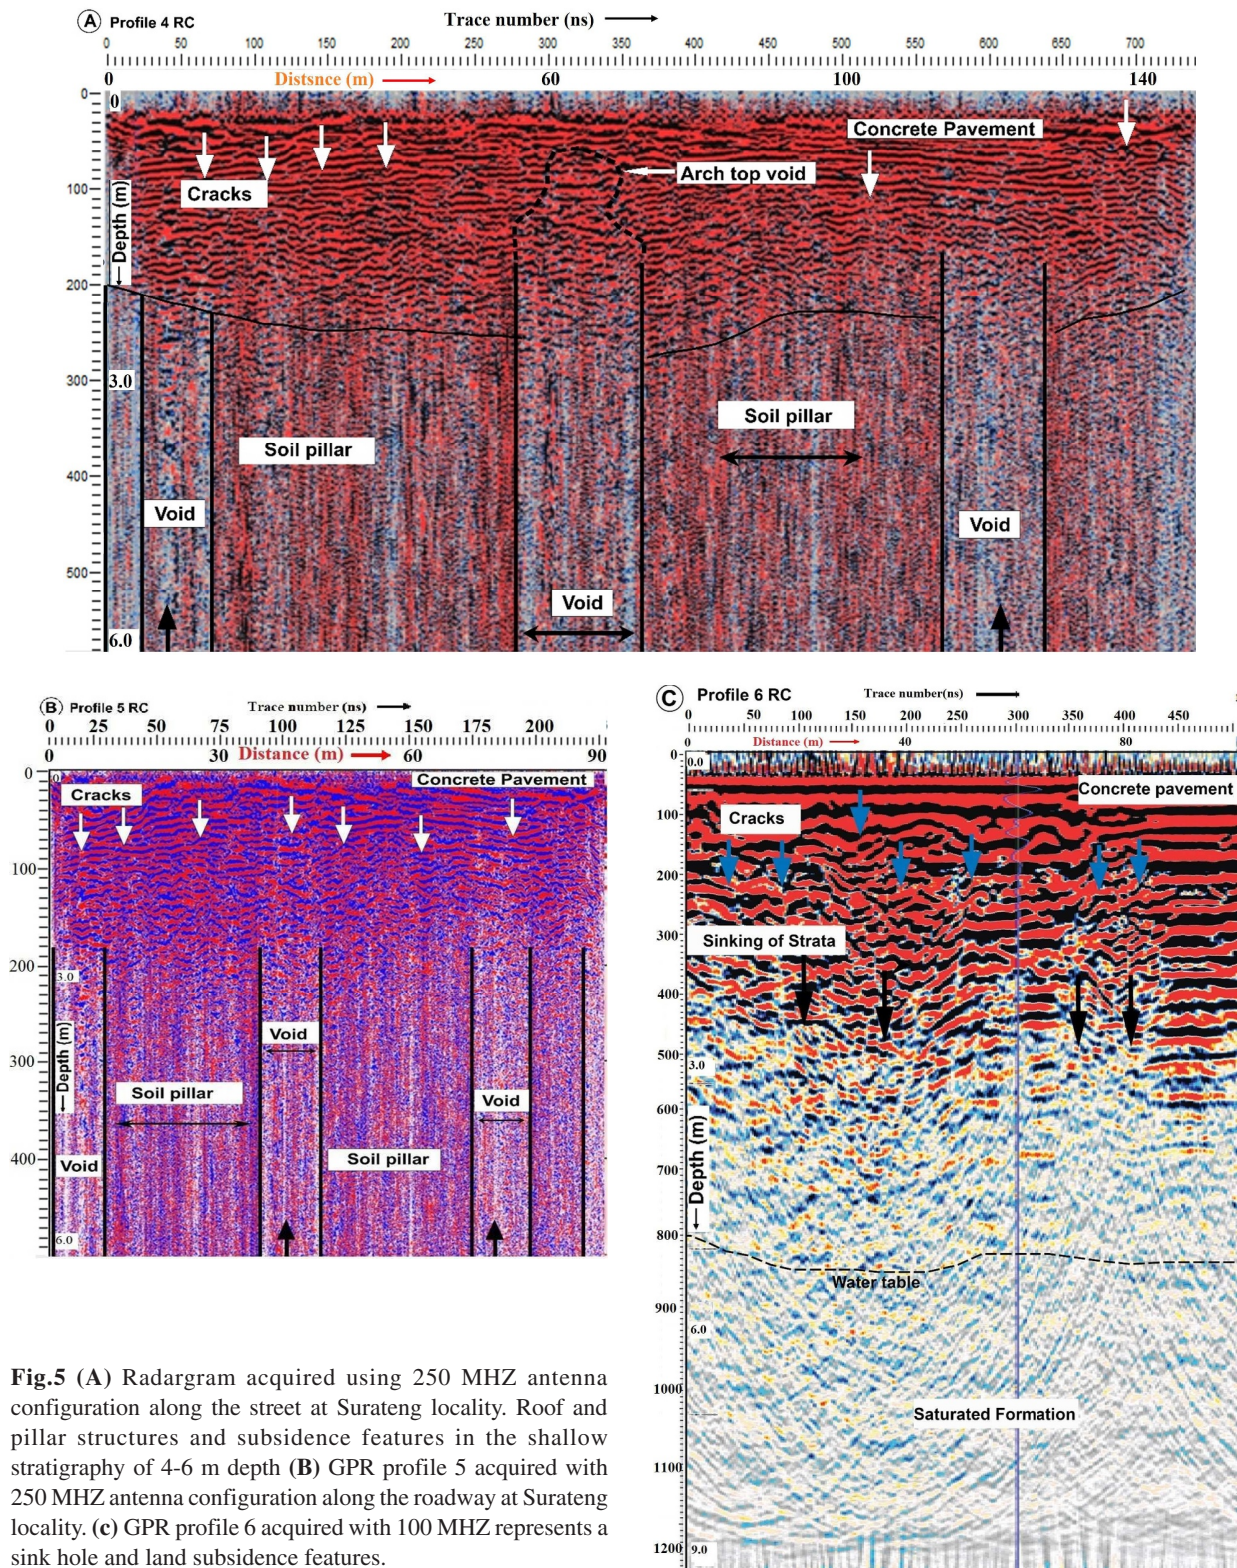
A total of three profiles were acquired at Surteng locality along the roadways to delineate the subsurface geometry and pattern of sink holes and deformation structures that accommodate the land subsidence in the area. The GPR profile 4 was taken along the street at Surteng locality with 250 MHz antenna and is 220 m long with a penetration depth of 5-6 m (Fig. 5 a). The profile illustrates a lateral changes in reflection geometry and pattern is consistent with asymmetrical pillar structures separated by intervening voids and cavities expressed between 2 m to 200 m as reflections with clear reflection termination and displacements. An arch top void is expressed between 75 m to 95 m distance marker that extends up to the near surface and shows upward termination. Several diagonal and vertical wide cracks are expressed between 8 m to 180 m as inclined radar reflections and diffraction hyperbolas that offset georadar reflections. Well defined sharp vertical truncations and offsets are expressed (15 m, 70 m, 150 m) from the base up to 2 m depth and an inclined to down warping radar reflections within upper 2 m depth reflect foundering and sinking of the formation as the arch top void has almost approach to the near surface that could results in the sudden collapse or sink hole formation in the near future at the site. The GPR profile 5 was taken with 250 MHz antenna along the roadway at Surteng locality is 170 m long striking NW with a penetration depth of 6 m (Fig. 5 b). The profile illustrates upwarping and down warping in the georadar reflections up to 2.5 m depth between 5 m to 150 m and several inclined wide cracks expressed as inclined and disconnected georadar reflections or hyperbolas between 2 m to 165 m distance marker. Very sharp abrupt vertical terminations expressed as diffraction hyperbolas from base to 2.5 m depth between 0 m to 170 m reflect soil pillars bounded by voids and cavities marked with thick vertical black lines. The soil pillars and voids are symmetrical in pattern and geometry and are expressed at equal intervals with almost 20 m wide soil pillars separated by 15 m voids. The higher amplitude and stronger reflections at the base of the voids between 0-15 m, 50 to 65 m and 140-160 m suggest the presence of water. The GPR profile 6 was acquired with 100 MHz shield antenna striking E-W is 120 m long that yielded penetration depth of 15 m (Fig. 5 c). The profile demonstrates a sink hole expressed as anomalous inclined and disconnected down warping radar reflections interspersed with on lap and vertical reflector geometries between 2 m to 100 m distance marker from the 1.5 m to 10 m depth. The disconnected and offset radar reflections showing an overall syncline geometry suggest internal foundering of the layers and downward movement of the strata and extends up to the base of the image. The deepest part of the sink hole is expressed between 10 m to 50 m as hyperbolas with clear down warping geometry bounded by sharp lateral offset and inclined reflections that forms the collapse structure and truncating upper soil cover almost up to the surface. The sink hole is overlain by discordant reflections and the outward margins of the sink hole is expressed coherent inclined disrupted reflectors and discrete breaks. The upper 1 m from the top reflects various vertical and diagonal cracks expressed as diffraction and offset hyperbolas. Very stronger coherent radar reflections from the base up to 6.5 m represent ground water table and is marked with thin black dashed line.

Fig.5 (A) Radargram acquired using 250 MHz antenna configuration along the street at Surateng locality. Roof and pillar structures and subsidence features in the shallow stratigraphy of 4-6 m depth (B) GPR profile 5 acquired with 250 MHz antenna configuration along the roadway at Surateng locality. (c) GPR profile 6 acquired with 100 MHz represents a sink hole and land subsidence features.
