Secondary geological hazard analysis in Beichuan after the Wenchuan earthquake and recommendations for reconstruction

Yu Huang · Wei Chen · Jinyuan Liu

Abstract The Wenchuan earthquake, also known as 2008 Sichuan Earthquake, occurred along the Longmenshan fault zone on 12 May 2008 at 14:28:01.42 CST (06:28:01.42 UTC). It caused serious damage to structures in the region. Beichuan is a town which is within these severely damaged areas. According to the earthquake intensity distribution map of 2008 Wenchuan earthquake officially released by the China Earthquake Administration, the earthquake intensity in Beichuan was XI on the China seismic intensity scale. As the earthquake occurred in a mountainous area, there were thousands of landslides, rockfalls, debris flows, and surface ruptures triggered by the earthquake over a broad area. These secondary geological hazards substantially increased the human, social and economic impact of the earthquake. This paper presents a post-earthquake analysis on the secondary

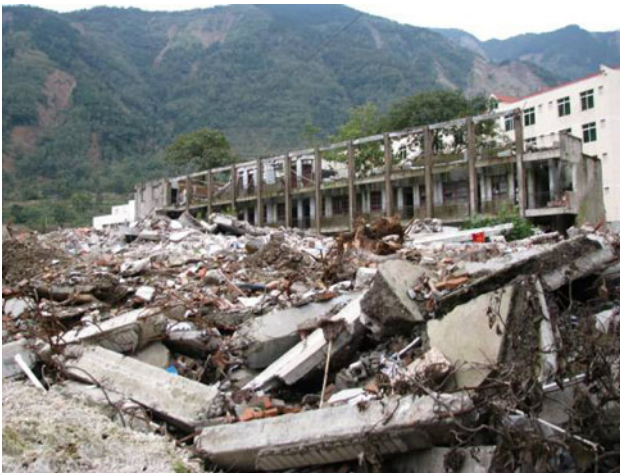
Beichuan is just above the south part of Longmenshan central fault, which is also called the Yingxiu–Beichuan fault. According to initial analysis of Wu et al. (2008), the main damage caused by the Wenchuan earthquake occurred in the hanging wall of the Beichuan–Yingxiu fault. The fierce fault dislocation led to a large number of landslides and devastating damages to buildings, as shown in Fig. 4 (ESM only), Figs. 1 and 2.

Fig. 1 Building damages at Xinbei Middle School

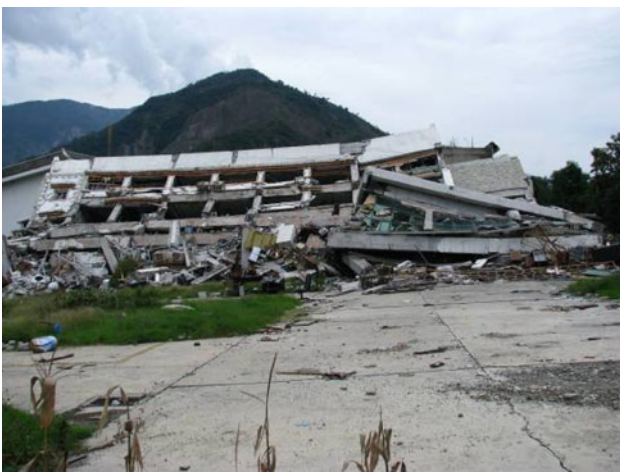
Fig. 2 Building damages at Beichuan Municipal Office

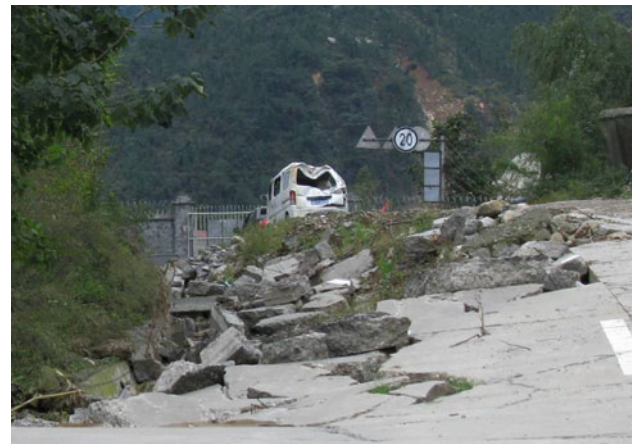
Fig. 3 Example of earthquake surface ruptures

Damages distributed mainly along the Longmenshan fault region. After the earthquake, the surface fractures were investigated in Beichuan and Yingxiu, as shown in Fig. 3. It was found that the Beichuan–Yingxiu earthquake fracture zone extends northeastward, dipping to the northwest (Fu et al. 2008). The earthquake fracture zone is mainly characterized by thrust faulting with a small strike-slip movement, and demonstrating various complexities for different areas. The phenomena related to dextral strike-slip displacement were found in the Beichuan and those related to left-lateral strike-slip movement were found in Yingxiu. The compressive shortening of the two surface fracture zones in Beichuan was 2.8–3.9 m and the left-lateral strike-slip displacement of the surface fractures in Yingxiu was 0.52 m (Deng et al. 2008).

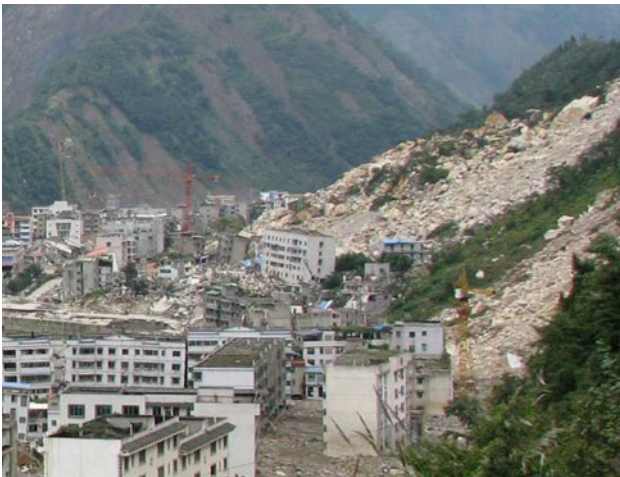
Fig. 4 Xinbei Middle School landslide at the new town in Beichuan

students and teachers, as shown in Fig. 4 (Xinhua News Agency 2008).

The Xinbei Middle School landslide was a complex of ancient landslide and cliff with a length of 650 m, a

breadth of 200 m, an average thickness of 20 m with some places reaching a thickness of 40 m, and an altitude difference of 300 m. The volume of this landslide was approximately 2,400,000 m³. This landslide had the characteristics of rockfalls and was composed mainly of blocks and stones with some having a volume of 1,000 m³ (Yin et al. 2009). Its impulsive force was huge and totally destroyed a three-storied school building in the Xinbei Middle School and adjacent buildings and took the lives of nearly 500 people. In the leading edge of the landslide, there was ground ballooning along the former main street, it might be related to the break thrust formed by the seism tectonic line.

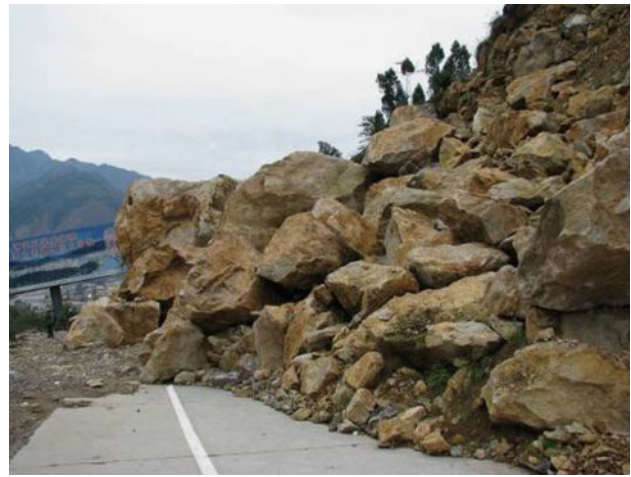
Fig. 5 Rockfalls on the road from Renjiaping to the old town in Beichuan

The rocks fell down under strong ground motion and surface rupture. Figure 5 shows Jingjiashan rockfall on the road from Renjiaping to Beichuan, which is situated on the Longmenshan central fault. The fall blocks were round or angular. The joints and beddings were full-fledged and the interfaces among block–block and block–soil were very clear.

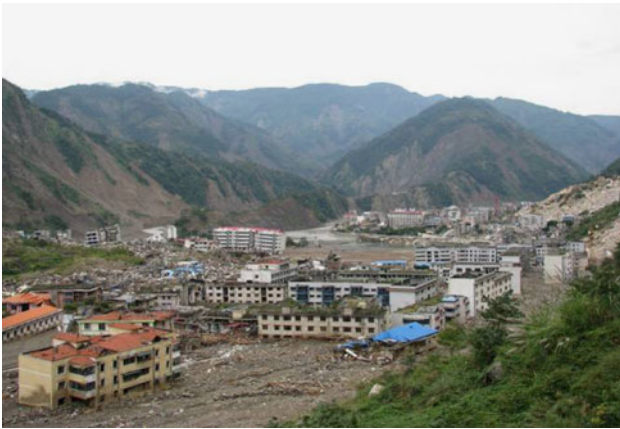
Fig. 6 Debris flow at the old town in Beichuan

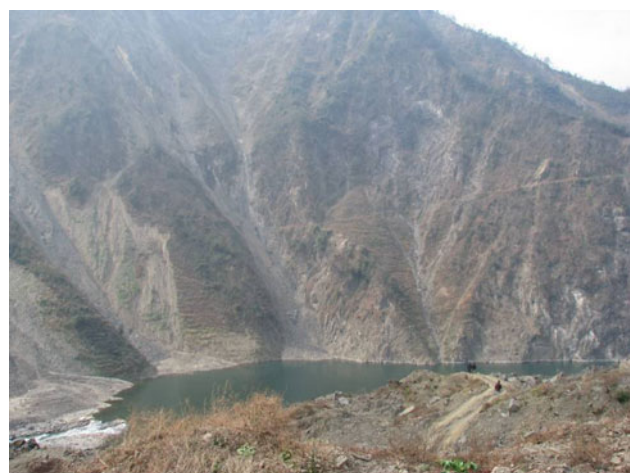
Fig. 7 Tangjiashan barrier lake

the barrier lake was 240 million m³; the backwater length was 10 km. At the beginning of June 2008, the excavation measures were taken in the dam with a slotting depth of 20 m. The upstream water level of the Tangjiashan barrier lake achieved the highest water level of EL. 743.10 m at 1:30 AM CST on 10 June 2008 and then fell back to EL. 719.48 m at 8:00 PM CST on 10 June 2008 and met the safety design standards (Hu et al. 2009).

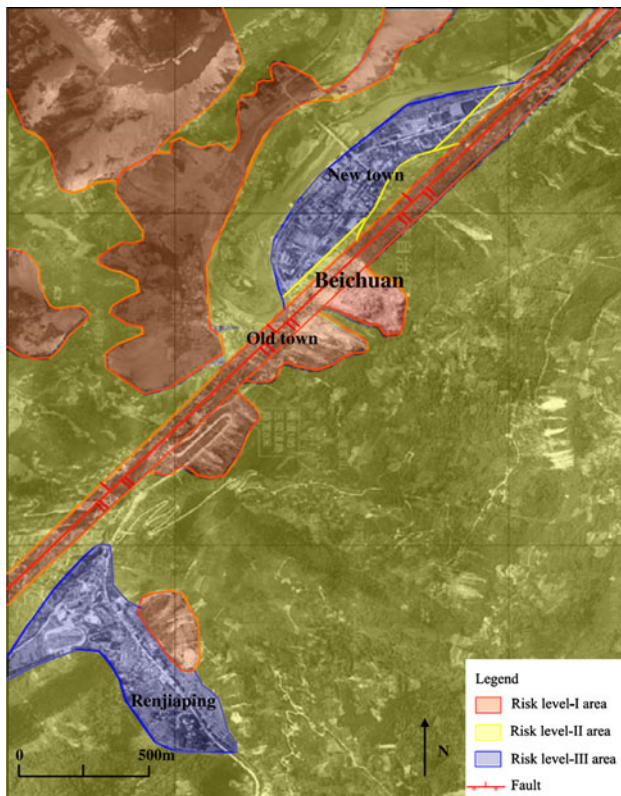
Fig. 8 Distribution of areas of different risk levels in Beichuan

It corresponds to the red areas in Fig. 8; its measures include immediately stops and alternative plans.

The area has the influence from landslides and rockfalls. It corresponds to the yellow areas in Fig. 8; the decision of policy-maker and controlling measures are needed in this area.

Based on the above analysis, the National Earthquake Memorial Museum is suggested to be constructed at

Renjiaping in Beichuan, which lies in the risk level-III area as shown in Fig. 8.
