Investigation of the failure mechanism and stabilization of a landslide in weathered tuffite, Giresun, northeastern Turkey

Abstract This study investigates the causes and failure mechanism of the Aksu landslide that occurred during the construction of the Giresun–Espiye road between KM: 1 + 030–1 + 170 in northern Turkey and recommends proper stabilization techniques. For the purpose of investigating the causes and mechanism of this slope failure, engineering geological mapping, geotechnical investigation and rock mass characterization were performed. From top to bottom, weathered tuffite, tuffite, flysch, and dacitic tuffite were the major units in the study area. The disturbance of the slope by the excavations performed at the toe of the slope (i.e., due to the foundation excavation for the Tünel restaurant building and for the road cut) led to a “translational slide”. The “translational slide” occurred in completely weathered tuffite due to the disturbance of the stability of the slope by the excavations performed at the toe of the slope, particularly for the foundation excavation of the Tünel restaurant building and for the road cut along the Giresun–Espiye road. The rise in t

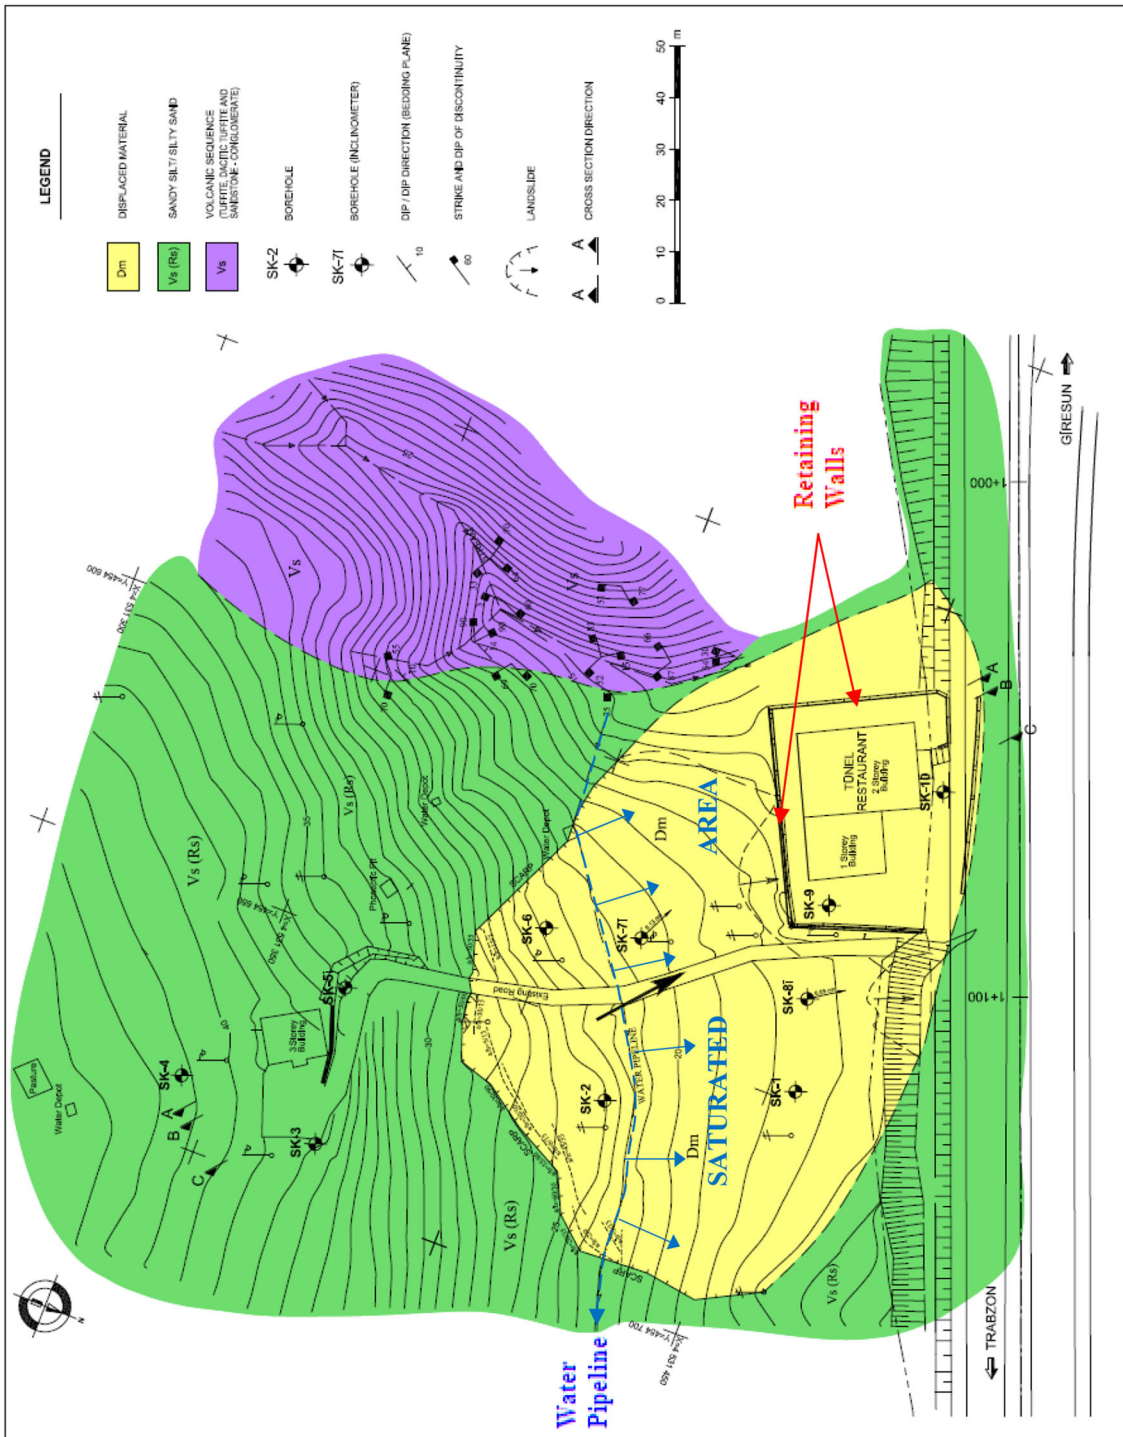
Fig. 3 Engineering geological map of the study area (scale: 1/1,000) which includes the outline of the Aksu landslide that occurred between KM: 1 + 030–1 + 170 of the Giresun–Espiye road. The map shows the outline of the excavated area for placing the foundation of the Tünel restaurant and the trend of the water pipeline (*thick blue dashed line*). Note that the soils between the pipeline and the Giresun–Espiye road were most probably saturated due to the leakage of water from the pipeline

footprint area is displayed in Fig. 3. Infiltration of water from this broken pipeline had most probably saturated the underlying units and caused an increase in the groundwater level. Figure 8 illustrates the anomaly in the groundwater level.

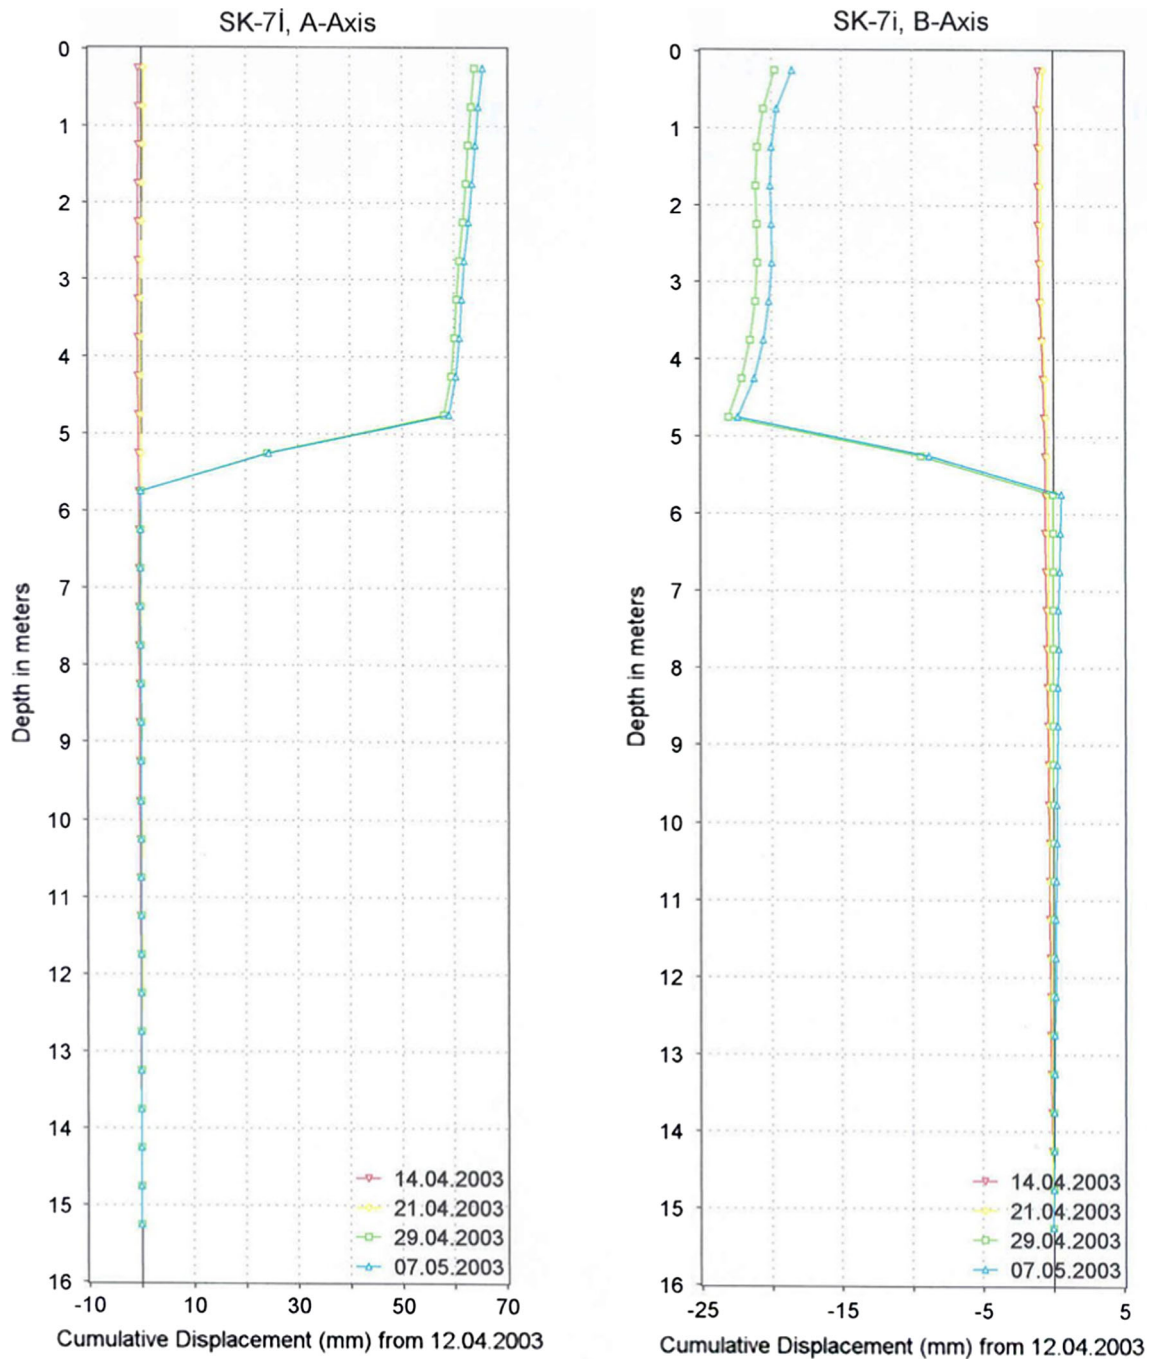
A summary of the inclinometer measurements is given in Table 1. As can be observed from Table 1, no significant movement was recorded in SK-5i whereas SK-7i and SK-8i indicated movement at depths of 5.31 and 4.85 m, respectively. A total of 4 proper inclinometer measurements were taken for a period of 24 days after which the measurements were terminated because the displacement of the ground caused a shift of the casing in such a way that the probe could not be inserted back into the boreholes.

Fig. 7 Depth versus cumulative displacement graph of borehole SK-7i which contained an inclinometer casing

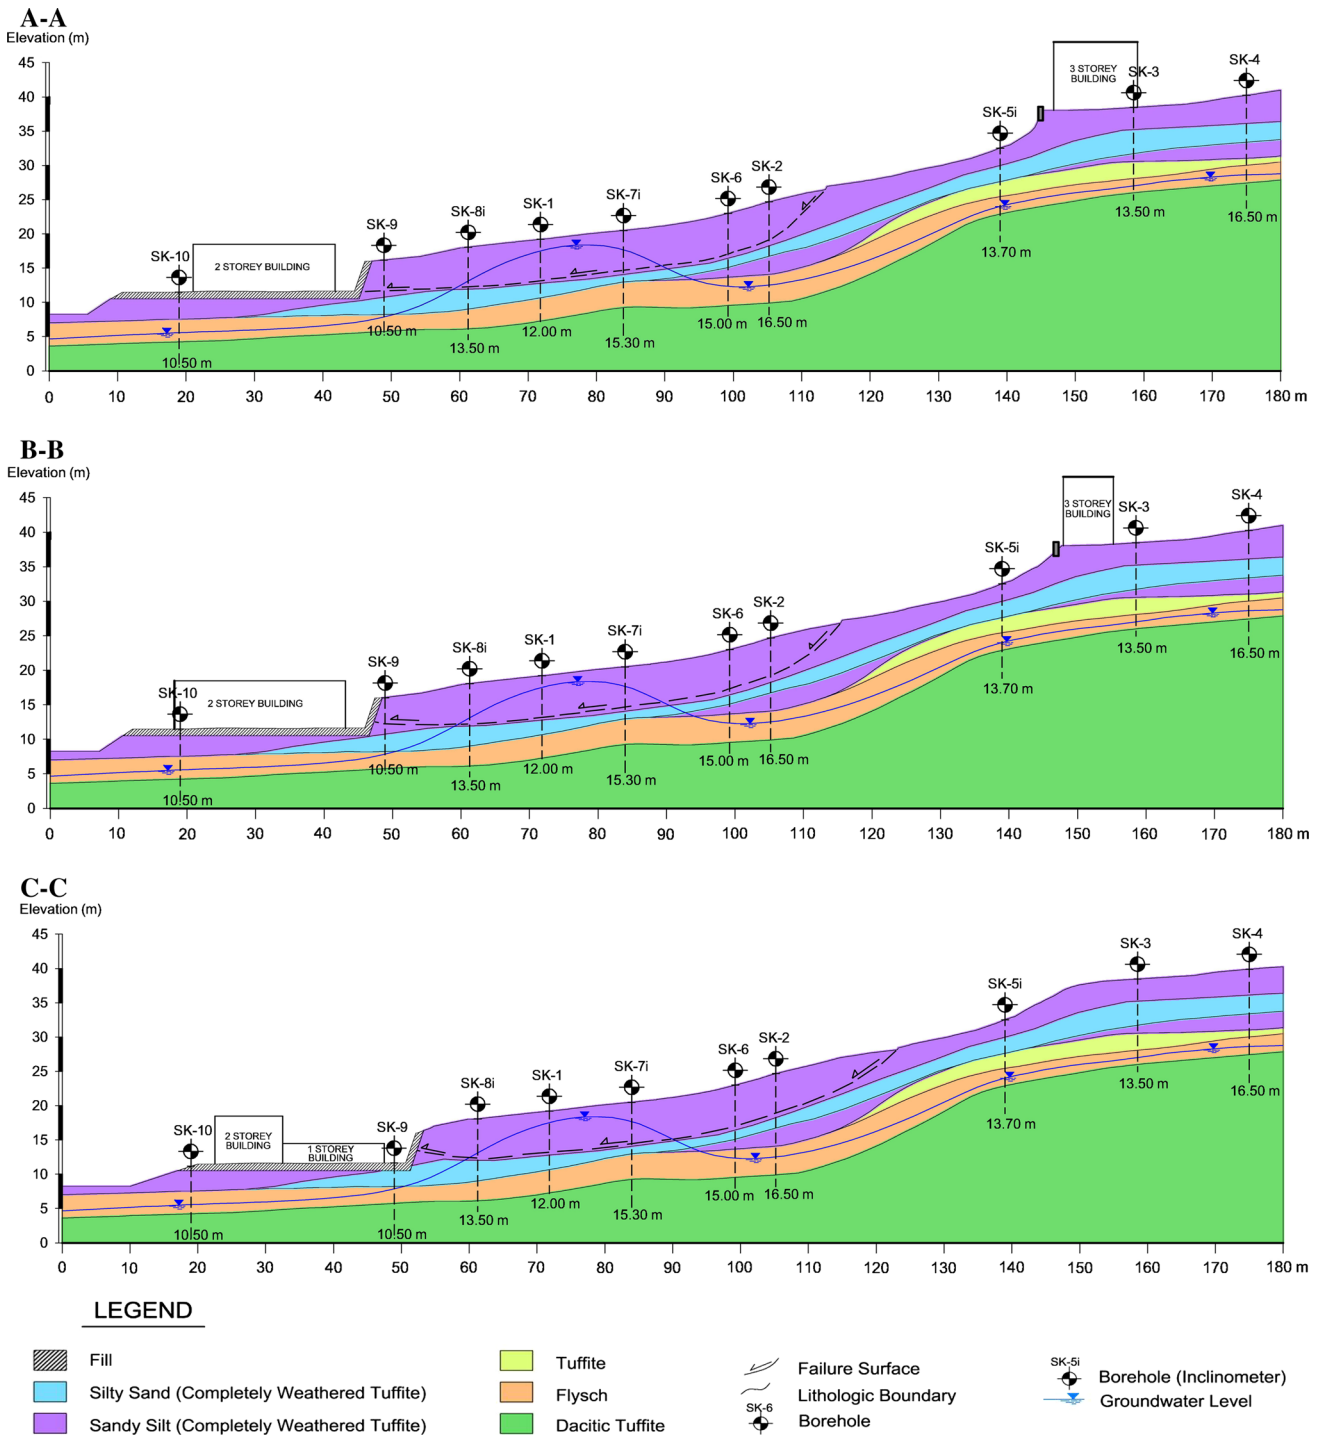
The groundwater table level was below the weathered tuffite in the study area prior to the unstable condition of the Aksu landslide. However, the effect of the dissipation of water from the pipeline, which is discussed above, has caused an increase in the groundwater table level at the north of the pipeline (i.e., as revealed by the groundwater level measurements in boreholes SK-1, SK-7i, and SK-8i) and might have consequently caused the saturation of the weathered tuffite unit at this location (Fig. 8).

Fig. 8 Cross-sections A–A, B–B and C–C. Note that Fig. 3 gives the trends of the cross-sections. The groundwater levels measured in boreholes SK-1, SK-7i, and SK-8i revealed a rise in the groundwater

level. The reason for this anomaly was the ENE–WSW trending broken water pipeline which caused an increase in the groundwater level

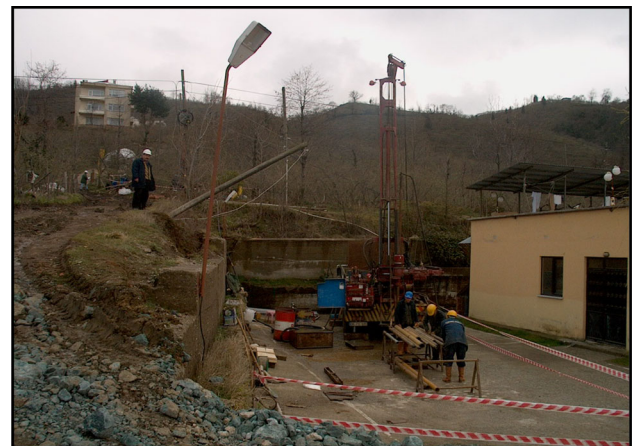
**Fig. 9** A view showing Tünel restaurant (to the right) and the tilted retaining walls after the occurrence of the landslide (to the left)

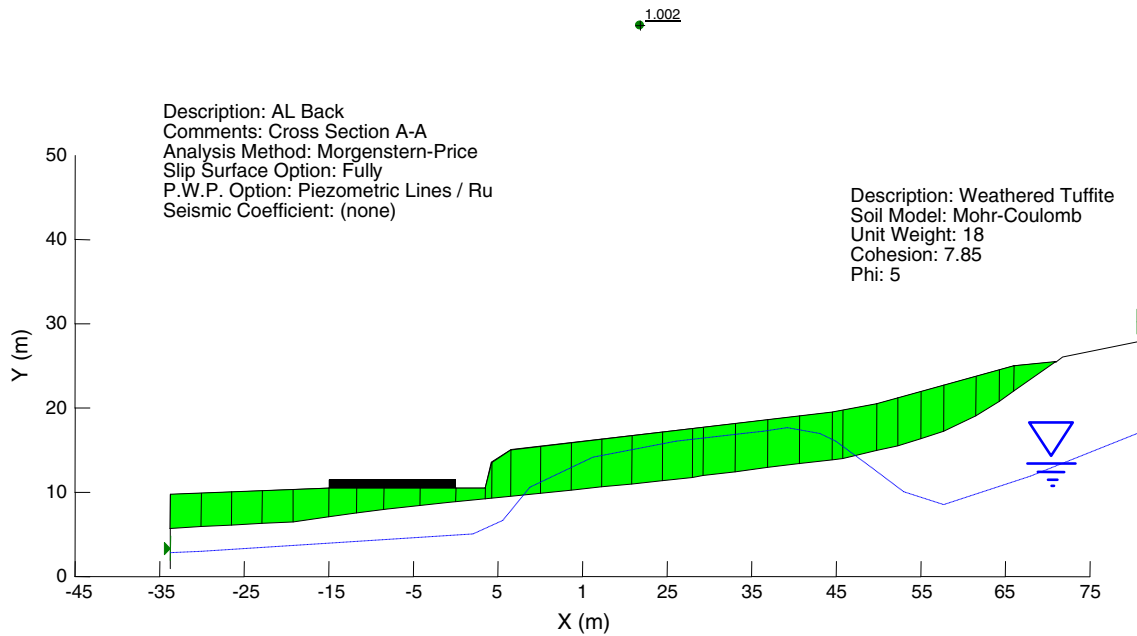
Fig. 10 The results of the back analysis for landslide cross-section A–A. Figure 3 gives the trend of the cross-section A–A. *AL Back* Aksu landslide back analysis

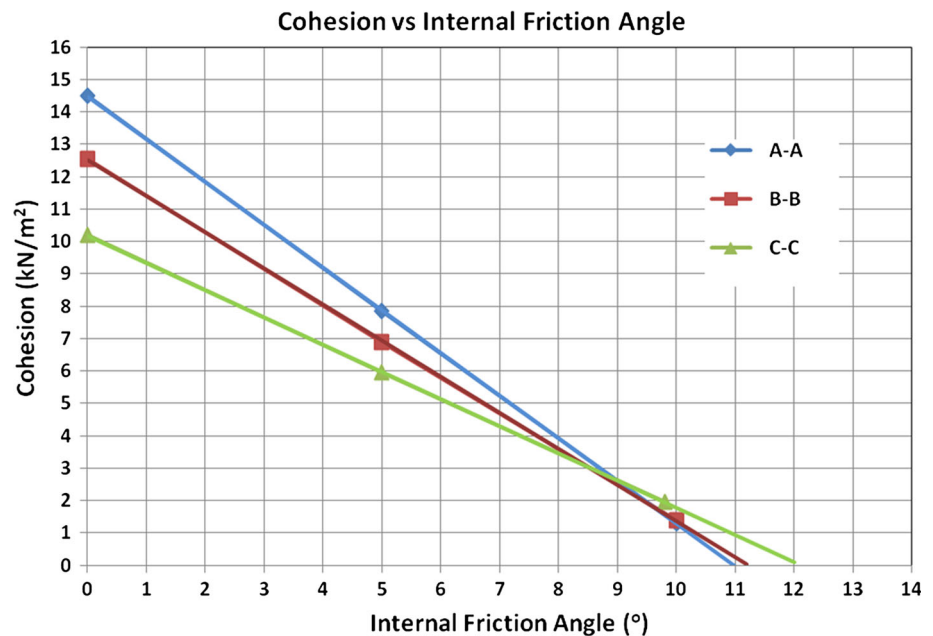
Fig. 11 Graphical representation of the back analysis results

Figure 11 presents a graphical representation of the back analysis results where the values of c' and ϕ' , as obtained from the points of intersections were determined to be 2.5 kPa and 9° , respectively.

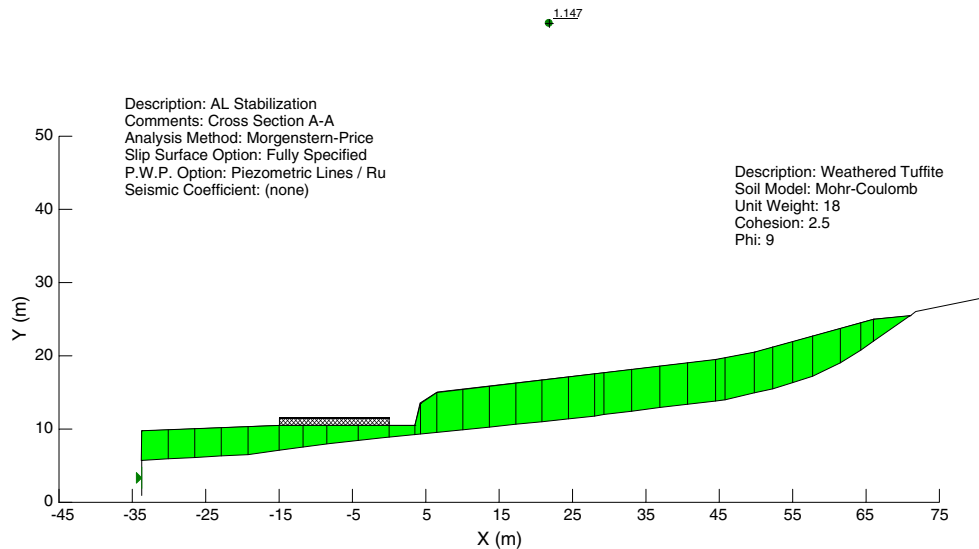
Fig. 13 Demonstration of the reduction in the groundwater level below the failure surface (Stage 5, Table 6) leading to an increase in the factor of safety (FS) to 1.147 for cross-section A–A (Fig. 8). AL Aksu landslide

surface. With the lowering of the groundwater level below the failure surface, the factor of safety (FS) of the Aksu landslide increased to 1.147 (Fig. 13). It should be noted that the back analysis was performed to estimate the Mohr–Coulomb shear strength parameters, namely cohesion (c) and angle of internal friction (ϕ) by using the slope model having a groundwater distribution as shown in Fig. 8. The results were that $c = 2.5$ kPa and $\phi = 9^\circ$. The shear strength parameters were then used to calculate the factor of safety of the slope without groundwater (i.e., groundwater level below the failure surface; Stage 5 in Table 6; Fig. 13) or with a full column of groundwater (i.e., groundwater level at the ground surface; Stage 6 in Table 6). It should be noted that when the groundwater level is lower than the failure surface or when the groundwater level rises to the ground surface, the shear strength parameters and the unit weight of rock masses will change. For example, in a very general sense, for a moist c – ϕ soil, both cohesion and angle of internal friction tend to increase due to the negative pore water pressure, i.e., suction, which increases cohesion and angle of internal friction by drawing the grains together, whereas for a saturated c – ϕ soil, positive pore water pressures could develop which push the grains apart, act against the normal stress, and reduce it by leading to a decrease in cohesion and angle of internal friction. This general trend may also be assumed to hold for silty soils (i.e., sandy silt and/or silty sand) even though the shear strength behavior of silts has not been studied as extensively and is not well understood as much as the behavior of granular materials or clays. Although the strengths of silts are governed by the same principles as the strengths

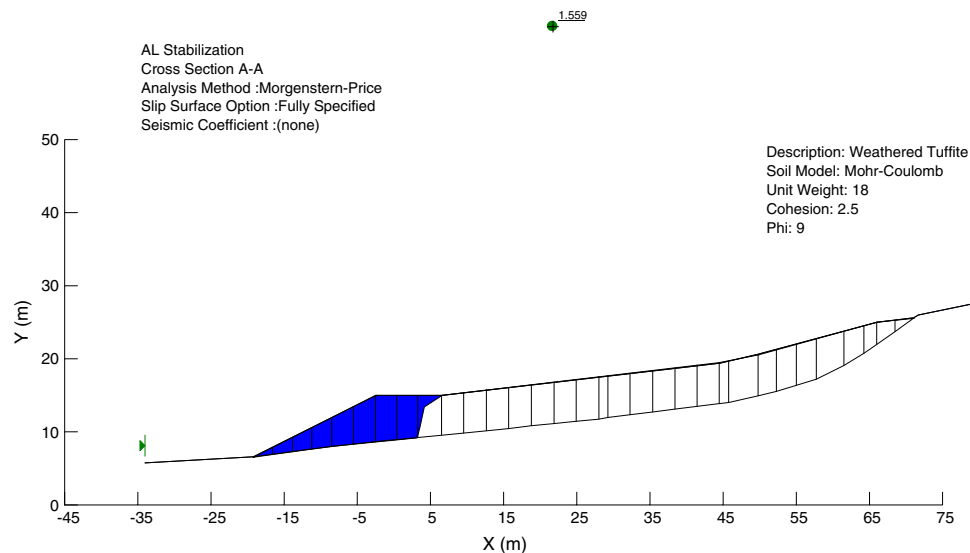
Fig. 14 Slope stability limit equilibrium model with rock fill buttress along cross-section A–A. *AL* Aksu landslide

of the slope stability analysis showed that the rock fill buttress was sufficient to stabilize the landslide which led to a factor of safety (FS) of 1.559 (Fig. 14).

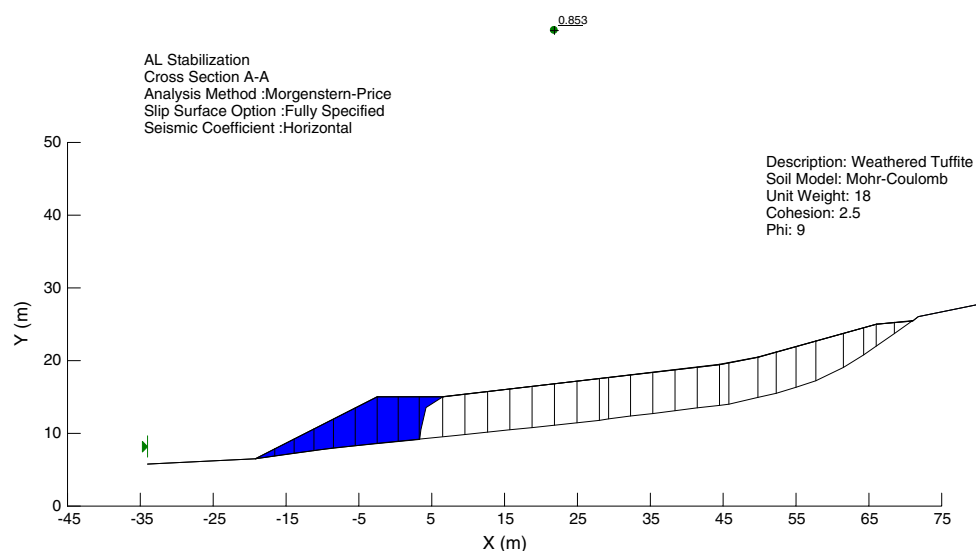
Fig. 15 Demonstration of the decrease of the factor of safety (FS) along cross-section A–A of the Aksu landslide from 1.559 to 0.853 when a horizontal seismic coefficient of 0.15 g is included in the limit equilibrium analysis. *AL* Aksu landslide

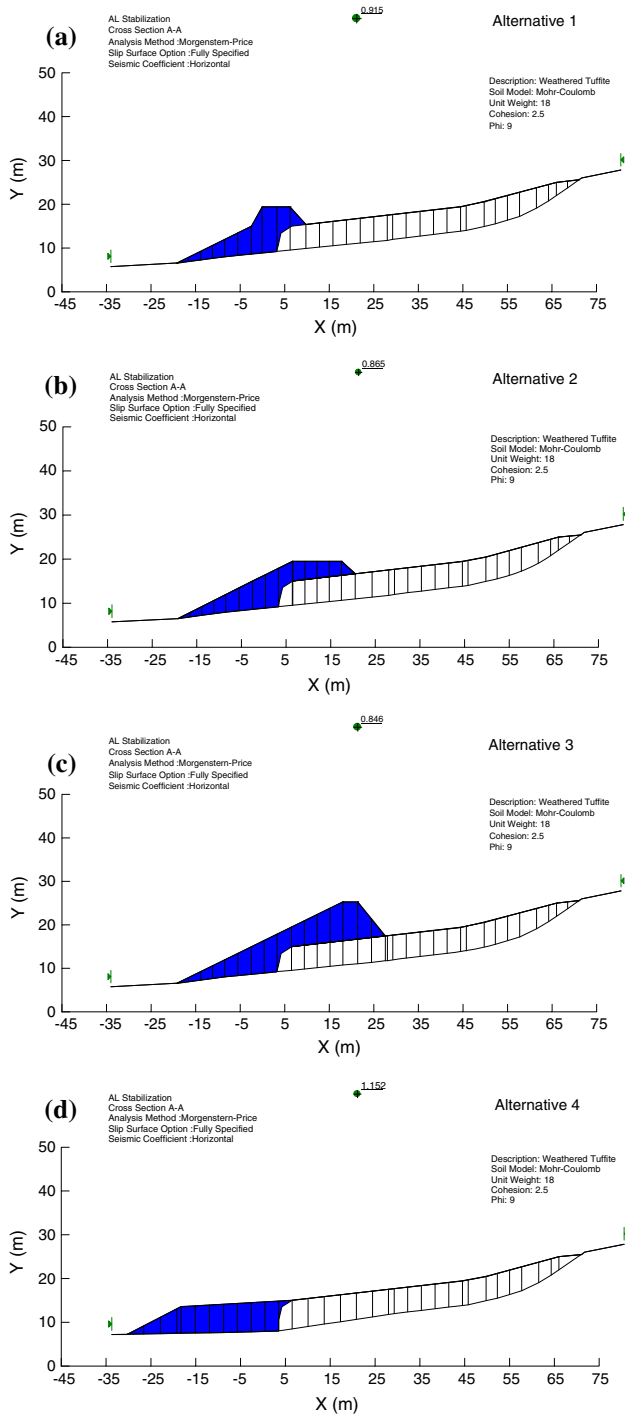
Fig. 16 Rock fill buttress alternatives **a** 1, **b** 2, **c** 3, and **d** 4, respectively

FS \geq 1.15 condition while with Alternative 4, the Aksu landslide was stabilized with a FS of 1.152.
