A holistic approach to the assessment of the groundwater destructive effects on stone decay in Edfu temple using AAS, SEM-EDX and XRD

M. A. El-Gohary¹

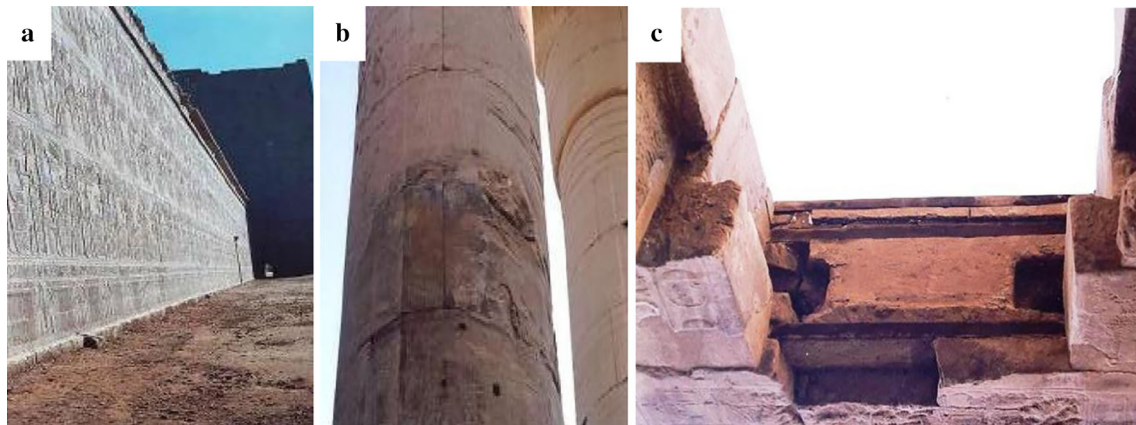
The negative roles of groundwater affecting Horus Temple could be summarized in two main mechanisms. The first mechanism, related to micro-deterioration symptoms through fracturing, complete disintegration and surface degradation. This mechanism led to wetting most of the temple surfaces especially in winter, forming different salt species which are one of the primary agents in the loss of the built culture heritage and lead to many forms especially in scaling and flaking forms (McCabe et al. 2011; Fig. 4a, b). The second mechanism is attributed to structural problems that led to some aggressive symptoms such as effective cracks and falling down of some stone fragments from the upper lintels of the temple (mostly resulted through indirect effects), in addition to splinters (Fig. 4c). These problems mostly resulted by water movements under the temple foundation (Cardell et al. 2008), rising damp effects occurred when groundwater flowed into the temple structure base through the pore structure (Rirsch and Zhang 2010); in addition, effect of water suction pressure migrating from the building foundations (estimated by $\sim 4\text{--}5$ m from ground surface) through capillary rising (defined by 12.30 %), water evaporation rate on its wall surface according to the dominating air temperature and relative humidity, finally, effects of seasonal swelling and shrinking of the clay portion of the soil as argued previously by El-Shishtawy et al. (2013).

Fig. 4 **a** Wetting most of the temple surfaces especially in winter in addition to the forming different salt species, **b** multi-system of fracturing especially in scaling and flaking forms, **c** some mechanical

problems in falling down of some stone fragments from the upper lintels of the temple and effective cracks, in addition to splinters

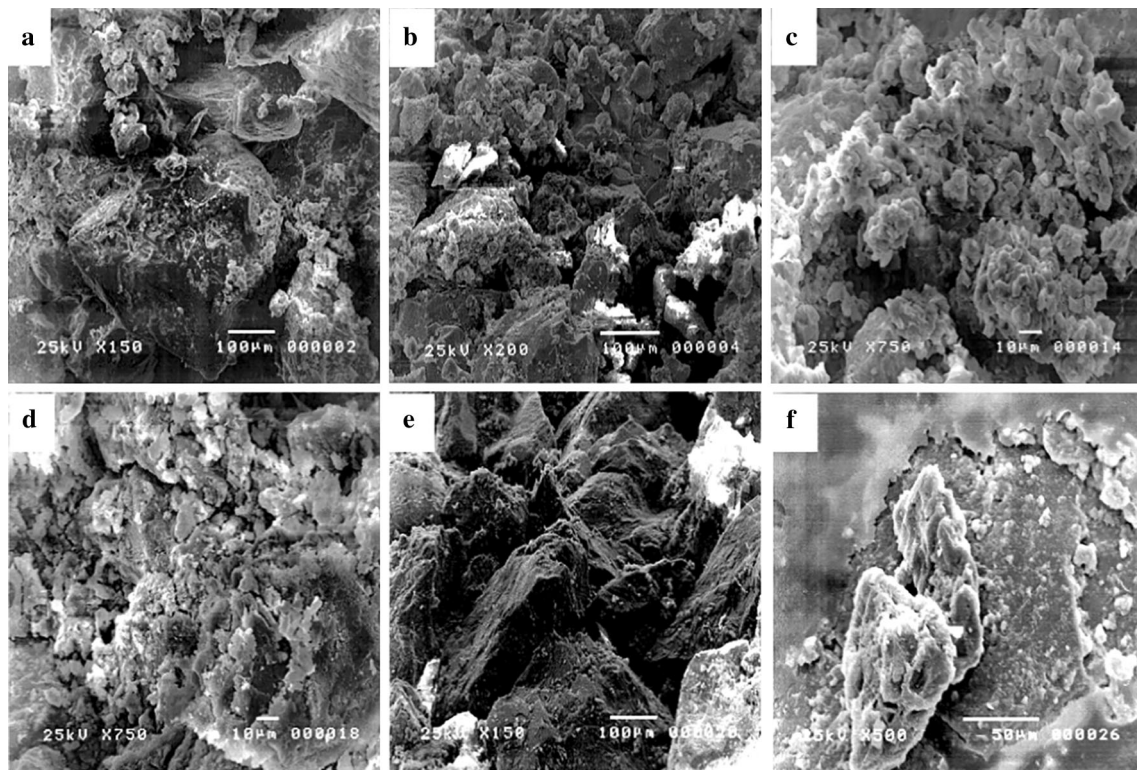
The morphological features of investigated samples captured by SEM affirmed that the stone was highly influenced by severe groundwater effects and its serious chemical components. Different photomicrographs deal with the presence of weakness and collapsing features, some salt

species such as sodium sulphate in its complex shape. Moreover, fracture and disintegration form in addition other noticeable symptoms such as disfiguring apparent, cracks, crevices and grains roundness and dissolution phenomena. All of these results are shown in Fig. 5a–f.

Fig. 5 Photomicrographs show, **a** weakness and collapsing of quartz grains as a result of drying wetting cycles, X-150, **b** fracture and disintegration phenomena affecting qz grains and presence of sylvite salt KCl, X-200, **c** sample of sodium sulphate in its complex shape and disfiguring apparent affecting stone surfaces, X-750, **d** cracks and crevices resulting from stress and strains inside the stone and

spherical gypsum crystals a result of interaction with salinity water and wetting drying cycles, X-750, **e** weakness and roundness of qz grains as a result weathering processes, dissolution phenomena and presence of NaCl and developed black crusts, X-150, and **f** fracture and dissolution affecting qz grains as a result of interaction with salinity water, X-500
