# Development of a loess-mudstone landslide in a fault fracture zone

**Abstract** A landslide occurred on the morning of December 16, 2013, in Liujiabao village, Tianshui City, Gansu Province, China. The 260,000 m<sup>3</sup> of landslide material traveled a distance of 190 m downslope and damaged a village road and several farmhouses before it stopped on the middle of the slope. These landslide materials are still threatening the lives and property of people in the downslope residential areas. A field survey revealed that this landslide was strongly affected by the geological setting. Six normal faults that extend from east to west developed in the Neogene mudstone of this region; these faults form a fault fracture zone with a width of 80 m. The authors performed a detailed investigation of the geological features of these six normal faults, and their spatial and faulting relationships to the landslide were examined. Finally, the evolutionary progress of the loess-mudstone landslide controlled by the fault fracture zone is discussed.

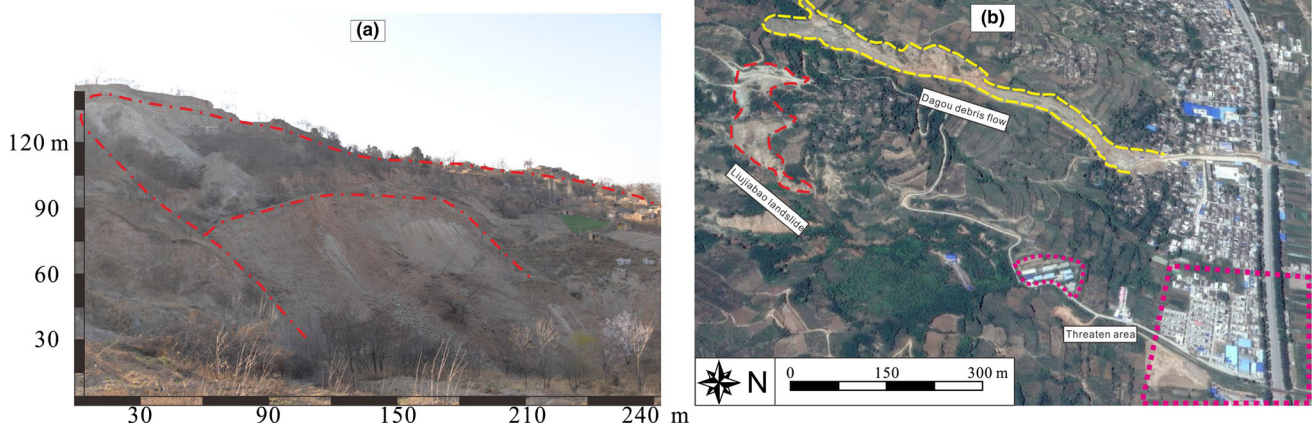
On December 16, 2013 at 06:00 a.m. local time, a landslide occurred in NW China. The landslide was located on a slope behind Liujiabao village. Liujiabao village is located in Mapaoquan town, Maiji district, Tianshui city, Gansu Province, and is about 20.5 km southeast of the city (location is shown in Fig. 1; this landslide is hereafter termed as Liujiabao landslide, and is shown in Fig. 2a). The displaced rock and soil of the flow slide, with a length of about 100 m, cut the road into two parts, forming a 20-m scarp between these two parts. In addition, the abandoned houses on the north side of the slope were damaged. At present, the slipped mass of Liujiabao landslide is “hanging” on the slope, strongly threatening the safety of the downslope urban residents and industrial premises as well as the expressway (as shown in Fig. 2b).

**Fig. 2** Macroscopic view of Liujiabao landslide. **a** Oblique front view of Liujiabao landslide. **b** The downslope residential area of Liujiabao landslide (based on satellite imagery captured on 17 June, 2014)

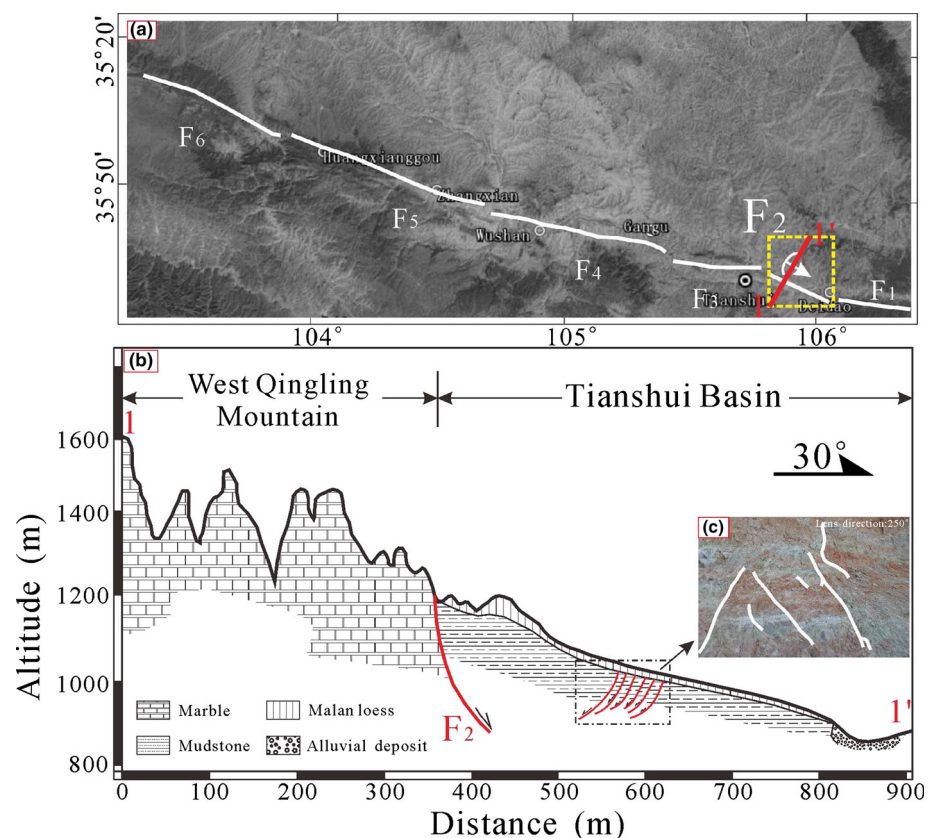
**Fig. 4** Geologic section map of the secondary faults on the hanging wall of the West Qinling fault. **a** The landslide is located on the hanging wall of the Tianshui–Fenghuang fault; **b** secondary faults with the same southward trend developed here, dislocating the Neogene mudstone; and **c** secondary faults as well as joints developed within the fault zone cutting the mudstone into a fragmented texture

there are many small faults as well as joints cutting the mudstone into a fragmented texture, as shown in Fig. 4c.

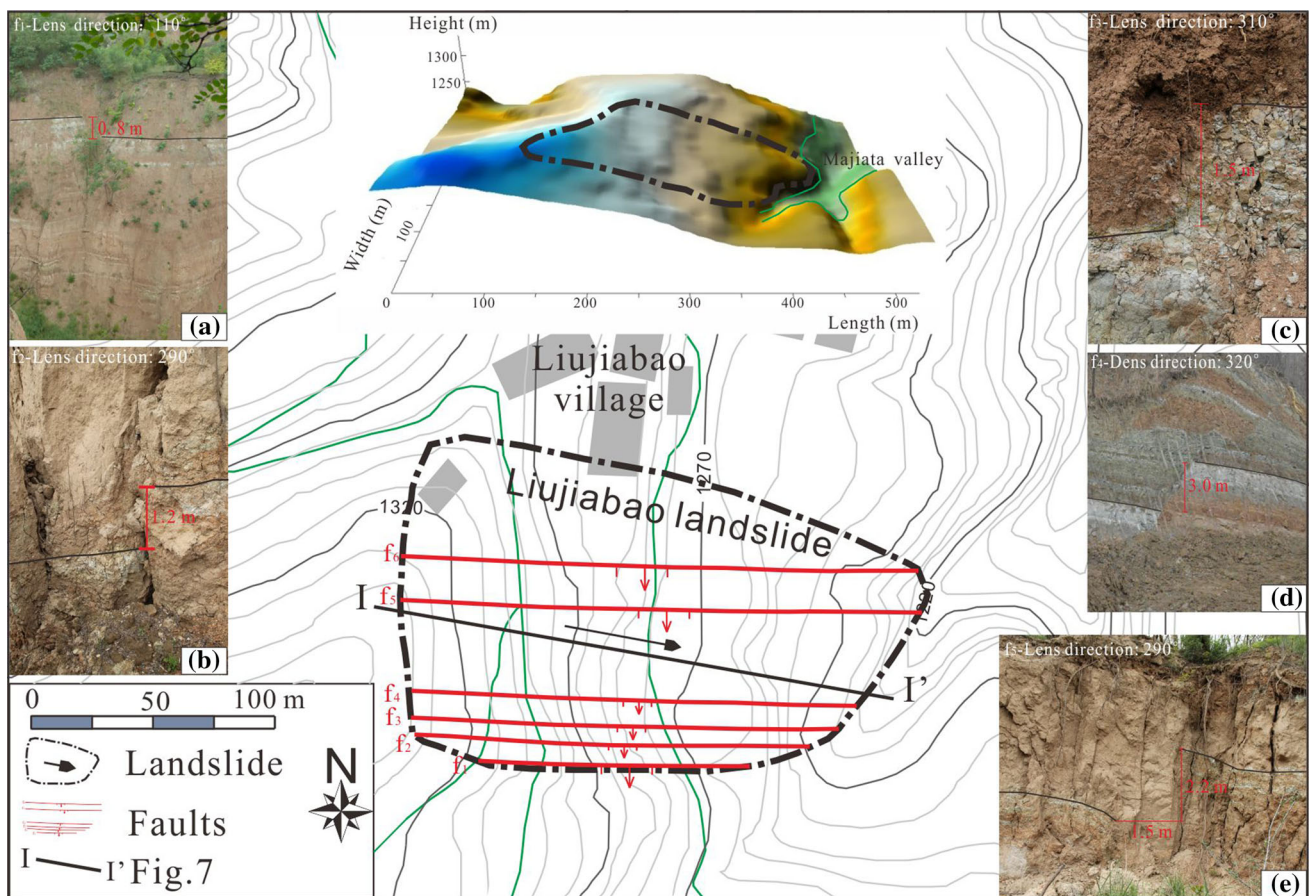
**Fig. 5** Contour map and 3-D topography of the area before the Liujiabao landslide occurred. Inside the landslide area, there were six normal faults. **a** The outcrop of the  $f_1$  fault was located in Majiata valley; **b** the  $f_2$  fault was exposed on the scarp situated in the middle

of the slope; **c** the  $f_3$  fault was about 6 m north of the  $f_2$  fault; **d** the excavation of the road, which was located to the west of Liujiabao landslide, made the  $f_4$  fault visible; and **e** the  $f_5$  fault was located on the same scarp as the  $f_3$  fault but was located 45 m to the north

topography before the landslide occurred. The slide area, which is marked in Fig. 5, is about 50,000 m<sup>2</sup>, 230 m in length (measured from the back scarp to the leading edge) and 225 m in width. On the contour map, it is clearly seen that the elevation of the shear opening is 1210 m, with the leading edge ranging from 1210 to 1255 m and the trailing edge ranging from 1300 to 1350 m, which results in an average height difference of about 110 m. The slip direction is 100° SE, and along this slip direction, the rock and soil debris moved downwards, eventually packing into the valley at the toe of the slope.

In the plane, as shown in Fig. 5, fault  $f_1$  was located in the south and defined as the southern boundary of Liujiabao landslide. The horizontal spacing between  $f_2$  and  $f_1$  was 8 m, and a small-scale fault  $f'_1$  developed between them. Fault  $f_3$  was approximately parallel to  $f_2$ , and the spacing between them was 6 m. Faults  $f_3$ – $f_6$  are arranged from south to north successively, and spacing between the adjacent faults was 11, 35, and 18 m.

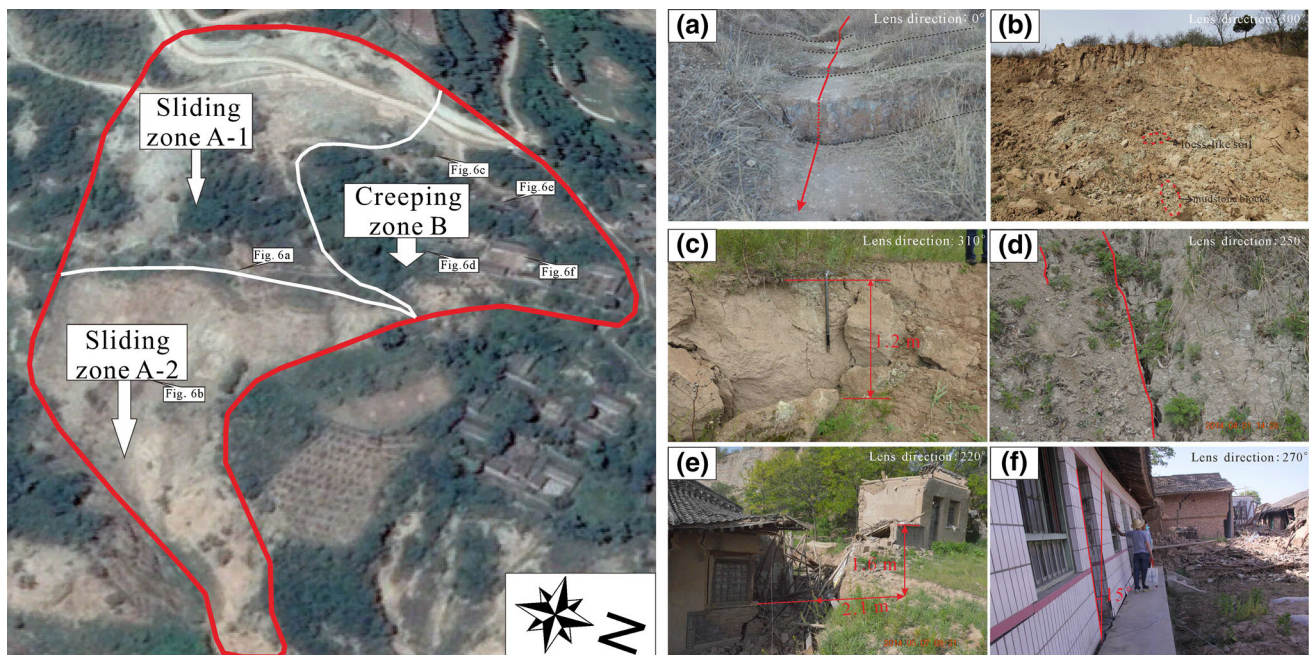
Sliding zone A was located in the southern part of the landslide, and a normal fault served as the southern boundary of the landslide. The width of zone A's back scarp was about 120 m, and using the artificial scarp at the middle of the slope, it can be divided into zone A-1 and zone A-2. Zone A-1 belonged to the upper part of the slope and was the main slide zone. In addition, in the sliding direction, Fig. 6a shows that there was a group of steps descending from the center to the margo lateralis of the landslide. Zone A-2 is located to the east of zone A-1. In this area, the slip mass was 6–8 m thick and was mainly composed of loess-like soil and gravelly soil. Figure 6b shows pictures of the leading edge of zone A-2, in which it is clear that the debris mass is mainly composed of loess-

**Fig. 6** Partition map of Liujiabao landslide (drawn from the satellite image captured on 17 June, 2014). The landslide can be divided into two sliding zones and a creeping zone according to the different motion characteristics. The basic characteristics of sliding zone A are as follows: **a** a group of steps descending from the center to the margo lateralis in zone A-1; and **b** the debris mass in zone A-2 is mainly composed of loess-like soil and mudstone blocks. The typical features

of the creeping zone B are as follows: **c** A 1.2-m staggered slab was formed by the extension crack trending S–N; **d** Radial cracks at the leading edge trended E–W with a stretch width of 3–5 cm; **e** Influenced by the extension crack, a house suffered a 2.1-m horizontal displacement and a 1.6-m vertical offset; and **f** creep deformation of the free face resulted in a house lying on its back and formed a 15° angle with the vertical direction

Creeping zone B is located to the north of sliding zone A. Its floor area was about 0.001 km<sup>2</sup>, with a length of 110 m and a width of 90 m. Creeping zone B was dragged by zone A, and since it was concentrated in a residential area, it was the worst-hit area when the landslide happened. A tension crack, extending from north to south, developed on the trailing edge of creeping zone B and created a staggered 1.2-m slab, as shown in Fig. 6c. Meanwhile, blocked by the slope located to the east, the leading edge of zone B developed a group of radial cracks extending from east to west (as shown in Fig. 6d). The radial cracks stretched for more than 10 m, and their widths ranged from 3 to 5 cm. About ten abandoned houses in this region suffered varying degrees of damage, and as such, they either had a horizontal displacement along with vertical offset (Fig. 6e), or lay on their own backs (Fig. 6f). Since it was characterized by creep deformation, this region was named the creeping zone.

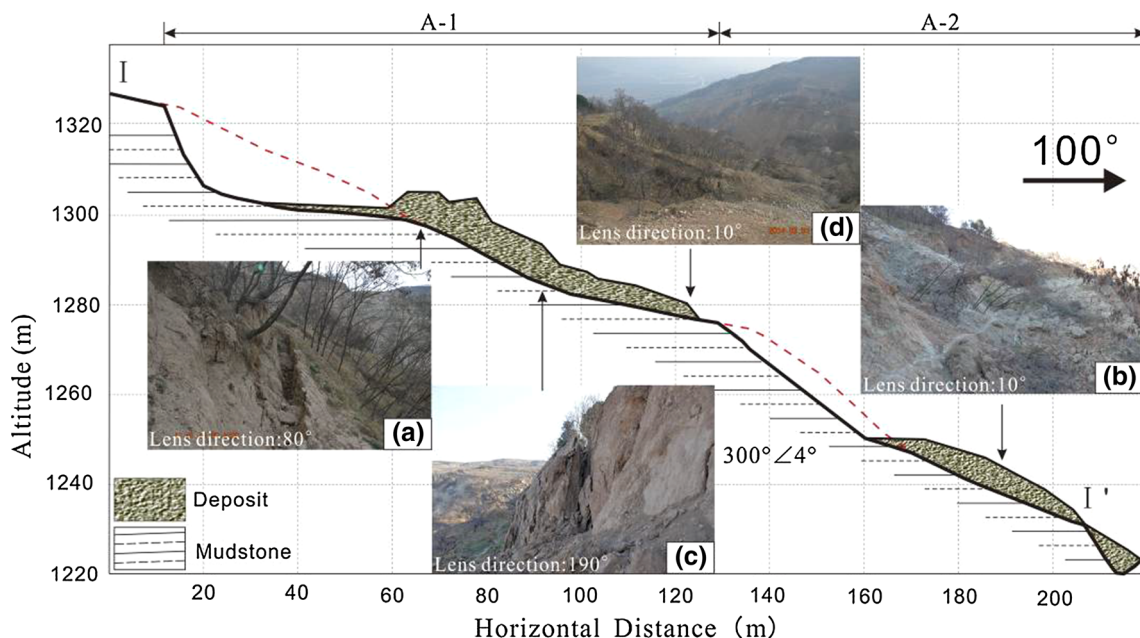
As mentioned before, there were two sliding zones. Zone A-1 was the main sliding zone, and it descended a vertical distance of 46 m over a horizontal distance of 113 m. Zone A-2 was located on the lower part of the slope body, and it descended a vertical distance of 44 m over a horizontal distance of 77 m. The displaced materials from the source area have an estimated volume of  $26.5 \times 10^4$  m<sup>3</sup>. Zone A-1 had a relatively slow moving surface; therefore, the slip mass materials were sheared out at the weak plane in a slow surge sliding motion (as shown in Fig. 7a). Compared with zone A-1, zone A-2 had a steeper surface and it mainly moved in a quick slipping motion (as shown in Fig. 7b).

According to the investigation and Fig. 7c, the slip mass materials were all sheared out at the soft mudstone layer. The high-steep trailing segment of the slip surface was excavated into the back scarp of Liujiabao landslide. Apart from the back scarp, all parts of the slope surface were covered by loose landslide deposits, which were mainly composed of loess-like soil and mudstone fragment. The loess-like soil was yellowish-brown and was mainly composed of fine particles, while the mudstone was greyish-green with an average grain diameter of 5–25 cm and a

**Fig. 7** Motion features of Liujiabao landslide, such as: **a** surge sliding motion in zone A-1 and **b** quick slip motion in zone A-2. Longitudinal section along line I-I' as shown in Fig. 5: **c** the slope

body was sheared out at the mudstone in zone A-1 and **d** the sorting of the slip mass was good in the plane

maximum diameter of 50 cm. The original rock sequence of the slip mass was disordered: on the one hand, mudstone fragments were overhead and overlapped with loess-like interleaved soil; while on the other hand, mudstone fragments were distributed in the front and middle of the slope with a thickness of 3–5 m, and loess-like soil was distributed in the posterior with a thickness of 10 m in zone A-1 and 6–8 m in zone A-2, as shown in Fig. 7d.

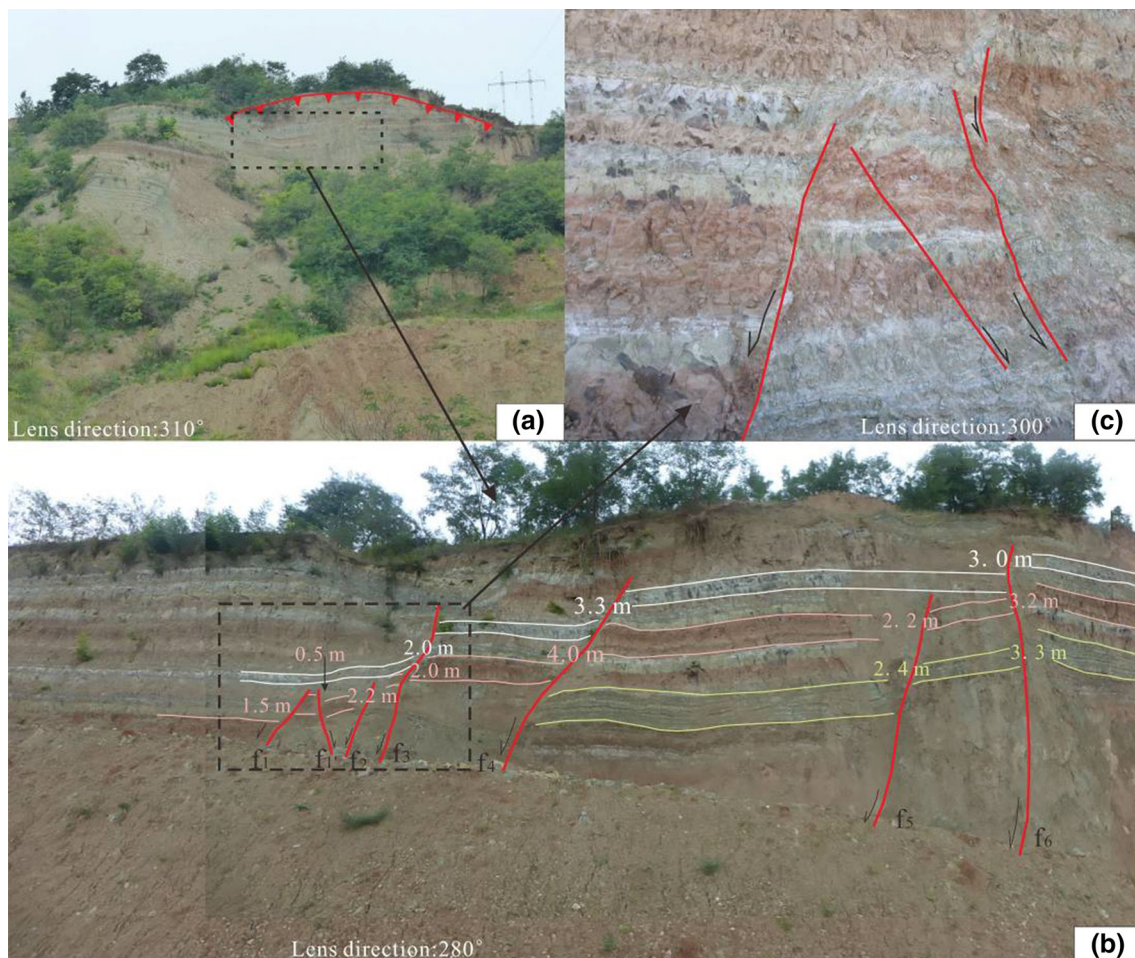
an 80-m wide fault zone was uncovered at the back scarp of Liujiabao landslide. There were 6 normal faults within the fault zone and they were named  $f_1$ – $f_6$  in Fig. 8b.

In profile, all the faults except  $f'_1$  trended  $190^\circ$ SW with inclination angles ranging from  $60^\circ$  to  $65^\circ$ ; whereas fault  $f'_1$  trended  $10^\circ$ NE with an inclination angle of  $65^\circ$ . Fault  $f_1$ ,  $f'_1$ , and  $f_2$  moved the red mudstone 1.5,  $-0.5$ , and 2.2 m, respectively, down and to the south (minus indicates to the north). Fault  $f_3$  was steeper at its bottom than at its top, and it dislocated not only grey-white but also red mudstone by 2.0 m. Meanwhile, fault  $f_3$  also formed traction structures at both walls of the fault. Since fault  $f_4$  formed 3.3- and 4.0-

**Fig. 8** Back scarp and fault section of Liujiabao landslide. **a** The width of the back scarp was 120 m, while the width of the fault fracture zone was 80 m. **b** 6 Normal faults developed within the fault fracture zone. **c** Mudstone was cut into pieces due to the development of secondary faults

m offsets in the grey-white and red mudstone, respectively, it became the fault with the biggest offsets within the fault zone. Fault  $f_5$  showed a vertical shape in profile, and it cut red and grey-green mudstone from its top to its bottom, with a 2.2-m displacement. Parallel to  $f_5$ , fault  $f_6$  dislocated grey-white, red, and grey-green mudstone from top to bottom, with displacements of 3.0, 3.2, and 3.3 m, respectively, which indicates a co-depositional activity characteristic.

The faults mentioned above were active in stages; therefore, their controlling effects on Liujiabao landslide were not the same. Faults  $f_1$ ,  $f'_1$ ,  $f_2$ , and  $f_5$  did not cut the grey-white mudstone at the bottom; therefore, they formed at an earlier age. In addition, all four faults had smaller displacements (the maximum was only 2.4 m), but they did cause the intense crushing of rock and soil, as Fig. 8c shows. Fault  $f_1$  defined the southern boundary of Liujiabao landslide and played an important role in the occurrence of the landslide. Faults  $f_3$ ,  $f_4$ , and  $f_6$  are larger and had bigger displacements (the maximum reached 4.0 m). These three faults cut the grey-white mudstone and were accessible to the near surface. It was assumed that they belonged to the secondary active faults located on the hanging wall of the northern margin fault zone in Qinling Mountain, and that they were persistently active in recent years (Cheng et al. 2007). According to a disaster report from the local government in 2008 after Wenchuan Earthquake (<http://www.gsdllr.gov.cn>), the movement of these faults had already provided dynamic conditions for the initiation and formation of Liujiabao landslide.

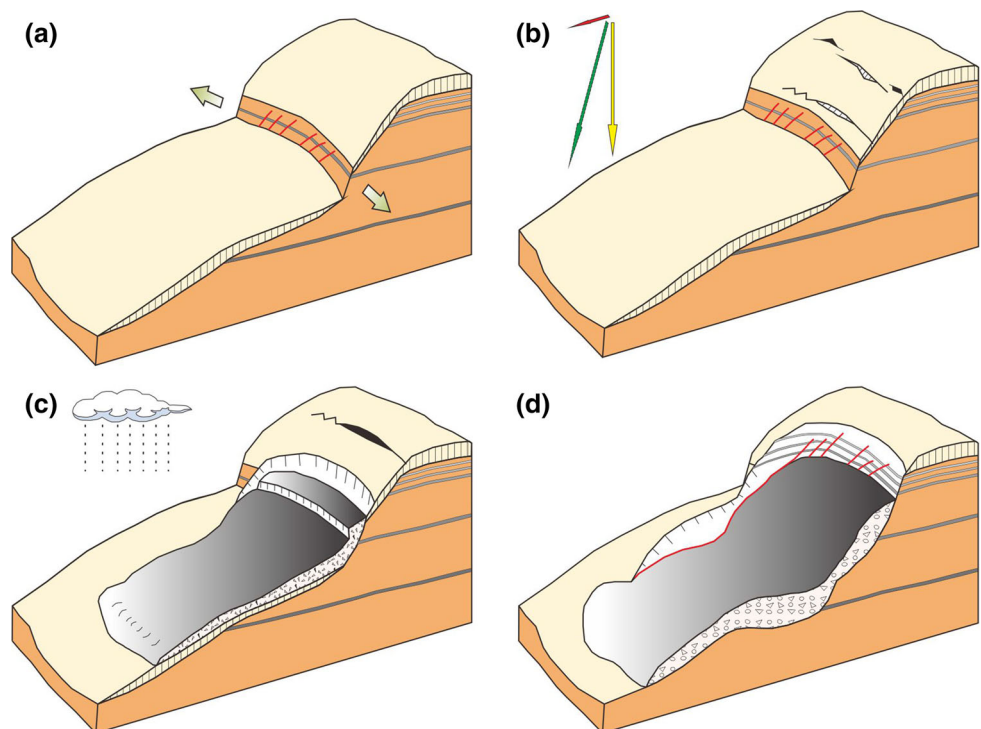
Step 1: the embryonic stage. Several normal faults developed in the slope, breaking the Neogene mudstone into a fracture zone, whose extension direction was consistent with the slope of the ridge. Then, a thin layer of loess covered the thick mudstone, but it was not subsequently cut through by the fault. Hence, the slope was in an East–West tensional stress field, which was more prone to create an unstable slope, as Fig. 9a shows. Step 2: the creep cracking stage. During the 2008 Wenchuan Earthquake, the slope suffered from a horizontal seismic force (as the red arrow shows in Fig. 9b), which produced the resultant force that caused

**Fig. 9** Evolution model of Liujiabao landslide. **a** A fault fracture zone developed along the slope direction. **b** Extension cracks emerge on the creeping slope after the earthquake. **c** The slope begins to slip during rainfall. **d** With the infiltration of rainfall, the slope starts to slide until it is in a semi-hanging state

the slope to rotate (as the green arrow shows in Fig. 9b). In addition, Quaternary neotectonic movement triggered the active faults in this area, dislocating the layers. Then, tension cracks emerged on both the upper and middle parts of the slope. That is, the Wenchuan Earthquake in 2008 aggravated the overall deformation of the Liujiabao slope.

Step 3: the sliding stage. In July 2013, the last long heavy rain resulted in large amounts of rainfall that seeped into the slope and weakened the strength of the rock and soil. Hence, the middle part of the slope started to slip, and the extension cracks kept on expanding until the sliding is through to the surface (shown in Fig. 9c). Step 4: the present stage. After the locked patch loses its stability, the upper part of the slope begins to slide along the cracks. The slip mass is semi-hanging on the slide bed, and the fault zone is exposed on the back scarp of the landslide, as Fig. 9d shows.
