Failure of a rock slope 16.5 years after excavation in repeated strata of sandstone and mudstone

Abstract The present study focuses on failure of a rock slope excavated in the autumn of 1997 and located in the repeated strata of sandstone and mudstone in Chongqing of China. The rock slope failed suddenly on April 28, 2014. The elapsed time from excavation to failure is about 16.5 years. The failure was sudden and unexpected seemingly, but it was mainly resulted from the initial excavation and the subsequent weathering in the long term. The initial excavation in 1997 as a reason why the rock cut slope failed was undoubted, because the excavation broke original ground stress balance, resulted in inducement or expansion of cracks and induced deformation and looseness of local rock masses. The weathering process, especially physical weathering process in the long term

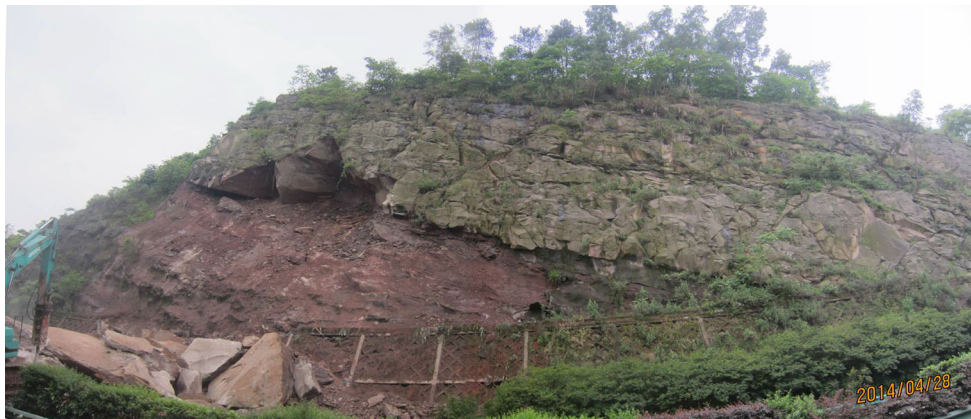
At about 8:00 am on April 28, 2014, about 16.5 years after excavation, the rock cut slope failed suddenly (Fig. 2). The rock blocks with about 1000 m^3 in amount, collapsed mainly from the upper sandstone stratum, piled on the highway and blocked the traffic. After about 18 h, at about 2:00 am on April 29, 2014, the rock slope collapsed again (Fig. 3). More rock blocks, with a volume of about 2000 m^3 , collapsed from the upper sandstone stratum too. The diameters of rock blocks were about 0.3–4.5 m. Figure 3 shows that there was an unstable rock mass near the top of slope, which might fall at anytime. In order to avoid possible hazard resulted from the failure of the unstable rock mass, the unstable rock mass, about 300 m^3 in volume, was excavated artificially on April 30, 2014.

Fig. 2 Photograph of rock slope after first failure (on April 28, 2014)

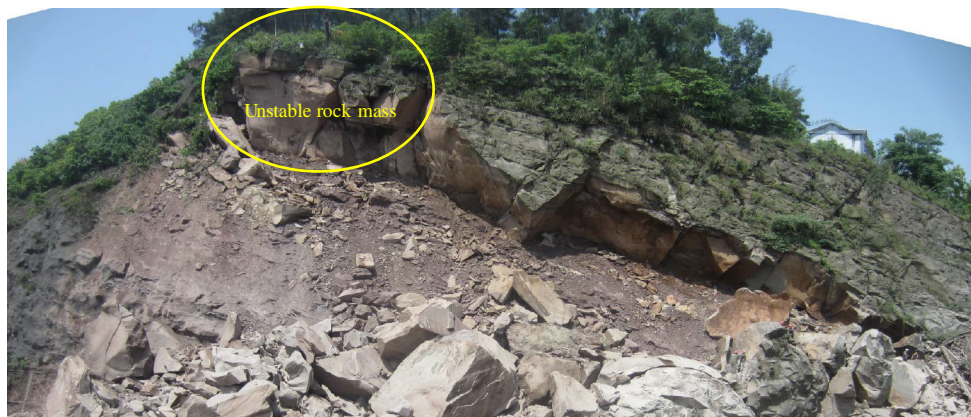
Fig. 3 Photograph of rock slope after second failure (on April 29, 2014)

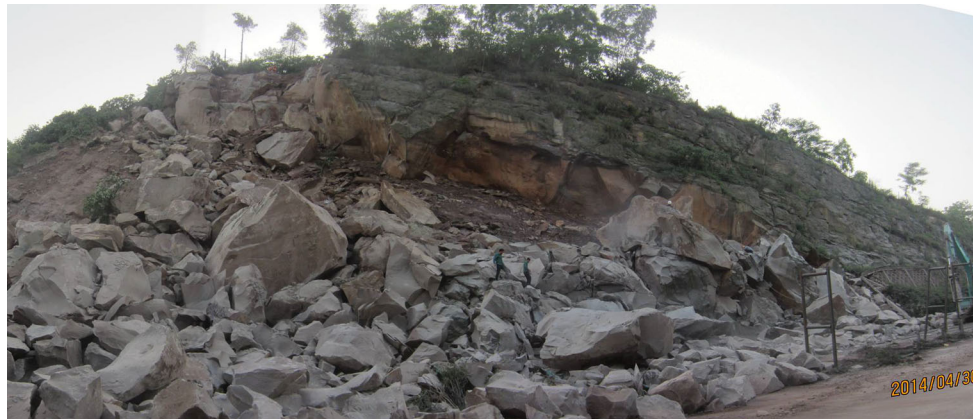
Figure 4 shows the full view of the rock slope after excavating the unstable rock mass.

Fig. 4 Photograph of rock slope after excavation of unstable rock mass (on April 30, 2014)

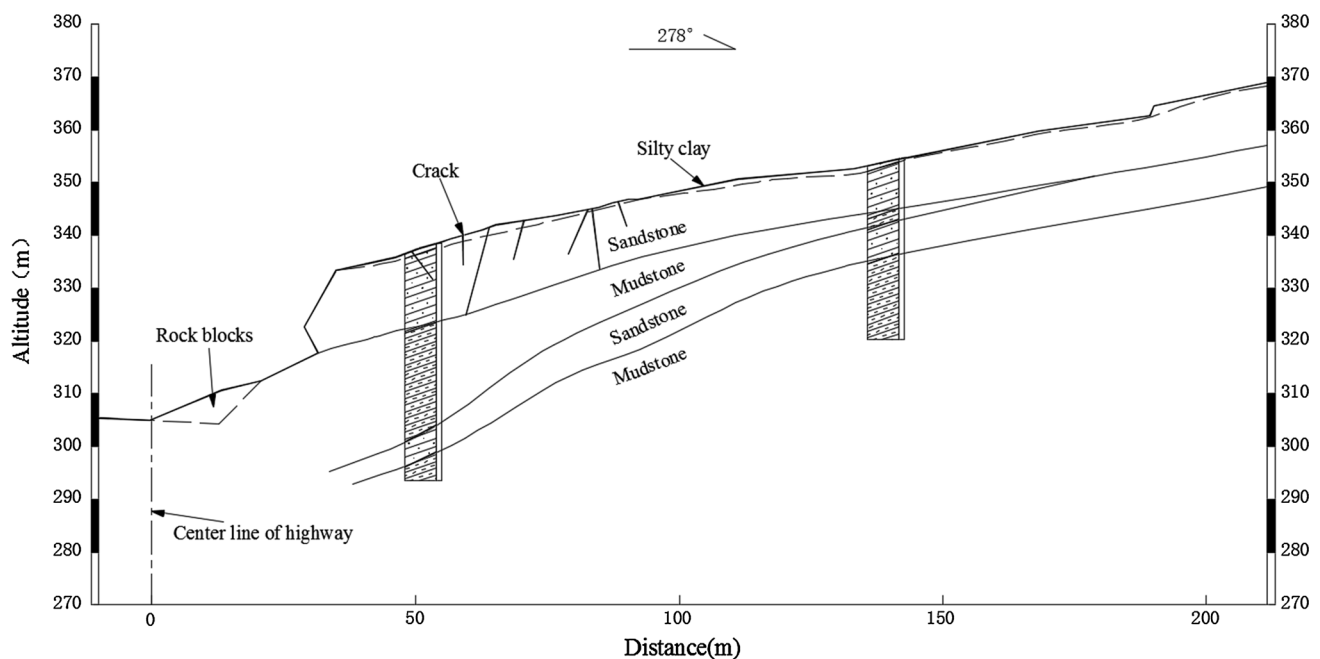
Fig. 5 Typical engineering geologic profile

The strata of the rock slope from its top to toe are, respectively, silty clay, sandstone, mudstone, and repeated sandstone and mudstone. The top-layer silty clay formed in Quaternary Holocene period is in plastic state and less than 1.0 m in vertical thickness. The repeated strata of sandstone and mudstone formed in Middle Jurassic period are in moderately weathered state except upper thin layer of 0.5–1.8 m in vertical thickness in highly weathered state. The vertical thicknesses of the sandstone layers are 4.5–19.4 m, and the mudstone layers are 2.3–20.3 m. Figure 5 shows the typical engineering geologic profile.

For the possible plane failure along the Interface #A, the value of F_s is calculated based on the engineering geologic profile shown in Fig. 5 and the shearing strengths of the mudstone–sandstone interface listed in Table 3, and it is 1.15 under natural conditions and 1.04 under saturated conditions. For the possible wedge failure along the Joints #B and #C, the value of F_s is also calculated based on the attitudes of the Joints #B and #C shown in Fig. 12 and the shearing strength of the argillation intermediate layer in the joints of the upper sandstone layer listed in Table 3, and it is 1.09 under saturated conditions. The calculated values of F_s exceed 1.0, and this means that the slope is considered stable. But the calculated values of F_s are very near to 1.0, in particular those under saturated conditions, and this means that the further failure of the rock slope in future is very possible under coming weathering process. For the safety, stabilization to the rock slope should be necessary.

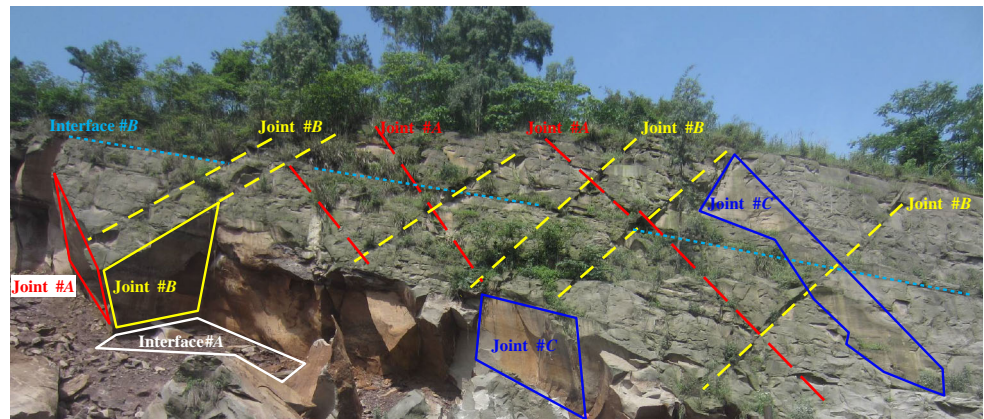
Fig. 6 Typical discontinuities found from slope face in upper sandstone layer

The other group of the discontinuities is the joints, which include three sets, i.e., “Joint #A,” “Joint #B” and “Joint #C” in Fig. 6. The dip direction and dip of the Joint #A are, respectively, about 235° and 66° , those of the Joint

#B about 144° and 64° , and those of the Joint #C about 54° and 61° , respectively. The Joints #A and #B are two-set shear joints. They are close, open or filled with soil particles. Their lengths vary from 2.0 to 20.0 m. Their roughness in small scale is usually smooth, and roughness in large scale near planar. The Joint #C is one-set unloading joints. They are often open and rough, but their lengths are smaller than the Joints #A and #B.

interfaces and joints shown in Fig. 6. If the shear stress was great enough, new cracks might be induced.

Typical sedimentary rock masses, such as the sandstone and mudstone of the rock slope investigated in the present study, are usually anisotropic due to bedding planes. The bedding planes or interfaces (see Fig. 6), in the sandstone or mudstone strata and between the strata of sandstone and mudstone, are often weak planes in mechanics. The joints (see Fig. 6) and cracks (see Fig. 7) are another important reason resulting in anisotropy of the rock masses. They are weaker planes in mechanics.

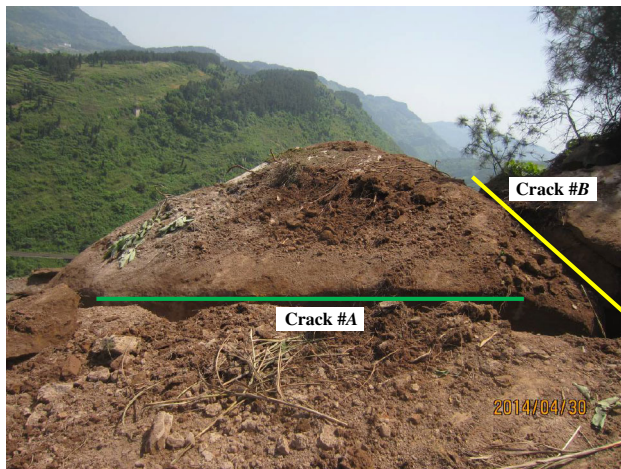
Fig. 7 Typical cracks found from top surface

Otherwise, another two-set open and smooth cracks were found on the top surface of the rock slope (“Crack #A” and “Crack #B” in Fig. 7). The dip direction and dip of the Crack #A are, respectively, about 90° and 86° and those of the Crack #B about 160° and 80° . The lengths of the two cracks are about 15.0–25.0 m.

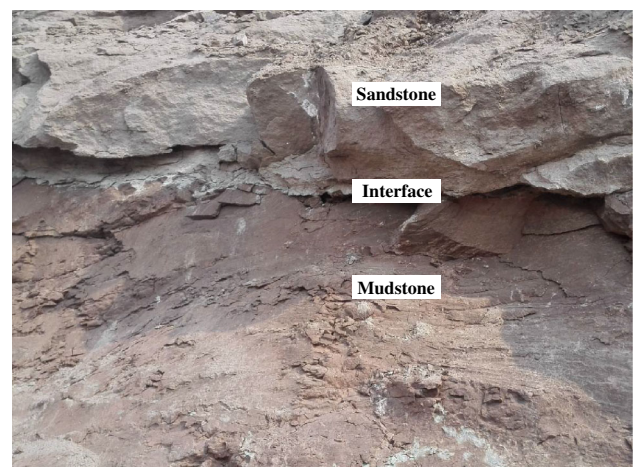
Fig. 9 Interface between upper sandstone and lower mudstone layers

interbedded interfaces in the sandstone and mudstone layers, in particular between the upper sandstone and lower mudstone layers, may be wetted and even soaked. The shearing strength of the interfaces may reduce in contact with water. During and after rainfall, the soil particles, in particular fine particles such as clay, silt and sand, entered into open crack with water flow. The soil particles might deposit in the crack, and formed a very thin layer. The thin layer filled in the crack was often called as argillation intermediate layer. Its shearing strength values, especially under saturated conditions, are usually very small.

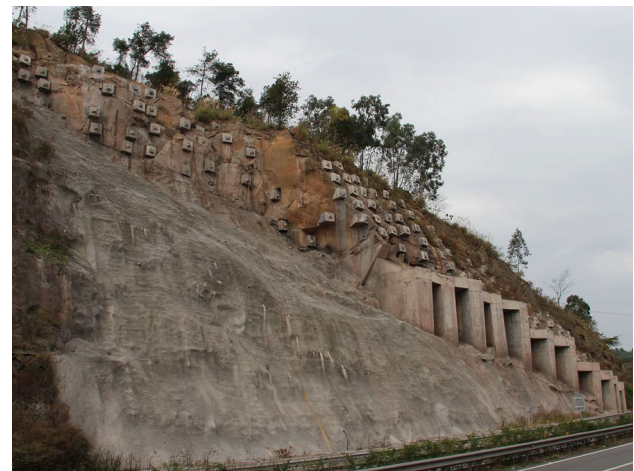
Fig. 15 Photograph of rock slope 2 years after stabilization

The construction of the stabilization on the rock slope was finished about nearly 2 years ago. Now, the rock slope (Fig. 15) is stable.
