# Characteristics of seismic disasters and aseismic measures of tunnels in Wenchuan earthquake

**Keywords** Tunnel · Earthquake resistance · Seismic damage · Disaster investigation · Wenchuan earthquake

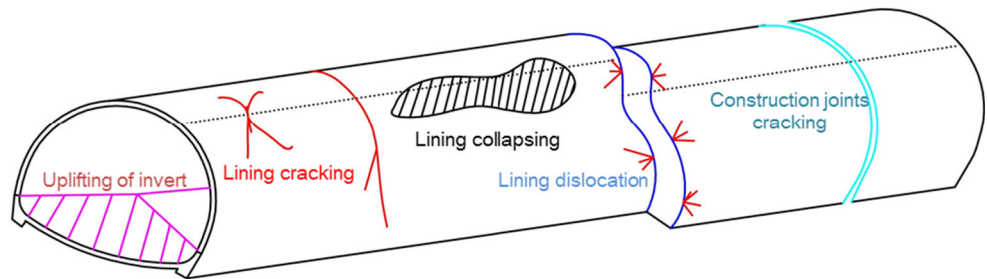
**Fig. 4** Seismic damage patterns of the Wenchuan earthquake

Tunnel structure damage, including slope instability, lining cracking, collapsing, and dislocation, fracture of tunnel portal, uplifting of invert, and fault slip were significant in Wenchuan earthquake, as shown in Fig. 4. The most common tunnel seismic damage patterns were lining collapsing and dislocation of tunnel (Ma et al. 2016). The probability evaluation and reasons of different seismic damage patterns are shown in Table 2.

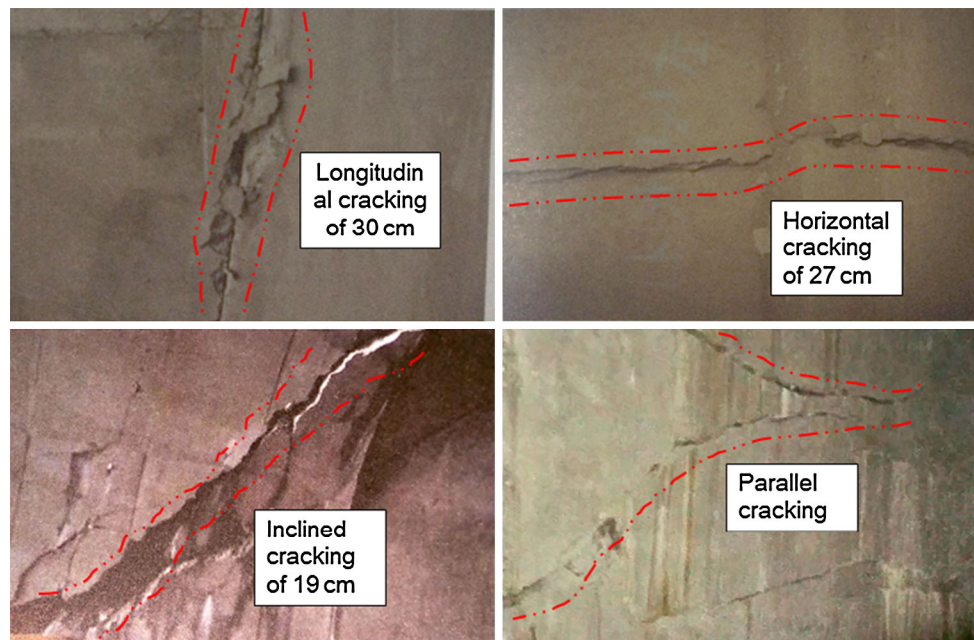
Lining cracking occurred on a large scale of LX tunnel, and the collapsed concrete block destroyed construction machinery and ventilation facilities, and an annular crack of 1–30 mm wide was formed on the road due to the lining cracking and dislocation. The internal lining of LDZ tunnel was shattered greatly and formed an annular crack about 10–20 mm wide on the road. LX tunnel and LDZ tunnel were located in Longxi Town of Dujiangyan City on the left bank of Minjiang River, and both of them passed through fault, anticline, and other unfavorable geology, with similar supporting measures. There were two kinds of lining cracking: distinct cracking along certain direction, uncertain direction cracking; and flake-like, as shown in Figs. 10 and 11.

As the commonest tunnel seismic damage, lining cracking mainly results from earthquake inertia force (general in section of tunnel portal) and forced displacement (near the interface of soft and hard rock at tunnel portal), as shown in Fig. 12. Concrete exfoliation is always accompanied by reticular fracture or lining crush. The directional lining cracking often occurs due to tension and shear action, flake-like crack is always caused by bending and deformed lining, and reticular crack results from the pressure and shear under the earthquake action as well as repeated movement (Pei et al. 2015).

**Fig. 10** The tunnel structure directional cracking (Cui et al. 2011)

1. Lining cracking occupied a high proportion in tunnel seismic damage during the Wenchuan earthquake, which proved the complexity of engineering analogy method in practice. Secondary lining cracking occurred because of the combined action of instantaneous

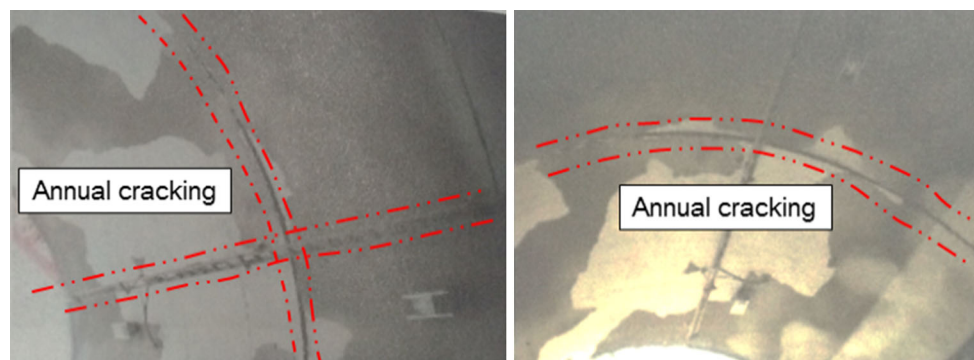
**Fig. 11** The lining structure annual cracking (Chen and Zhuang 2011)

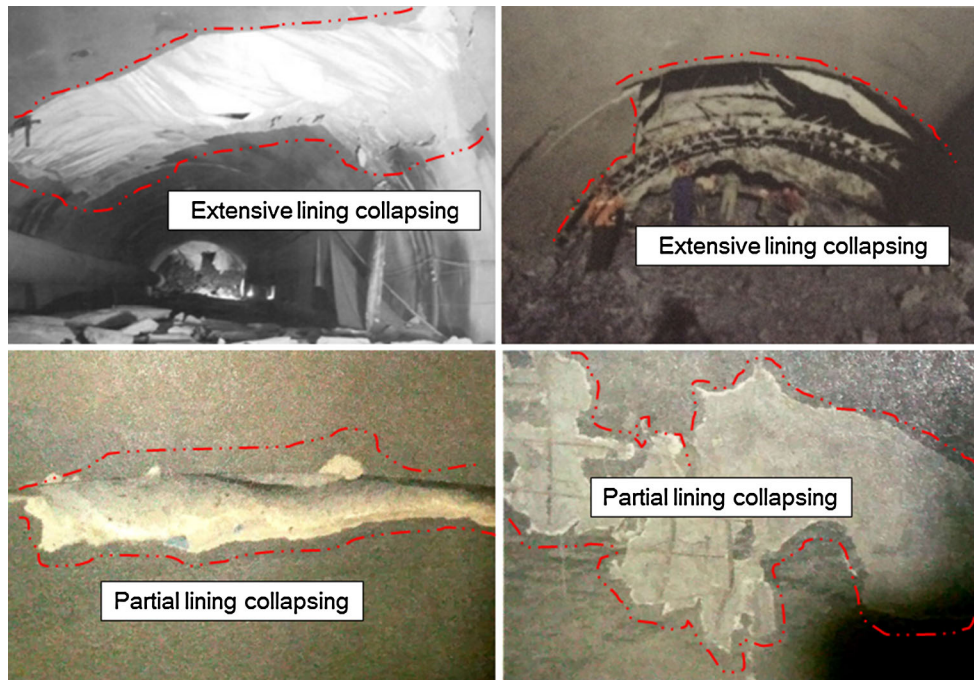
Located in the massif between Zhichanggou and Xiaotaogou in heavy-hilly area, YY tunnel was a deep tunnel (Shen et al. 2008). There were emptied coal mines, rock weathering, relaxation, and other unfavorable geological conditions in the areas that the tunnel passed through; thus, the secondary lining completely collapsed. The lining collapsing of the two tunnels showed massive falling-off on a large scale, and it was difficult to restore. Hence, it must be reinforced again, the secondary lining should be strengthened, and the opportunity for implementation of secondary lining should also be grasped, so as to avoid the similar seismic damage, as shown in Fig. 13.

**Fig. 13** The collapsing of secondary lining (Yu et al. 2016a)

2. During the Wenchuan earthquake, collapsing of secondary lining all had no reinforcements, and the seismic damage of reinforced concrete structure was obviously lower than that of plain concrete structure which indicates the necessity of reinforcement for lining. For example, the collapsing of secondary lining was 100 m in the LX tunnel without reinforcement (Yu et al. 2014), which was mainly because the large-scale geological condition of the tunnel was not fully considered. Hence, during design of tunnel, the preliminary geological and topographical condition should be fully considered and also the relevant

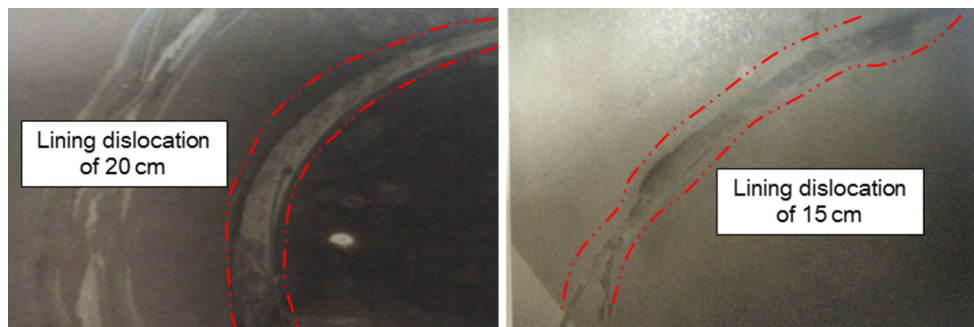
For LX tunnel, though the lining dislocation occupied a little proportion, it was serious at portal section, with dislocation of 20 cm; and the lining dislocation of LDZ tunnel

was as much as 15 cm. Hence, the lining dislocation of tunnel occupied a little proportion, but it was difficult to be handled in later period, as shown in Fig. 14.

The causes of lining dislocation include: unreasonable trolley structure leads to failure in resisting the deformation caused by exogenic actions such as concrete; in case of great difference in workability of concrete of same label, the shrinking percentage of concrete would differ. Therefore, the performance of concrete mixing each time is basically different. The lining dislocation results from the improper selection for concrete of tunnels in collapsing area (Mao et al. 2011).

**Fig. 14** The lining structure dislocation (Mao et al. 2011)

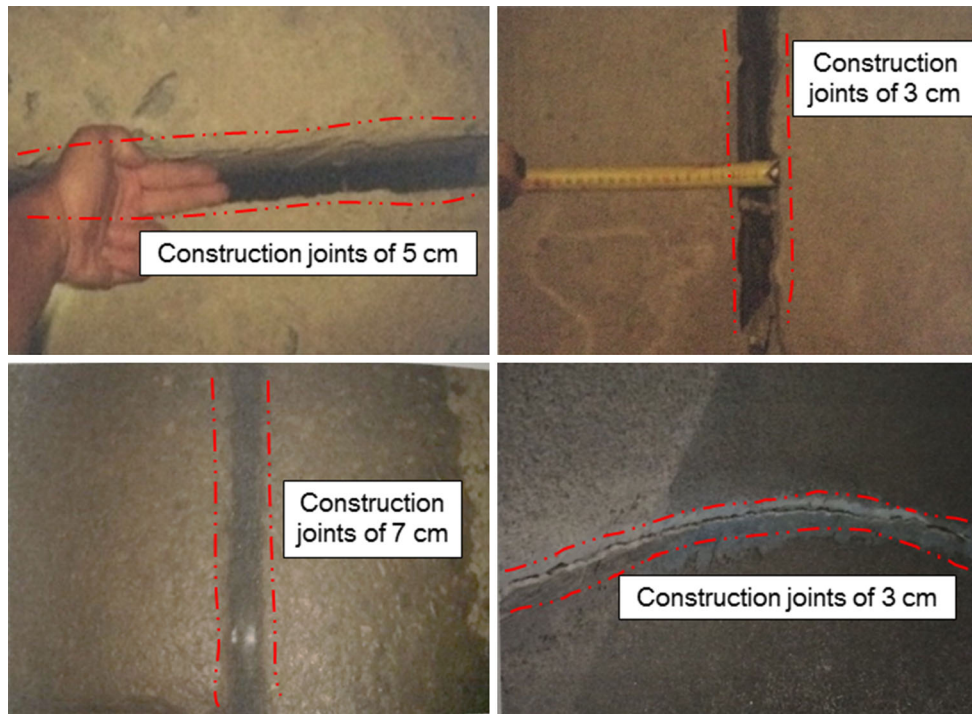
For ZZP tunnel, the construction joint basically cracked, and some form annular cracks with the width of 5–70 mm; for BYD tunnel, the construction joints within the tunnel all cracked, and crack width even reached up to 10 mm for the part with serious damage, and the tunnel showed annular crack and longitudinal crack. The construction joints cracking was inevitable in the seismic damages of tunnels. During Wenchuan earthquake, the construction joints cracking had a large proportion in special terrain condition. The specific damage condition is shown in Fig. 15.

The structural causes for construction joints cracking: mortar leakage, hydration reaction insufficiency of concrete, resulted in concrete strength reduction in concrete. It was too fast for concrete grouting due to settlement of concrete, earthquake loading, and mainly caused by the defects in construction quality, etc., during the constructions (Chen et al. 2010).

Fig. 15 The construction joints cracking (Chen et al. 2010)

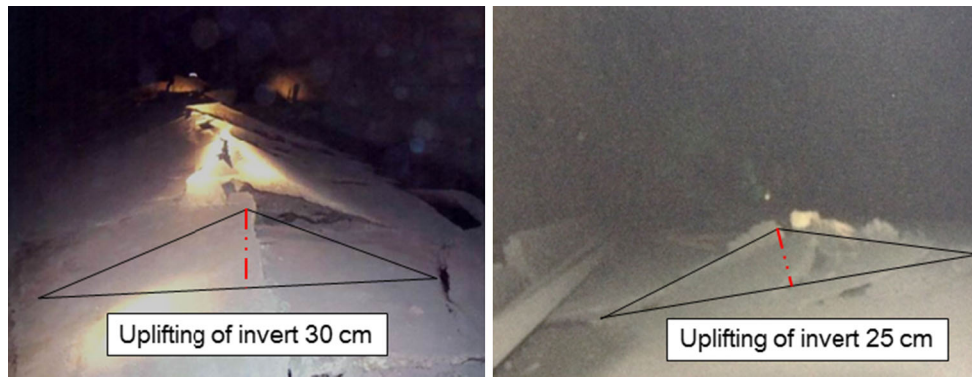
Uplifting of invert in the left line of LX tunnel was 100%, the uplift reached to over 30 cm, and the longitudinal cracking reached to 30 cm wide in serious damage section. The uplifting of invert reached to 22.1% in LDZ tunnel, as shown in Fig. 16.

Fig. 16 The uplifting of invert (Yu et al. 2016b)

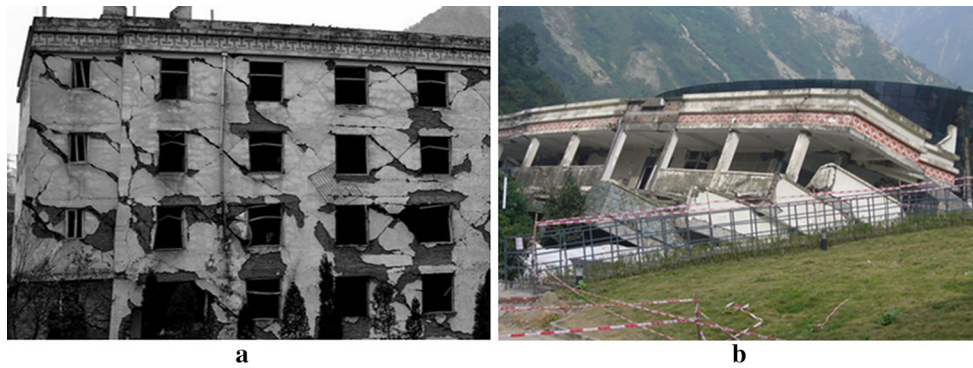
**Fig. 21** The seismic damages of the superstructure. **a** Framework structure. **b** Frame masonry structure

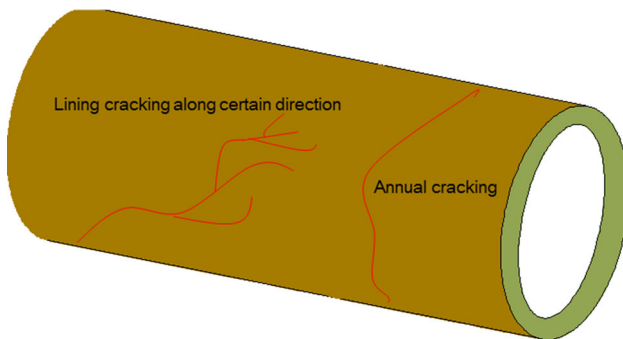
In terms of mountain tunnel, the Rokko tunnel of Sanyo Shinkansen suffered from the seismic damage during the Hanshin earthquake. The Rokko tunnel led to Osaka, 16,235 m long, and passed through several active faults of Rokko fault system. On the inner cement walls of the Rokko tunnel, there were three cracks as long as dozens of meters (Wang et al. 1998a).

**Fig. 22** The cracking of lining structure in Hanshin earthquake
