Behavioral characteristics and structural stability of the walls in the ancient Korean Royal Tombs from the sixth century Baekje Kingdom

Abstract

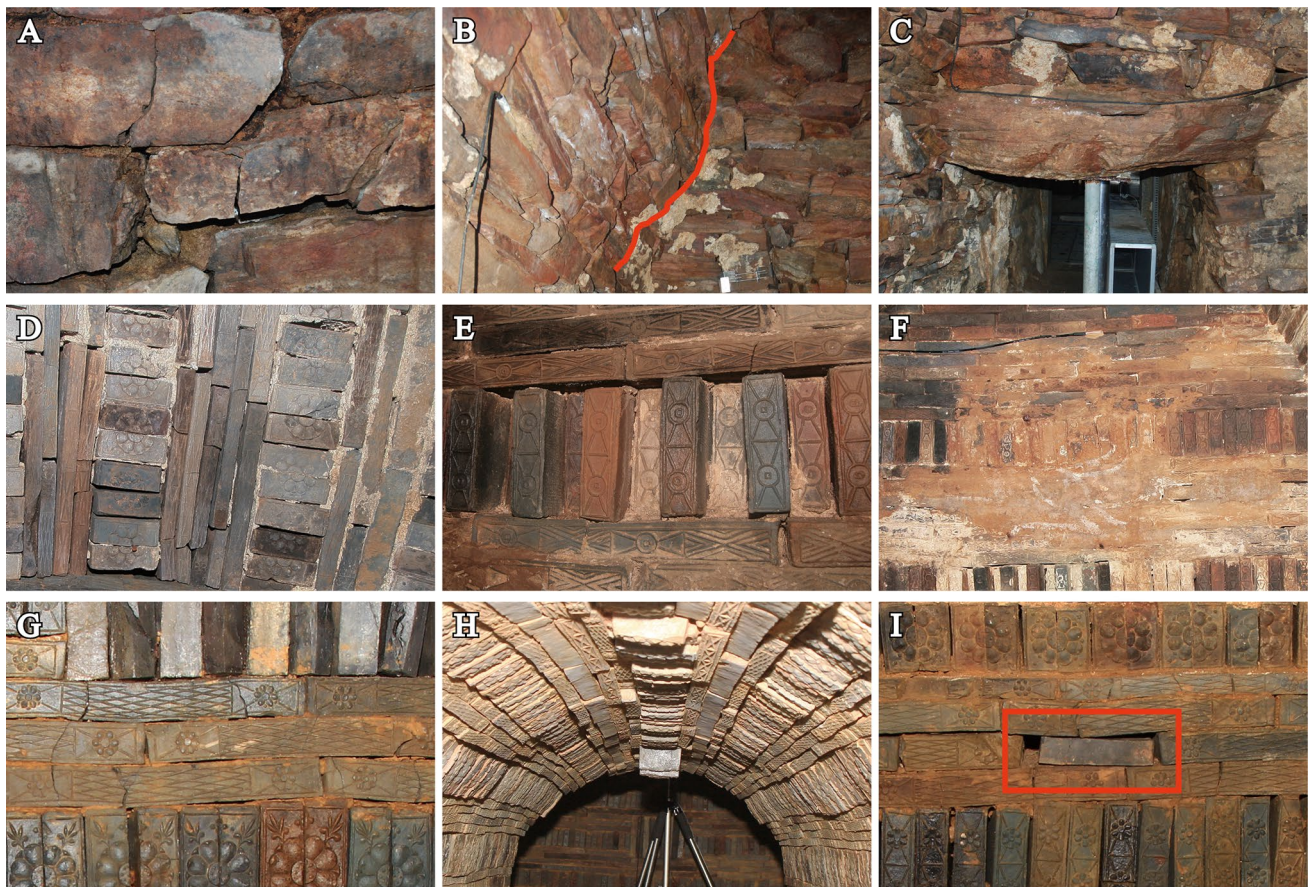
Tomb no. 5 is a stone-chamber tomb built by gneiss with irregular shapes; however, material study of the gneiss has not been performed yet. Currently, the damage largely comprises structural cracks and shear fractures with several stones being dislocated by vertical deformation (Fig. 3a). In particular, the swelling phenomenon of the rock in the upper parts of the northern and south-western walls provides evidence of structural instability (Fig. 3b). The western and northern sides of the walls exhibit more physical damage than the rest do, such as cracking and separation of stones. Some stones of the northern wall even moved independently or fell due to the weakening of the structural support between adjacent stones.

Moreover, the large stone forming the entrance of the burial chamber exhibited considerable subsidence due to the concentrated load at the central part as well as cracks due to the concentration of tensile and frictional forces on the sides of the stone (Fig. 3c). Additionally, a large-scale structural crack can be observed at the base of the stone. To mitigate the structural instability, straight vertical steel supports were installed. However, they have since been corroded due to the moisture in the environment and those installed between the ground and structure are being deformed by the constant load.

Kim et al. 2012; Moreira et al. 2016). However, physical damage to the bricks and structural deformation appear to have occurred over the long period since its construction. The physical damage is concentrated in the ceilings of the burial chamber and the dromos (Fig. 3d). Furthermore, many horizontally placed bricks of the internal walls have numerous structural cracks and fractures and some of the vertically placed bricks that are stacked between front and back walls are irregularly arranged (Fig. 3e).

ceiling with an arch structure. Compared with the others, the physical and structural damage in this tomb is more conspicuous than that in tomb no. 6, including cracking, fracturing, separation, and twisting. The horizontally placed bricks on all four walls exhibit significant physical damage in the form of cracks, fractures, and missing parts (Fig. 3g). Separation has occurred among many of the bricks, and some of the vertically placed bricks are slightly unstable and have begun to diagonally tilt owing to structural deformation.

Notably, it is believed that the bricks in the center of the ceiling of the dromos have shifted downward; three of these bricks have moved by up to 7 cm (Fig. 3h). In this tomb, bricks have been used to fill the empty spaces that were caused by separation and missing parts; however, most of them are no longer in contact with the adjacent bricks and, thus, do not provide proper support due to the severe extent of the deformation (Fig. 3i). Additionally, large-scale structural cracks can be seen in the floor bricks, resulting in separation between some of the bricks.

Fig. 3 Present status of the Royal Tombs at Songsanri (**a–c** tomb no. 5, **d–f** tomb no. 6, **g–i** Royal Tomb of King Muryeong): **a** structural cracks and fractures in the rock. **b** Swelling phenomenon on the west wall. **c** Subsidence of the large horizontal member due to loading. **d** Cracking, separation, and distortion concentrated on the ceiling. **e**

Vertical bricks arranged unevenly. **f** Wall painting on the south wall (Vermilion Bird). **g** Cracks and fractures concentrated on the horizontal bricks. **h** Lack of dromos ceiling where it appears that the bricks moved downward. **i** Brick that is thought to have been inserted secondarily after being lost

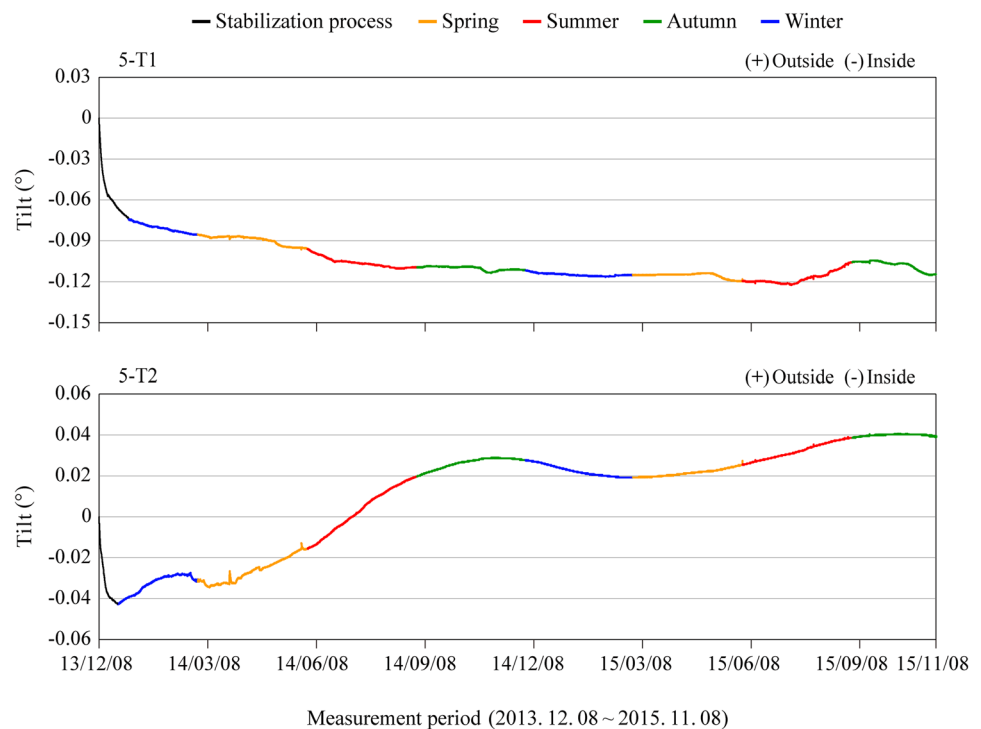
Fig. 5 Annual changes in tomb no. 5

As Table 2 and Fig. 5 show, sensors 5-T1 and 5-T2 in tomb no. 5 reported rapid displacements toward the inside of the tomb during the initial stage of monitoring (tilts of 0.07° and 0.04° , respectively). However, the measurements stabilized gradually and the variation had ceased by the end of the study period. Sensor 5-T1, in particular, reported more displacement during the first month than during the subsequent 22 months combined. The tilt observed by sensor 5-T1 was consistently towards the inside of the tomb and the final displacement was approximately 0.12° . In contrast, the direction of the tilt measured by sensor 5-T2 varied, repeatedly alternating throughout the study period; however, the sensor reported a net outward tilt of approximately 0.04° .

The abnormal changes observed during the initial stage of the study period can be attributed to the stabilization process of the sensors and only the changed measured after the rapid initial changes were considered to be due to actual displacements in the structure. Thus, excluding the initial changes, each of 5-T1 and 5-T2 exhibited a minimal tilt in the range of 0.05° and 0.08° that remained constant despite external environmental changes.

To analyze the movements of the walls due to seasonal environmental changes, the abnormal movement data from the initial stabilization stage were excluded and only the data corresponding to actual movements after this initial period were considered. First, the data from sensor 5-T1 revealed that only gradual movements occurred toward the inside during all four seasons of the first year and no distinct behavioral differences were observed between the seasons. During the second year, movements to the inside were observed during the spring, autumn, and winter as in the first year; outward movement was only observed during the summer. Thus, considering that Korea has four distinct seasons and the environmental conditions differ significantly between the summer and winter, it can be concluded that sensor 5-T1 did not detect any seasonal changes.

Sensor 5-T2 generally detected outward movement but also regularly detected repetitive movements in both directions. In both the first and second years, outward movement was observed beginning in the spring, during the summer, and into autumn. Then, in autumn, the movements stabilized and there was a tendency toward inward movement.

Different movement characteristics were observed in the winters of the first and second years. However, based on these findings, it can be considered that the movement of the wall on which sensor 5-T2 was installed is affected by seasonal environmental changes.

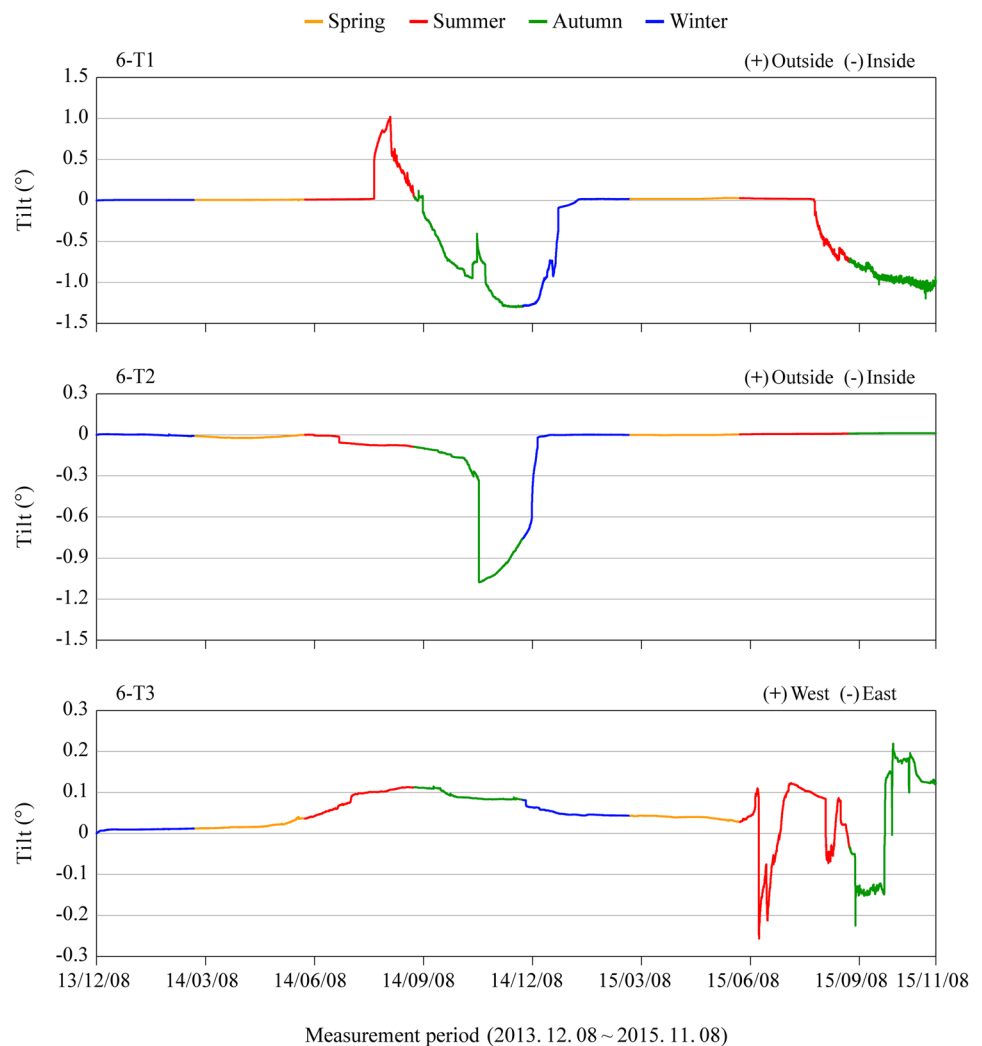
Fig. 6 Annual changes in tomb no. 6

As Table 3 and Fig. 6 show, the walls of tomb no. 6 exhibit numerous abnormal movements. In particular, sensors 6-T1 and 6-T2 detected regular movements within a tilt range of 0.03° but also large movements exceeding 1.07° in periods

of contrasting movement characteristics (herein referred to as abnormal periods). Sensor 6-T1 detected two periods of abnormal changes; the first such period involved tilts of over 2.37° and, of the seven sensors used in this study, exhibited the greatest difference in movement behavior compared with the period of normal movement. Similarly, sensor 6-T2 detected only micro-movements during the first six months of the study period but later detected rapid inward movements with significant displacement of 1.07°. However, the wall on which sensor 6-T2 was placed returned to its initial position more quickly than that on which sensor 6-T1 was placed and the net movement was small (within 0.03°) thereafter with no further evidence of abnormal movement.

Sensor 6-T3, which was installed on the ceiling of the tomb, revealed different movement characteristics compared with those of the walls. In the periods during which sensors 6-T1 and 6-T2 detected large movements (i.e., tilts of over 1.07°), the ceiling maintained a relatively stable position, exhibiting displacement of only 0.11°. However, there was an abnormal period, with a maximum displacement of 0.27°,

during the second year, during which sensor 6-T3 detected repetitive movements in the east and west directions. However, by the end of the study period, the net displacement measured by sensor 6-T3 was small due to repetitive movements towards its original position; they may indicate structural damage, because such abnormal movements were only observed during the second year (and not the first).

Of the sensors that were installed in tomb no. 6, the movements detected by sensor 6-T1 corresponding most closely to seasonal changes. In both years of the study period, the measurements were very stable throughout the spring season but were abnormal from summer and until autumn. However, the wall appeared to return to its initial position during the winter of the second year and remained stable thereafter. In the winter of the first year, the wall position was stable from the beginning of monitoring process; thus, it can be deduced that the abnormal movements had already occurred and that the wall had reverted to a stable position before the study period. Based on this pattern of movement, the abnormal movements during the summer can be attributed to heavy rainfall, increasing the water content in the soil that

The measurements obtained from sensor 6-T2 in the first year were similar to those obtained from sensor 6-T1. Sensor 6-T2 recorded a large displacement, indicating instability; however, the tilt returned to its original state and was stable thereafter. However, in the second-year, such abnormal movements in the summer and autumn did not occur, indicating that the wall was consistently stable during this year. This difference can be attributed to the difference in the amount of rainfall in the first and second years.

Compared with the other sensors, sensor 6-T3 detected a relatively small amount of displacement during the first year; however, there was still evidence that the movement of the ceiling was affected by seasonal changes. The measurements indicating that the ceiling was stable in the winter and spring (with only minor movements in the spring) but underwent abnormal movements in the summer and autumn; this behavior was observed in both years of the study period but was more prominent during the second year.

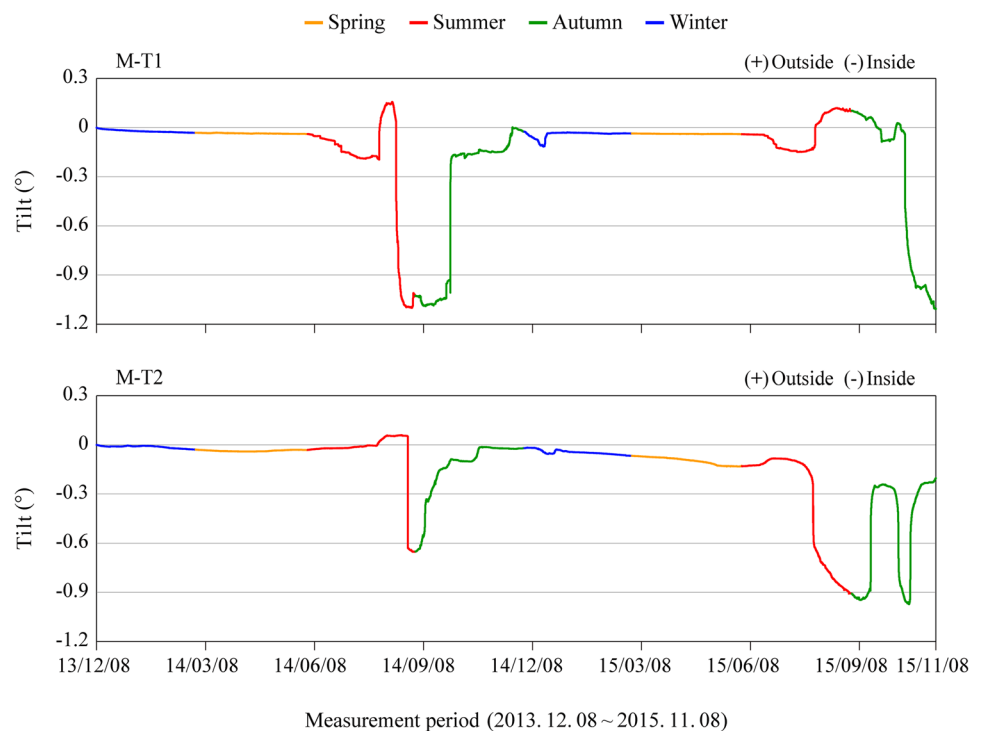
Fig. 7 Annual changes in the Royal Tomb of King Muryeong

As Table 4 and Fig. 7 show, the two sensors installed in the Royal Tomb of King Muryeong recorded very similar movement characteristics, including clearly distinct alternating stable and abnormal periods. Sensor M-T1 recorded only minor movement (tilt within 0.02°) for about six months but later underwent rapid and large movements toward the

interior (up to 1.11°) and exterior (up to 0.16°) of the tomb. Then, this wall returned to its initial state and remained stable for another six months, before another period of abnormal movement (over 1.10°) near the end of the study period.

The measurements from sensor M-T2 revealed a relatively unstable condition in the second year, characterized by abnormal movements with a maximum displacement of 0.18° more than that in the first year. While in the first year period, the wall quickly reverted to its original position following the period of abnormal movements, there were two periods of abnormal movements in a short period of time during the second year, indicating significant instability.

The movement of the walls of the Royal Tomb of King Muryeong closely reflected the seasonal changes. Specifically, the readings from sensors M-T1 and M-T2 exhibited clearly distinguishable variation patterns following the seasons in both years of the study period. The measurements indicated that the walls were stable in the spring when the monitoring began, underwent abnormal movements occurred starting in the summer, indicating instability, then returned to the original state and showed signs of recovery in autumn.

These tendencies observed by sensors M-T1 and M-T2 reflected those of sensor 6-T1 in tomb no. 6. However, unlike the wall on which sensor 6-T1 was installed, which returned to its original state in the winter, the walls with sensors M-T1 and M-T2 exhibited abnormal movement during the winter of the second year with displacements within 0.10° followed by relative stability until the spring. Additionally, there was another period of instability (indicated by a reoccurrence of abnormal movements) from the beginning of the summer until the following autumn. The wall on which sensor M-T2 was installed had reverted to its original position by the end of the study period although that on which sensor M-T1 was installed had not. However, as noted for the ceiling in tomb no. 6 (monitored by sensor 6-T3), these abnormal behaviors may be due to structural damage; therefore, constant monitoring is highly recommended.

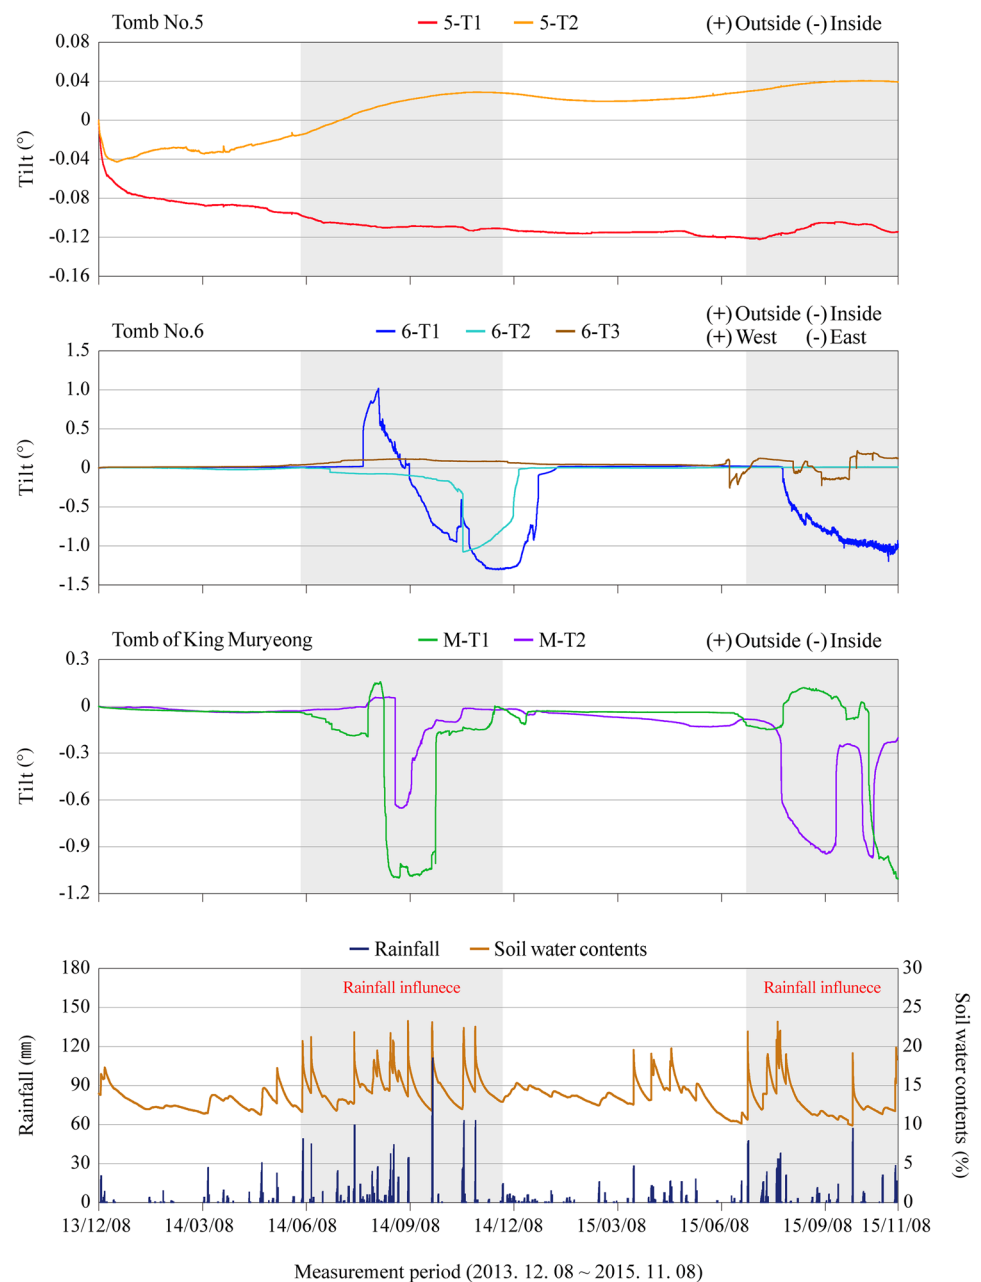
Fig. 8 Behavioral characteristics attributed to rainfall

As Table 5 and Fig. 8 show, tomb no. 5 remained stable even when the soil water content increased rapidly due to the concentrated heavy rainfall during the summer. On the other hand, tomb no. 6 and the Royal Tomb of King Muryeong exhibited abnormal changes and tended to be very unstable during this period. Particularly for the abnormal sections (corresponding to two of the sensors in the Royal Tomb of King Muryeong, M-T1 and M-T2), the changes generally coincided with increases in the soil water content exceeding 20% and the movement continued until the soil water content returned to normal.

Regarding tomb no. 6, abnormal changes indicating instability occurred due to the heavy rainfalls in the summers of both years of the study period (sensors 6-T1 and 6-T2 in the first year and sensors 6-T1 and 6-T3 in the second year). In particular, sensor 6-T1 recorded abnormal changes in both years and extreme changes of over 2.37° in the first year. The abnormal changes (inward and outward movements) at sensor 6-T3 began when the soil water content decreased before the concentrated rainfall in the second year and continuing until the end of the study period. Similarly, the abnormal movements recorded by sensor 6-T2 occurred as the soil water content decreased after rainfall.

Such periods of abnormal behaviors persisted even after the rainy season. Thus, it can be inferred that these changes are because of the remaining internal pressure on the walls, which can affect the micro-movements despite the fact that the soil was completely dehydrated; this implies that the external forces applied to the tomb change even during the dehydration of the soil.

To minimize the increase in soil water contents and loads of the mounds due to rainfall, the rain cover could be installed as a temporary expedient. However, the rain cover should be installed in a very wide range, which requires enormous budget and labor. The rain cover is also not a suitable method considering the long-term preservation and views of the World Heritage. Thus, precise and detailed investigations from a structural engineering perspective should be performed to mitigate further damage to the bricks of tomb no. 6 and the Royal Tomb of King Muryeong and recover the structural stability.

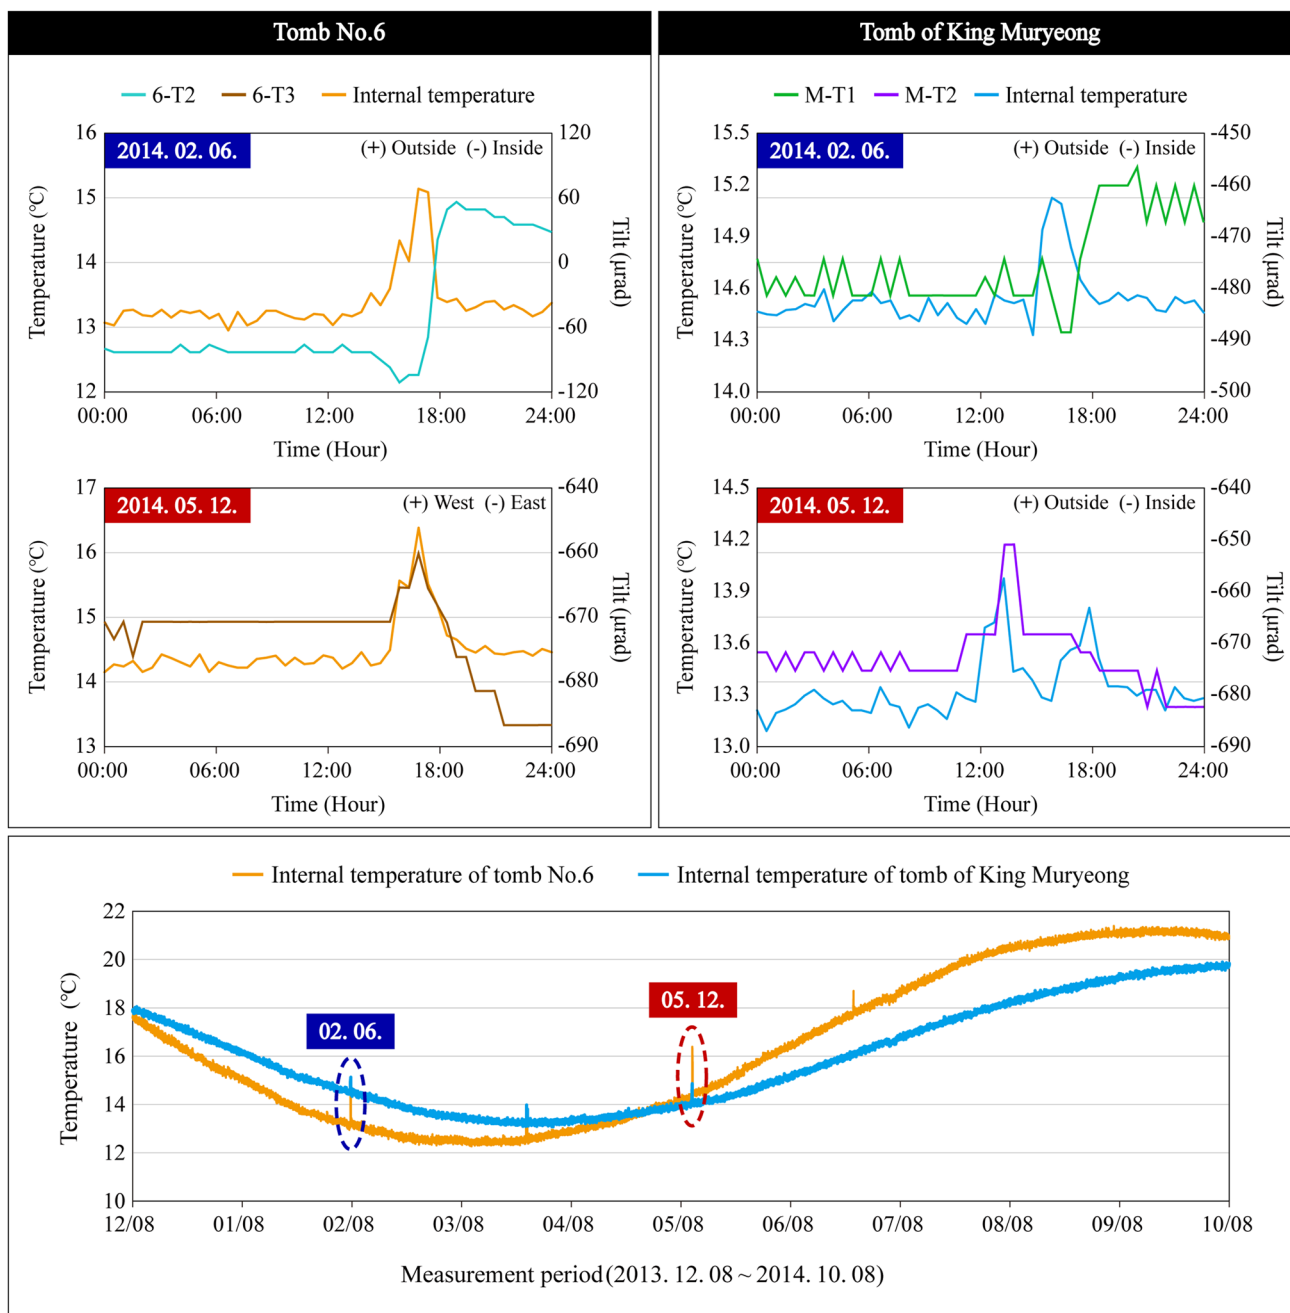
Fig. 9 Changes in tomb no. 6 and the Royal Tomb of King Muryeong corresponding to artificial environmental changes

As Fig. 9 shows, abnormal movements were observed on February 6th and May 12th of 2014 in both tomb no. 6 and the Royal Tomb of King Muryeong when investigators entered the tombs. The movements stabilized as the internal temperature decreased after the investigation was complete and most measurements returned to their previous values. However, some sensors detected permanent changes following the artificial activity but the

displacement was very minimal. However, some of the movement and internal temperature data were not collected due to errors in the sensors in tomb no. 5; yet, it can be assumed that the movement characteristics were similar to those in tomb no. 6 and the Royal Tomb of King Muryeong.

The displacement due to abnormal movements did not always correlate with temperature increases and, thus, may have taken place due to various reasons other than temperature changes, such as air pressure change and micro-vibration, which simultaneously occurred. Thus, because artificial environmental changes not only affect the environment of the tombs but also the micro-movements of the walls, it is

recommended that access to the tombs be minimized for maintenance and research purposes.
