# Slope stability analysis of landslide zones in the part of Himalaya, Chamba, Himachal Pradesh, India

Kanwarpreet Singh<sup>1</sup> · Virender Kumar<sup>2</sup>

Received: 2 June 2019 / Accepted: 3 April 2021 / Published online: 14 April 2021  
© The Author(s), under exclusive licence to Springer-Verlag GmbH Germany, part of Springer Nature 2021

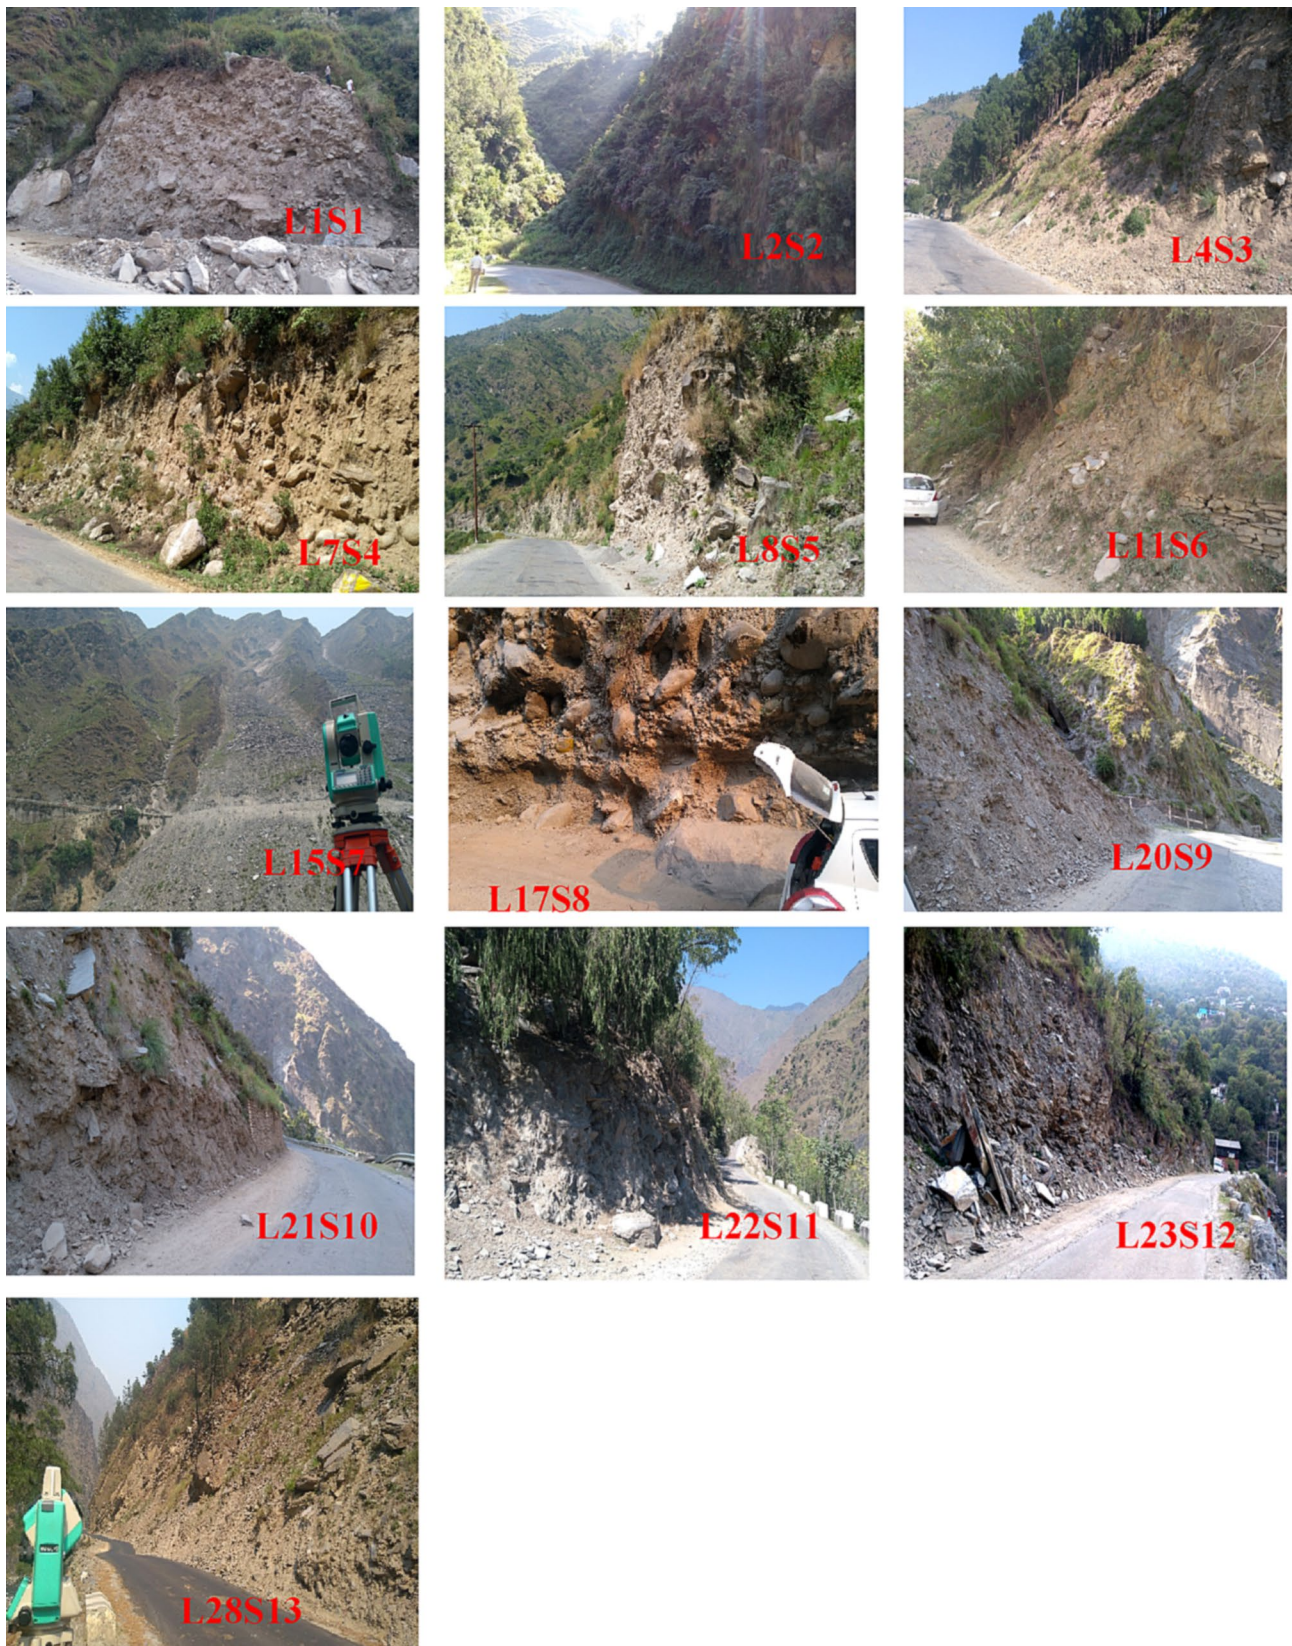
**Fig. 3** Field photographs of the soil slope sections along NH-154A where in LS, L and S represent location number and soil slope respectively
