Failure Investigation of Frame 6FA Gas Turbine Compressor Blades

Abstract This investigation elucidates failure of a land based 6FA gas turbine compressor 2nd stage blade. During discussions with site officials, it was learnt that this particular compressor operated in good condition for over 20,000 h at two other sites. In this power station, this was second such failure with less operation duration. Due to failure of blades, it was requested for a detailed root cause analysis by the utility officials in order to avert such failures in future. Failed blade samples were collected from the site and cut into the suitable sizes for investigation procedures. Investigation techniques like visual observation, stereomicroscopic, metallographic, scanning electron microscopic examinations (SEM), etc. are employed to ascertain the root cause for failure. During the investigation it was noticed that there is no degradation in the material. During stereomicroscopic examination, a number of beach marks were observed to be present on the fractured surface of the blade. It was also noticed from both stereomicroscopic and SEM examinations that the blade failed due to fatigue. The cracks have orig

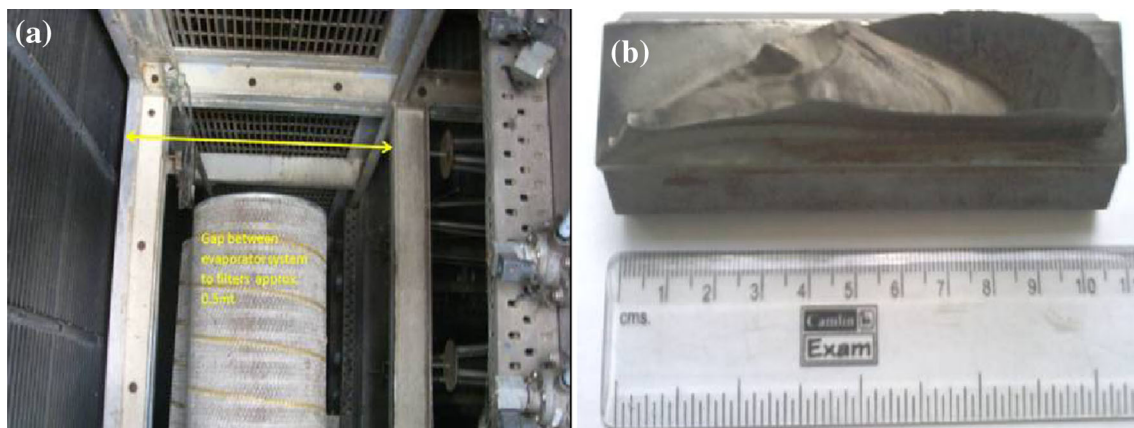
Fig. 1 Photograph showing **a** the evaporation system for cooling air, **b** showing fracture surface of failed compressor blade

suction side, propagated towards leading edge and failed. A number of micro cracks are noticed while scanning under SEM in the shot peened area at trailing edge on both the pressure and the suction sides. It is also noticed that the deposits are of the combination of silicates and chlorides, which is confirmed by EDS spectrum. It is also noticed from both the stereo and the SEM scanning that the blade failed due to fatigue fracture because of the cracks generated during operation. During discussions and with available information, there was no problem for the machine at the first two sites. One more specific observation is that the failure of compressor blades had occurred only at this third site. It was noticed that the air filtration mechanism as shown in Fig. 1a at this site is different from the first two sites.

During air filtration, probably sufficient amount of air might not have been fed to the compressor due to the clogging of evaporator filters located in the inlet air path. Due to insufficient amount of air, flow variation of air might have occurred leading to surge/stall. The same observation was reported by [3]. This surge/stall would

- Air surge has occurred due to insufficient air fed to compressor during operation. The compressor blades had vibrated beyond their natural frequency due to air surge.
- Cracks were originated from the micro cracks developed due to shot peening at the trailing edge.
- It is recommended to examine the air filtration mechanism, installed especially at the third site.

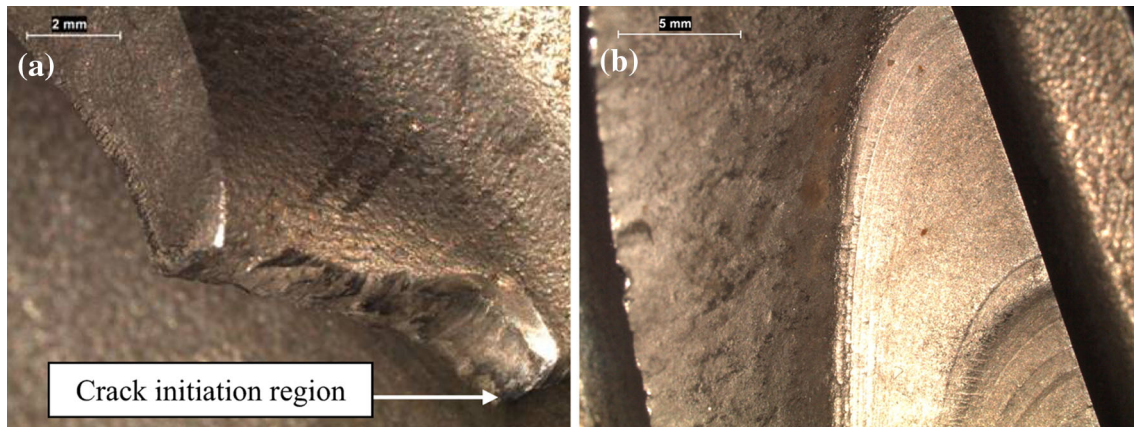
Figure 2a shows the crack initiation region and Fig. 2b shows beach marks in the fracture surface.

Fig. 2 Stereo micrograph of fracture surface of failed blade showing **a** crack initiation region, **b** beach marks on the fracture surface

During stereomicroscope examination, it is also noticed that the crack has initiated at the trailing edge 10 mm away from the blade base, just before end of the shot peened area and propagated further. As it is noticed that a number of beach marks are present in fracture surface of the blade indicating that the crack was initiated at trailing edge in

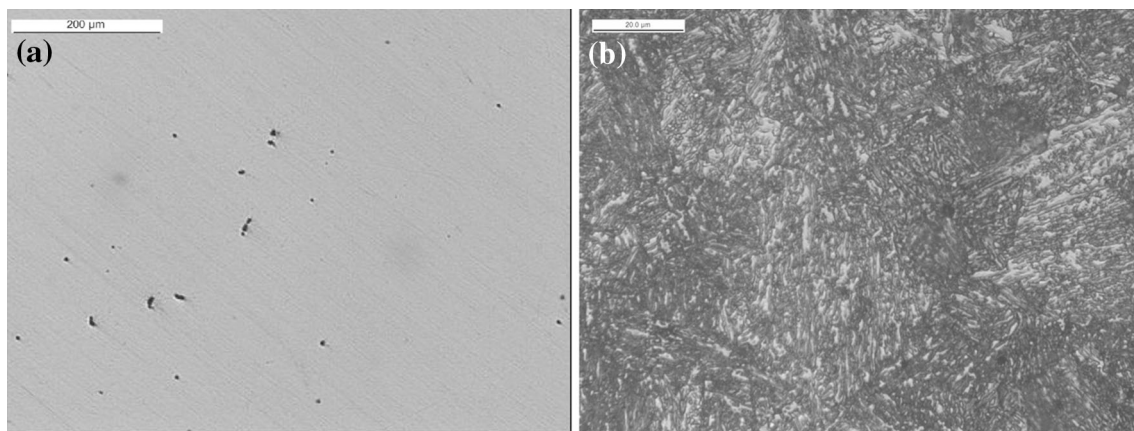
Two samples were cut from failed blade at root portion (base). The samples were polished and observed under optical microscope in un-etched condition for assessment of inclusion rate as shown in Fig. 3a. It was observed the inclusion rate is falling under the thin series D2 as per ASTM E45-13 standard [2] and it is within the acceptable range. Then the sample was etched (using Villella's reagent) for obtaining microstructure. The microstructure contains lath martensite as shown in Fig. 3b and it is as per the requirement.

Fig. 3 **a** Optical micrograph in un-etched condition showing inclusions, **b** microstructure of failed blade showing the lath martensite

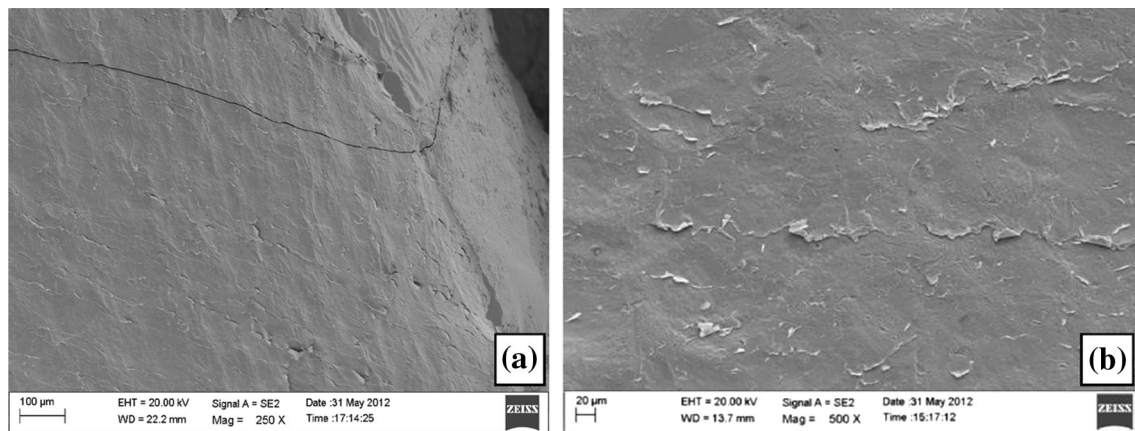
the fractograph of sample with micro cracks origin. Figure 4b shows blisters like features in shot peened area. Figure 5a shows the fractograph of 1st sample and Fig. 5b shows the corresponding EDS spectrum.

Fig. 4 Fractograph showing **a** micro cracks and **b** blister like features on shot peened area

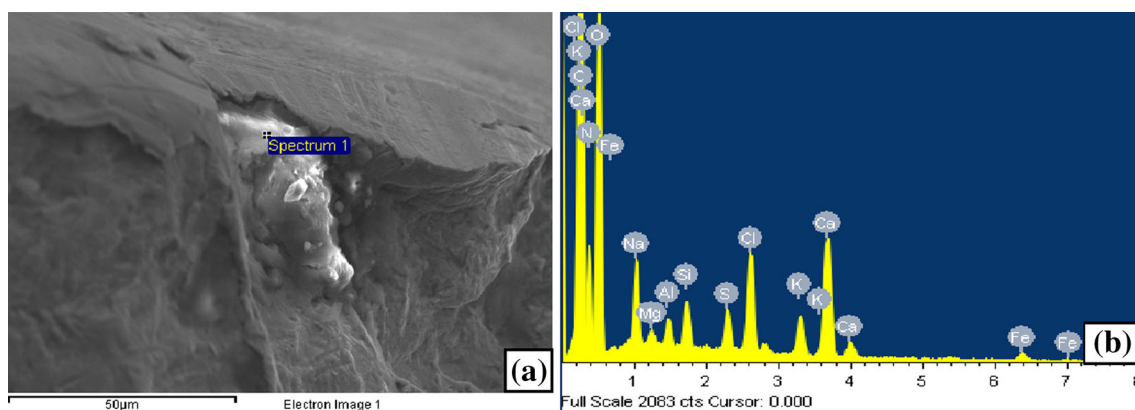
Fig. 5 **a** Fractograph showing deposits on the fracture surface, **b** EDS spectrum of the deposits in fracture surface
