Structural and health assessment of historic timber roofs from the Convent of Christ in Tomar

Maxime Verbist¹ · Filipe T. Matos¹ · Jorge M. Branco¹

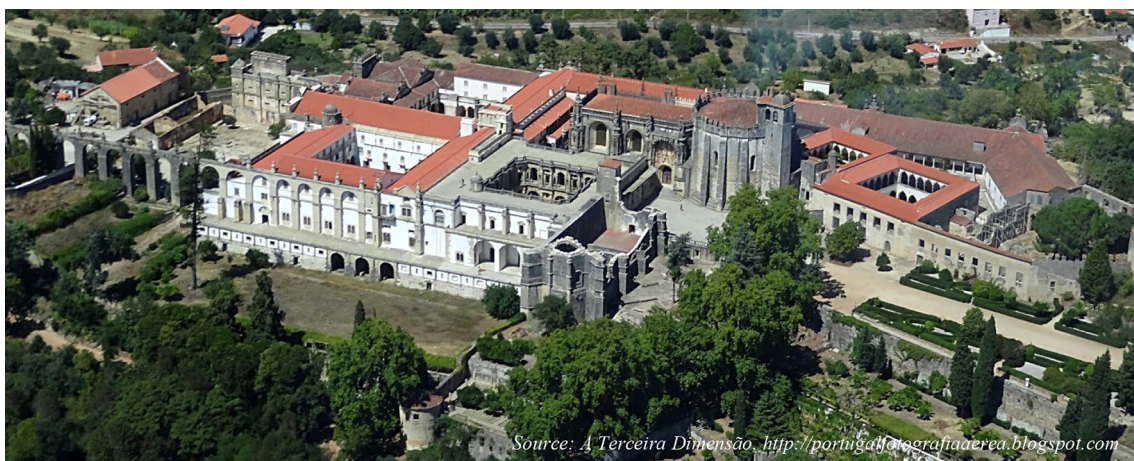
Fig. 1 Aerial view of the Convent of Christ, in Tomar, Portugal. *Source:* A Terceira Dimensão, <http://portugalfotografiaaerea.blogspot.com>

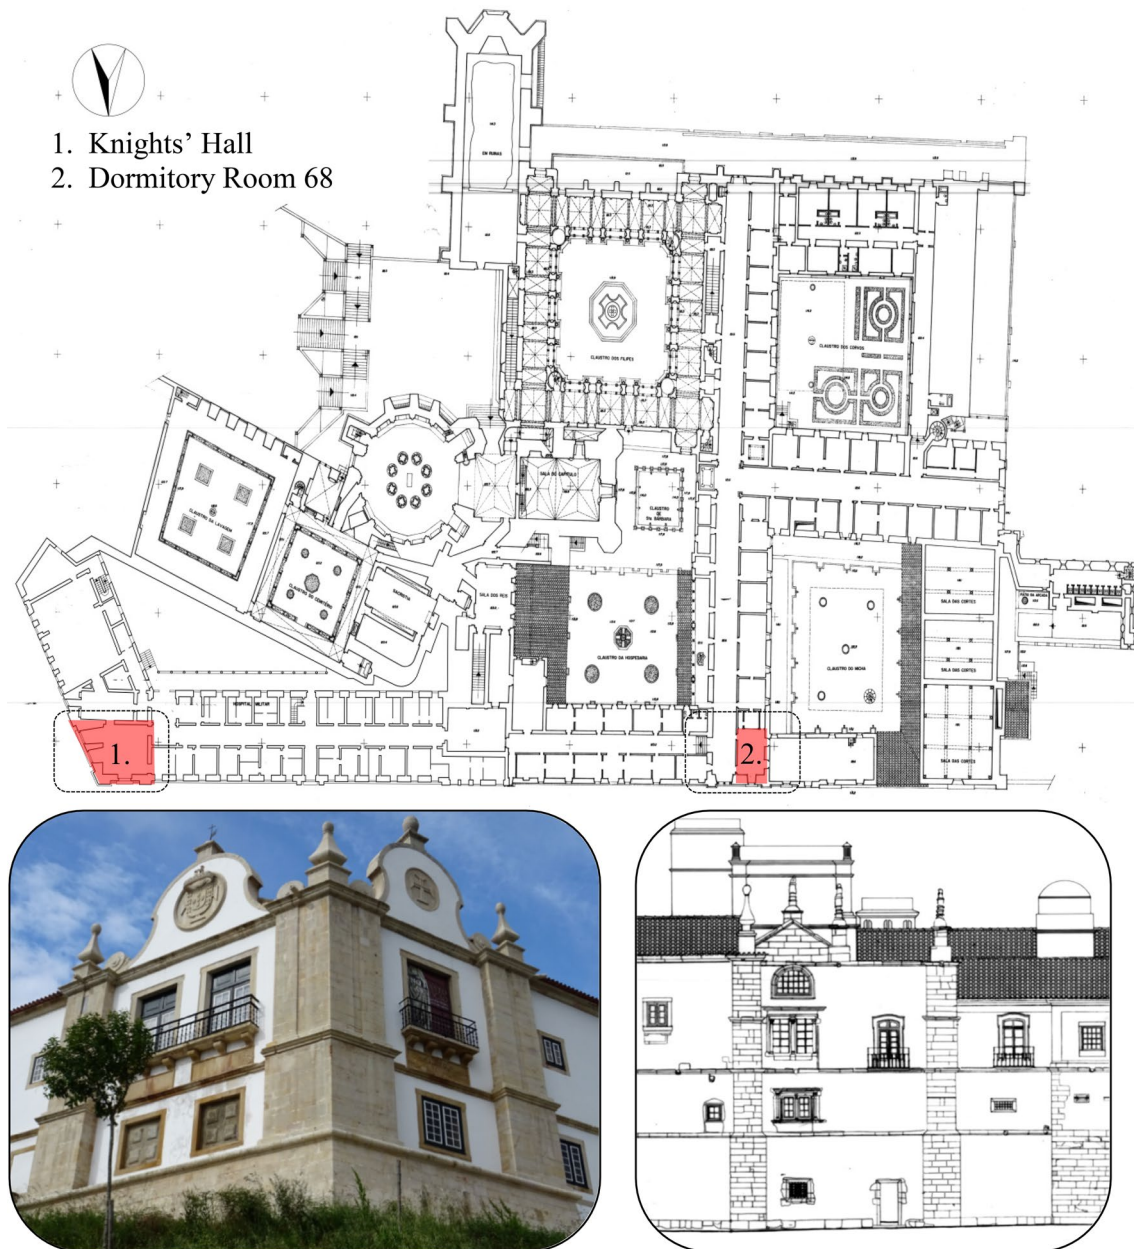
Fig. 2 Second floor plan of the Convent of Christ in Tomar, with the location of timber roof structures under investigation (red areas)

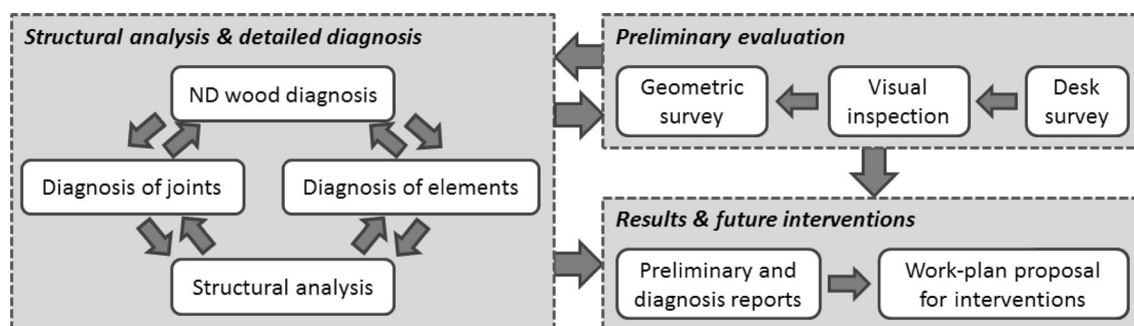
Fig. 3 Methodological steps required for a complete inspection and diagnosis in historic timber structures (modified from [5])

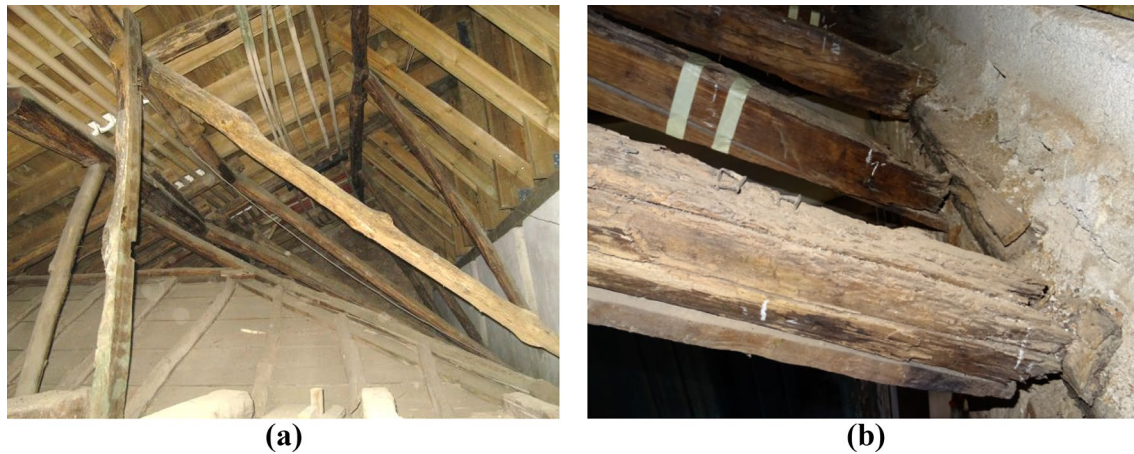
Fig. 6 Coexistence of old and new timber roof structures above the dormitory Room 68 (a). Rafters featuring insect wood deteriorations on their external surfaces and fungal decay at their ends (birdsmouth joint) with the wall plates (b)

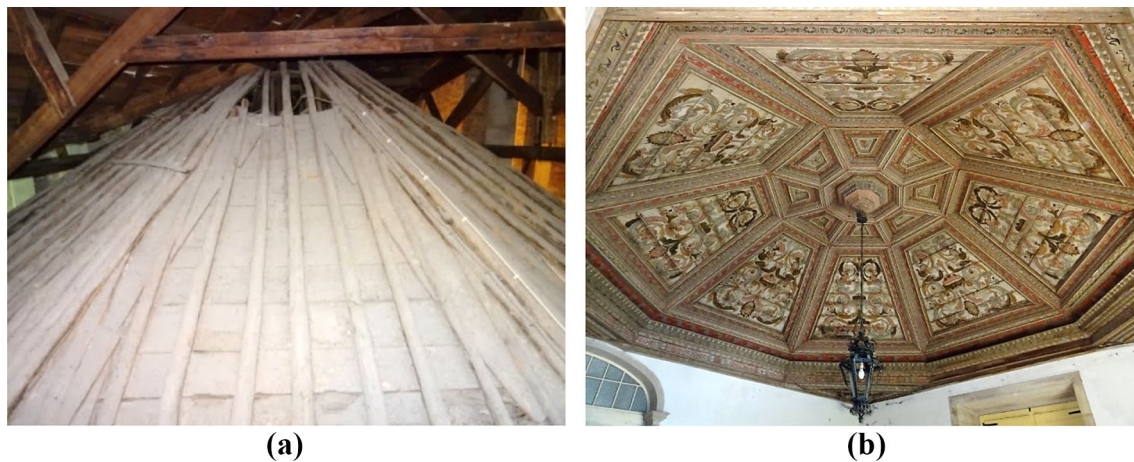
Fig. 7 Upper view of the octagonal dome (a). Paintings on the ceiling planks constituting the visible bottom part of the octagonal dome in the Knights' Hall (b) from [20]

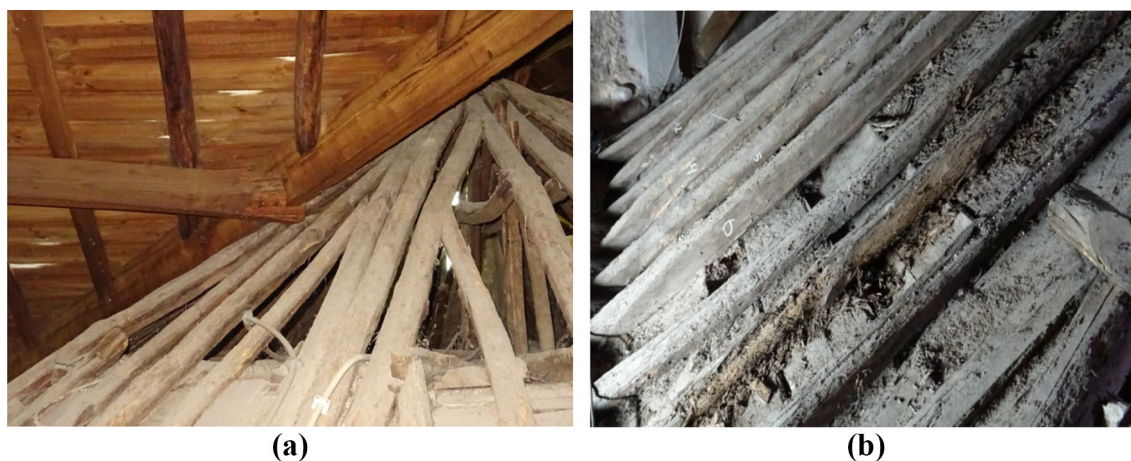
Fig. 9 Beam of the northern roof structure pressing the top of the octagonal dome (a). Severe insect wood deterioration on the external surfaces of the joists from panel V (b)

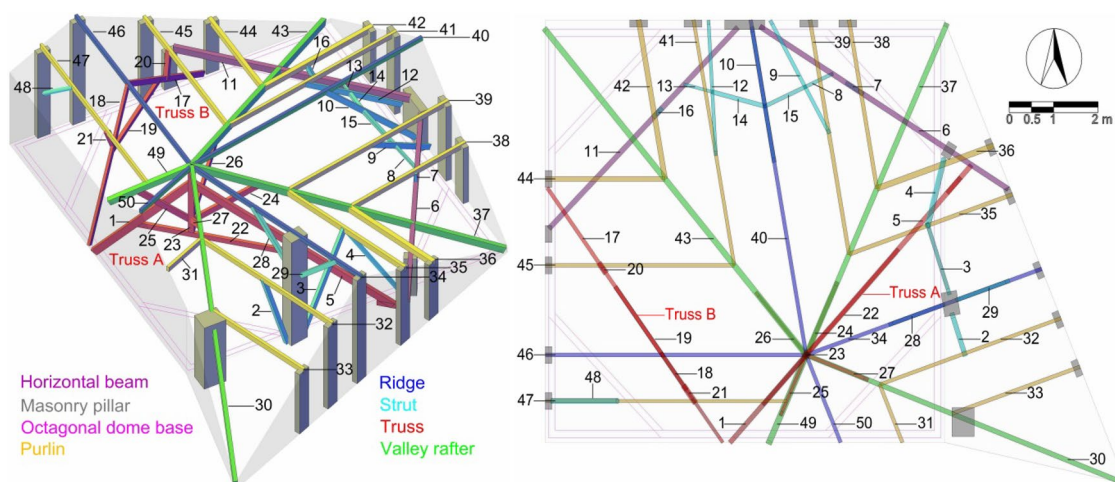
Fig. 10 3D modelling and horizontal blueprint of the carpentries set above the octagonal dome in the Knights’ Hall. King-post truss (Truss A) and A-shaped truss (Truss B)

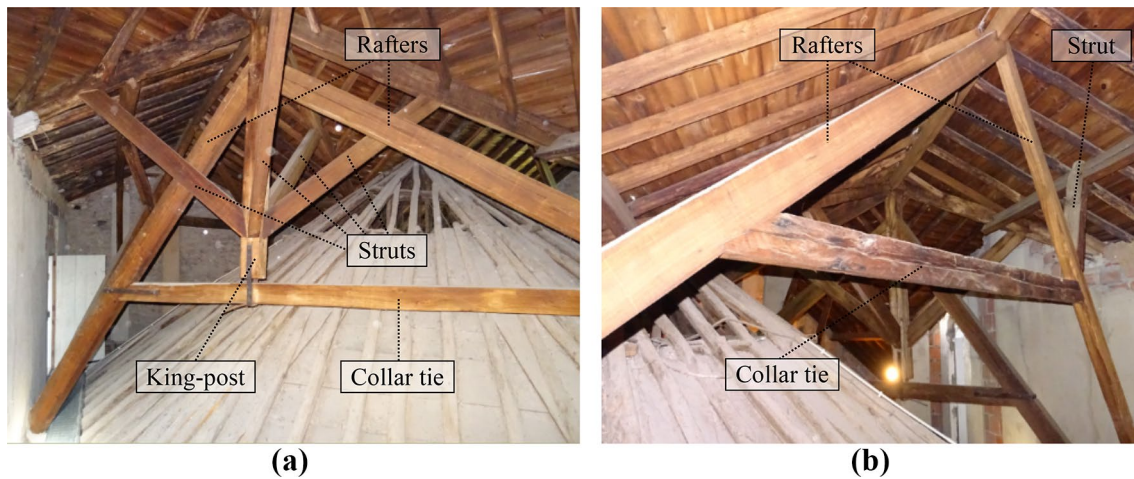
Fig. 11 Components of the king-post truss (a) and the A-shaped truss (b)

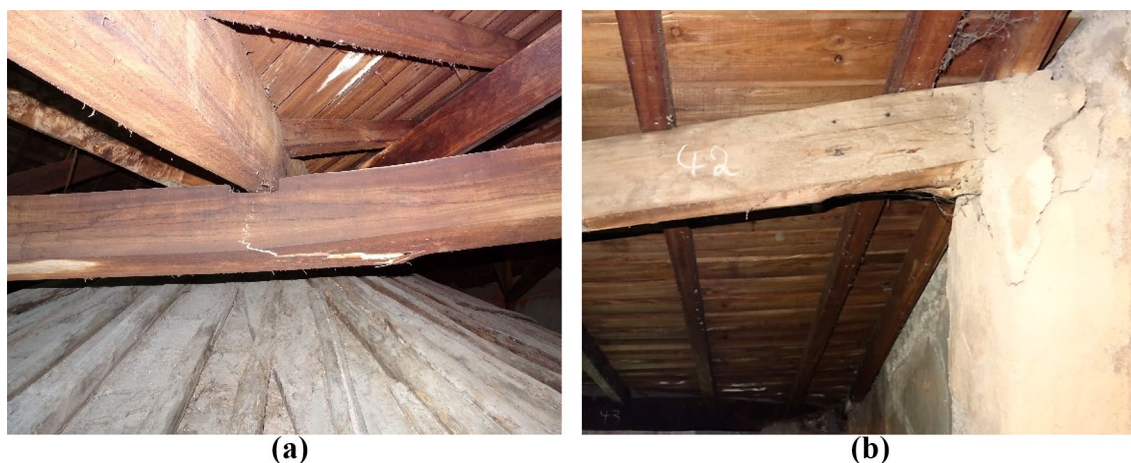
Fig. 13 Tensile crack of the horizontal beam (11) under excessive bending (a). Collapse of the purlin (42) due to the failure of the masonry support (b)

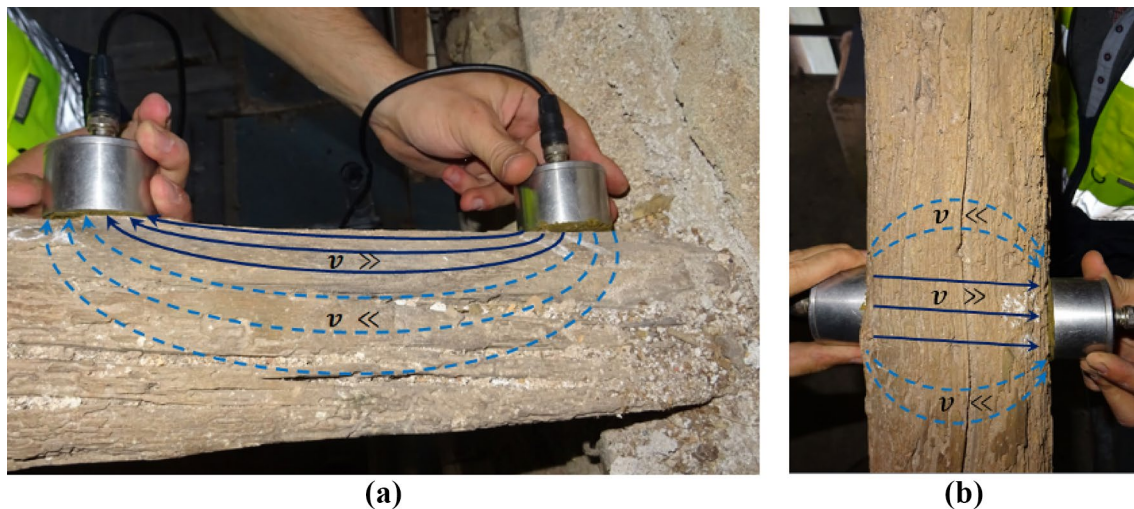
Fig. 14 Wave's propagation with respect to the indirect method parallel to the grain (a) and the direct method perpendicular to the grain (b), through using the equipment Pundit Lab®

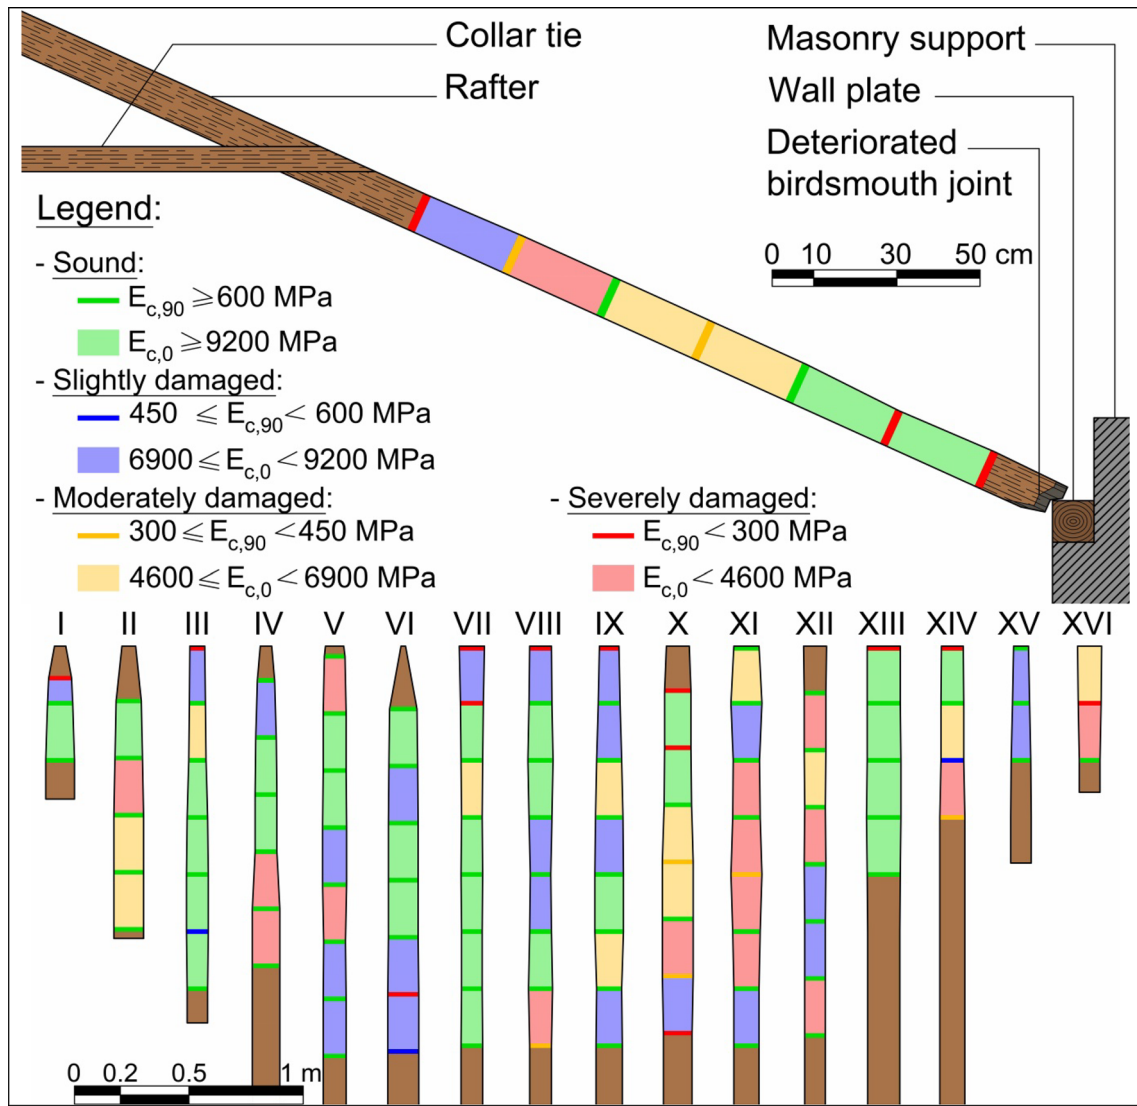
Fig. 15 Classification of external surfaces exposed to biological deteriorations, according to the wood compressive elastic modulus parallel ($E_{c,0}$) and perpendicular ($E_{c,90}$) to the grain, for the rafters in Room 68

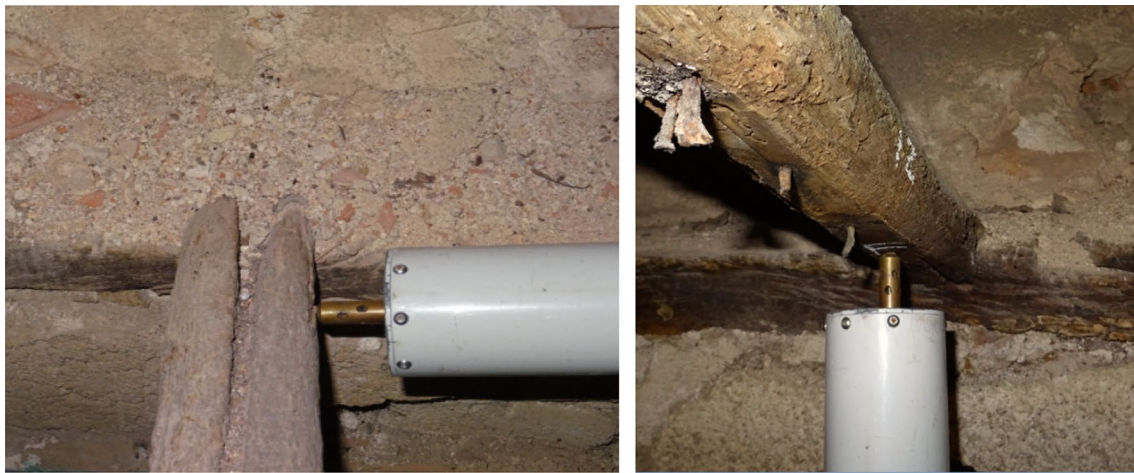
Fig. 16 Resistograph® 3450 RINNTECH used for the drilling resistance tests

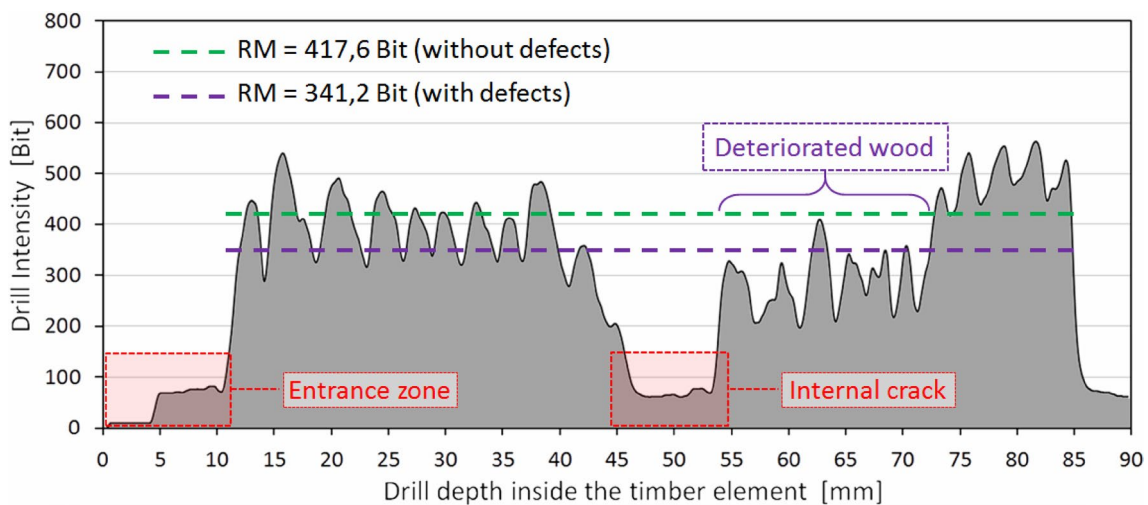
Fig. 17 Drilling resistance graph with respect to the drill penetration depth, including resistance measure (RM) values with and without defects

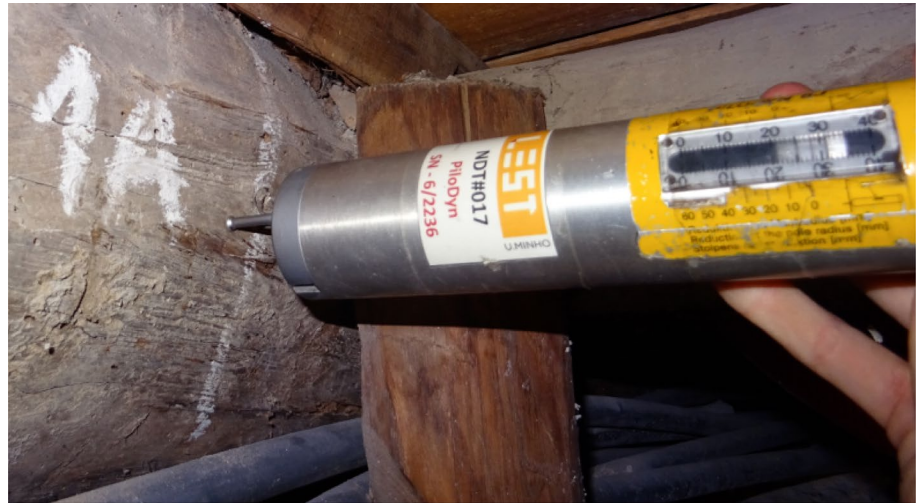
Table 3 Penetration depth of the rod $d_{p,rod}$, wood density ρ and external layer thickness of deteriorated wood t_D , inferred from the impact penetration test in the Knights' Hall

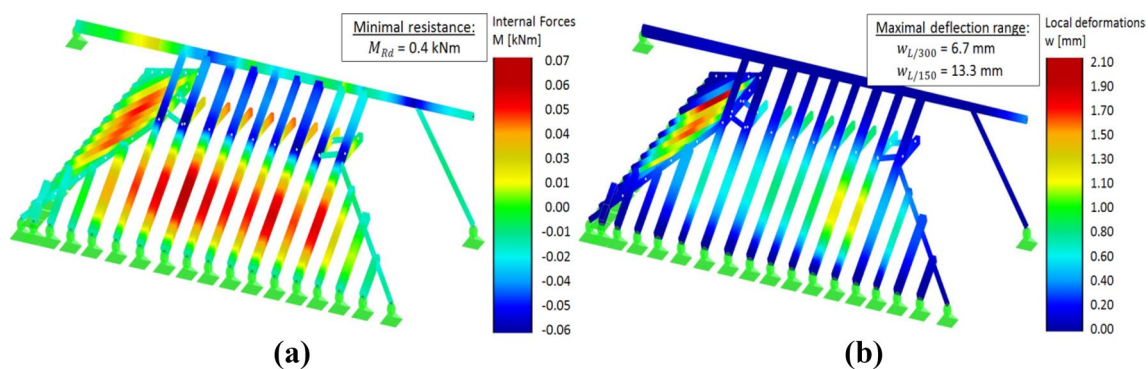
Fig. 19 Internal bending moments (a) and local deflections (b) within the old roof structure in Room 68

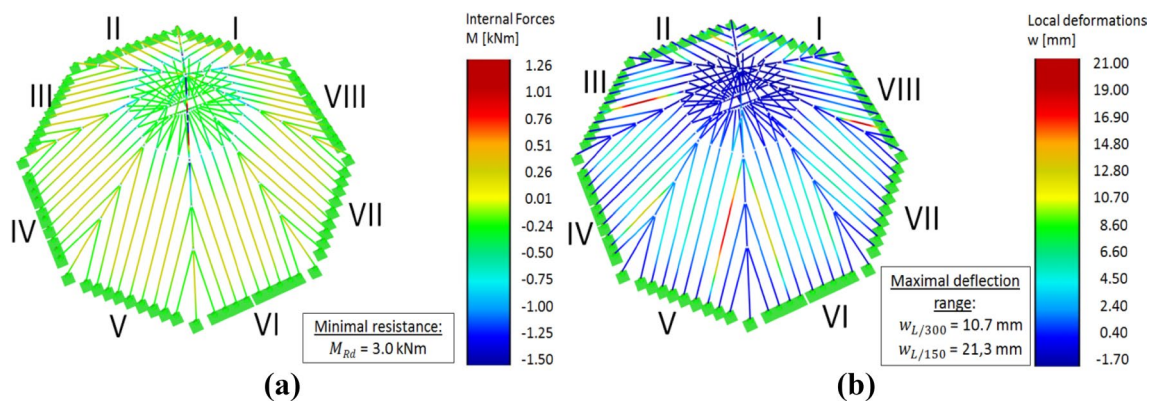
Fig. 21 Internal bending moments (a) and local deflections (b) of the octagonal dome in Knights' Hall

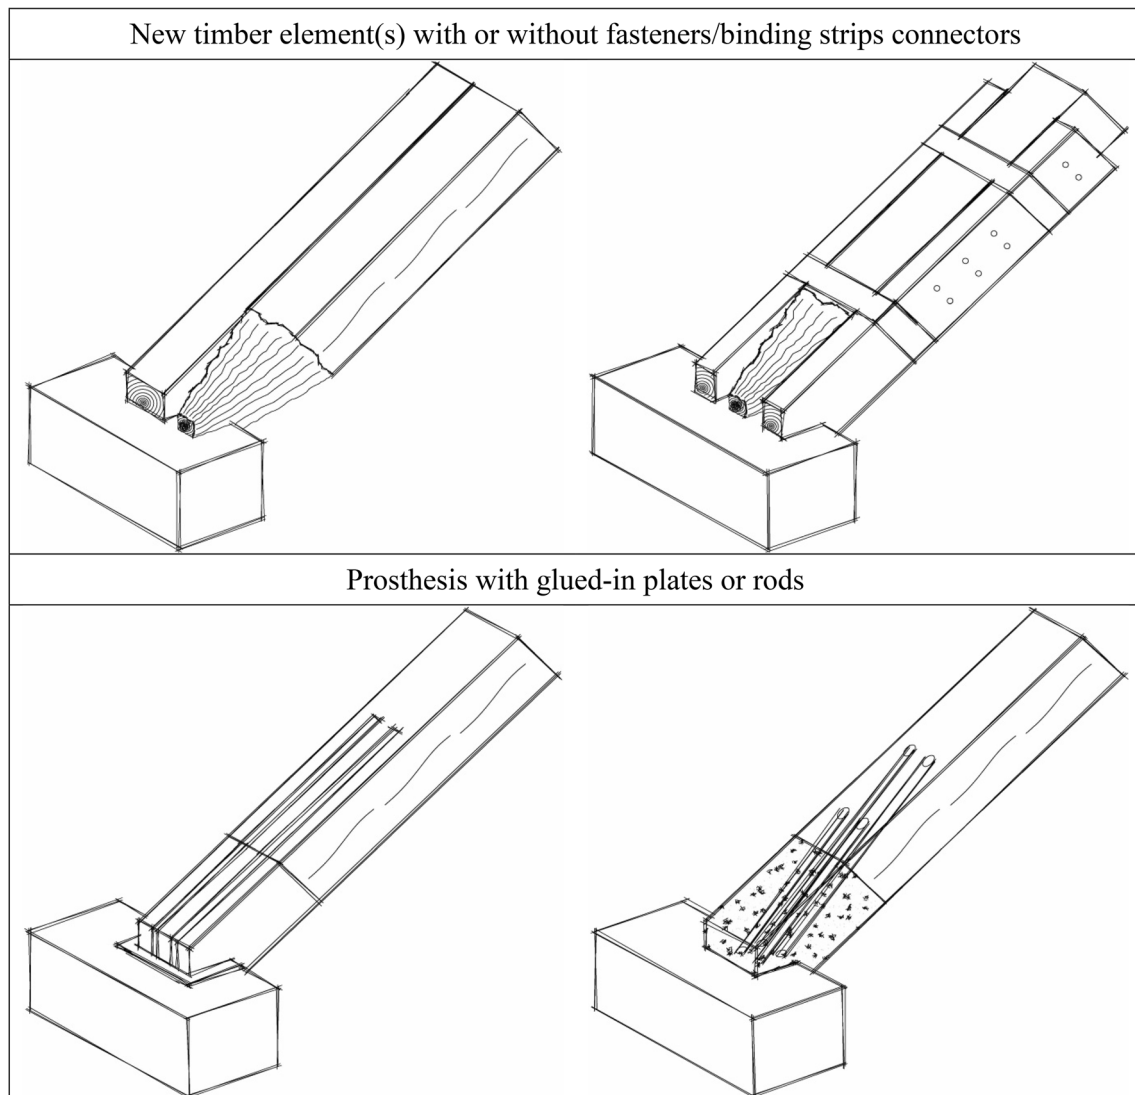
Fig. 22 Techniques to retrofit or repair decayed birdsmouth joints. Adapted from interventions on the decayed timber beam end [36]

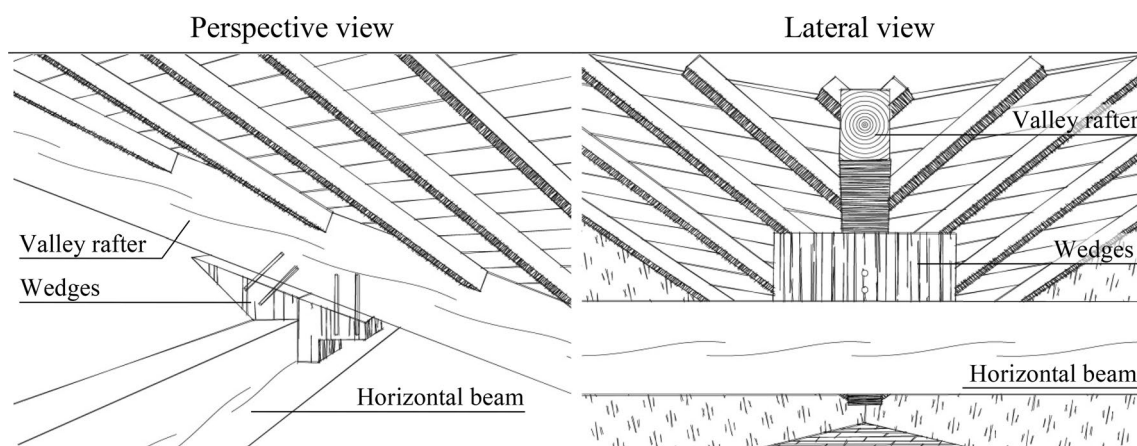
Fig. 24 Substitution of the failed horizontal beam and enhancement of the compressive contact area with the valley rafter
