Metallurgical Analysis of Failed AISI 304L Stainless Steel Tubes Used in Launch Vehicle Applications

Abstract Two numbers of AISI 304L stainless steel tubes with Ø6 and Ø4 mm used in pressurisation system module of a liquid engine of a satellite launch vehicle were found to crack after the qualification level random vibration test. The module has undergone resonance survey, sinusoidal vibration, and random vibration along two different axes before the occurrence of failure. The tubes failed during third-axis random vibration test. The failed tubes were subjected to detailed metallurgical analysis to understand the reasons for failure. The location of failure in both tubes was at the cross-section change area in the nipple. Cross-section change was provided in the design to reduce the diameter of the nipple to suit to tube diameter for welding. The cross-section change in the nipple acted as stress concentration resulting in the initiation of fatigue cracks. The presence of sharp-cornered inclusions in the material helped easy crack initiation. Smaller radius and angle at the weld–parent interface resulted in additional stress concentration. The presence of striations on the fractu

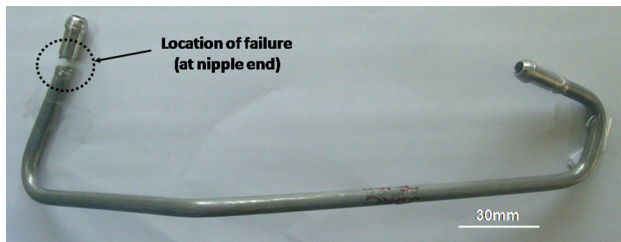
**Fig. 1** Photograph showing the full view of the failed Ø6 tube

The AISI 304L stainless steel tubes of Ø6 and Ø4 mm which failed during the vibration test were visually observed for details with respect to location of cracking. The failure was near to the weld joint (Figs. 1, 2, 3 and 4). Observations on Ø6 mm tube indicated that the primary crack initiated at the cross-section change area of the nipple and propagated partially in the plane of cross-section change area but deviated toward the weld side of the nipple (Fig. 2). On the other hand, in the case of Ø4 mm tube, the crack initiated at the cross-section change area of nipple and propagated in the same plane. In this case, no deviation of crack path was observed (Fig. 4).

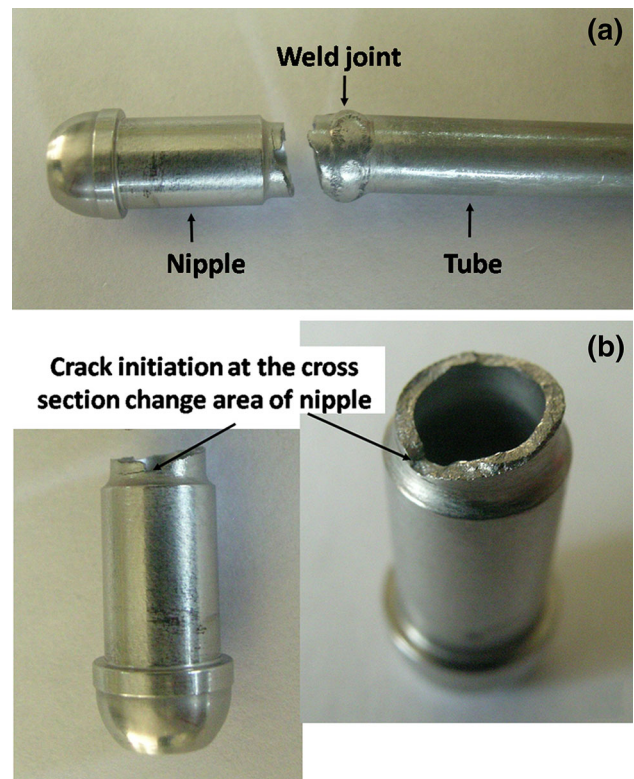
**Fig. 2** Photograph showing the location of the failure in Ø6 tube

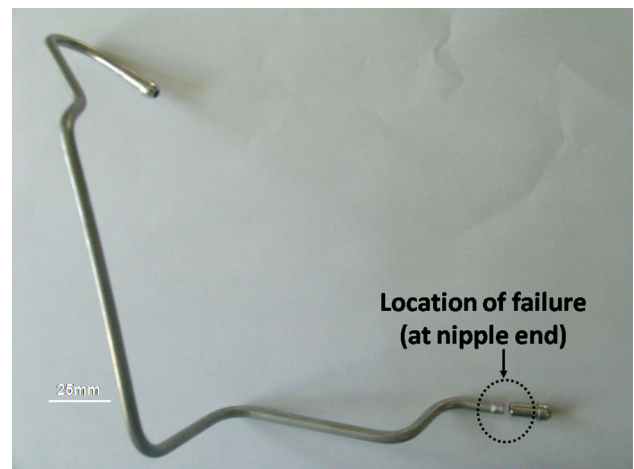
**Fig. 3** Photograph showing the full view of the failed Ø4 tube

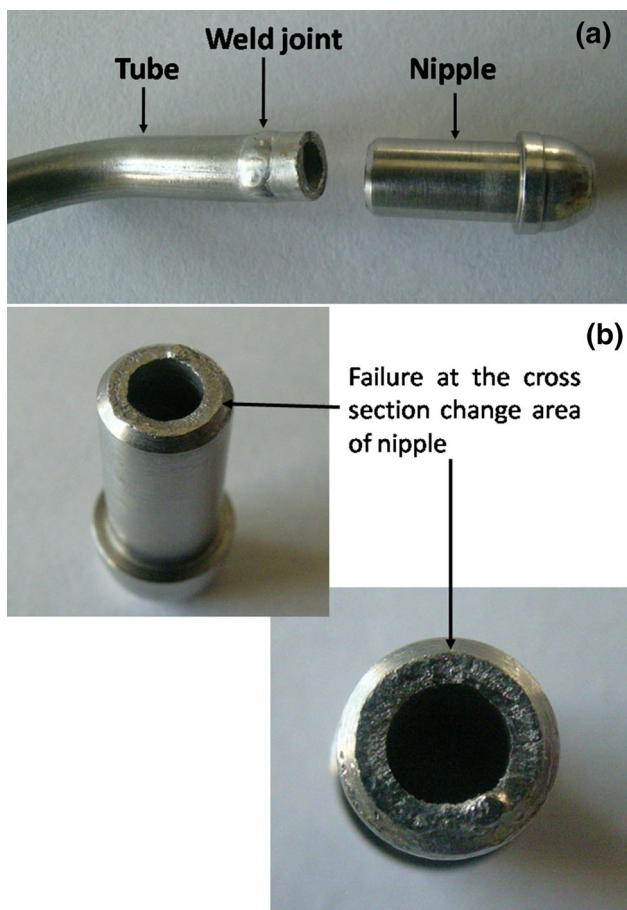
Fig. 4 Photograph showing the location of the failure in Ø4 tube

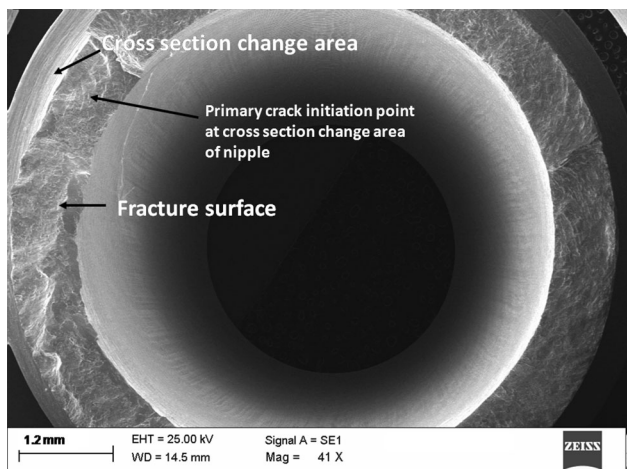
Fig. 5 SEM photograph showing the overall view of fracture surface of Ø6 nipple. The primary crack initiation can be seen on inner surface of nipple

the same plane and subsequent deviation of fracture path toward weld side of the nipple (Fig. 5). However, the observation on the Ø4 mm nipple indicated that the fracture initiation and propagation on the plane of the cross-section change area only (Fig. 6).

Ø6 mm tube, the primary crack was initiated at the cross-section change area and deviated in its path during propagation. However, in case of Ø4 mm tube, the crack initiated at cross-section change area and propagated in the same plane. The crack path deviation observed in Ø6 mm joint could be related to the presence of sharp-cornered non-metallic inclusions in the material.

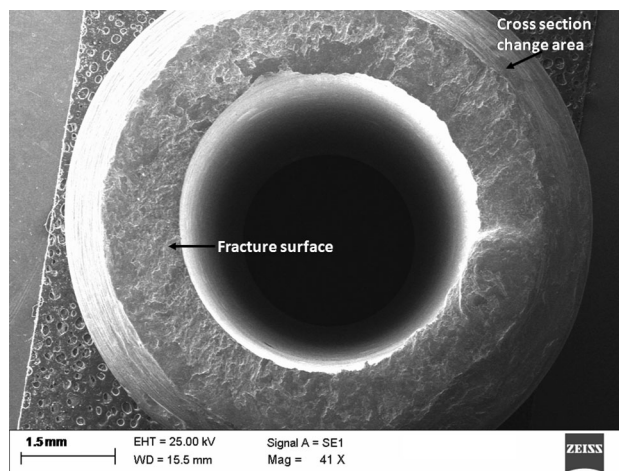
Fig. 6 SEM photograph showing the overall view of fracture surface of Ø4 nipple. Fracture initiation and propagation at the cross-section change area

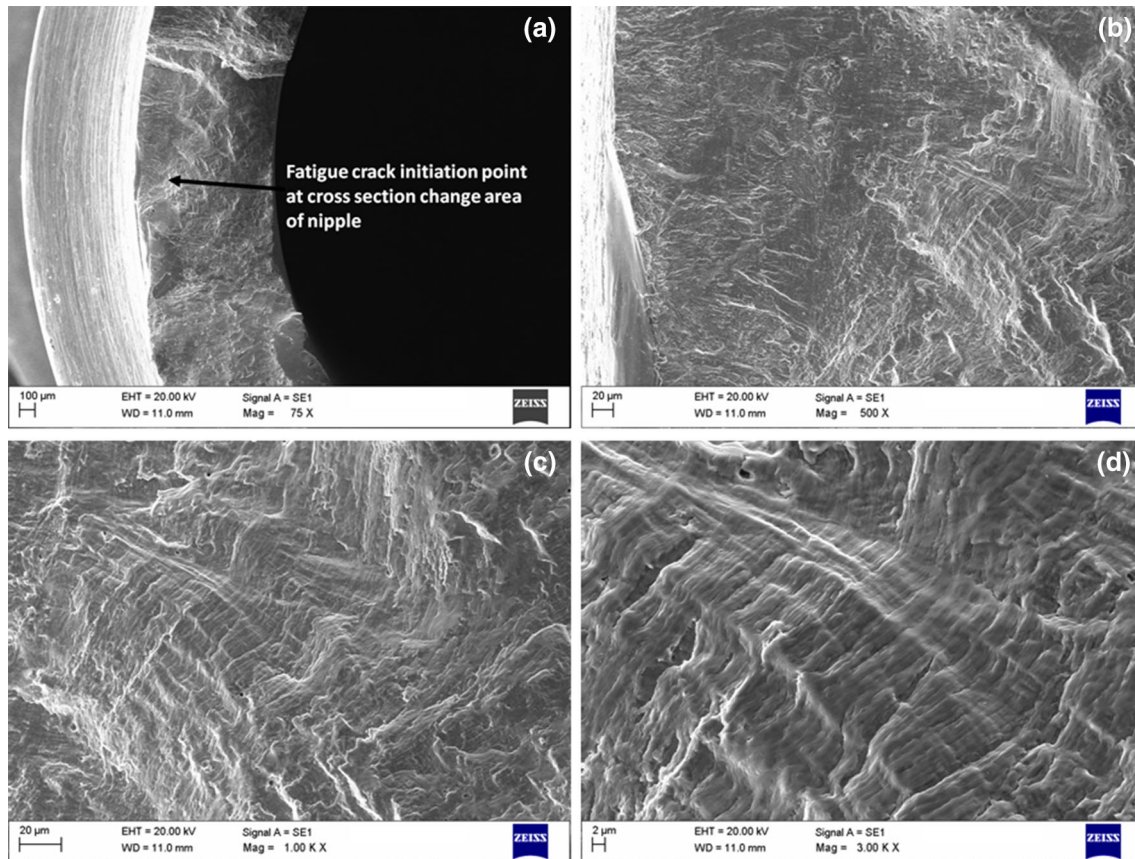
The observation on fracture surface of Ø6 mm nipple revealed the fatigue crack initiation from outer diameter side of the nipple and fatigue striations were observed at crack initiation (Fig. 7). The inclusions were also present at the location of crack initiation (Fig. 8). Fractographic observations at different areas clearly revealed the presence of fatigue striations throughout the fracture surface (Fig. 9). Micro cracks were also observed at several regions of striations (Fig. 10). Some of the striated areas indicated that the secondary cracks initiated at the sharp-cornered inclusions on the fracture surface of Ø6 mm nipple (Fig. 11). The presence of dimples on small area is attributed to the last ligament of the material which failed due to overload (Fig. 12).

Fig. 7 SEM photograph showing the features on fracture surface of Ø6 nipple at fatigue crack initiation location at different magnifications

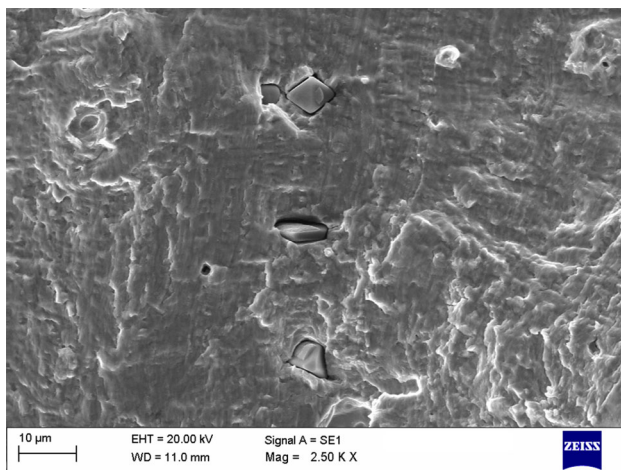
Fig. 8 The presence of non-metallic inclusions at crack initiation location of Ø6 nipple

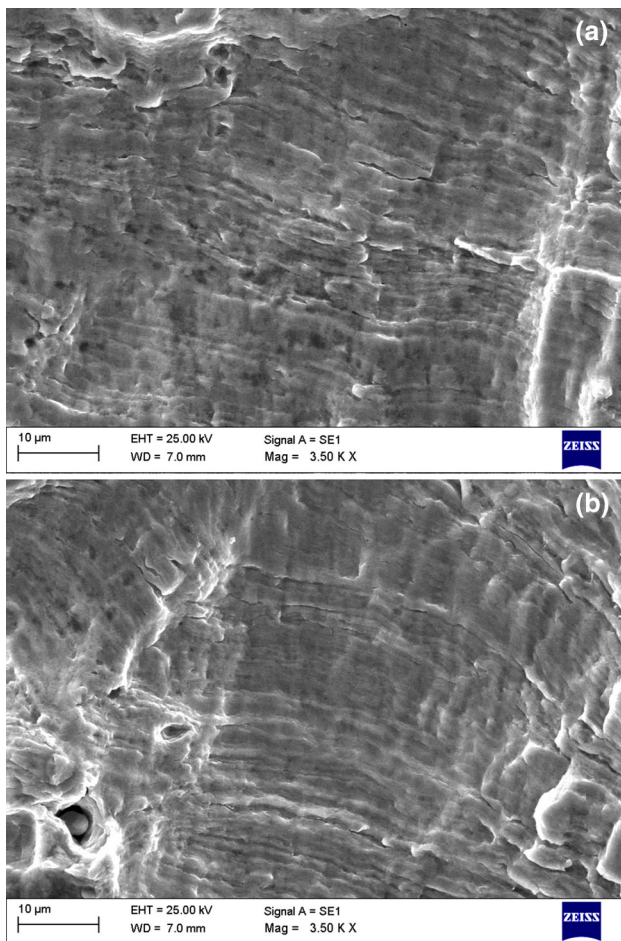
Fig. 9 SEM photograph showing the fatigue striations on fracture surface of Ø6 nipple

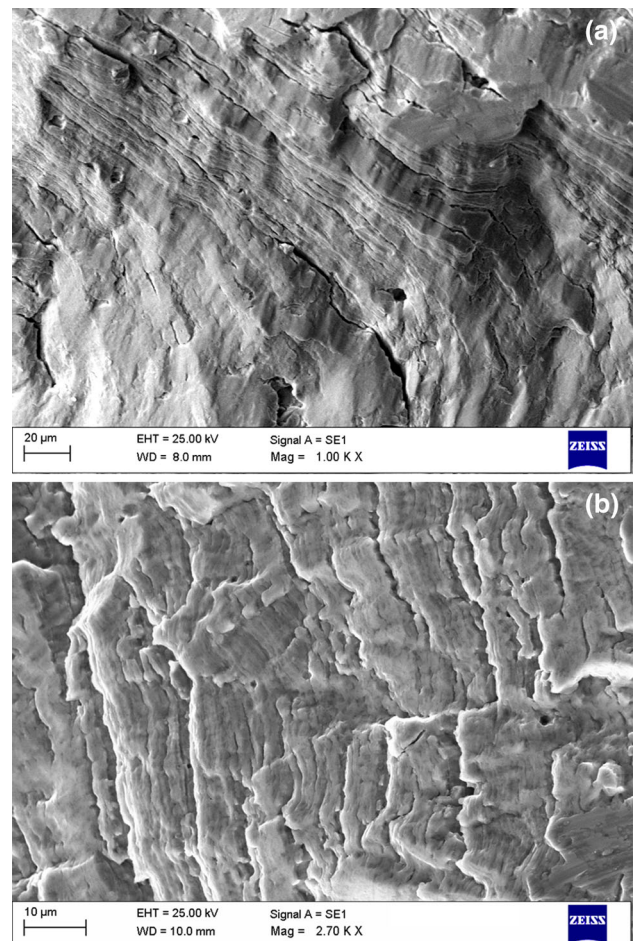
Fig. 10 SEM photograph showing the microcracks at the fatigue striations on fracture surface of Ø6 nipple

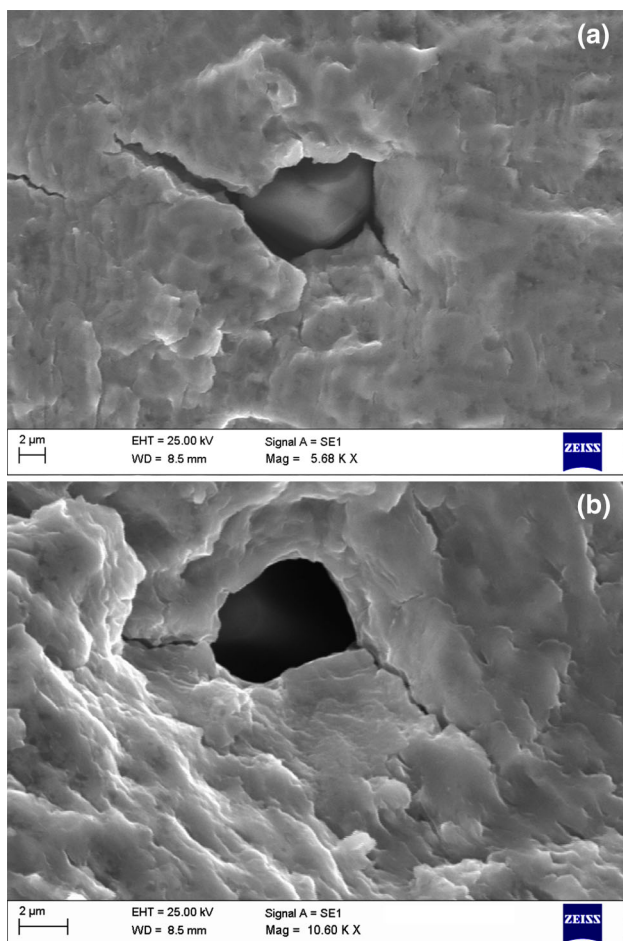
Fig. 11 SEM photograph showing the secondary cracks initiating at the sharp-cornered inclusions present on the fracture surface of $\varnothing 6$ nipple

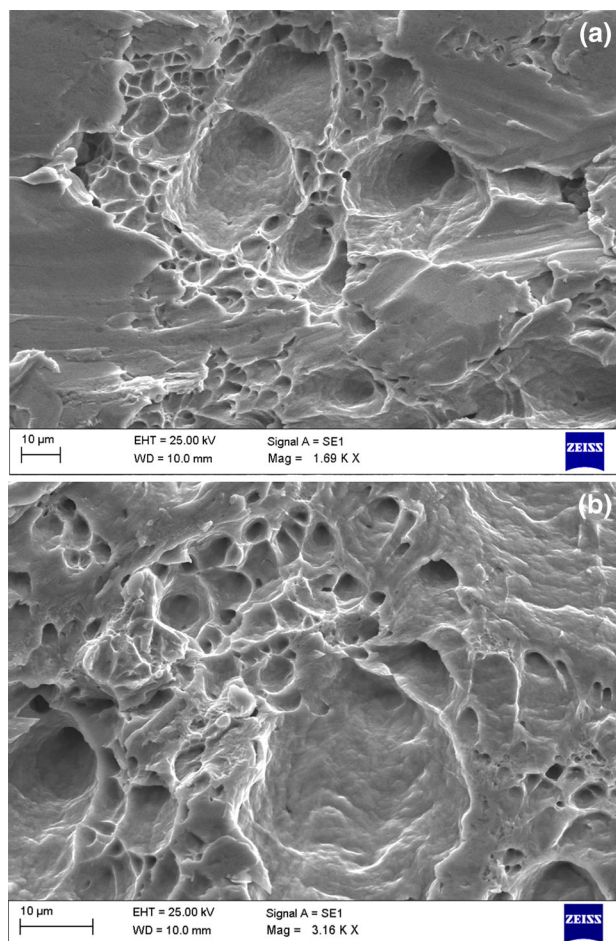
Fig. 12 SEM photograph showing the dimples on the small area of fracture surface of $\varnothing 6$ nipple, which failed at last due to overload

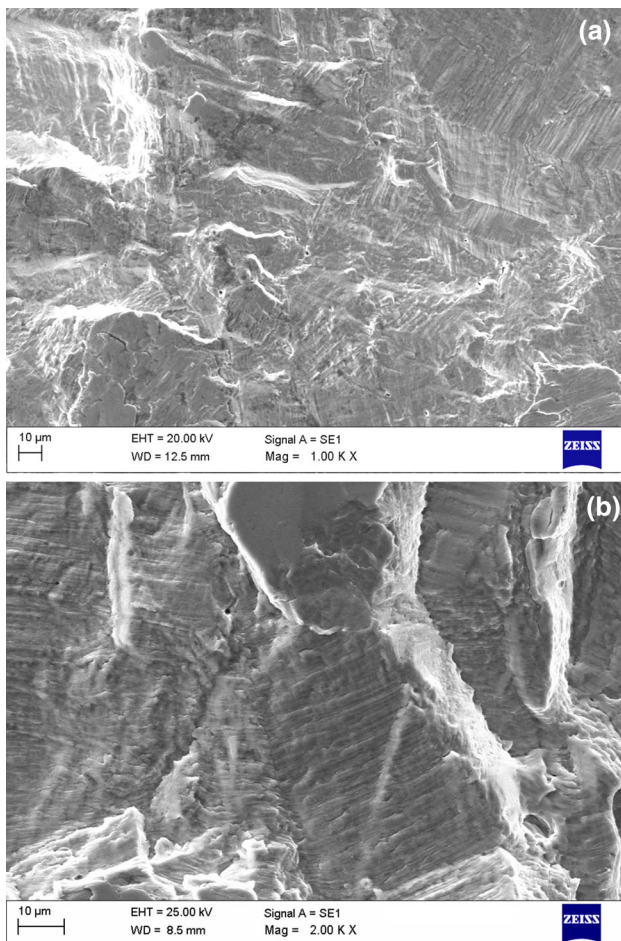
The fatigue crack origin on fracture surface of Ø4 mm nipple could not be located as a significant area of fracture surface was damaged due to mechanical rubbing after failure. However, fatigue striations could be observed throughout the undamaged areas on the fracture surface (Fig. 13). Micro cracks were also observed at several regions of fatigue striations (Fig. 14).

Fig. 13 SEM photograph showing the fatigue striations on fracture surface of Ø4 nipple

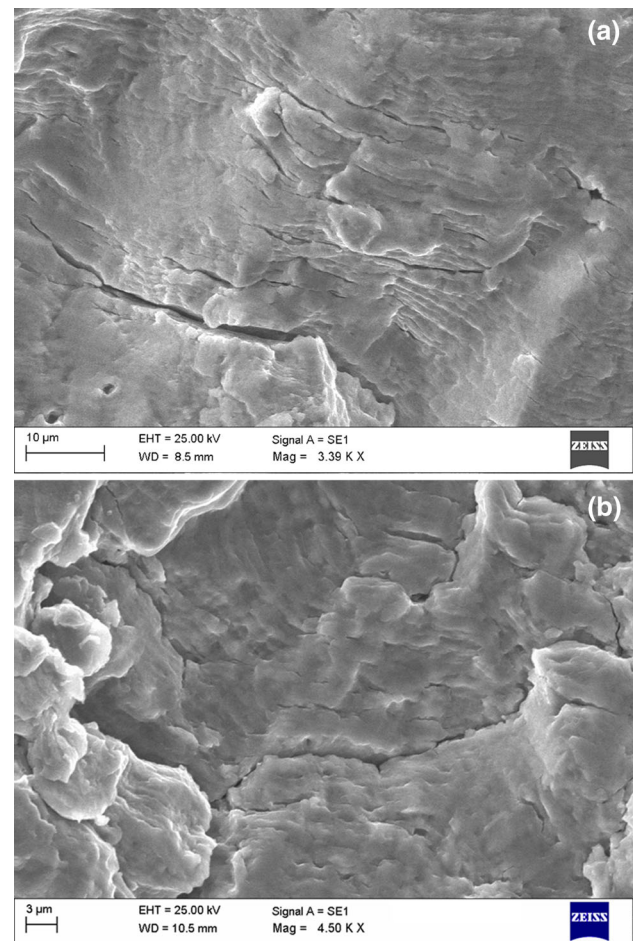
Fig. 14 SEM photograph showing the microcracks at the fatigue striations on fracture surface of Ø4 nipple

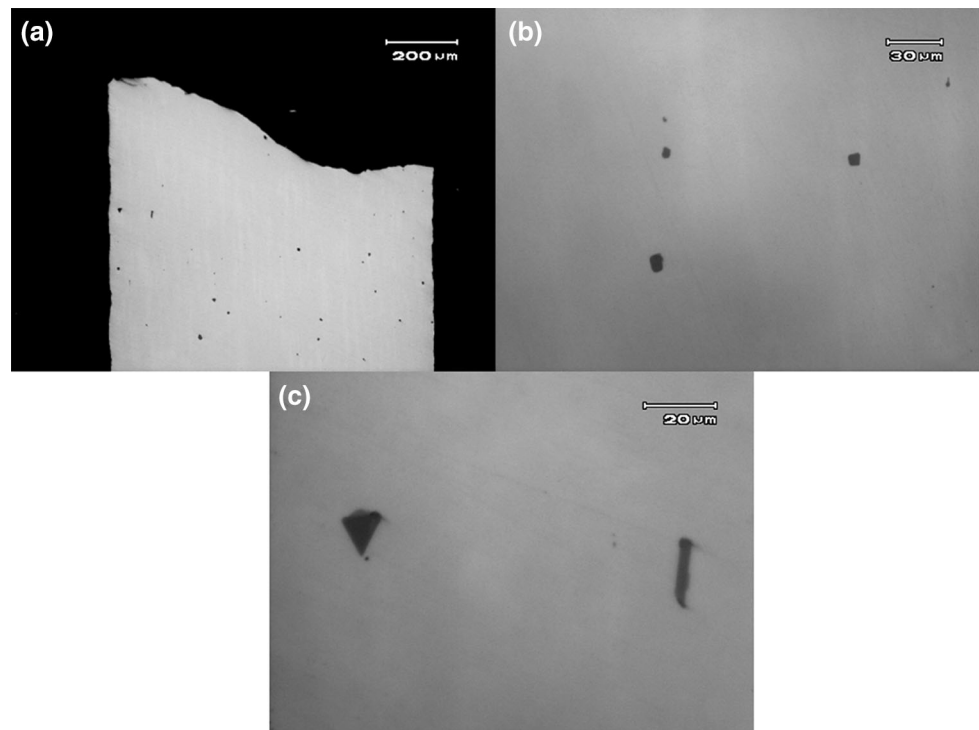
Optical microscopic observations on the unetched specimen of Ø6 and Ø4 mm nipple indicated a large number of sharp-cornered inclusions as shown in Fig. 15. The EDS analysis on the sharp-cornered inclusions and globular inclusions indicated similar chemical composition. The size of inclusions was in the range of 8–10 µm. The chemical composition of inclusions corresponds to the mixed oxide type inclusion (Fig. 16). Observations at the weld joint indicated the presence of a micro crack at weld–parent interface in Ø6 mm joint, whereas no cracks were observed at weld–parent interface in Ø4 mm joint (Fig. 17). Large variation in weld bead thickness was observed between Ø6 and Ø4 mm tube joint as shown in Fig. 17. The weld bead thickness in Ø6 mm plumbing joint was 3 times the tube wall thickness, whereas Ø4 mm plumbing joint has weld bead thickness 1.5 times the tube wall thickness. The angle between the weld bead and parent was measured to be 105° in case of Ø6 mm joint and 150° in Ø4 mm joint (Fig. 18). The radius at the weld–parent interface was found to be 66 µm in Ø6 mm tube

present case, the sharp-cornered inclusions were present in the material, which can easily initiate the crack or deviate the crack path as in case of Ø6 mm plumbing. The crack path deviation could be related to the presence of sharp inclusions at the path of primary crack.

Fig. 15 Optical photomicrographs showing the large nos. sharp-cornered inclusions present in the material $\text{\O}6$ nipple

surface finish at the cross-section change area should be ensured and should be free of tooling marks. Alternatively, the design of the tube joint can be modified to remove the cross-section change. A sufficiently large radius and angle should be ensured at weld–parent interface to reduce the stress concentration at weld joint. The raw material used for fabricating tubes should be microstructurally cleaner with respect to the sharp-cornered inclusions as they contribute to easy crack initiation are more detrimental to the fatigue loading conditions.

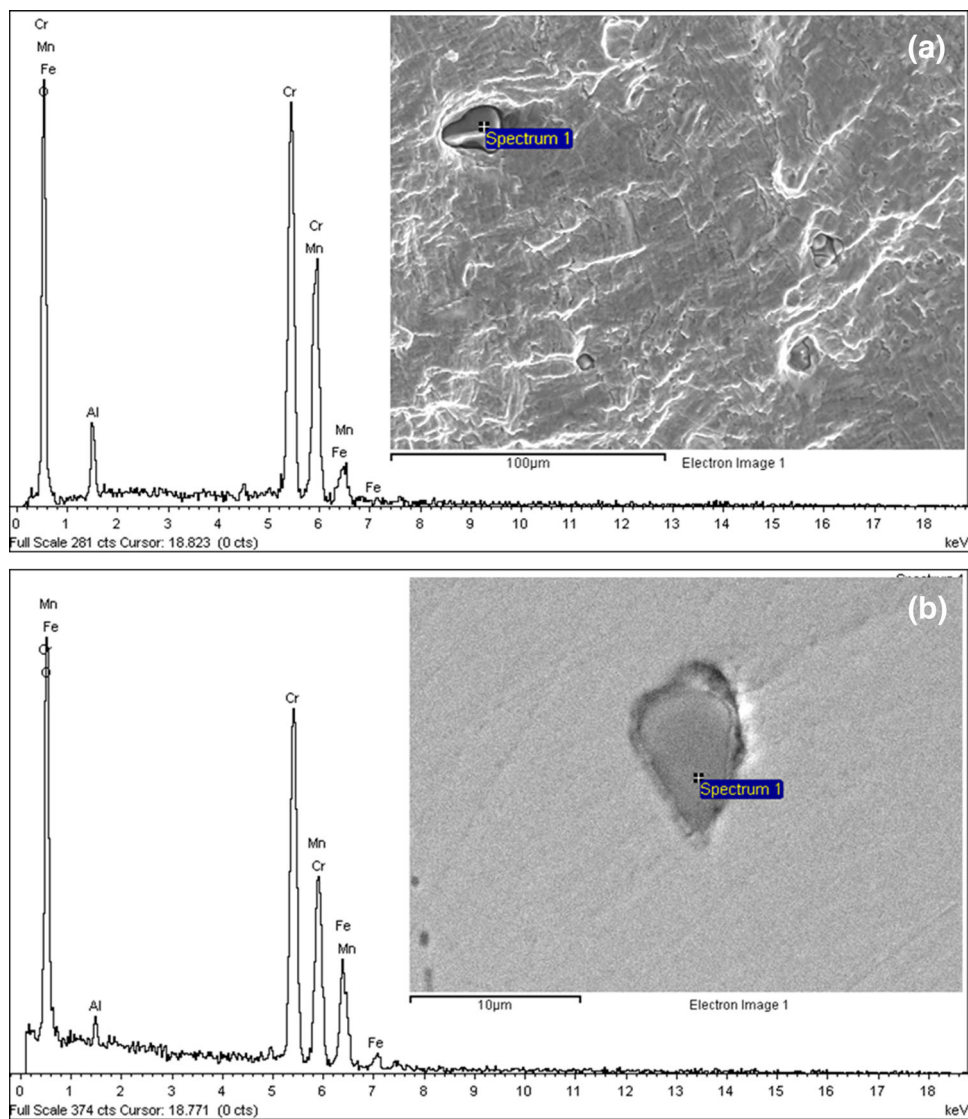
dynamic loading conditions [5]. In the present case, no exogenous inclusions were found. The inclusions were indigenous in nature as confirmed by the EDS analysis, indicating the composition of inclusions consisted of mixed oxide of Cr, Mn, Fe, and Al (Fig. 16 a and b).

Fig. 16 EDS spectrum showing the chemical composition of the inclusion on the fracture surface (a) and polished surface (b) of Ø6 nipple

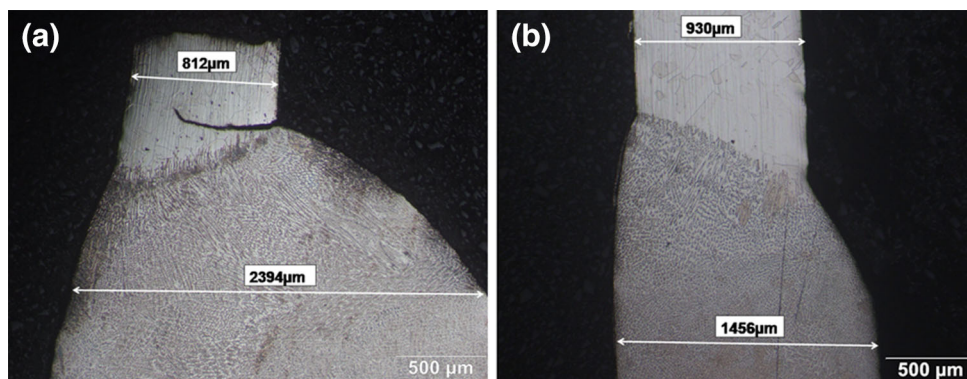
The presence of micro crack in Ø6 mm tube joint near to the primary fracture surface at weld–parent interface could be due to the additional region of stress concentration. In Ø6 mm plumbing the weld bead thickness was about 3 times the parent tube wall thickness and it leads to the lower angle (105°) between weld bead and parent. This also resulted in less radius of curvature (66 µm) at weld–parent interface. In case Ø4 mm plumbing where the weld bead thickness was 1.5 times the parent tube wall thickness resulted in higher angle (150°) between weld bead and parent and higher radius of curvature (455 µm). In butt

Fig. 17 Optical photomicrographs showing large variation in weld bead thickness between Ø6 mm (a) and Ø4 mm (b) tube joint

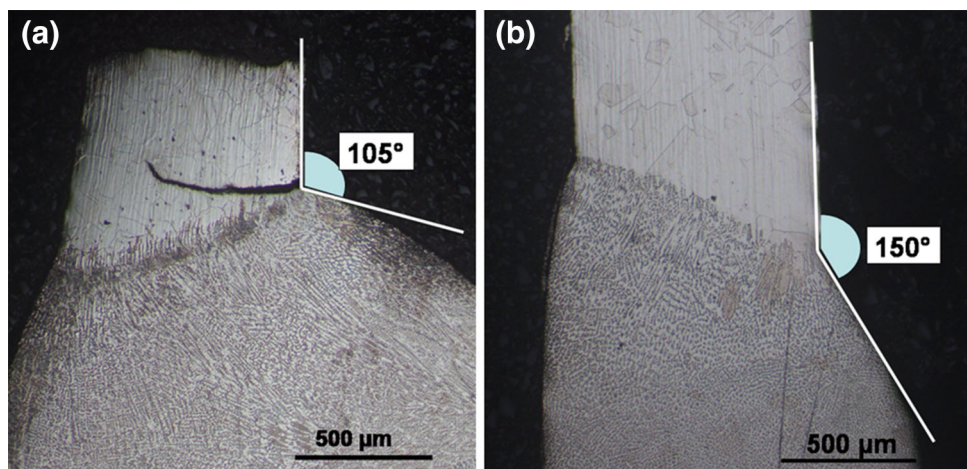
welded joints, the angle at weld–parent interface is a measure of stress concentration at the interface and higher stress concentration reduces the fatigue strength [10]. The lower angle and less radius of curvature at the weld–parent interface increases the fatigue stress concentration factor [11, 12].

Fig. 18 Optical photomicrographs showing angle between weld bead and parent in Ø6 mm (a) and Ø4 mm (b) tube joint

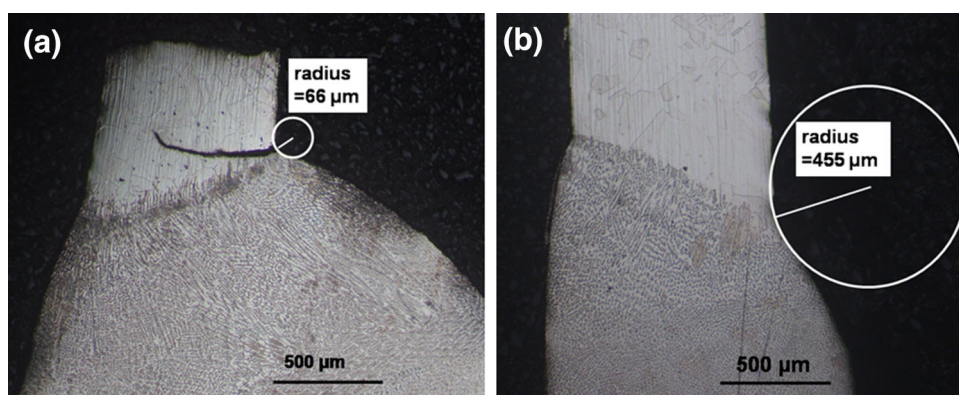
joint, whereas the radius in Ø4 mm tube joint was 455 µm (Fig. 19). The microstructural observations at the fracture edge revealed the presence of slip bands formed due to fatigue (Fig. 20). Microstructure consisted of austenite grain structure typical of AISI 304L stainless steel.

Fig. 19 Optical photomicrographs showing the radius at weld–parent interface in Ø6 mm (a) and Ø4 mm (b) tube joint

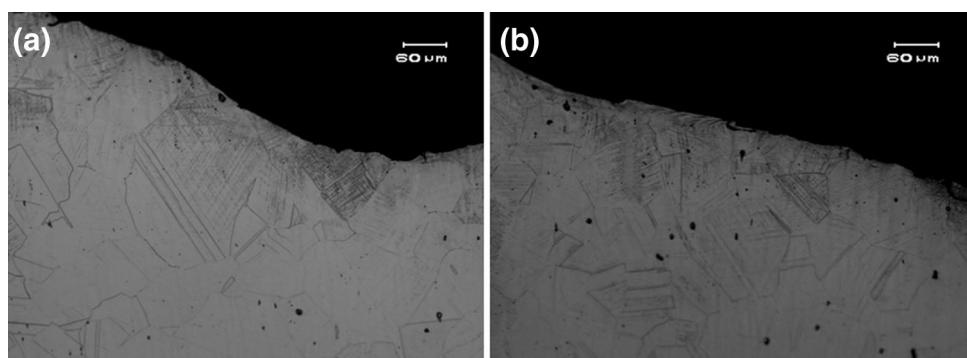
Fig. 20 Optical photomicrographs showing the presence of slip bands near to the fracture edge of Ø6 nipple
