# Sterilization of Dry-Type Transformer Winding by Conducting Short-Circuit Test in Nuclear Power Plant: A Case Study

Kudiyarasan Swamynathan<sup>1</sup> · A. Singadurai<sup>1</sup> · P. Sivakumar<sup>1</sup>

Received: 18 August 2020 / Accepted: 16 June 2021 / Published online: 30 June 2021  
© The Institution of Engineers (India) 2021

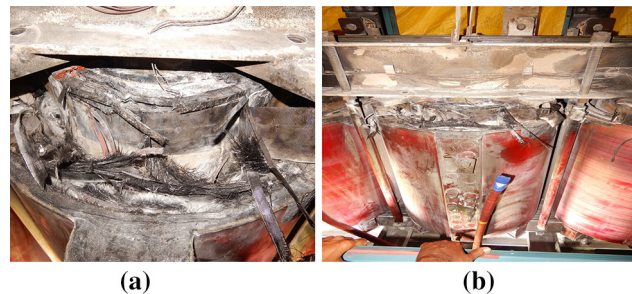
The visual inspection of the failed transformer was carried out. The as-found condition is shown in Fig. 2a, b.

In first preliminary view, a flashover was occurred due to failure of insulation between turn-to-turn in Y-phase near tapping point which leads to peel off insulation in Y-phase of the transformer as shown in Fig. 2a, b. After visual inspection, the winding resistance and insulation resistance were measured, and corresponding factory results are given in Table 1.

The above test results were compared with factory test (2010) reports and latest preventive maintenance records (2020) and found matching for R and B phases. However, for Y phase, it was found that winding between tap position 2 and 6/7/8 was found open. Further, on physical checking of burnt insulation at top of the winding, few winding strips were found in snapped condition. There might have been partial discharge inside Y-phase insulation and inter-turn fault near tapping position in Y phase winding due to insulation deterioration. The sealing of HT cable entry as well as control cable entry to the transformer and sealing arrangement for the LT bus duct at the top of the transformer were all found to be intact indicating the source of fire is from the transformer due to partial discharge. For further analysis, yearly preventive maintenance records were reviewed for checking if there were any leads. Interestingly, the images shown in Fig. 3a–d, taken on the transformer for clearing the functional test of a thermal imaging camera, were recalled and were studied now. Figure 3d clearly shows a slight sign of higher temperature in the Y-phase compared to other two phases [6, 7].

**Fig. 2** a Failure of the insulation that came out from the transformer Y-phase winding. b Failed Y-phase winding insulation and winding top side view

In the present failed transformer, the moisture was found to be deposited over the surface. Cleaning with cloth does not help much due to fine undulation and surface pores. Use of cleaning agent is effective only when resin temperature is increased. The gaps between winding can be cleaned only by a custom made sponge. Hence, heating of transformer is mandatory. The heating methods are

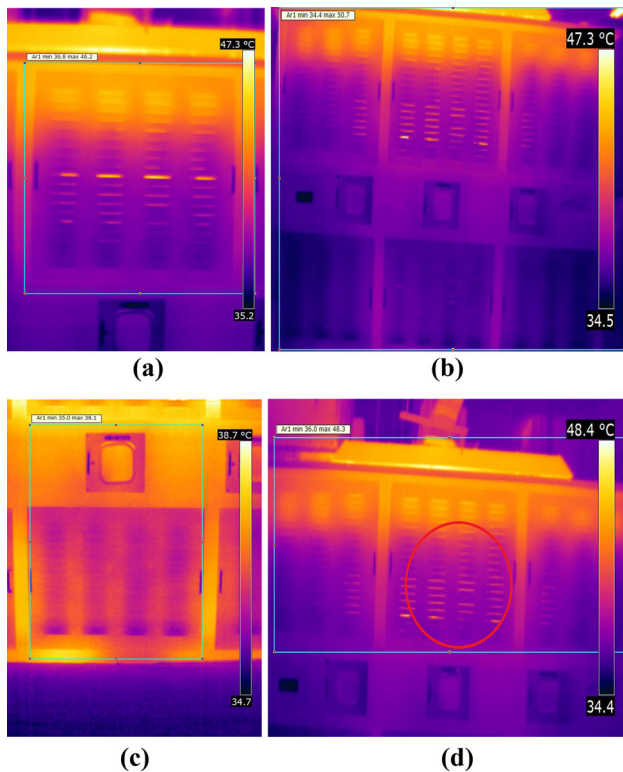
**Fig. 3** **a** Thermal image of one phase of the transformer with upper half side, **b** thermal image of the all the three phase of the transformer, **c** thermal image of one phase of the transformer with lower half side, **d** thermal image of all the three phase upper half of the transformer

described below. Thermal imaging of transformer is recommended as a good maintenance practice.

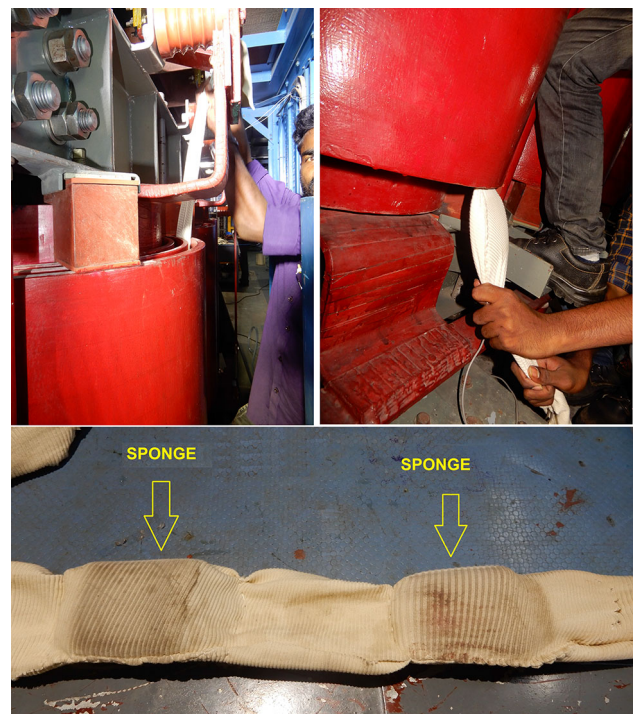
**Fig. 4** Cleaning of the transformer winding using special cloth arrangement with sponge at higher temperature

A special cloth arrangement with sponge was used to clean the dust between the winding surfaces when it is still

hot. The special cloth should be a baniyan cloth made with 100% cotton, woven type, lint free with high rate of absorbency (< 2 s) and this would be rinsed with Isopropyl Alcohol which is having antibacterial properties, Volatile, colorless liquid with a sharp musty odor like rubbing alcohol. Figure 4 shows the method of cleaning the winding. The special cloth with sponge clearly shows the deposit of dust which is removed from the winding surfaces. This is an enhanced method for removing the heavily bonded dust. It is not a conventional method and posed a great challenge since cleaning was carried out in a hot environment.

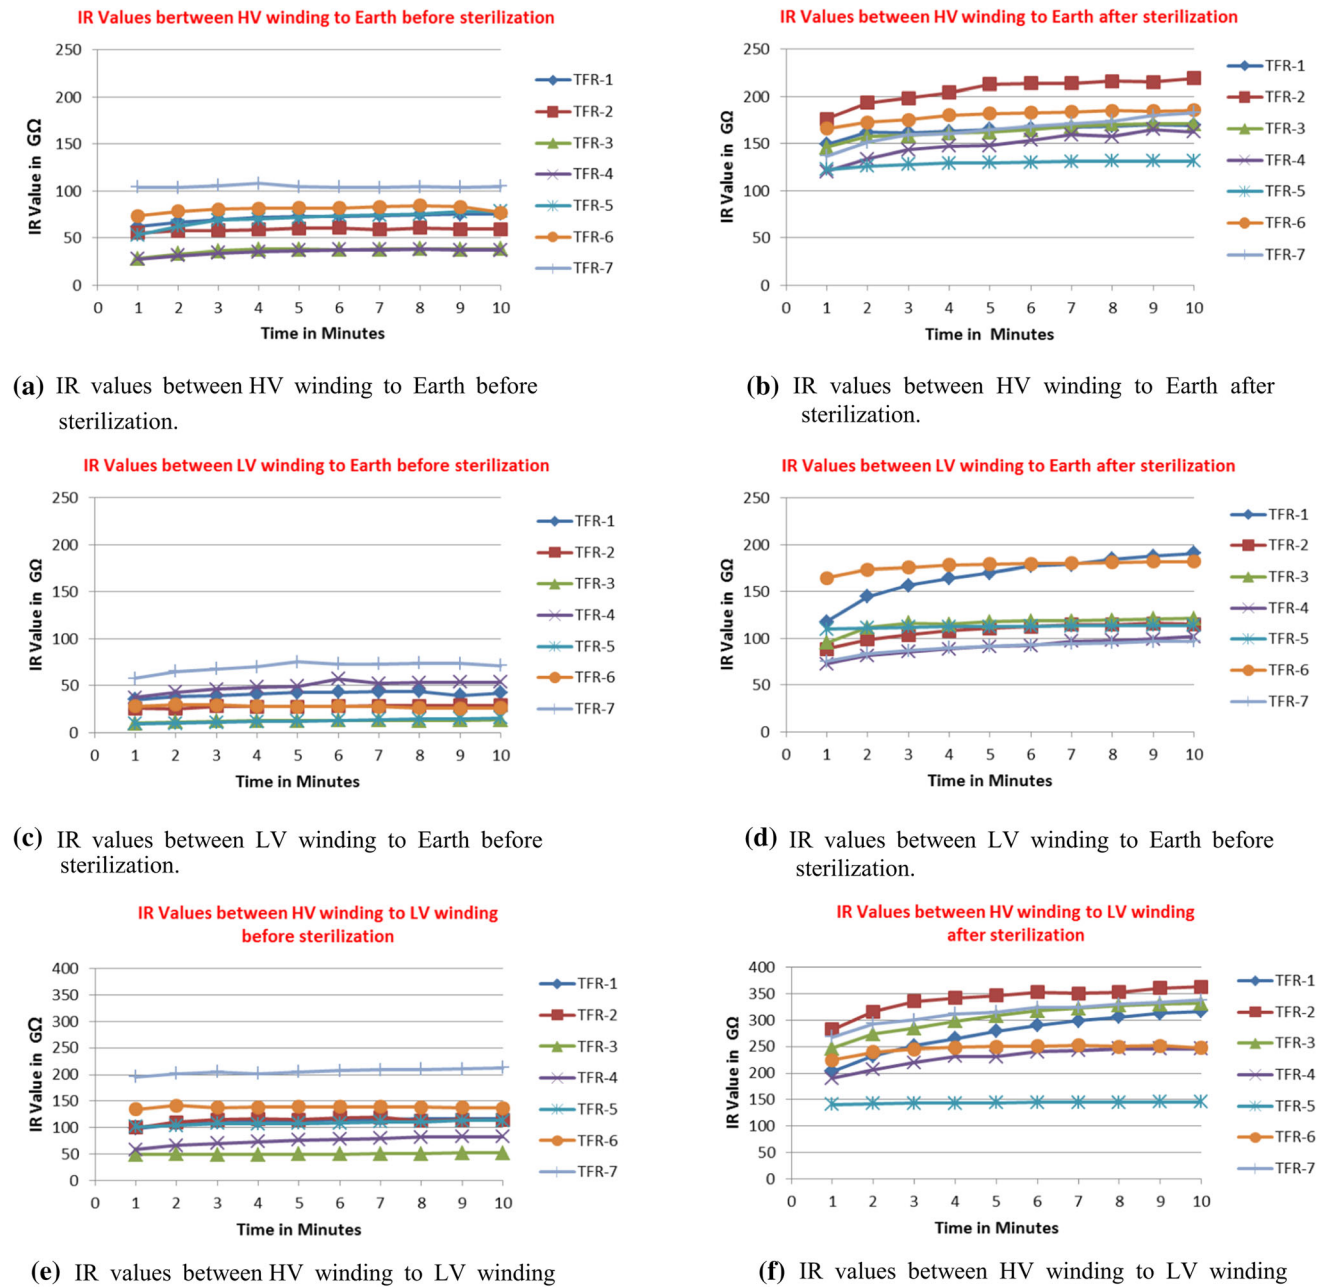
**Fig. 5** **a** IR values between HV winding to Earth before sterilization. **b** IR values between HV winding to Earth after sterilization. **c** IR values between LV winding to Earth before sterilization. **d** IR values between LV winding to earth before sterilization. **e** IR values between HV winding to LV winding before sterilization. **f** IR values between HV winding to LV winding after sterilization

The results observed before and after sterilization was plotted. The insulation resistance is usually measured after 10 min, whereas in our case, it is noted every minute and plotted as graph shown in Fig. 5a–f.

The Insulation resistance values between HV winding to Earth, LV winding to earth and HV winding to LV winding before sterilization are shown in Fig. 5a, c and e, respectively. The corresponding results after sterilization are shown in Fig. 5b, d and f, respectively. The IR values were observed to be doubled after the sterilization process which shows the effectiveness of the procedure in removal of moisture, dust, etc., which could not be cleaned in conventional methods. The above overall results are extraordinary when compared to the conventional methods of heating the windings. The method of taking the insulation resistance values at the end of every minute after sterilization shows gradual increase and becomes steady after few minutes.

This indicates increase in dielectric strength resulting from the formation of dipole and polarization owing to cleaner gaps between winding and core. The resin also is free from moisture and dust which supports the effectiveness of sterilization.

Figure 5c, d brings the effectiveness of the overall process where most of the transformer LV winding to earth values are improved four fold after sterilization process. Normally, cleaning the LV winding inner surface and removing dust and moisture is very difficult, whereas this sterilization technique effectively removes the same and improves the values to an extraordinary level.

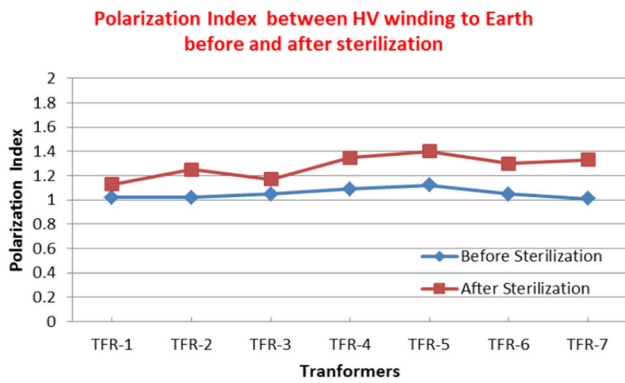
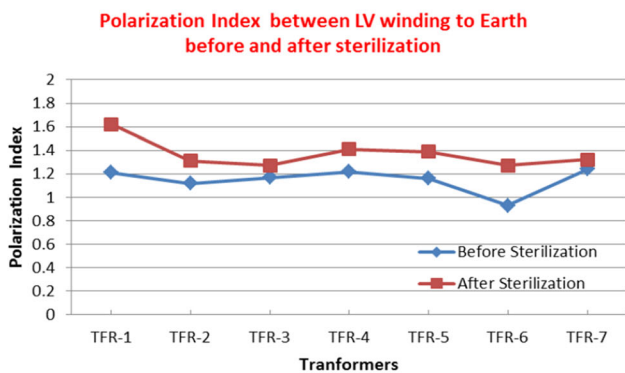
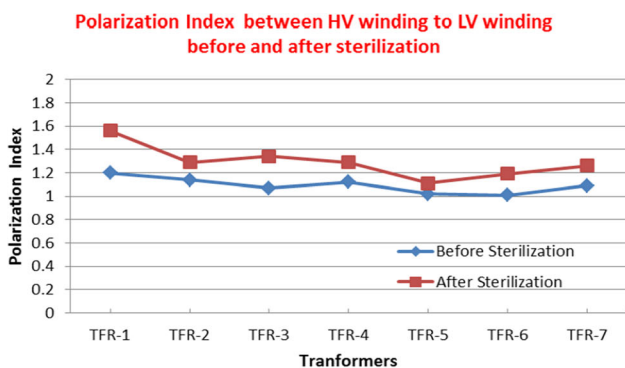
**Fig. 6** a Polarization index values between HV winding to Earth before and after sterilization. b Polarization index values between LV winding to Earth before and after sterilization. c Polarization index values between HV winding to LV winding before and after sterilization

The polarization index gives an indication of the buildup of dirt or moisture, the deterioration of insulation and the feasibility for operating the transformer. Usually, the polarized index indicates the degradation of the insulation. The PI values before and after the sterilization are given in Fig. 6a, HV winding to earth, Fig. 6b, LV winding to earth, Fig. 6c, HV winding to LV winding. After sterilization, there is only a minor change in magnitude which shows that the sterilization process does not have any effect on the insulation of the transformer windings. This improvement in PI values aids in increased transformer life. Measuring capacitance and dissipation/power factor help to determine insulation condition in bushings or between windings. All the tan delta values are subjected to temperature correction done for 20 °C.

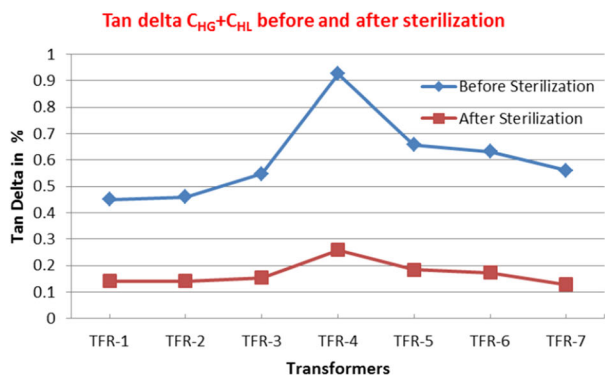
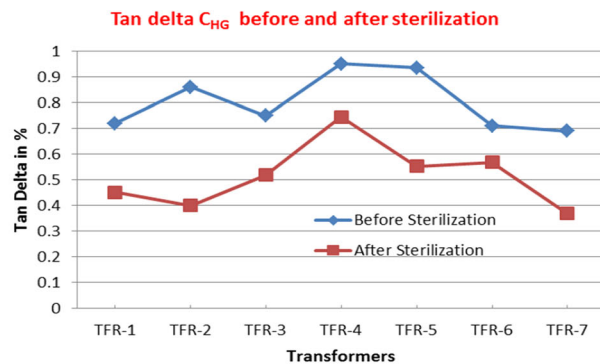
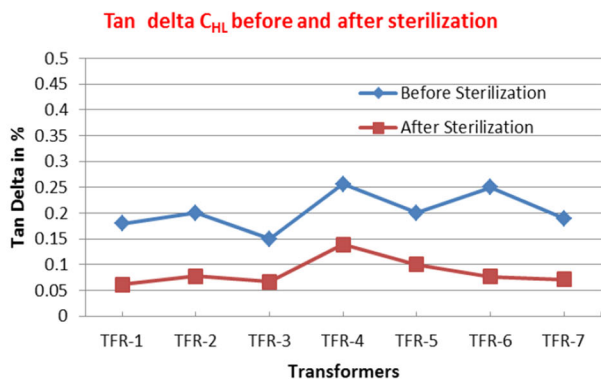
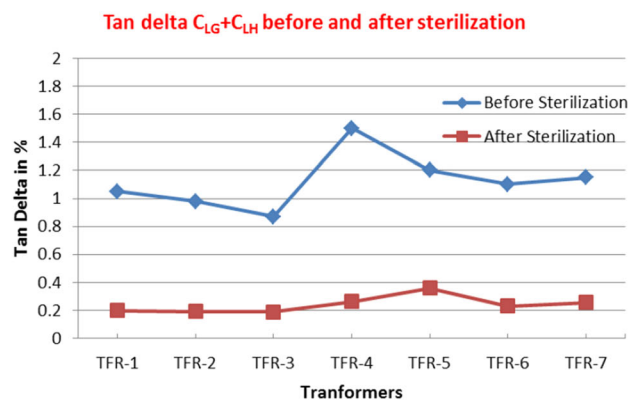
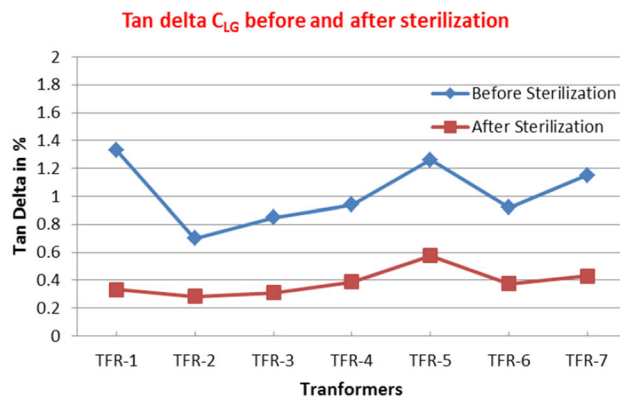
**Fig. 7** a Tan delta value  $C_{HG} + C_{HL}$  before and after sterilization of the transformers. b Tan delta value  $C_{HG}$  before and after sterilization of the transformers. c Tan delta value  $C_{HL}$  before and after sterilization of the transformers. d Tan delta value  $C_{LG} + C_{LH}$  before and after sterilization of the transformers. e Tan delta value  $C_{LG}$  before and after sterilization of the transformers

A tan delta test is special test to know the healthiness of the transformer. Usually, a tan delta test is conducted on an oil cooled-type transformer only [12]. It has been extended to dry-type transformer for a detailed analysis. Figure 7a shows that the tan delta values  $C_{HG} + C_{HL}$  before and after

sterilization indicate a twofold increase. Similarly, increased values after sterilization are observed for other modes such as  $C_{HG}$ ,  $C_{HL}$ ,  $C_{LG} + C_{LH}$  and  $C_{LG}$  as shown in Fig. 7b–e, respectively. Before sterilization, each transformer gives different values but after sterilization all the transformers give almost equal values and low in magnitude which shows good healthiness of the transformers.

The overall results of tan delta test are extraordinary and are a clear indication of improvement in transformer healthiness and extended life in the long run of the plant [13].
