# Geotechnical Aspects of Sikkim Earthquake of September 18, 2011

B. K. Maheshwari · M. L. Sharma ·  
Y. Singh · A. Sinvhal

**Abstract** There was wide spread ground failure and landslide during the recent Sikkim earthquake (Magnitude  $M_L = 6.9$ ) of September 18, 2011. An intensive damage survey was carried out after a week of the earthquake. This paper presents the results of a reconnaissance study in Sikkim. The various geotechnical aspects of the damage caused by earthquake including landslides, failure of retaining walls, foundation failures, damage to roads and creep of soil due to ground shaking have been investigated. The maximum damage was observed in Lachung, North Sikkim district. The paper presents the geotechnical aspects of damages correlating it with level of shaking (intensity on MSK scale) and epicentral distances at different locations. It was found that major damage was due to landslides and failure of retaining walls which in turn are due to movement of soil. In this paper, causes of damages have been investigated and remedial measures, to avoid these in future earthquakes, are suggested.

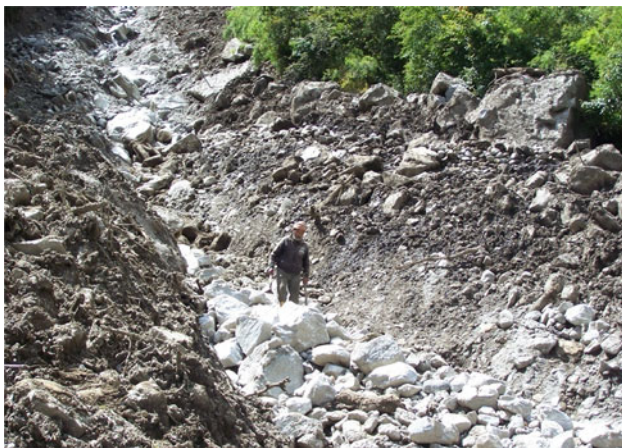
Figure 3 shows a mudslide in Singring, Lachung (North Sikkim), intensity of shaking VIII+. Due to incessant rain followed by earthquake, a water stream changed its path and created a new stream. In this stream, water flown at

**Fig. 3** Massive mudslide in Singring, Lachung (North Sikkim)

such a high velocity that debris of rock also flown with it and created mud mountains at both sides of this stream, this was a strange phenomenon. Perhaps, this is attributed to reduction in strength of rock material due to saturation, Kramer [13] and then it slid due to earthquake force carrying huge boulders and rock pieces with it. This phenomena may be termed as the landslide lake outburst flood where an earlier blocked stream breached due to earthquake shaking. The locals were trying to divert the path of this new stream as it poses threat to the buildings at the downstream. Though size was not measured, however, approximate size of the slide was about 1,000 m in length and about 200 m in width.

In nutshell, all 4 districts of Sikkim witnessed a number of landslides. There are a number of measures to mitigate the landslides which include installation of anchors and nails on unstable rocky hillside. The reinforcement measures generally consists of introduction of metal elements for increasing the shear strength of the rock. Anchorage can be classified either as active anchorage (subjected to pre-tensioning) or passive anchorage (reinforce of blocks). The other measures include the drainage of water, plantation and geometry modification. The presence of water within a

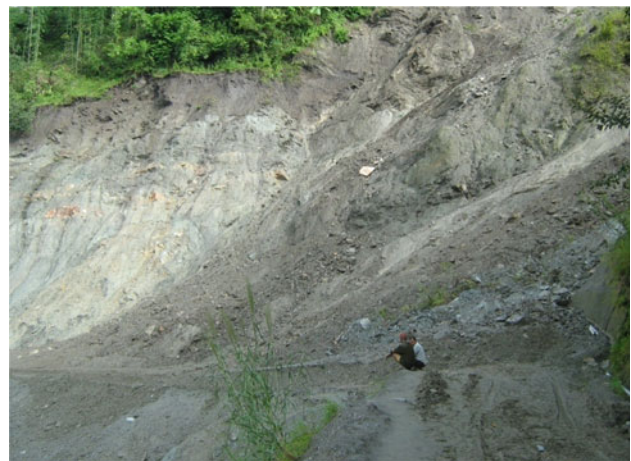
A massive landslide occurred near Sorang in West Sikkim (Fig. 4). Sorang (near Jorhang) area is at epicentral distance of about 66 km and intensity of shaking here can be assigned as VIII. It blocked the road and thus movement of vehicles from Jorhang to Sorang. Exposed overburden can be seen in the photograph. Another landslide was spotted in Singtam (East Sikkim) as shown in Fig. 5. Singtam is about 70 km south of Gangtok and is at junction between East Sikkim and West/South Sikkim. Its distance from epicentre was about 70 km with shaking intensity as VII. Approximate area of the slides shown in Figs. 4 and 5 were about 500 × 500 m.

**Fig. 4** Landslide at about 10 km from Sornag (West Sikkim)

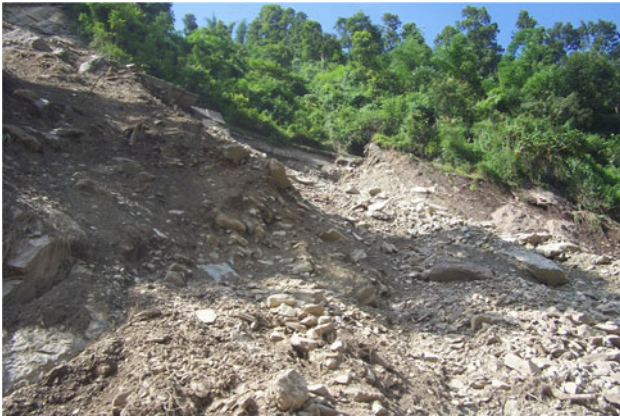
**Fig. 5** Landslide near Singtam (East Sikkim)

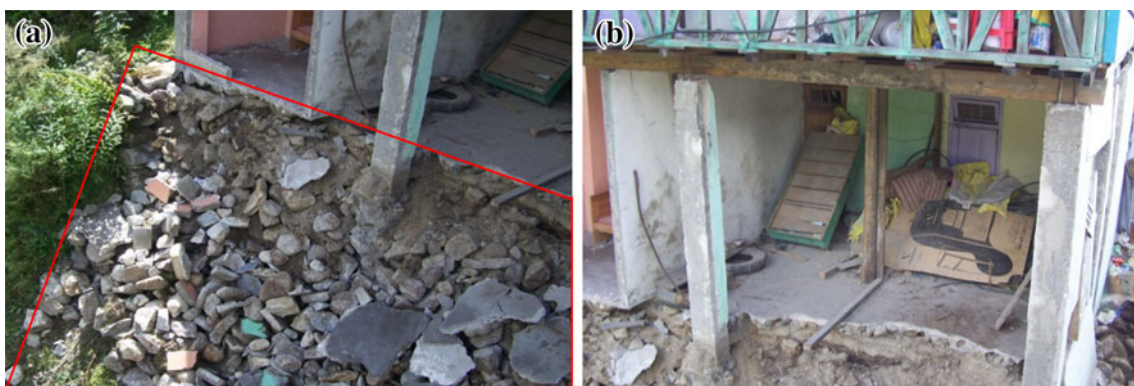
Figure 6a indicates collapse of retaining wall (inside boundary drawn) in Lachung and consequently support to columns of a small building is removed. This posed a clear threat to building (Fig. 6b) which could fall at any moment even in a moderate aftershock.

**Fig. 6** Failure of a retaining wall (with red boundary) near Snowlion Mountain Resort, Lachung. (Color figure online)

To mitigate the damage of retaining walls during shaking, the soil supporting these walls require strengthening treatment and also the seismic design of walls shall be considered before construction. For strengthening of soil, reinforcement or nailing may be used while for seismic design of retaining walls pseudo static method (such as M–O method) may be employed, Kramer [13].

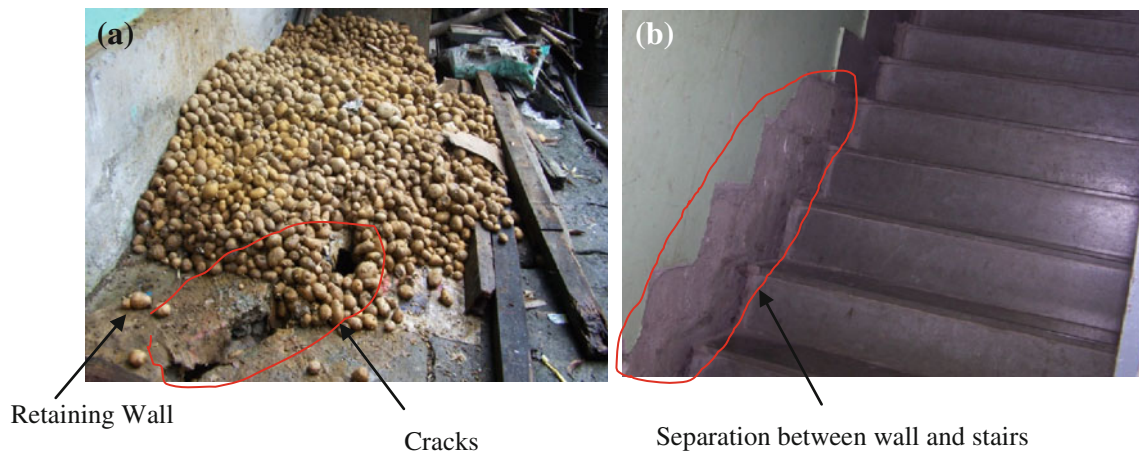
Failure of retaining wall was also observed in Ranipool (intensity VII), which is a small suburban town located near Gangtok at the confluence of tributaries to Teesta and is about 12 km from Gangtok main town. Figure 7a shows retaining wall failure in Ranipool where this failure damaged a building. It was observed that due to earthquake, the

retaining wall on the backside of the building had wide cracks (Fig. 7a) with a gap of more than 15 cm. The cracked portion of retaining wall moved away from the building, creating a wide gap. It was observed that this failure of retaining wall was up to a considerable distance on both sides of the building (Fig. 7a). This in turn separated the stair case from the wall of the building by about 15 cm (Fig. 7b).

**Fig. 7** Failure of a retaining wall in Ranipol, Gangtok

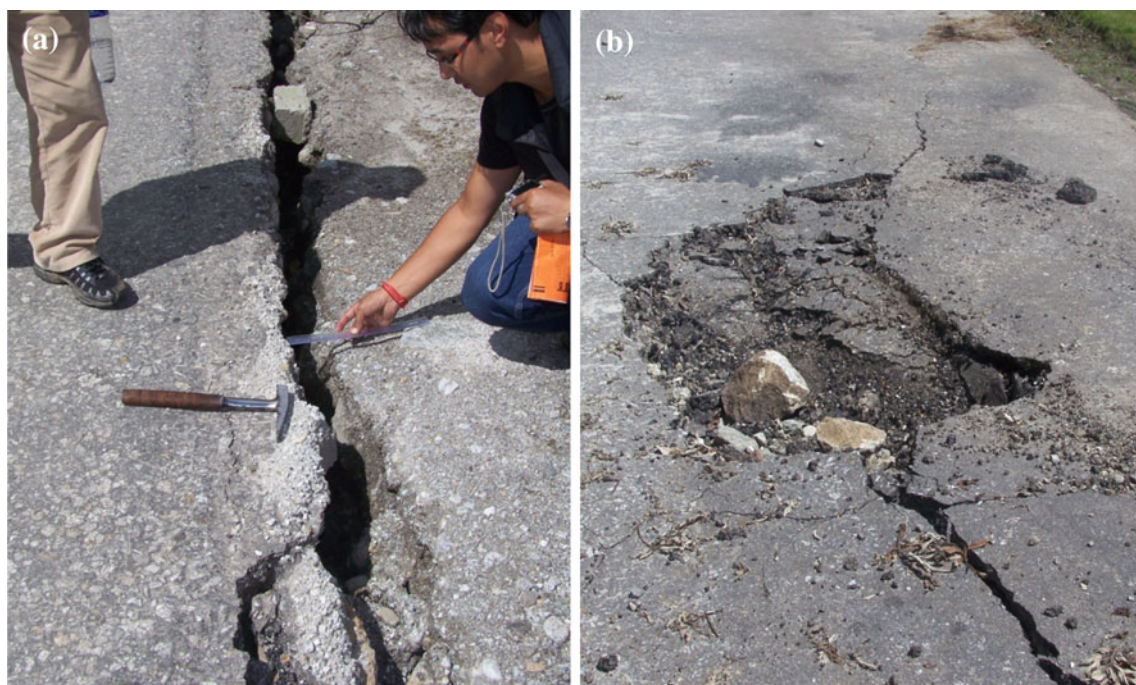
In Lachung, wide cracks with a gap of about 20 cm were observed on the road (Fig. 8a) which can be attributed to the failure of backfill on riverside. The gap created on the road by earthquake shaking is indicating the intensity of shaking. Also the road was damaged due to falling of heavy rock pieces (Fig. 8b). This ground failure in Lachung indicated high intensity of shaking (VIII). The damage to roads can be minimized by providing supports/retaining walls at both uphill and downhill sides. At the same time, the stability of slopes need to be checked for seismic conditions.

**Fig. 8** Ground failure and damage to Roads in Lachung

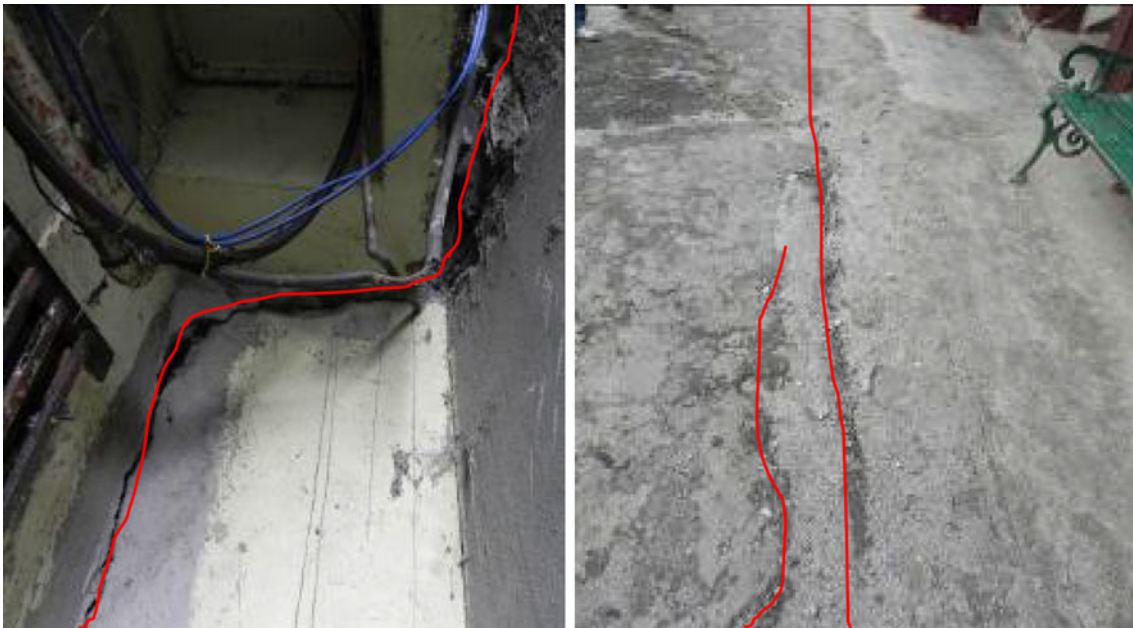
**Fig. 9** Cracks (marked *red*) on the road due to creep of soil in Gangtok. (Color figure online)

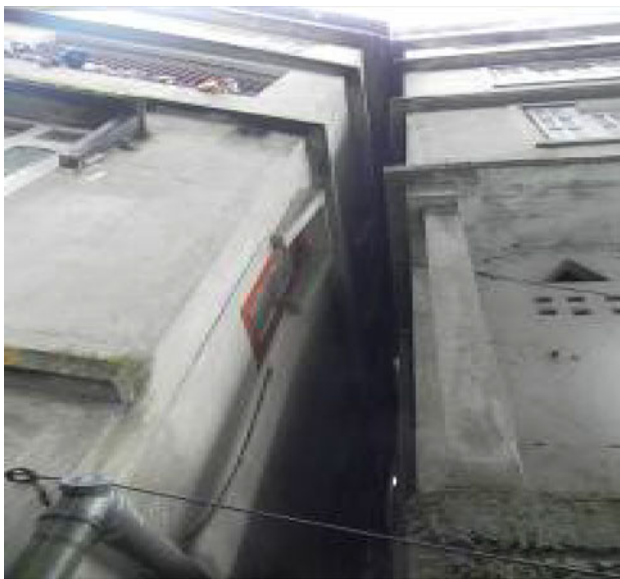
**Fig. 10** Tilting of 2 adjacent buildings in “Seesa Gola, Gangtok”

the earthquake to different extents, depending on the local conditions and construction. Particular attention was drawn by the damage in ‘Seesa Gola’, where wide cracks have developed in the ground and a 4 storey building has tilted and leaned to the adjacent building (Fig. 10).

4–5 storey RC frame buildings with narrow lanes. The 4 storey building (Fig. 10) has tilted and is thrusting the adjacent building at the top. The movement at the top of the 4 storey building is about 0.5 m. However, no structural damage has been observed in the tilted building and all the movement of the building can be attributed to the rocking at foundation. There is possibility of foundation failure, as it was evident that two floors have been added to the building recently and the original foundation may not be adequate for the added floors.

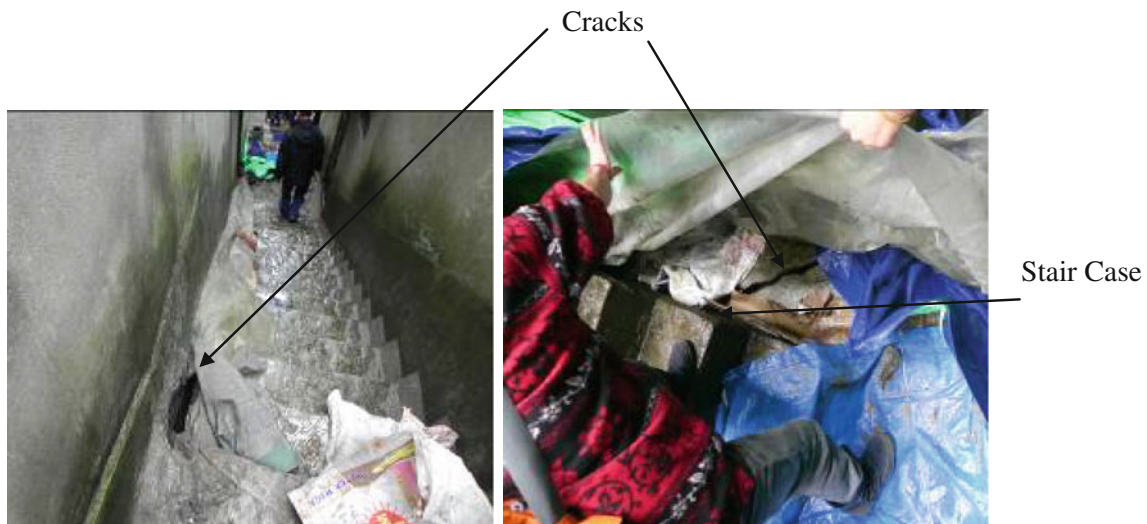
The wide cracks in soil all around the building, as shown in Fig. 11 reveal that the movement is mostly due to rocking at foundation level. It appears that “Seesa Gola” area of Gangtok is located on the debris of a past landslide and the debris mass has undergone some movement during the earthquake. The locality consists of very closely spaced

**Fig. 11** Wide cracks in soil all around the building in “Seesa Gola, Gangtok”

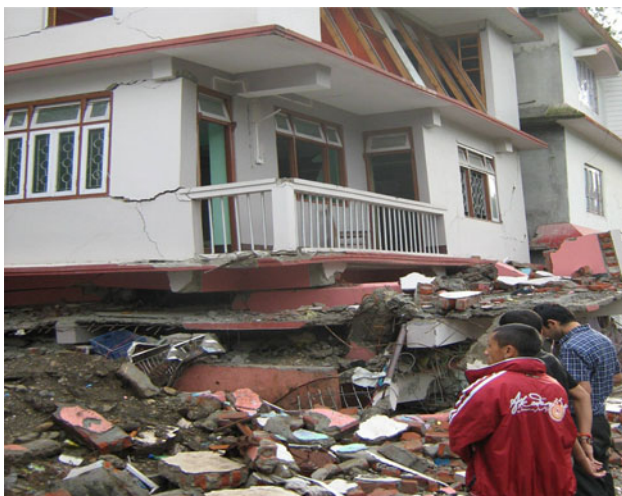
The damage survey was carried out in Jorthang (West Sikkim) which is located on the terrace of Rangit River. Jorthang has epicentral distance about 66 km and intensity assigned is VIII. One of the buildings in Jorthang was totally damaged (Fig. 12) in which 2 of the floors (G + 1) were collapsed. As the ground floor of the building is completely collapsed, perhaps this is due to foundation failure which may be due to excessive settlement caused by shaking. However, the foundation of the building could not be inspected, therefore, the exact order of settlement of soil is not known. However, as the ground floor of the building is completely collapsed, it appeared that soil displaced/settled by about 0.5–1 m in vertical direction. This excessive settlement lead to collapse of soil which in turn lead to failure of foundation and collapse of ground floor.

**Fig. 12** Collapse of ground and first floor of a building in Jorhang (West Sikkim)

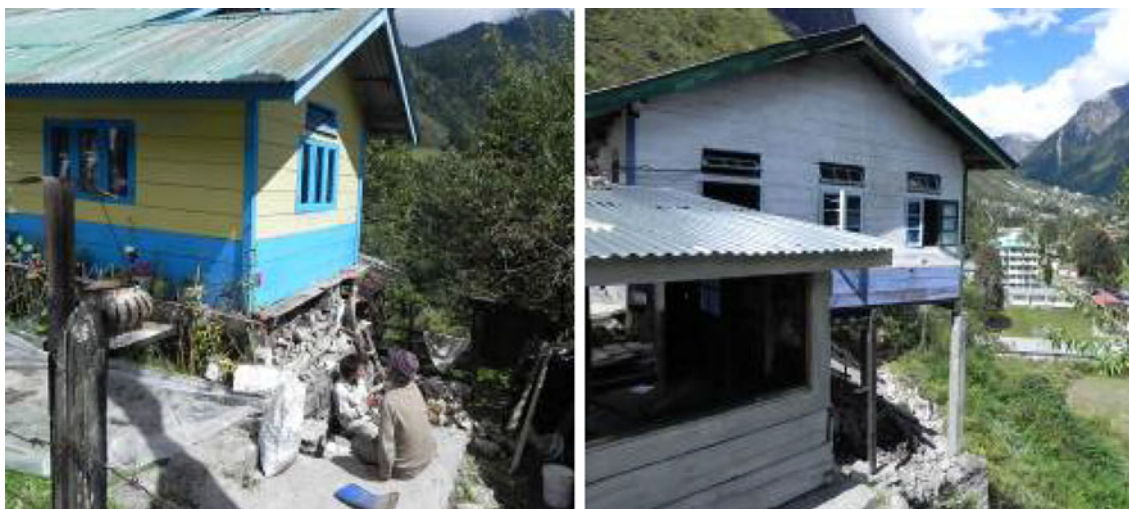
timber buildings with GCI sheet roof, and supported on RC columns (stilts) without beams have shown failure of columns and their foundations and retaining walls on downhill side (Fig. 13). However, collapse was avoided due to light weight of timber structure. This suggested that traditional buildings (Ekeras houses) performed well during the earthquake.

**Fig. 13** Traditional light weight construction performed well except failure of foundation and supporting structure, Singring, Lachung (North Sikkim)
