Characterizing Diesel Particulate Filter Failure During Commercial Fleet Use due to Pinholes, Melting, Cracking, and Fouling

Kun Yang¹ · John T. Fox¹ · Robert Hunsicker²

Abstract Diesel particulate filters (DPFs) are essential particulate matter emission control devices. Some diesel particulate filters have been observed to fail during industrial-fleet vehicle use. DPFs that fail during vehicle use compromise particulate matter emission capture. Herein, failures in cordierite DPF substrates observed during commercial fleet use were characterized as pinhole failure, melt failure, crack failure, and fouling failure. The observed failures were correlated to particulate matter chemical composition and physical changes in the cordierite substrate of the exhausted DPFs. The physical-chemical characteristics of pinhole failure, melt failure, crack failure, and fouling failure were determined by applying scanning electron microscopy-energy dispersive spectrometry (SEM-EDS), X-ray photoelectron spectroscopy (XPS), and X-ray diffraction (XRD). Results indicate that the chemical composition and crystalline structures of cordierite DPF substrate changed according to the failure characterizat

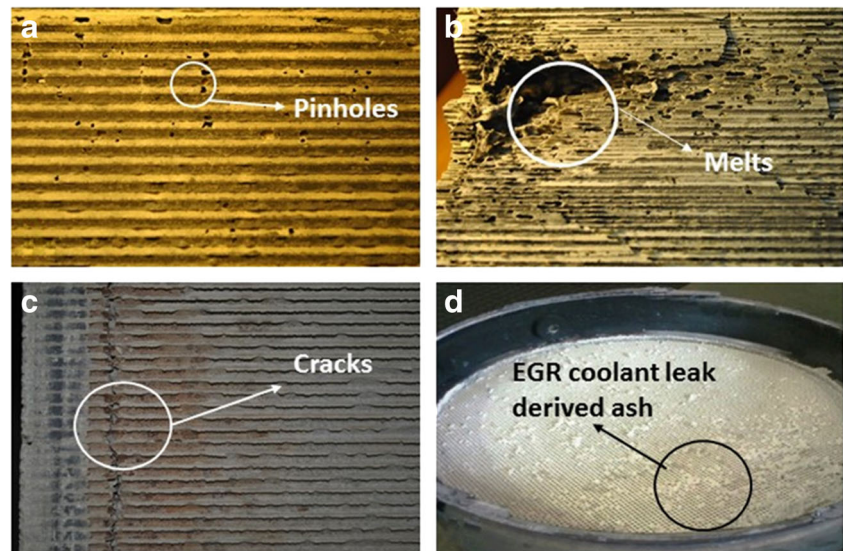
Fig. 2 Photographs of a DPF which experiences (a) pinholes, (b) melts, (c) cracks, and (d) EGR failure

Four specific modes of failure were observed for compromised DPFs provided by Hunsicker Emissions Services LLC. Figure 2 illustrates the mode of failure for four separate DPFs. The authors have characterized the failure mechanisms based on the visual appearance by which the DPF failed. Specifically, the figure demonstrates failure by pinholes (a), melting (b), cracking (c), and EGR coolant leak-derived ash

(d). Pinholes were failures observed when DPFs were cut in half and 0.1–10-mm holes between channels were observed by the authors. Melting failures were observed for DPFs where a significant volume of the DPF melted and left a void. Cracking failures were observed on cross sections of DPFs, where a crack continued through the entire cross section of a DPF. The crack was located within 1 in. of the DPF outlet face, but its presence was not observable prior to cutting the DPF and exposing the cross section. The crack pattern is most likely attributed to the difference of the thermal expansions among these crystalline phases [8, 15, 16, 22]. Fouling failures were DPFs with layers of agglomerated ash on the inlet face that the DPF no longer was permeable via exhaust. These samples were sacrificially utilized for ash chemical appraisal, XRD analysis, XPS analysis, and SEM characterization, which are detailed herein.

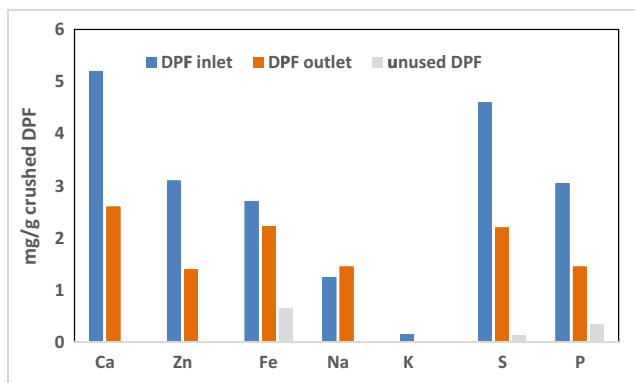
Fig. 3 Commercial fleet DPF ash chemical components (mg ash components/g of DPF substrate)

The total ash loading found in the separately crushed inlet and outlet substrate halves of an urban transit fleet DPF was consistent with ash deposition results reported by others [13, 14]. Figure 3 plots the inlet and outlet concentration by chemical species. Considering the chemical composition distributions in Fig. 3, Ca composed the majority of ash with a concentration of 5.2 and 2.6 mg/g for the inlet and the outlet. Other compounds S, P, Na, Zn, and Fe are found in the range of 1.25 to 4.6 mg/g. Potassium was found as trace levels in both the inlet and outlet, with concentrations of 0.15 mg/g for the inlet and 0.01 mg/g for the outlet.

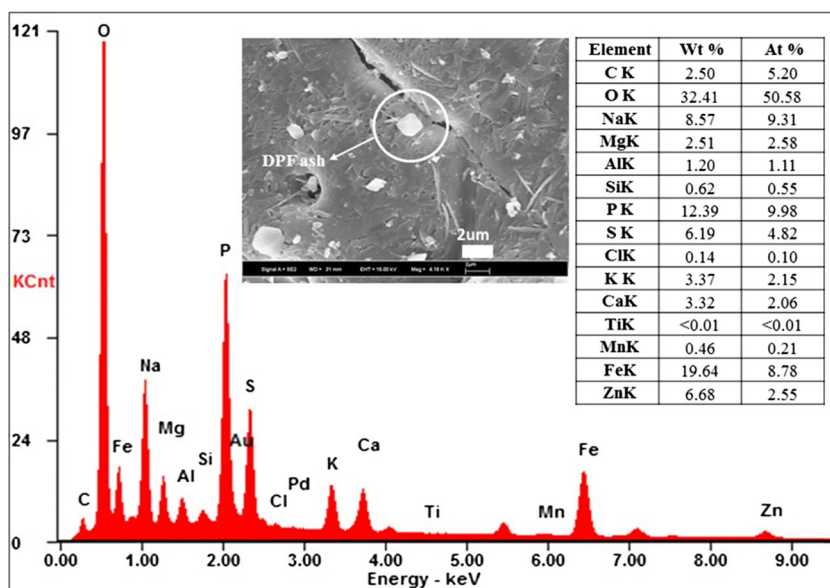
present study, ash chemical compositions are appraised by either ICP-OES or SEM-EDS. The authors focused on seven components, specifically, Ca, Zn, Fe, Na, K, S, and P. Results of ash composition analysis of a crushed DPF substrate based on ICP-OES are depicted in Table 2 and Fig. 3. Corresponding SEM-EDS photograph and spectra are shown in Fig. 4.

Fig. 4 SEM-EDS spectra of DPF ash particles (coated by Au/Pd)

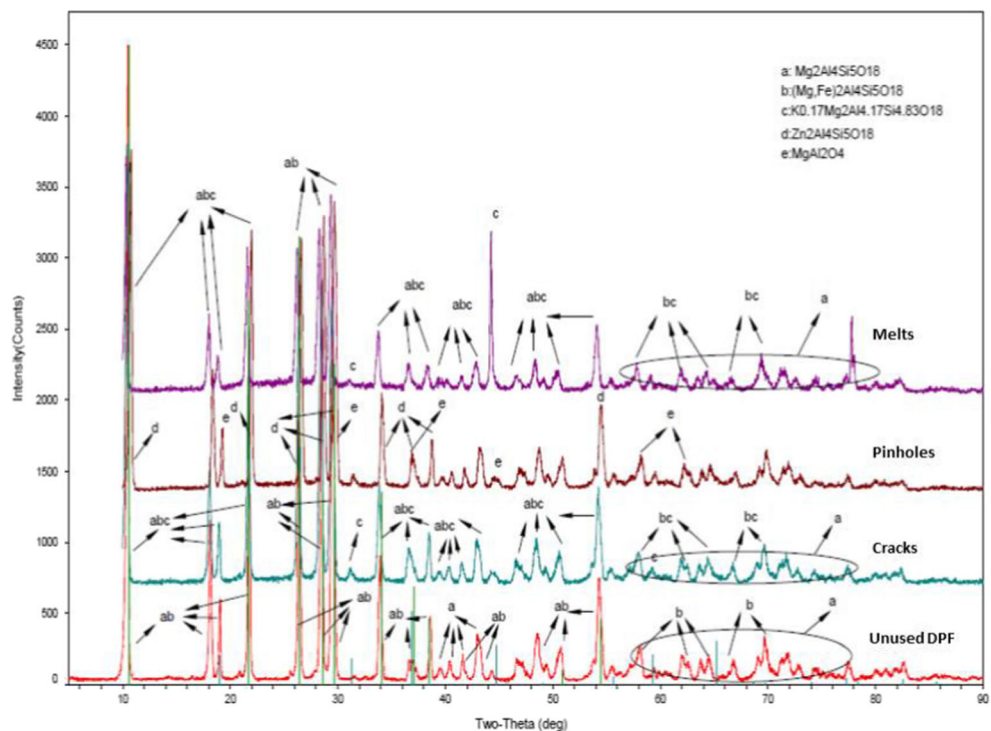
Figure 5 depicts the XRD analysis profile of a new, unused DPF substrate without pinholes, melting, or cracks. The XRD analysis was performed with scanning angle ranges from $\theta = 10^\circ$ to $\theta = 90^\circ$ under a wavelength of 1.5406 Å. XRD analysis indicates that the unused DPF substrate possessed two crystalline structures. These two crystalline phases, which include Mg₂Al₄Si₅O₁₈ (a) and minor phase of (Mg, Fe)₂Al₄Si₅O₁₈, show a strong correlation with the XRD peaks,

The XRD analysis of pinhole areas in Fig. 5 shows two unique crystalline phases, the major crystalline phase $\text{Zn}_2\text{Al}_4\text{Si}_5\text{O}_{18}$ (d) and the minor crystalline phases of MgAl_2O_4 (e). These two phases are not found in the XRD pattern of the new, unused DPF sample and may indicate possible chemical reaction between the cordierite substrate and ash. The crystallinity of (d) $\text{Zn}_2\text{Al}_4\text{Si}_5\text{O}_{18}$ and (e) MgAl_2O_4 is 99 and 89 %, respectively. This suggests the pinhole samples display less perfect crystal orientation and more amorphous phases.

Fig. 5 XRD patterns from unused DPF, pinholes, melts, and crack samples

The XRD spectra of DPF melts in Fig. 5 show three unique crystalline phases, two with major crystalline phases of $\text{Mg}_2\text{Al}_4\text{Si}_5\text{O}_{18}$ (a) and $(\text{Mg}, \text{Fe})_2\text{Al}_4\text{Si}_5\text{O}_{18}$ (b), and one minor crystalline phase of $\text{K}_{0.17}\text{Mg}_2\text{Al}_{4.17}\text{Si}_{4.83}\text{O}_{18}$ (c). The crystallinity of $\text{Mg}_2\text{Al}_4\text{Si}_5\text{O}_{18}$ (a), $(\text{Mg}, \text{Fe})_2\text{Al}_4\text{Si}_5\text{O}_{18}$ (b), and

The XRD analysis in Fig. 5 of the cracked DPF sample identifies the same phases as the melted sample. This includes $\text{Mg}_2\text{Al}_4\text{Si}_5\text{O}_{18}$ (a), $(\text{Mg}, \text{Fe})_2\text{Al}_4\text{Si}_5\text{O}_{18}$ (b), and $\text{K}_{0.17}\text{Mg}_2\text{Al}_{4.17}\text{Si}_{4.83}\text{O}_{18}$ (c). The respective crystallinity for the two major phases is 91 % for $\text{Mg}_2\text{Al}_4\text{Si}_5\text{O}_{18}$ (a) and 93 % for $(\text{Mg}, \text{Fe})_2\text{Al}_4\text{Si}_5\text{O}_{18}$ (b). The crystallinity of the minor phase $\text{K}_{0.17}\text{Mg}_2\text{Al}_{4.17}\text{Si}_{4.83}\text{O}_{18}$ (c) is 88 %.

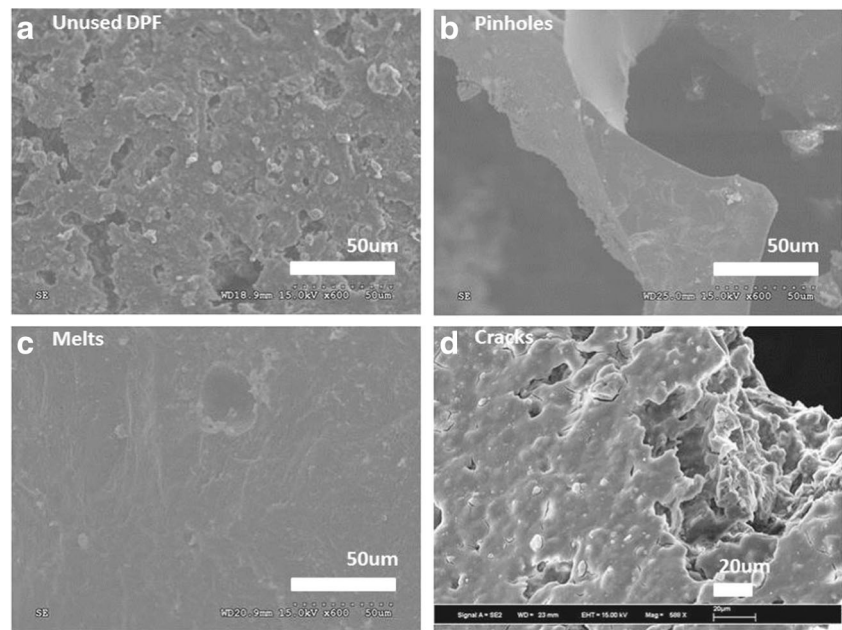
SEM photographs in Fig. 6 compare the microstructures of unused DPF with pinholes, melts, and cracks. The SEM photograph of the unused DPF shows a regular shape with a layered structure. This structure changes as the layers melt and combine together in pinholes, melts, and cracks. The corresponding EDS spectra are illustrated in Fig. 8 and compared in Table 4. The EDS spectra in Fig. 8a show Ca, Zn, K, and Fe are not present in the new, unused DPF samples.

Fig. 6 SEM photographs of **a** unused cordierite, **b** pinholes, **c** melts, and **d** cracks

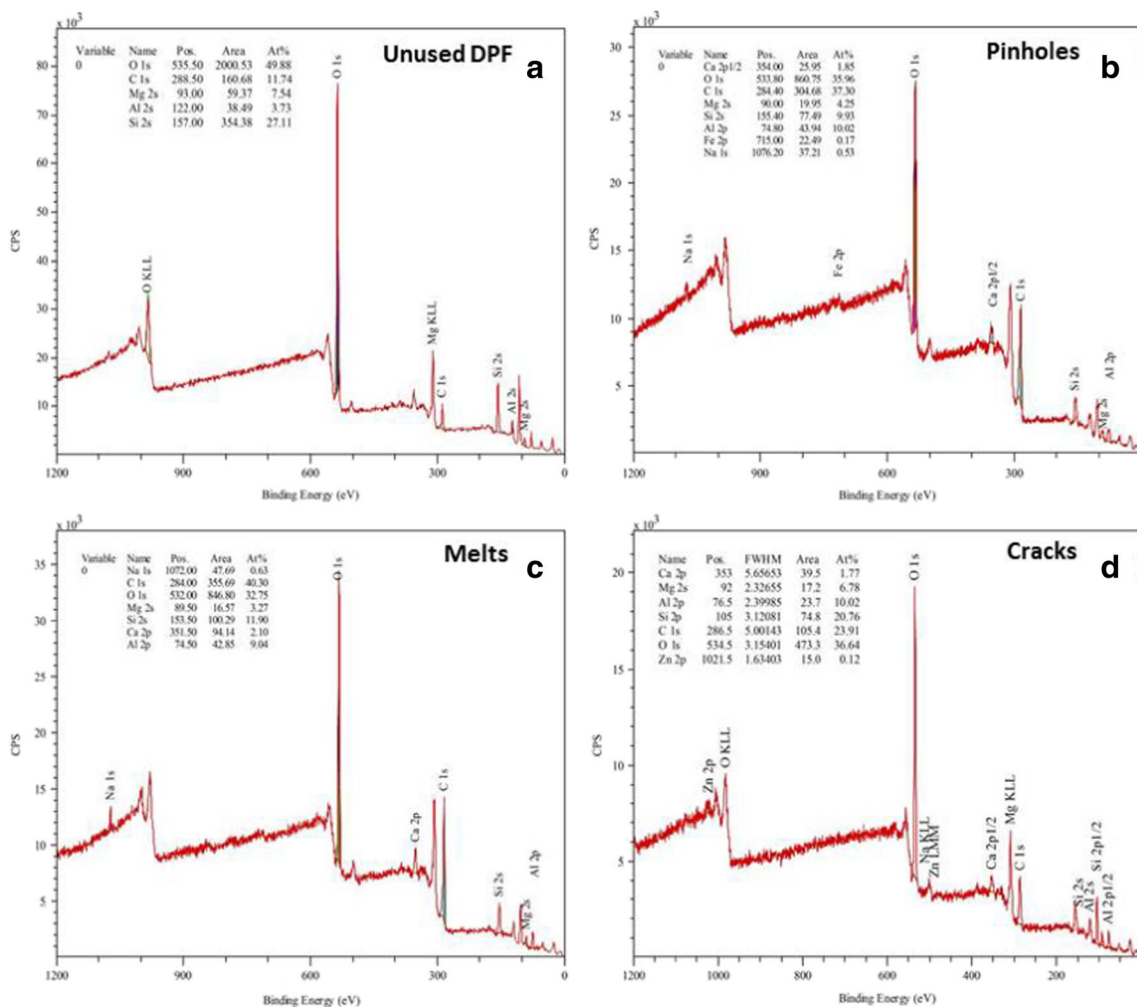
The XPS analysis in Fig. 7 compares XPS spectra of the unused DPF substrate with pinhole, melt, and cracks. A comparison of the results is also provided in Table 5. The XPS spectra in Fig. 7a show the new, unused DPF substrate is free of Ca, Zn, K, Na, and Fe.

The XPS spectrum of the pinhole areas is provided in Fig. 7b. This spectrum shows the presence of Na, Fe, and Ca at the surface of the pinhole area. The relative amounts of the ash components found are 0.53 % Na 1s, 1.85 % Ca 2p, and 0.17 % Fe 2p.

The corresponding XPS spectrum of the melted DPF in Fig. 7c shows the melted surface contains peaks of Na and Ca. The SEM-EDS spectra of melts are shown in Fig. 8c. The melt spectra show the presence of major levels of Fe, Ca, P, and minor levels of Na.

The XPS spectrum of the cracked DPF substrate is located in Fig. 7d. The spectrum shows the presence of calcium and zinc. The SEM-EDS spectra of cracked substrate are located in Fig. 7d. This spectrum shows the presence of major levels of Ca and Zn, as well as P, Na, K, and Fe. The presence of Zn near cracks in the substrate is consistent with the findings of Maier et al. [8], although the underlying mechanisms are not yet understood as to why zinc concentrations are prevalent near cracks.

Fig. 7 XPS scanning survey spectra of **a** unused DPF, **b** pinholes, **c** melts, and **d** cracks

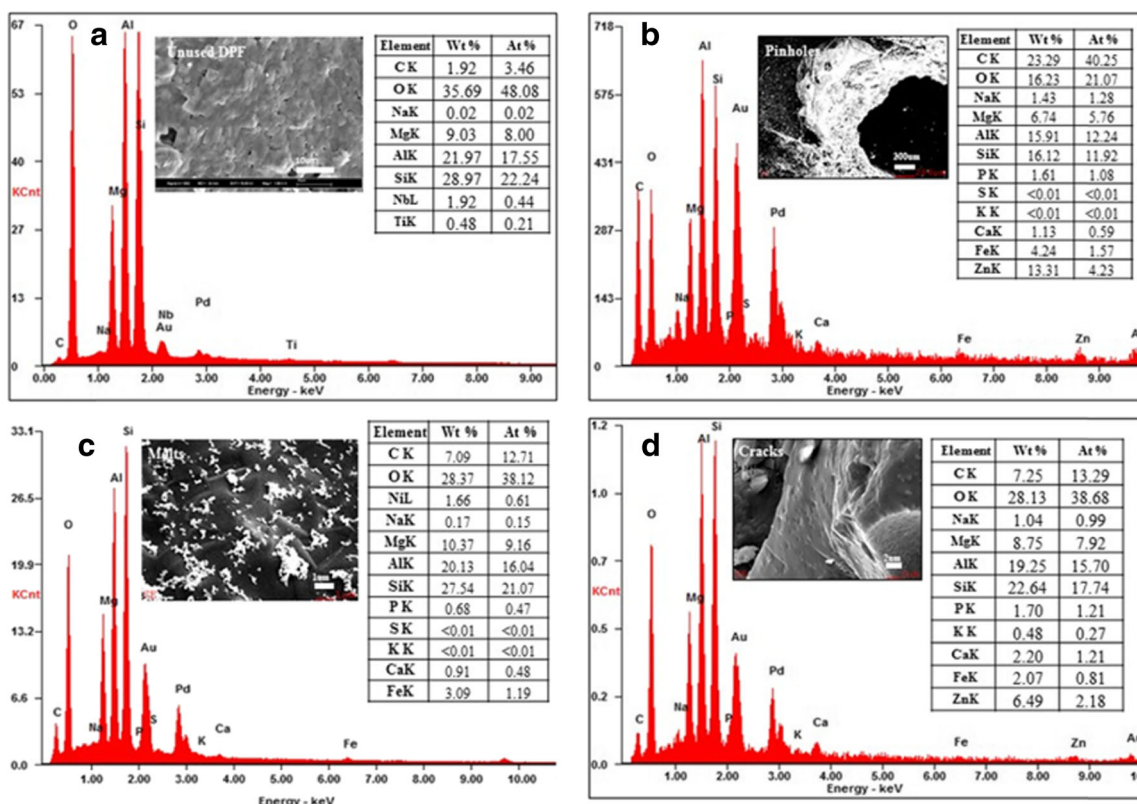
The SEM-EDS spectra of the pinhole areas are located in Fig. 8b. This spectra show the presence of major levels of Na, Fe, Ca, P, and Zn. The presence of high levels of zinc in the

XRD data and SEM-EDS data, but not the XPS data, suggests zinc might penetrate deeper into the substrate, below the top 10-nm surface layer measured by XPS.

Fig. 8 SEM-EDS photographs and spectra of **a** unused DPF, **b** pinholes, **c** melts, and **d** cracks (material coated with Au/Pd)

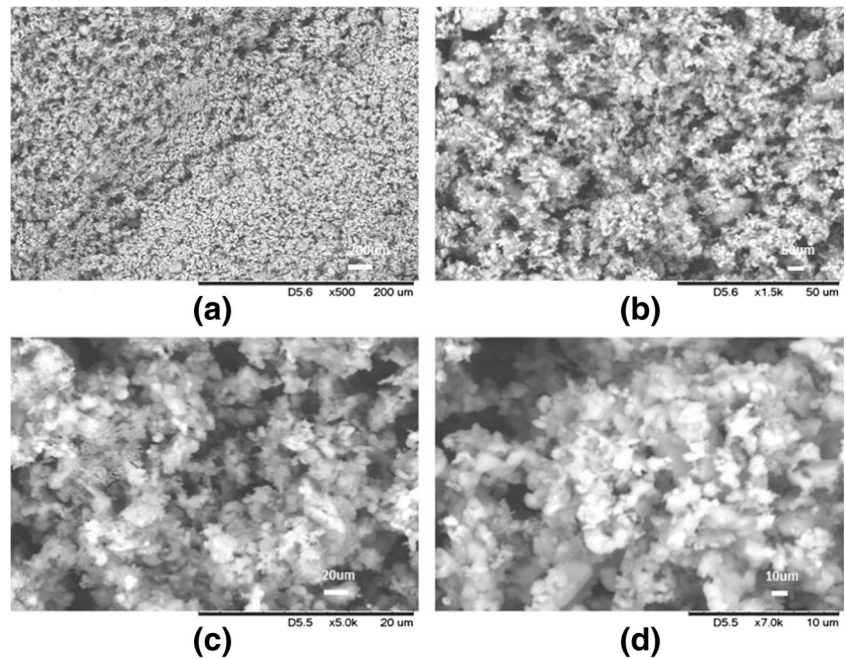
Scanning electron microscopy (HITACHI, TM1000) of the EGR coolant-derived ash particles, illustrated in Fig. 9, shows the white ash substance on the DPF inlet face is comprised of 5–10- μm -sized ash agglomerates. The agglomerates are loosely packed and can act as an adsorbent for smaller soot or ash particles in the exhaust gas. An elemental spectrum of the white ash substance which was acquired using EDS under accelerating voltage of 15 kV shows the observed EGR coolant leak derived ash is composed of similar chemical compounds as typical DPF lube ash, although at different elemental distributions. The EDS results show no detected zinc or magnesium and much higher levels of potassium and sodium. High levels of potassium are indicative of a coolant leak, as fully formulated HDD coolants may contain significant quantities of S (sulfur), P (phosphorus), Na (sodium), and K (potassium) [21].

Fig. 9 SEM images at 15.0 kV, showing surface structures of EGR coolant leak-derived ash articulate under different magnifications ranging from **a–d** 500 to 10K

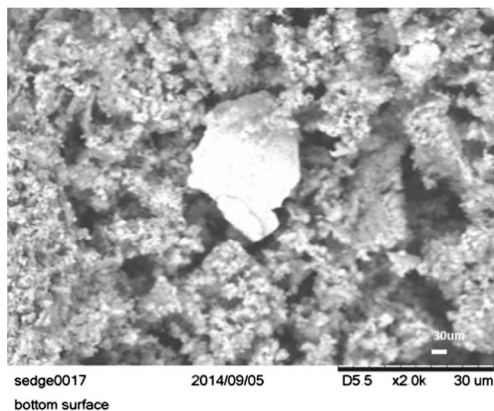
particle surface (Fig. 10). EDS analysis confirms that 48.9 % of weight of these white ash particles are iron. Merkel indicated the iron in DPF ash is mainly attributed to rusting of exhaust component upstream [16]. Therefore, the EGR coolant failure could contribute to exhaust system corrosion and transport iron particles within the DPF.

Fig. 10 SEM image showing an iron particle embedded within an EGR coolant leak-derived ash particulate
