Structural Performance of Masonry Buildings Under Harsh Climate and Seismic Loads

Abstract

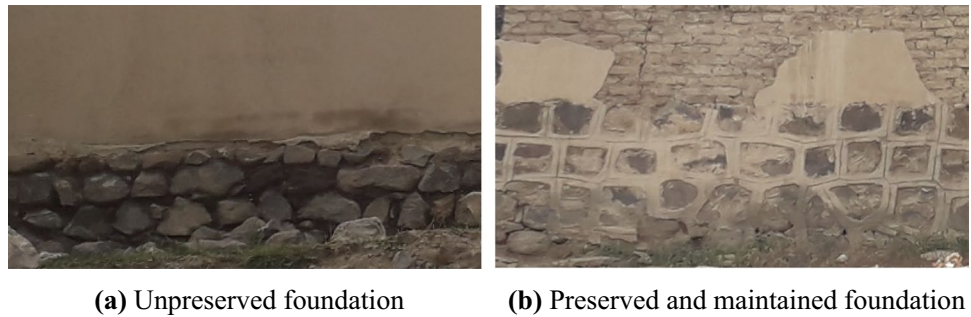
Fig. 9 Preserved and unpre-served foundations

Foundations of the investigated masonry buildings are not stiff enough due to the reasons mentioned above because rubble masonry has mud mortars and mortars deteriorate because of wet-dry cycles and freeze–thaw cycles each year due to the rain and snow. 29-year freeze–thaw frequency and average daily temperature cycles of the region which were provided by the General Directorate of State Meteorological Affairs in Ankara are given in Fig. 8. From the 29-year data, it was found that approximately 124 freeze–thaw cycles take place in the region per year and the freeze–thaw period lasts 6 months. 104 days were reported to be rainy or snowy meaning that the foundation is wet in those days causing the disintegration and deterioration of the mortar. In other words, those adverse effects force mud mortar to wash away from the joints. Figure 9a shows the highly deteriorated joints in the foundation. If the bed and head joints of the foundation are preserved and maintained as shown in Fig. 9b, then the foundation may behave stiffer and ensure the box behavior at the bottom layers of the walls.

(a) Unpreserved foundation

(b) Preserved and maintained foundation

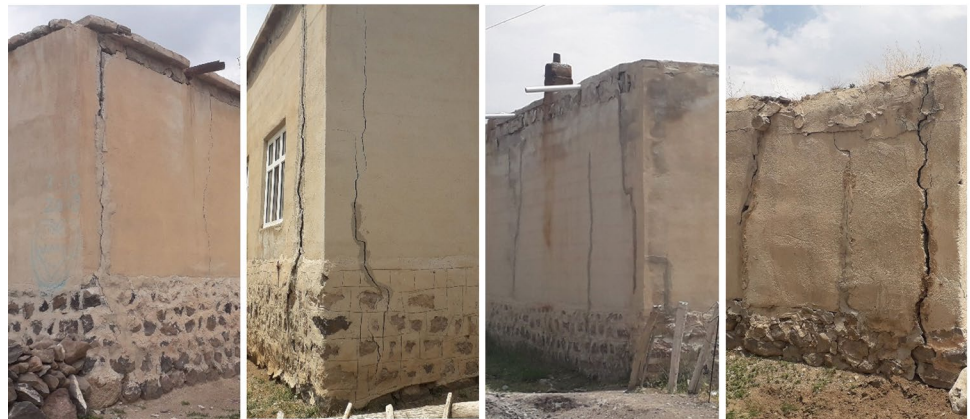
Fig. 11 Wall cracks due to the foundation movement

During the field investigations, it was observed that available cracks either widened or resulted in collapse. Besides the available cracks, new cracks due to the foundation movement were seen to be developed. Cracks again developed at the corner resulting in separation of the walls (Fig. 12). In the region, the wooden logs at the roof level were mainly placed on a solid wall rather than the walls with openings. The reason can be attributed to the reduced vertical and horizontal capacities because of the openings and inadequate bending capacity of the lintels. The lack of axial load on the front wall with opening reduces the friction between the masonry elements thus increases the rotation ability of the foundation below those walls. The rotated walls created tensile stresses at the corner, and this resulted in out-of-plane displacement of the unloaded wall. Thus, those unloaded and displaced walls were the most vulnerable ones.

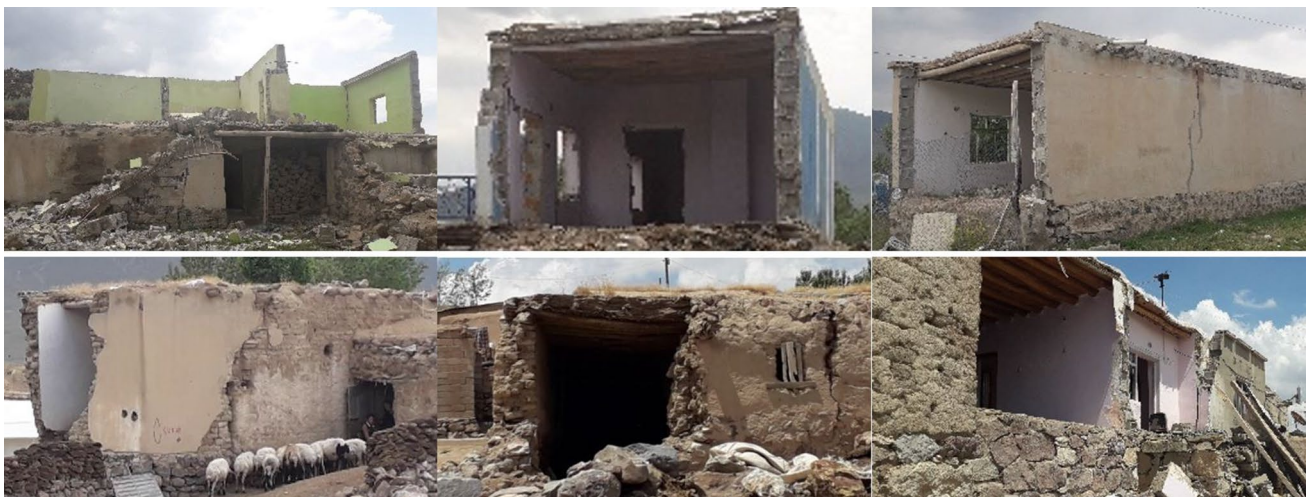
Fig. 14 Out-of-plane failures

Most of the out-of-plane failures observed in the region were in lightweight pumice block walls in which the wall was slender (H/t is between 13–15), the mortar was inadequate to connect the wall to the transverse walls and in some cases even the tensile strength of lightweight pumice blocks was so low that crack penetrated from mortar through the blocks. In those buildings the out-of-plane displacement resulted in the total collapse of the walls. However, when the connection between the masonry elements was increased and slenderness was reduced (H/t is less than 7) then the contribution of the transverse walls increased, and the wall partially collapsed (Fig. 14).

The vertical roof force is observed to be important in masonry buildings. As previously noted, the wooden logs of the roof run in one direction and exert vertical forces to the walls at their ends. Since they are one directional element, they only tie two opposite walls remaining the adjacent walls free from the vertical forces. In addition, the vertical force-free walls are not directly attached to the roof. Besides, if they are not adequately attached to the transverse walls, they can freely rotate at the base in case of a lateral force (Fig. 14).

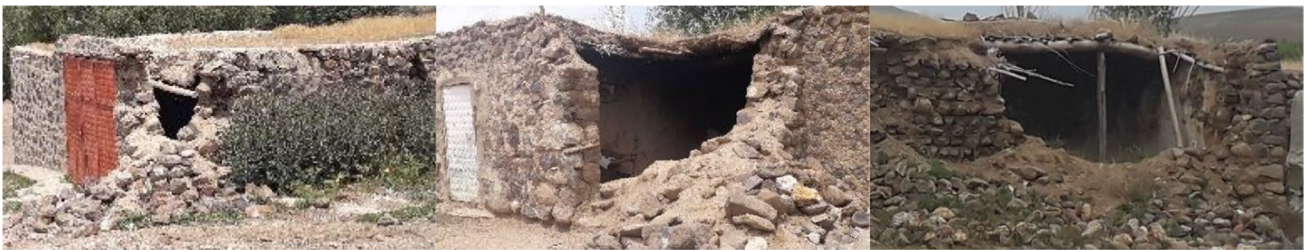
Fig. 15 Corner failures

in Fig. 15 experienced partial corner failure because the walls had adequate connections at the corner, the slenderness was low, and the mortar strength was adequate (Erdil et al. 2020). Although the connections were adequate, still the tensile strength of the mortar was low and tensile stresses developed due to the out-of-plane forces. The corner being exposed to two-way loading and two-way displacements during lateral loads, and out-of-plane displacement being great at the roof level, stress concentrations will occur at the top corners resulting in partial collapse (Bansal et al. 2017, Casapullo et al. 2018, Vlachakis et al. 2020).

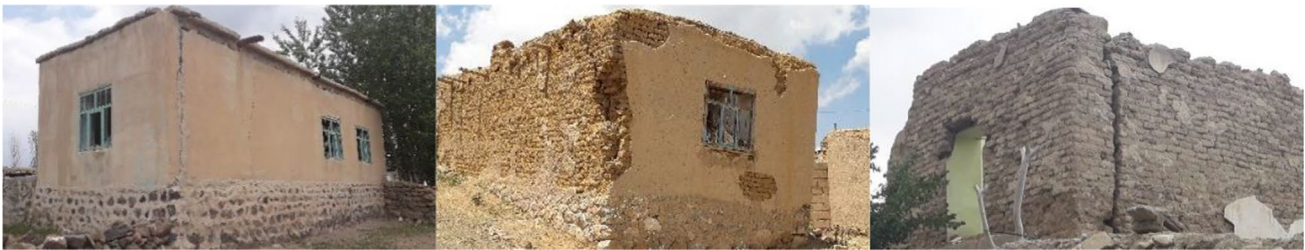
Fig. 16 Breakage of the link between the walls

In some buildings, it was observed that connections between the walls at the corners were failed and significant cracks throughout the wall height became visible (Fig. 16). Although those cracks were significant, the separated wall did not collapse because of the great mass and stiffness of the wall which resisted the seismic load. Since the seismic

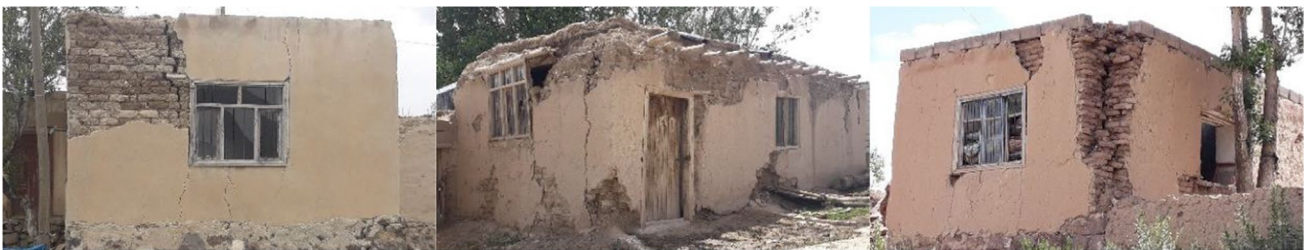
Fig. 17 Damage around openings

In most of the buildings, external walls had one window opening placed at the center. However, there exist some buildings which had door and window openings on the same wall, and some buildings having window openings without having adequate spacing between sides of the wall. From the field investigation, it was observed that some buildings experienced in-plane damages at their walls with openings. Either the cracks developed at each side of the opening, or diagonal cracks started at each corner of the opening. In all cases, the cracks were wide (almost 4 cm) and adversely affected the capacity of the walls resulting in severe damage condition (Fig. 17).

Since in-plane capacity of a masonry wall is greater than its out-of-plane capacity, in-plane failures were not common in the region. Pictures given in Fig. 17 show some examples of in-plane damages. As can be seen, in-plane damages became visible in diagonal shear cracks. In all the buildings although the roof is heavy, the maximum vertical stress is almost 0.2 MPa which would have limited contribution to the shear strength of the wall. If the walls had adequate out-of-plane capacity, then in-plane damage becomes visible and either X-cracks develop on the wall (especially the wall segments between the openings), or stepped or continuous diagonal shear cracks become significant on the walls without openings. In some cases, high in-plane deformations cause the cracked wall to be partially collapsed in out-of-plane direction (Fig. 18).

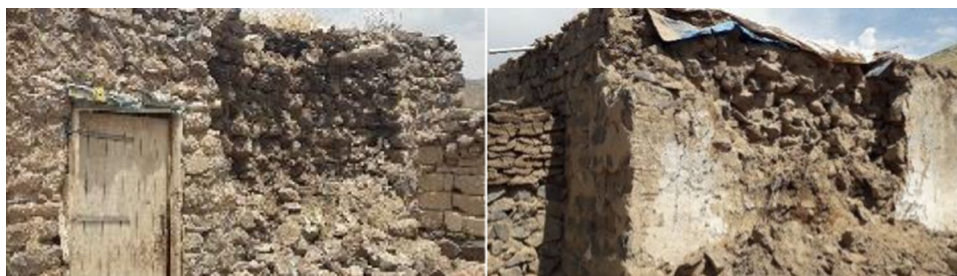
Fig. 19 Separation of external leaves

Multi-leaf walls are generally exposed to leaf-separation by either horizontal seismic loads or high compressive forces (Candela et al. 2016). In both case, the partial or total separation is seen at the external leaf since this leaf is subjected to environmental exposures throughout its lifetime. As previously noted, the region is exposed to approximately 124 freeze–thaw cycles annually and almost 1/3rd of the

year there is rain or snow indicating that wet-dry cycles are also great which creates adverse environmental effects to the external leaf. The continuous environmental cycles decrease the strength and bond between the wythes and since the outer wythe is susceptible to the harsh environment, it deteriorates continuously and delaminates easily even under low level of stress (Vintzileou and Tassios 1995). The other reason is that the inner wythe carries loads from roof increasing the bonding of the masonry units and their flexural strength. Additionally, the out-of-plane deformation of the inner wythe is prevented to deform inside the structure by the roof or floor beams. Another reason for the leaf separation is the lack of shear keys that connect the leaves and take care of the shear forces. The repair and retrofit of this type of collapse are stated to be hard in rubble masonry buildings since there is no significant and patterned configuration (Corradi et al. 2007).

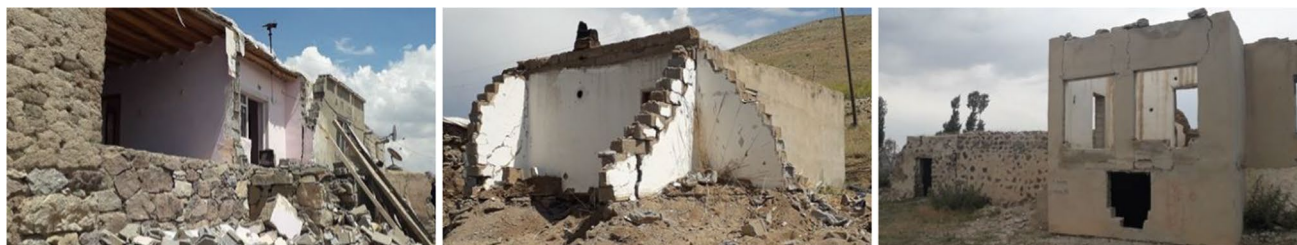
Fig. 20 Damaged newly constructed lightweight pumice block buildings

During the field investigation, most of the lightweight pumice block buildings were observed to have damages. Some lost their walls due to the out-of-plane action, some experienced separation (Fig. 20). However, the abandoned adobe buildings behaved well instead. Of course, the effect of the roof is important in the behavior, but it should not be forgotten that those adobe buildings were lack in box behavior. Some adobes were deteriorated too much due to

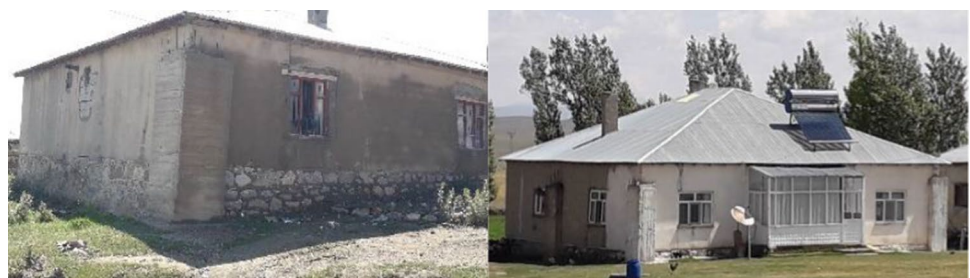
Fig. 22 Locally strengthened masonry buildings

The local people in Gözdeğmez village observed the environmental effects and realized that corners continuously crack, and those cracks widen year by year. That village sometimes experiences flood because it was located on a valley where flood is inevitable when certain conditions (amount of rain or snow) are met. Some local people tried to repair and increase the bond at the corners of the walls with lime or mud-based mortars. However, there exist some people applying significant structural interventions at the corners. They strengthened the cracked corners by adding L shaped reinforced concrete columns as shown in Fig. 22. They did not use those additional corner columns at all corners, instead they used at the cracked corners only. Some people added additional columns at the midspan of the wall where a transverse wall connected. Although there are no engineering calculations for those additions, those buildings were found to behave adequately, and no earthquake related damage was observed. The reason can be attributed to the increase in lateral strength and stiffness, and also the partial confinement of the masonry. The additional reinforced concrete columns tie the walls at the corner, prevent the separation and provide additional stiffness in in-plane and out-of-plane directions. With those improvements, the lateral deformation reduces, and box behavior is guaranteed at low level of seismic acceleration.

Besides, one other reason is the low PGA level of the earthquakes. Behavior of those strengthened buildings during a strong earthquake is still questionable because not adding columns at each corner, torsional irregularity may be induced, and additional shear forces may develop at the unstrengthened corners. However, since that strengthening seemed to be adequate for low seismicity, it can be said that even inadequate strengthening has great impact on the lateral capacity of the non-engineered masonry buildings. Therefore, since the masonry buildings in rural areas have one or two stories, additional lateral load bearing elements can be used at critical locations externally to ensure box behavior and by this way their seismic performance can be improved practically.
