# January 24, 2020 Sivrice-Elazığ (Türkiye) Earthquake: The Seismic Assessment of the Earthquake Territory, Geotechnical Findings and Performance of Masonry Buildings

## Abstract

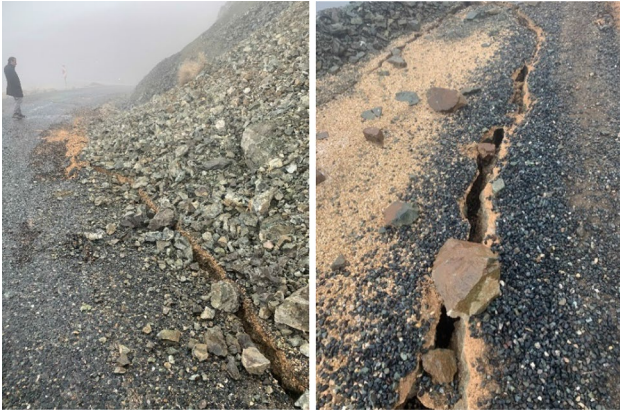
**Fig. 8** Small-scale mass movements and stone falls due to these movements

Considering the geotechnical effects of the earthquake, small-scale mass movements were observed in the north of Hazar Lake and the northern cuts of the highway between Elazığ and Sivrice and large stone falls on the highway due to these movements (Fig. 8). In addition, cracks formed on the asphalt highway connecting the Çevrimtaş village where the earthquake occurred and parallel to the road route were determined. It was observed that the width of these cracks exceeded 10 cm in places. It has been determined that there are also vertical separations in some parts where these cracks occur (Fig. 9). These mass movements and vertical separations occurred as a result of the triggering of main shocks and aftershocks depending on the lithology, slope and climatic conditions of the region.

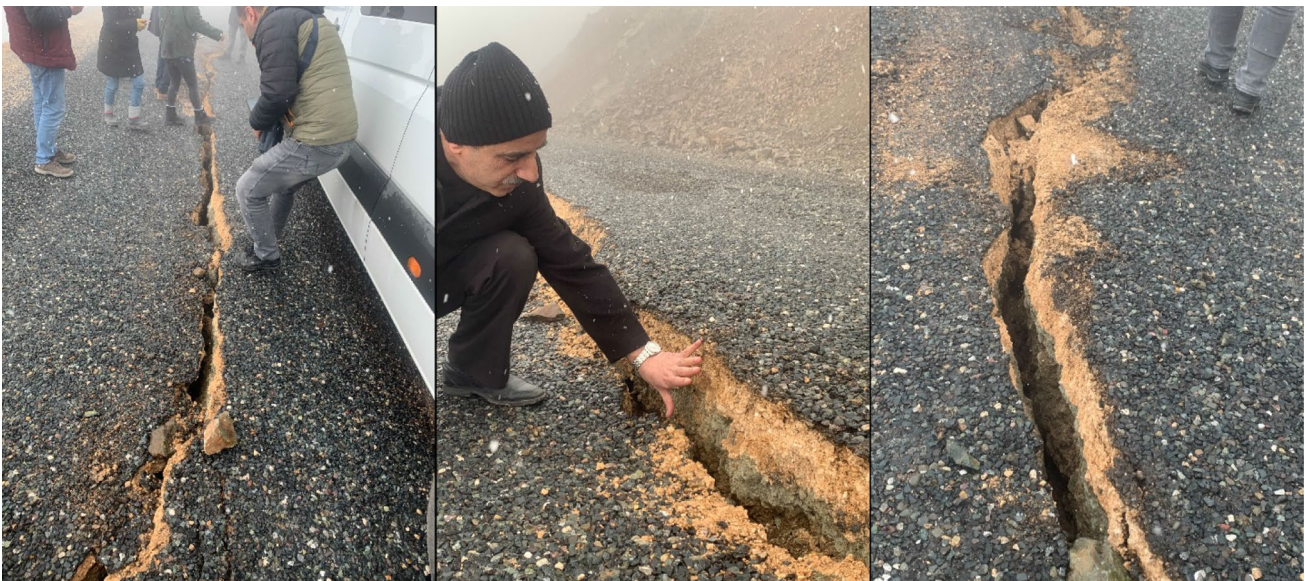
**Fig. 9** Views of soil surface cracks on the highways by the earthquake (Çevrimtaş village, Sivrice)

These geotechnical findings were detected in places close to the Sivrice district, and such findings were not encountered in locations further away from the district center. Sivrice district center and its villages, where the greatest geotechnical damage occurred, are the locations where the damage occurred the most in general. The most important reason for this situation is that the Sivrice district center is located at a place where the Pütürge Segment reaches Hazar Lake (Fig. 2). The Pütürge Segment is traced as a fault bundle approximately 1.5 km wide in the vicinity of Sivrice. Although part of the district center is on the bedrock, part of it is built on the alluvial deposits and part of it is built on the coastal sediments of Lake Hazar. All these geological and tectonic effects are considered as the factors causing damage in the district center (MTA Report 2020).

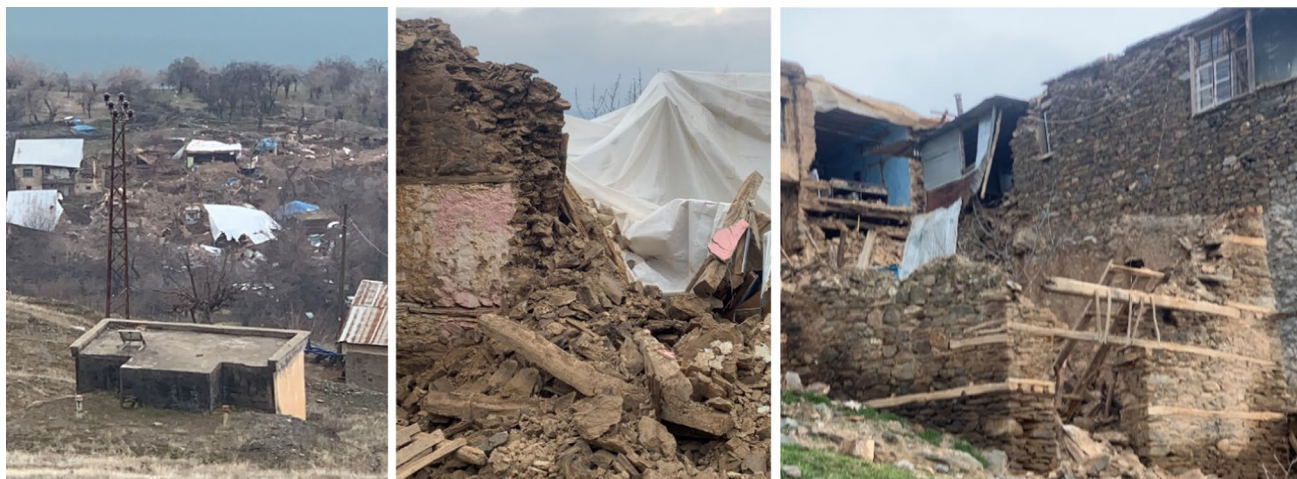
**Fig. 10** Çevrimtaş village damages

During field observation, it was noted that almost all stone masonry buildings were constructed with weak mud mortar binders. It was observed that most of the buildings in the area were heavily damaged and some of them were destroyed (Fig. 10).

Buildings in rural areas are generally built without engineering service. Therefore, the workmanship and construction quality of the structures is generally poor. This situation caused the buildings to be weak against the effects of earthquakes and to receive heavy damage. Lime mortar supported with cement or cement mortar should be used as binder mortar in load-bearing walls depending on earlier TEC (1998) and TEC (2007). Furthermore, according to TBEC (2018), the minimum compressive strength of mortar for unreinforced masonry should be at least 5.0 MPa.

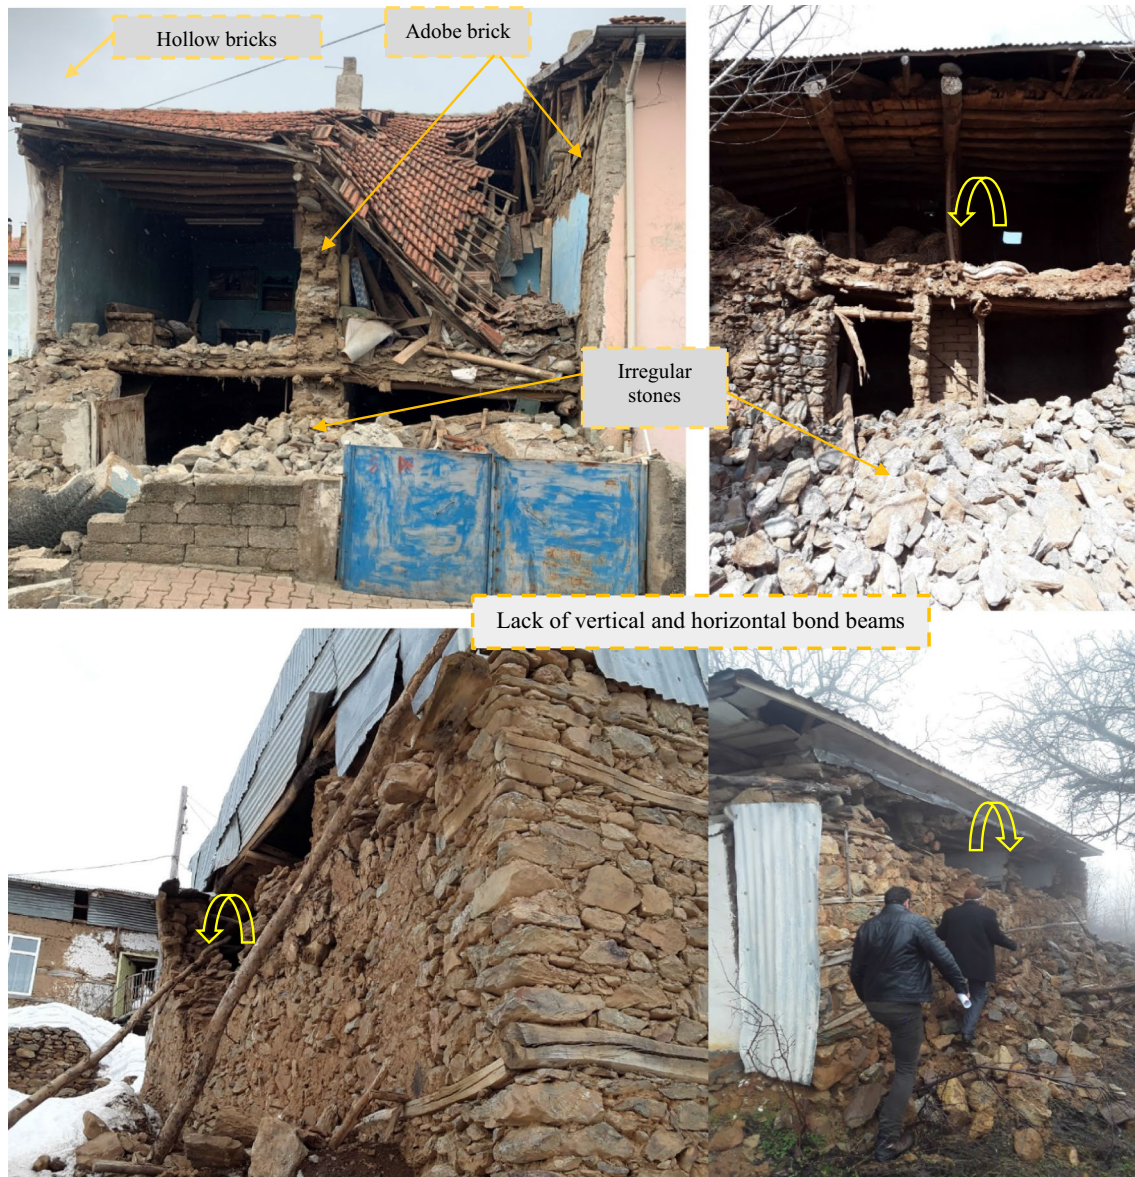
In masonry buildings, wooden beams that carry the weight of the floors are placed on the load-bearing walls in one direction only. The dynamic loads that occur during the earthquake are transferred to the perpendicular walls by these wooden beams. If a masonry structure has not vertical and horizontal bond beams that ensure the integrity of the structure, masonry walls not supported by wooden beams can be overturned in out-of-plane direction. Masonry buildings damaged due to out-of-plane mechanism in the affected region of the earthquake are shown in Fig. 11.

Fig. 11 View of out-of-plane failure on load-bearing walls

In order to prevent these damages in masonry buildings, the unsupported length of a wall should be limited by using perpendicular walls and vertical bond beams. Regulation rules for this situation are quite clear. In the TBEC (2018), some rules are given for the maximum unsupported lengths of load-bearing walls and distances between vertical bond beams in unreinforced and confined masonry buildings (Fig. 13).

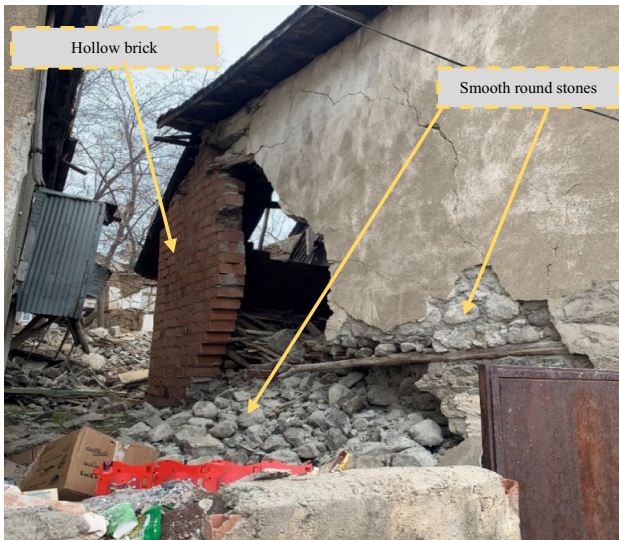
In addition, Fig. 12 shows the damage caused by the absence of horizontal and vertical beams and the irregular use of different materials.

**Fig. 12** Lack of horizontal and vertical bond beams and irregular use of different materials together

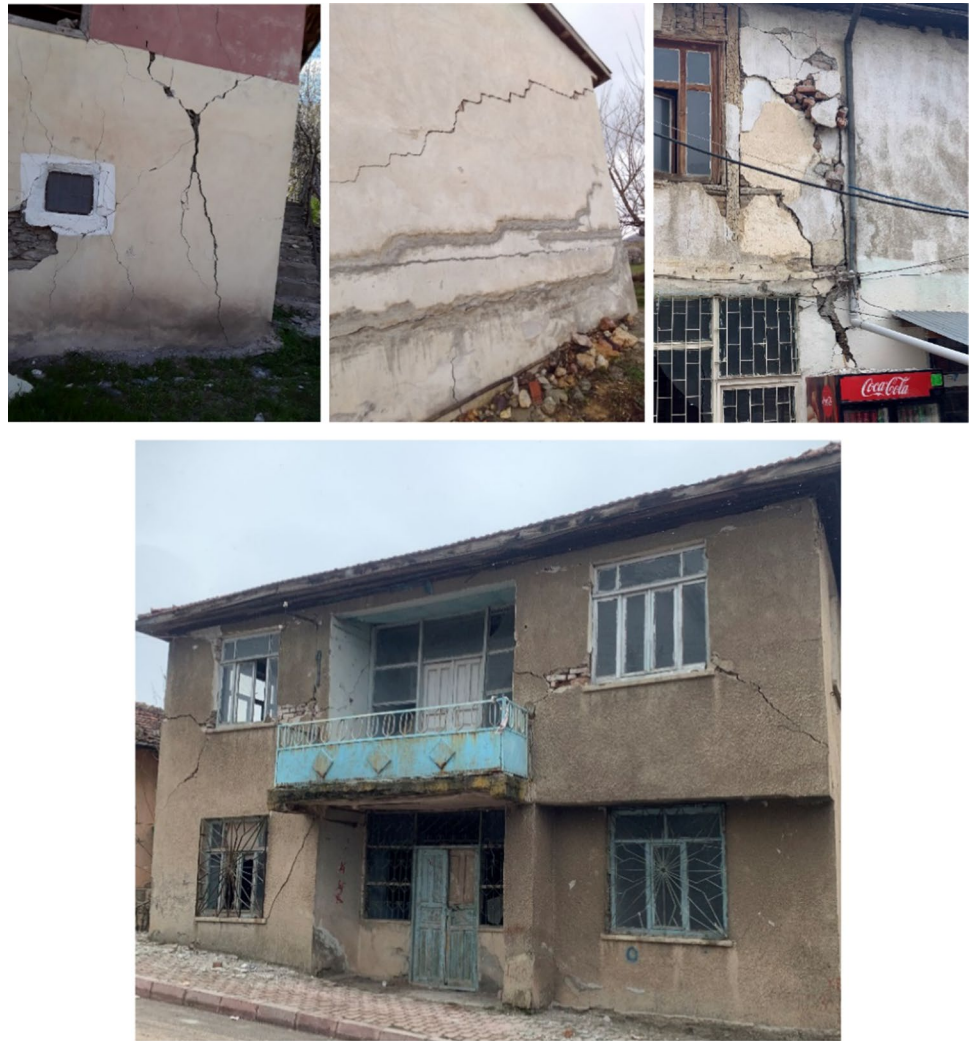
It is generally accepted that load-bearing masonry walls act like shear walls in resisting the horizontal forces caused by earthquakes. Shear forces increase with earthquake loading and in case of insufficient strength on the walls, shear cracks form and the structure is damaged. These cracks in load-bearing wall cracks can be triggered by several factors: (i) poor construction detailing and poor material properties; (ii) large window or door openings; (iii) excessive wall lengths without any side support; and (iv) insufficient interlocking between wall units. Figure 14 shows the damage due to shear cracking on the load-bearing walls of masonry buildings.

**Fig. 14** In-plane mechanism damages

In-plane mechanism damages usually occur due to the absence of tie beams that add lateral strength to the walls. Therefore, masonry walls should be constructed with sufficient and suitable vertical and horizontal beams to increase lateral seismic performance. In this regard, TBEC (2018) rules are quite clear as mentioned above.

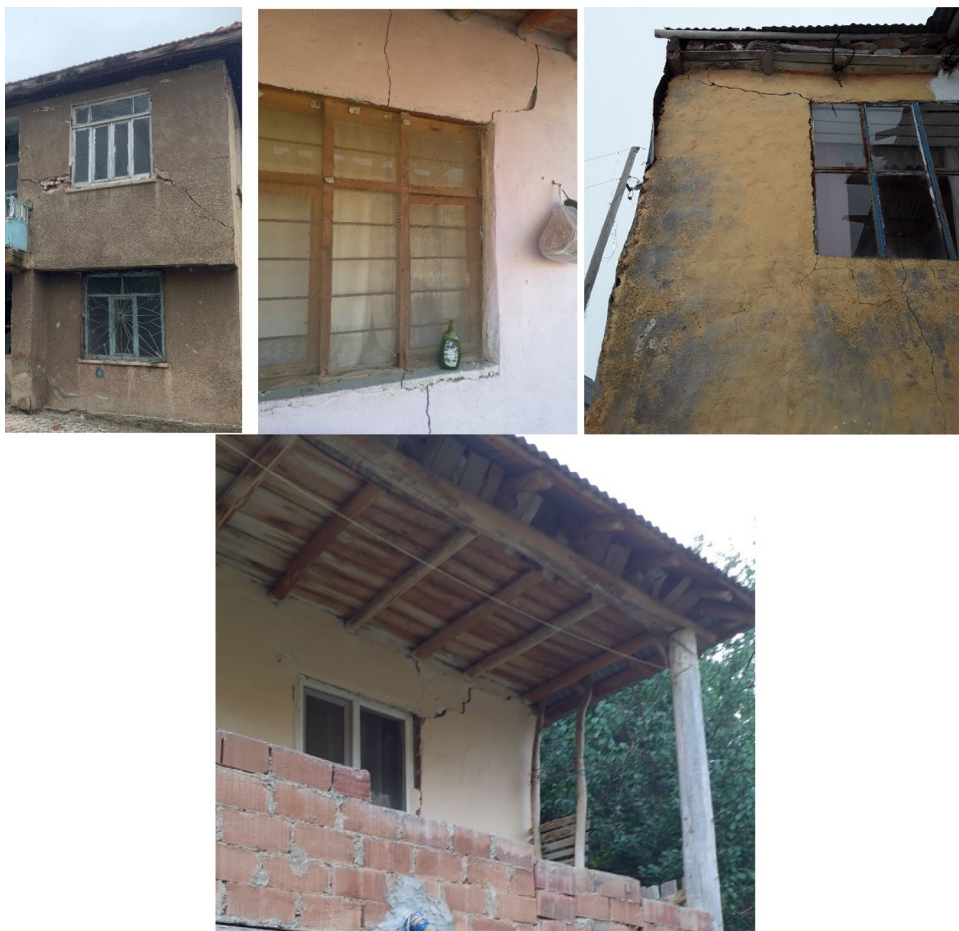
Severe cracks were also observed at the window and door corners of the masonry buildings in the field area. The main causes of these damages are the absence of lintels or insufficient lintel length (Fig. 15).

**Fig. 15** Examples of cracks at corners of windows and doors of masonry buildings in Sivrice district

In order to prevent such damages, TBEC (2018) has specified the necessary rules about the dimensions of the door and window openings and the lintel lengths. Reinforced concrete lintels will be built above the door and window spaces. The length of the parts of the lintels that rest on the wall shall not be less than 200 mm. The lintel height shall not be less than 150 mm. The rules given in Fig. 16 shall be complied with in the door and window spaces to be left on the load-bearing walls.

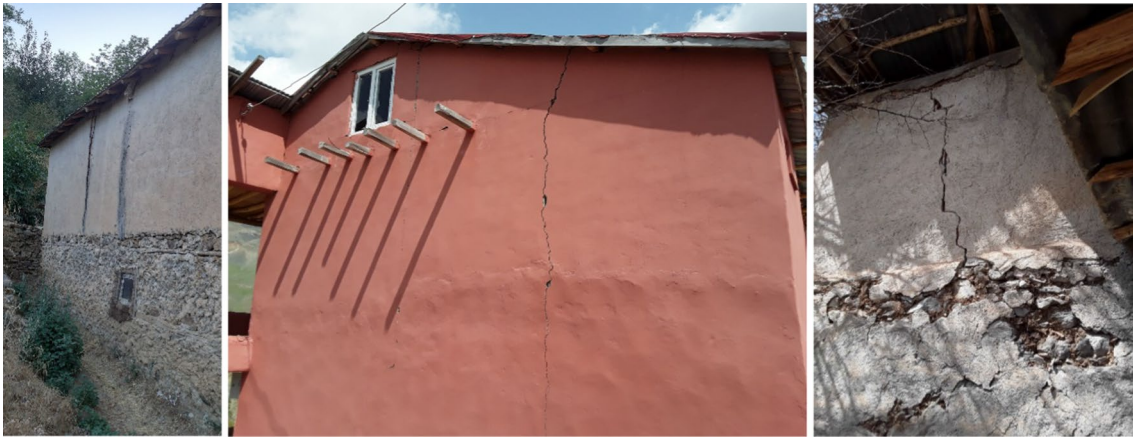
Another damage seen in the fieldwork after the earthquake is cracks in masonry walls with weak load-bearing capacity

(Fig. 17). Earthquake Regulations have introduced some standards to prevent such damages and for masonry buildings to have a certain foundation capacity against vertical and horizontal forces.

**Fig. 17** Vertical cracks in low-strength masonry

In this line, TEC (1998) and (2007) stated that masonry walls can only be used in basements and ground floors, and the minimum thickness of load-bearing walls is limited to 0.50 m. The storey height is limited to 2.70 m and 3.0 m from the top of each floor to the next in adobe and stone masonry buildings. In addition, according to the current regulation, TBEC (2018), some rules have been introduced for masonry walls under the shear force (Table 3).

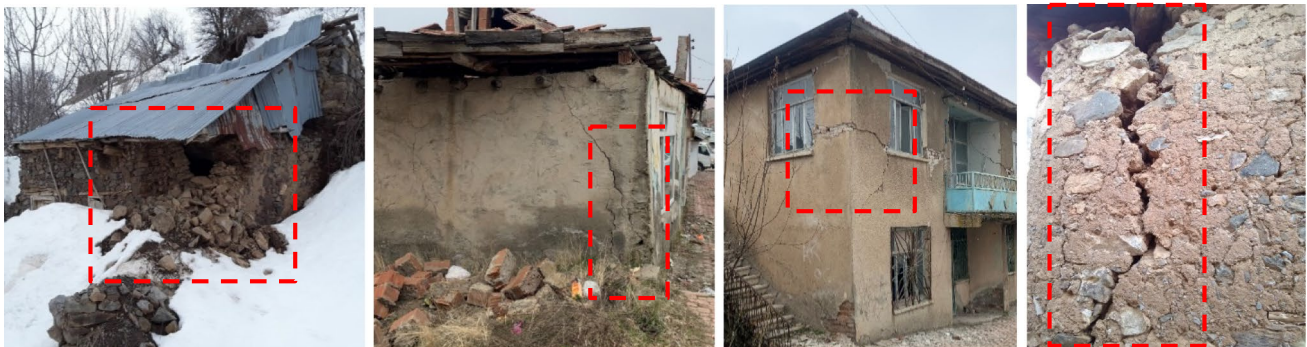
One of the major damages seen in existing masonry buildings in earthquake-affected areas is corner failure. This damage type results from poor wall-to-wall connections when forced by the out-of-plane mechanism. In case of an earthquake, vertical cracks develop, and wall corners are separated. Serious damages are caused because of weak connections among adjacent walls and the absence of bond beams. The corner damages at different buildings are shown in Fig. 18.

**Fig. 18** Examples of corner damages

It is understood that the connections of the perpendicular walls of the masonry buildings are very important when looking at the damage in the pictures. Therefore, in masonry buildings, attention should be paid to the wall connections and should be designed in such a way that the system behaves as a whole.

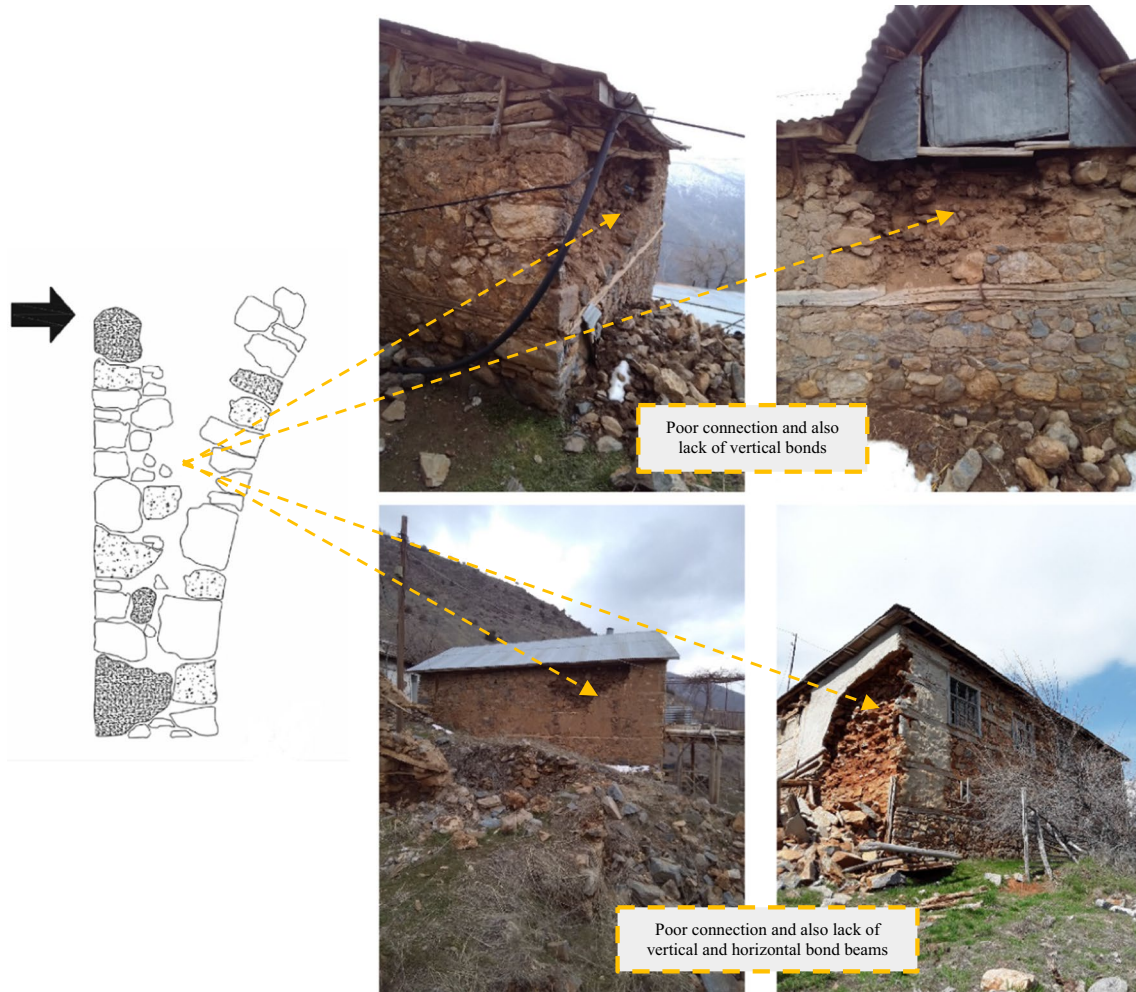
masonry leaves connected with a considerably weaker, filler material, usually made of rubble and mortar and have a high percentage of voids. However, connections of these multi-leaf walls are weak generally. This weak joint results in the two leaves working almost independently, which may bring about their separation and therefore subsequent failure Valluzzi et al. (2001) under combined lateral and axial loading (Fig. 19). During the field survey, masonry structures damaged as a result of this weak connection were encountered (Fig. 20).

It was observed that the masonry buildings built in rural areas were damaged due to the above-mentioned reason under the influence of the earthquake.

Fig. 20 Walls poorly constructed stone masonry building
