Protection of interrupted concrete structure to prevent degradation: a case study

Abstract

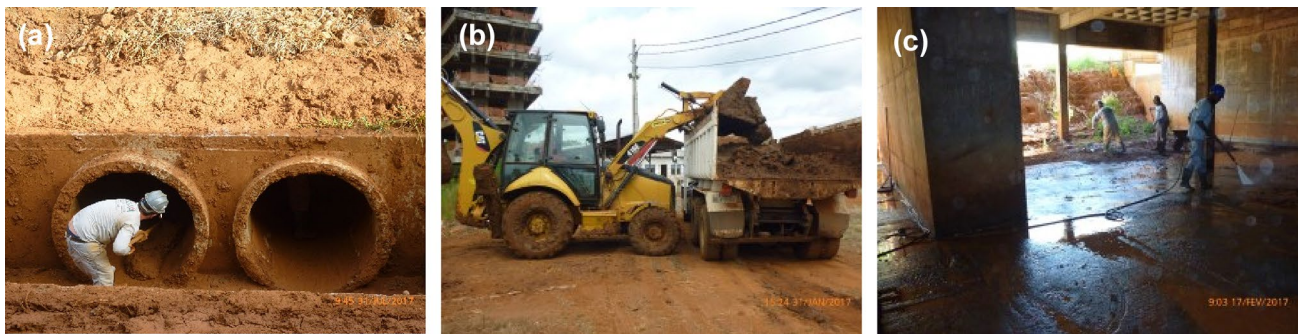
Fig. 11 a Cleaning services; b galleries mud removal; c main building underground cleaning

Firstly, the accumulated mud was removed from underground technical galleries Fig. 11a). To remove the mud, mechanical equipment (mini loaders, backhoe loaders, excavators) and manual equipment (shovels, wheelbarrow, etc.) were used. Fig. 11b). Cleaning services were conducted by applying water jet Fig. 11c).

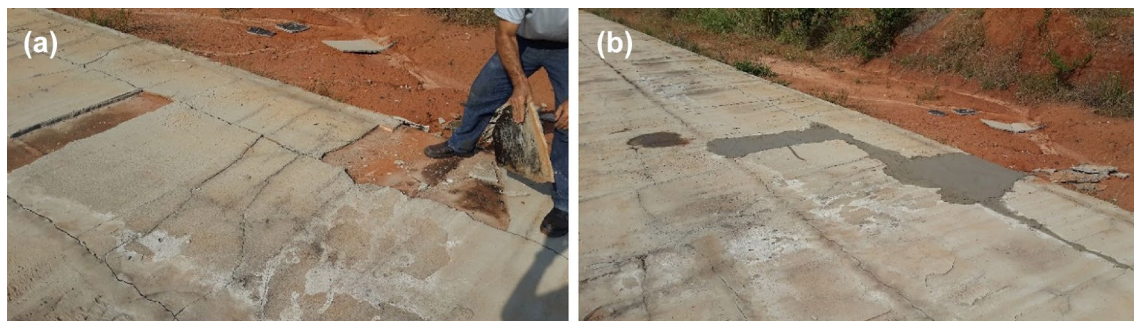
During recovery actions, visual inspection was made on existing structures, identifying locations where mechanical protection had failures (cracks and displacement) and/

or it was not performed. Where failures were found, the existing waterproofing system (membranes and protection) was removed, and it was replaced by a new system (double polymeric cover for gallery ceiling and utility center, and painting on gallery walls). The polymeric cover was mechanically protected before structures grounding, as

Fig. 12 a Removal of degraded waterproofing system; b correction of the same system

When construction execution services was interrupted, part of structures waterproofing systems was not adequately protected, and it suffered degradation due to weather exposure Fig. 12. As water is one of main degradation agents of concrete structures, waterproofing systems are important in ensuring their durability [32]. With this concern, waterproofing services were conducted, such as recovery of completed

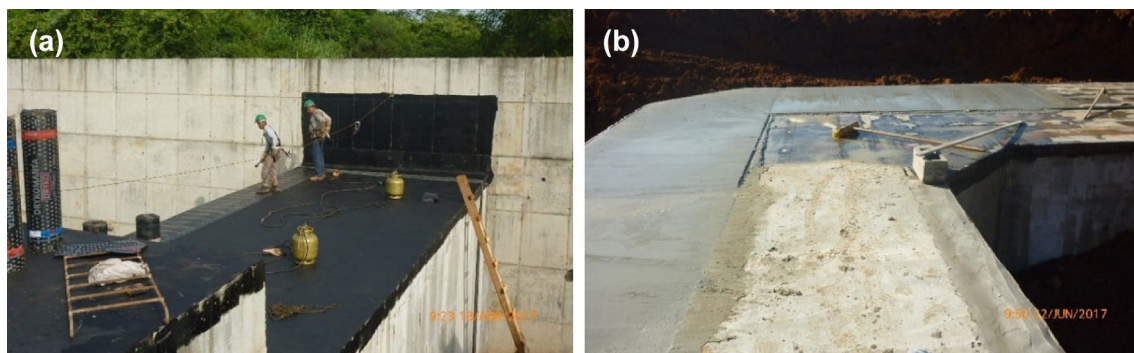
Fig. 13 a Blanket application of the waterproofing system; b application of the mechanical protection

systems with damage Fig. 13b and new systems implementation Fig. 13a, b.

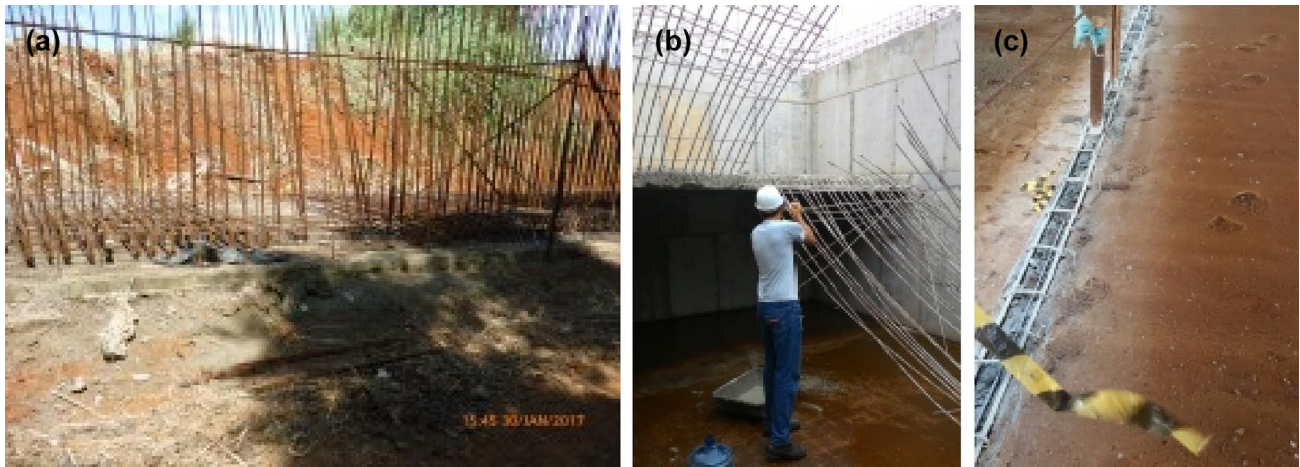
Fig. 14 a Reinforcement without protection; b cement paste treatment; c protection with cement paste

The exposed reinforcement cleaning—start bars—Fig. 14a was performed with water blasting (on all

existing structures). Subsequently, cement paste was manually applied Fig. 14b, c with the proportion 1:1 (cement:water). Among the main protection systems for exposed reinforcement (such as polymeric cement mortars), cement paste without additives was chosen due to its easy application, low cost of acquisition and considering materials in stock (cement and water), avoiding bidding necessity.

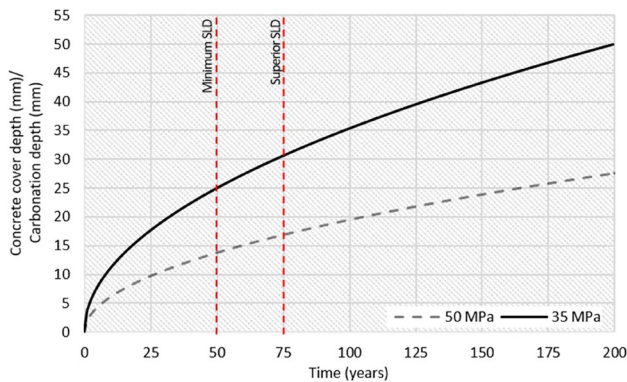
Fig. 15 Simulation for design service life (DSL) and superior performance levels as a function of concrete compressive strength

[37]. Figure 9 presents the simulation result for the structure under study considering concrete degradation by carbonation action over time, in order to evaluate the structure DSL. For the simulation, the conditions of the structure's exposure environment were included the model (Eq. 1), considering the average relative humidity 73% and a CO_2 content of 0.038% (380 ppm), for the outdoor, sheltered from rain condition. Pozzolanic Portland cement with 7% and 8% of silica fume was used to produce concrete with compressive strength of 35 MPa applied in slabs and columns and 50 MPa used in columns, respectively.

According to NBR 6118 [34]—which is equivalent to ACI 318R-19:2019—the structure under analysis is in a zone of moderate aggressiveness (Class II, urban environment), with small deterioration risk. Using Eq. 1 for simulate the carbonation advance over time Fig. 9, a period of 235 years can be estimated or CO_2 to reach the reinforcement in columns and slabs (compressive strength 50 MPa and concrete cover 30 mm). Thus, it is noted that the structure will possibly meet NBR 6118 [38] as well as the Performance Standard regarding the minimum service life of 50 years, NBR 15575 [39]—equivalent to EN 1992-1-1:2014.

For the slabs, with 35 MPa compressive strength and 25 mm cover thickness the simulation indicated a 48-year service life, so that the carbonation front is equal or greater than the concrete cover thickness used. This value is slightly below the minimum SLD stipulated in the Brazilian performance standard [39], which is not desirable from a durability standpoint. Possan [40] reports that Portland cement without

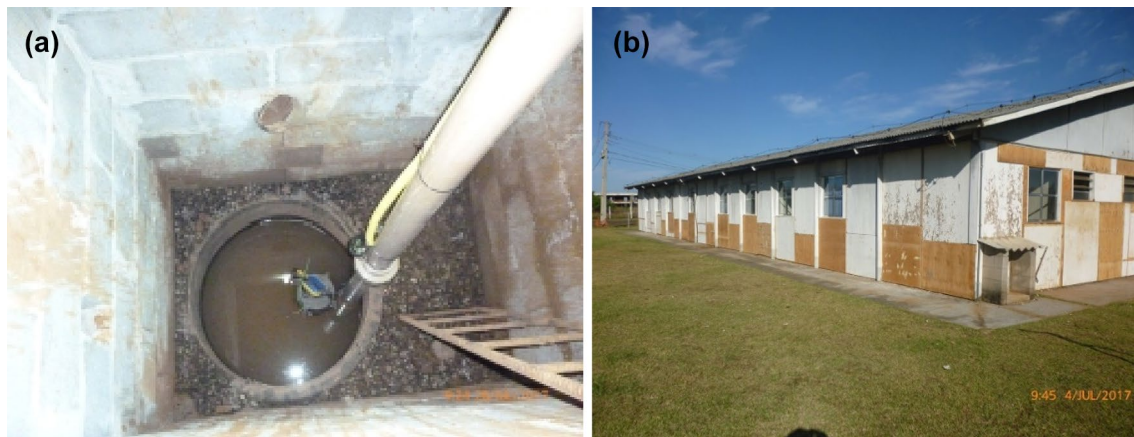
Fig. 16 **a** Drainage well executed; **b** existing temporary structure

After cleaning central building underground, two sewage pumps with automatic drive were installed to prevent flooding in this space. These machines are in permanent operation. The drainage system was also finalized Fig. 16a and a retaining wall execution, both located near to the utility center, in order to finish the campus earthworks services.

In direction of maintain NR 18 minimum conditions [38], so that construction provisional installations could be reused Fig. 16b), wooden walls transformed and/or damaged were replaced by new elements. The roof was also repaired with damaged roofing tiles replacement. Finally, areas were isolated to provide safety, with doors and barriers installed to prevent access to buildings or part of them and to prevent possible accidents and thefts.
